## **APPENDIX A**

### **PREP CHANNEL CROSSINGS ON TRIBUTARIES OF THE MIDDLE AND LOWER EXETER RIVER**

**Exeter River Stream Crossing Assessments**

Survey Conducted on August 13 and 14, 2009

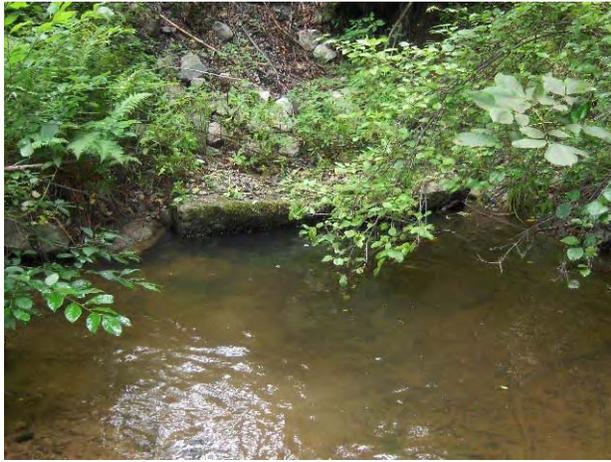
Inlet

Sediment Continuity – Elevation of sediment deposits upstream is greater than ½ bankfull elevation

Additional problems noted: Inlet of culvert obstructed by wood and sediment; culvert is likely 6 foot wide by 2.5 foot wide, but so much sediment has aggraded within the structure that it is significantly blocked at the upstream end; water in crossing is deeper and slower than stream.

**Priority for Replacement - High**

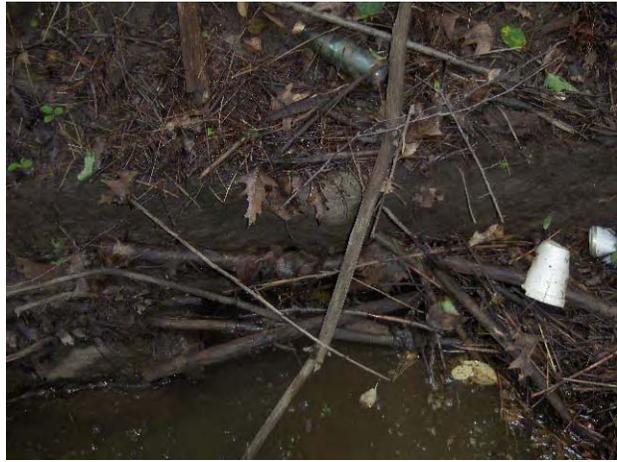
Outlet – at grade

Erosion and Armoring – Sharp bend below structure with high bank erosion downstream

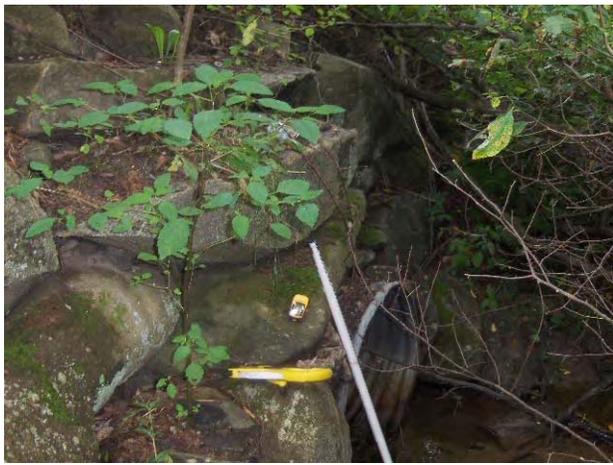
Inlet

Sediment Continuity – Elevation of sediment deposits upstream is greater than ½ bankfull elevation; mid-channel bars upstream and downstream of structure

**Priority for Replacement - Moderate**

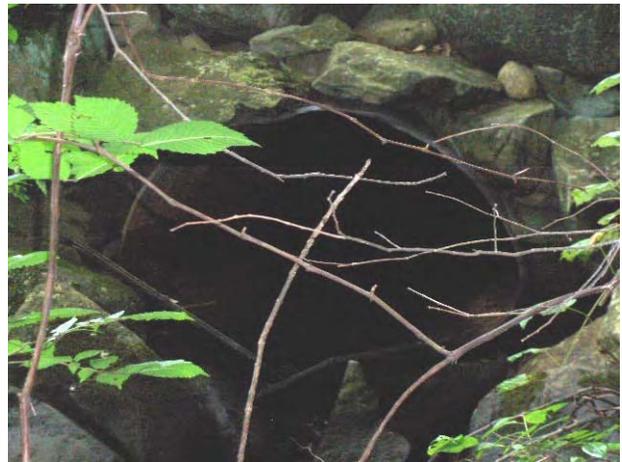
Outlet – cascade

Erosion and Armoring – Downstream bank armoring failing; high bank erosion (widening) below structure

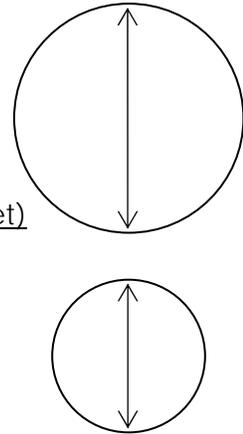
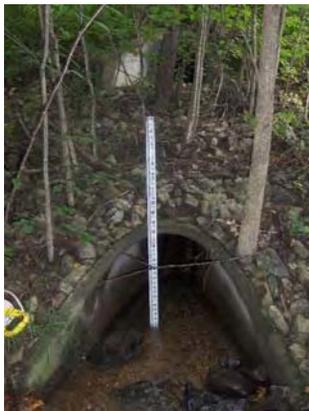
Inlet

Notes: Crossing has two stacked culverts. Base flow culvert below is small; 2 foot diameter and overflow culvert is significantly larger 3 foot diameter.

**Priority for Replacement - Moderate**

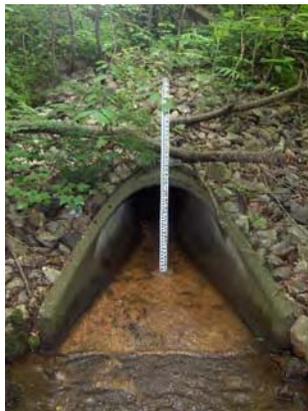
Outlet – at grade

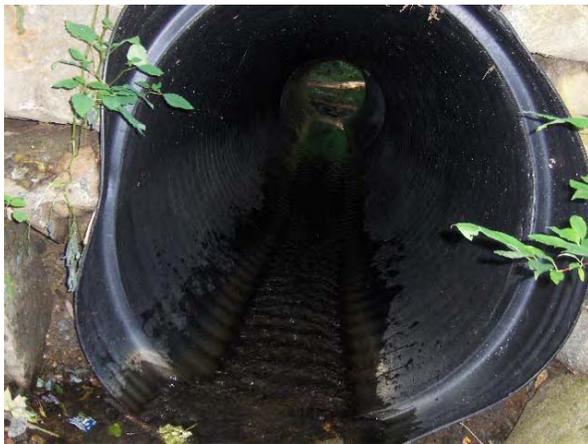
Inlet

Notes: Upstream of culvert the channel has good floodplain access and wetland vegetation. However, this culvert is new and has been installed without regard to fish passage and hydrology. It is undersized and severely perched.

**Priority for Replacement - High**

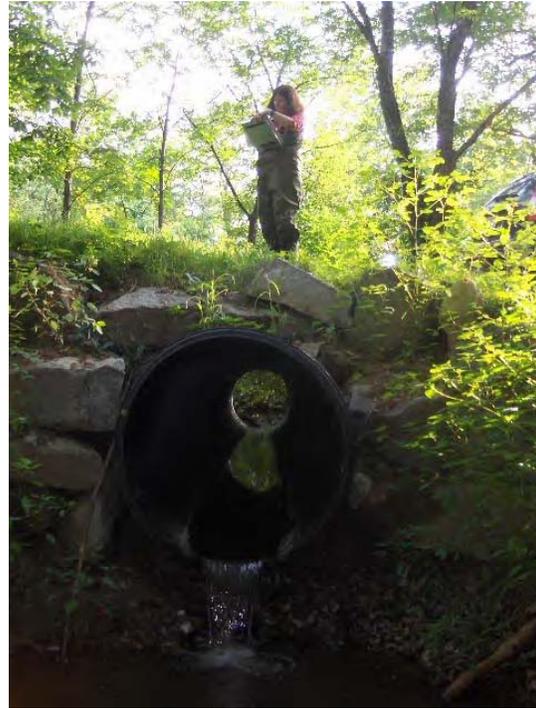
Outlet – freefall

- Outlet freefall and outlet drop greater than 1 foot
- Outlet freefall and water depth at outlet less than 0.3 feet

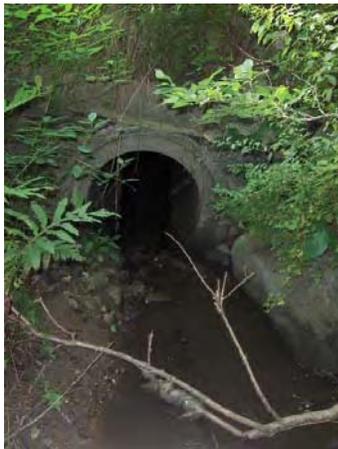
Inlet

Notes: Undersized and fish passage issue; water in crossing is shallower and faster than stream

**Priority for Replacement - High**

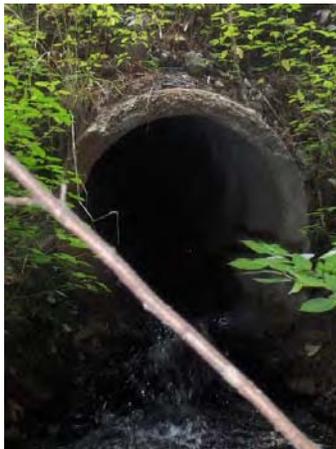
Outlet – freefall

Erosion and Armoring – Coarse gravel sized material on the slope between the culvert and road on the downstream end is washing into the channel; bank erosion high above structure

- Outlet freefall and outlet drop greater than 1 foot
- Outlet freefall and water depth at outlet less than 0.3 feet

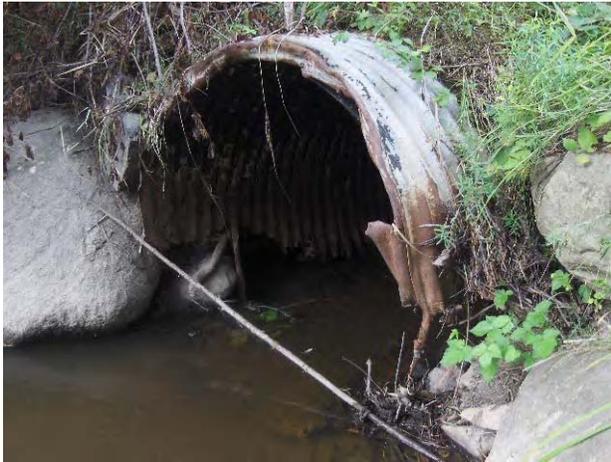
Inlet

Notes: Culvert is perched and the bottom is rusted out at the upstream end. This culvert is in poor condition and should be replaced. A wetland is located upstream of the culvert, so no bankfull measurement could be made.

**Priority for Replacement - High**

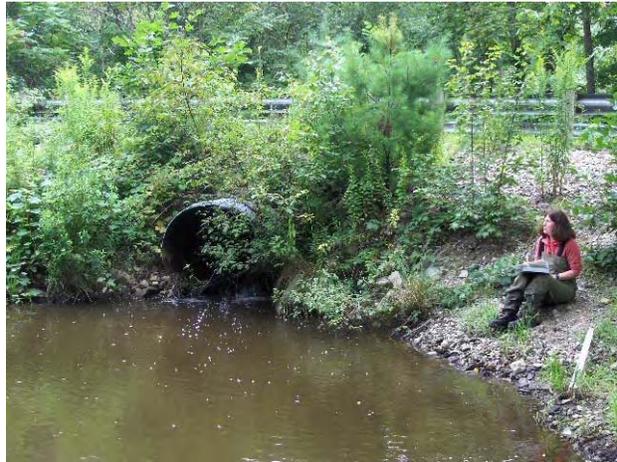
Outlet - cascade

Erosion and Armoring – No bank erosion was noted; however, hard bank armoring is failing above and below the structure.

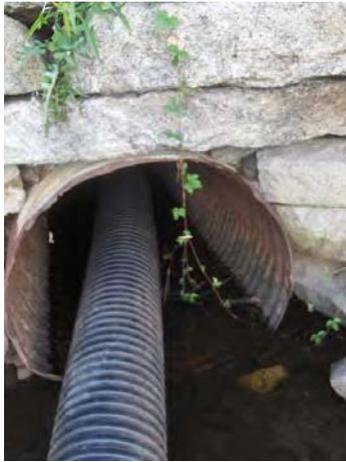
Inlet with beaver baffle

Notes: Structure has a beaver baffling device through it that extends out into the upstream wetland. No beaver activity was noted at the time of the survey; but the site has the potential to be dammed that could lead to flooding.

**Priority for Replacement - High**

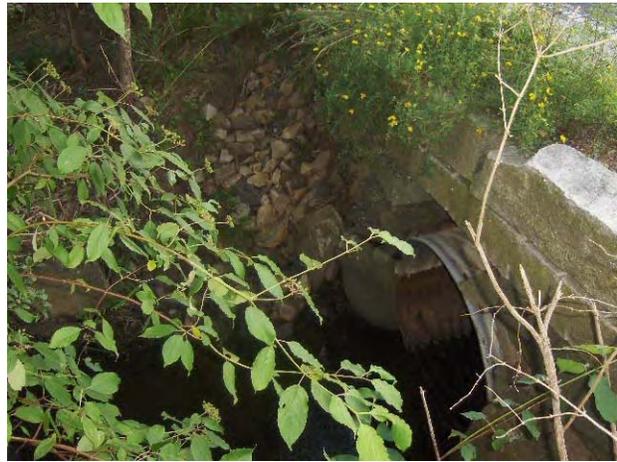
Outlet at grade

Erosion and Armoring – No bank erosion was noted; however, hard bank armoring is failing below the structure.

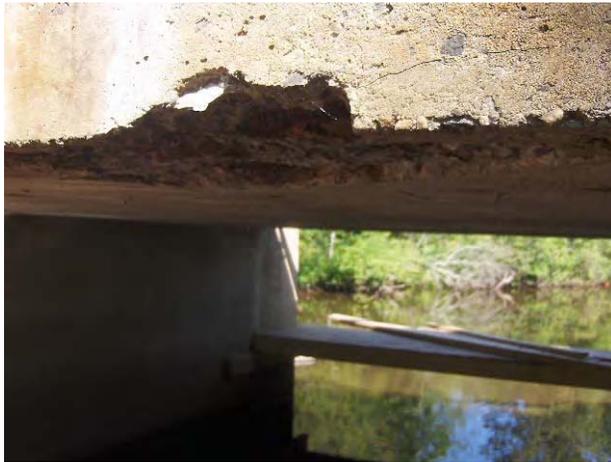
Erosion of the bridge underside looking downstream at the inlet

Notes: Structure is a severe constriction. Degradation to the road surface and underside of the structure was observed. Structure was being restored at the time of the survey. Poor erosion control was noted, including a failing silt fence.

**Priority for Replacement - Low**

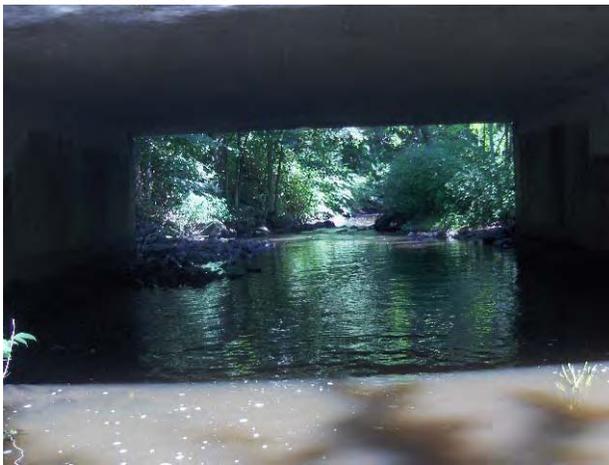
Bridge Inlet

Notes: Structure located about 100 feet downstream of a crib dam. The structure is a channel constriction, but does not appear to be causing localized geomorphic instability. Japanese knotweed is present downstream of the bridge.

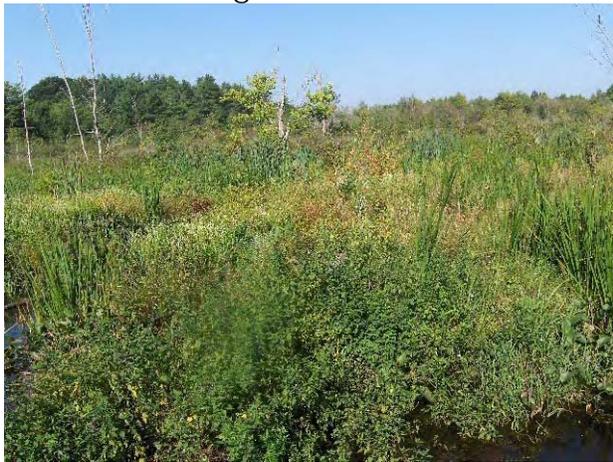
Wetland Upstream

Additional problems noted: The capacity to handle large flood events at this structure site is very low. The road has reportedly been flooded over with water during large storm events.

**Priority for Replacement - High**

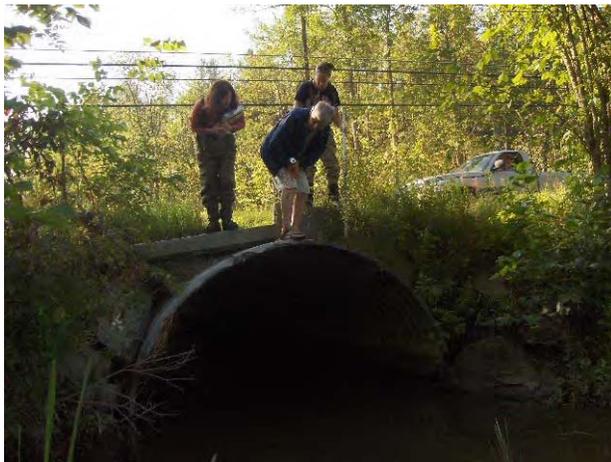
Inlet

Additional problems noted: The capacity to handle large flood events at this structure site is low.

**Priority for Replacement - High**

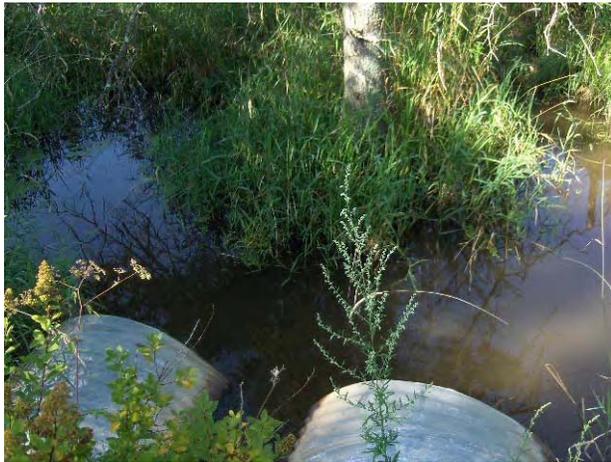
Inlet

Additional problems noted: The two culverts to the north are partially rusting out on the bottom; this could be problematic in the future.

**Priority for Replacement - Moderate**

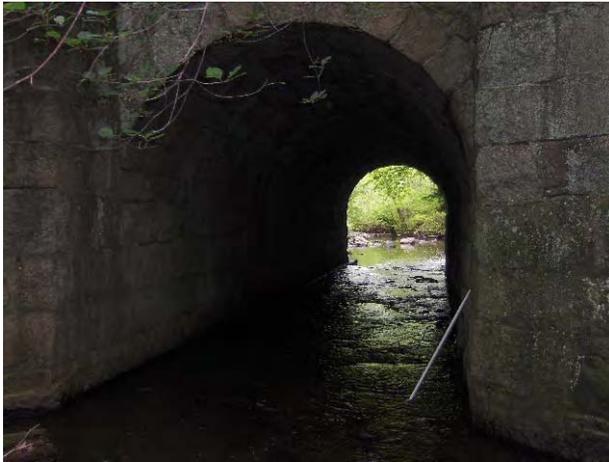
Inlet

Erosion and Armoring – High degree of bank erosion was observed up and downstream and hard bank armoring was failing up and downstream

Additional problems noted: Channel is braided downstream and appears to enter into a wetland approximately 1,000 feet downstream. The structure is robust, but the constriction has led to some aggradation upstream in the form of bars, and some bank erosion and a large pool downstream. The bottom of the structure is lined with large slabs of stone.

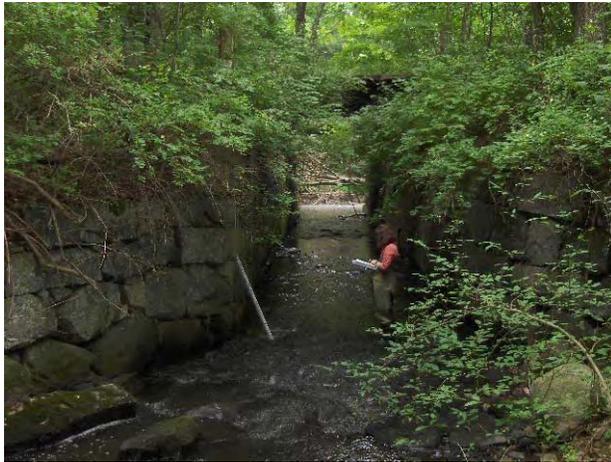
Inlet

jam Additional problems noted: Bridge assessment is for two individual crossings that have the same stone sidewall structure for 130' the downstream crossing is the B & M Railroad Bridge and the upstream crossing is a small bridge that is part of a private driveway. The channel bed within the structure is large rock slabs, similar to the arch downstream.

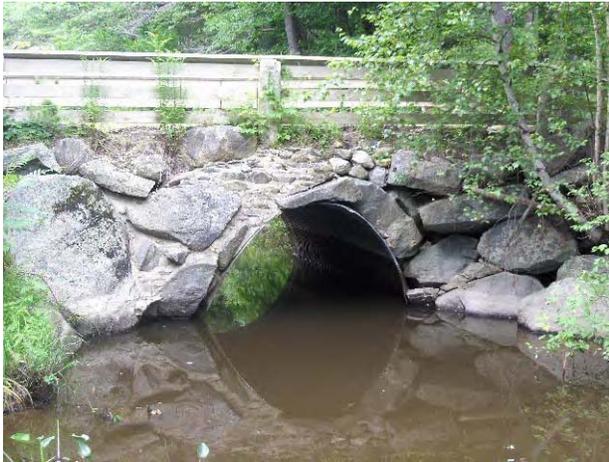
Inlet

Additional problems noted: Culvert is a squashed culvert that is a bankfull and floodprone channel constriction. Upstream of Bioteau Drive crossing the west bank had some gravel that seems to have been placed there. The culvert bottom is rusted at the inlet.

**Priority for Replacement - Moderate**

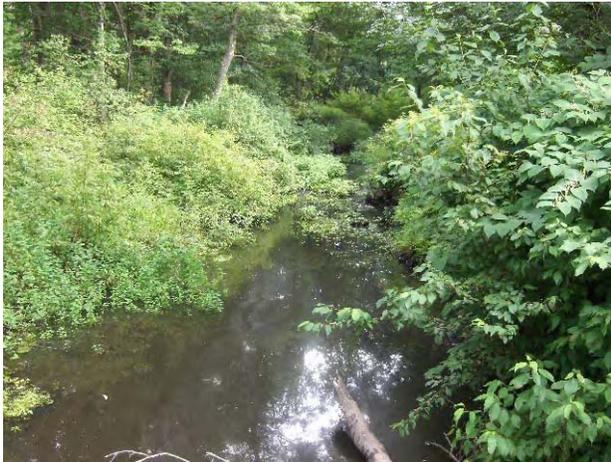
Upstream from Inlet

Additional problems noted: Structure is a bankfull and floodprone constriction. There were invasive herbaceous species noted at this crossing; both purple loosestrife and Japanese knotweed. Aerial imagery shows ponding in the upstream channel approximately 250 feet above.

**Priority for Replacement - Moderate**
