APPENDIX C

ASSESSED CHANNEL CROSSINGS IN THE MIDDLE EXETER RIVER BASIN

**Middle Exeter River
Brentwood, NH**

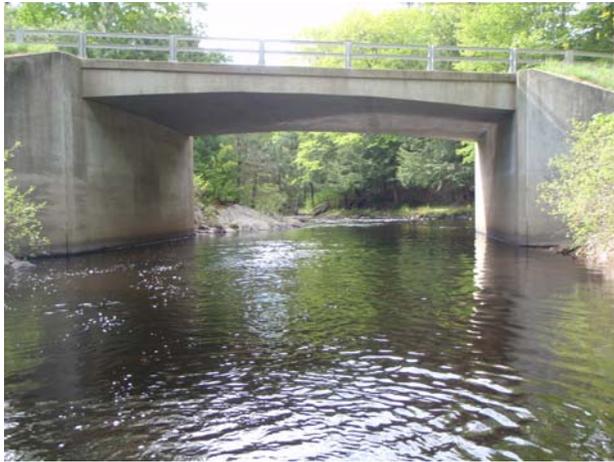
Bridge Inlet

Geomorphic Compatibility – Mostly Compatible

Percent Bankfull Width –Undersized (59%)

Erosion and Armoring – No bank erosion up or downstream; armoring is intact both above and below the structure

Sediment Type in Structure - Sediment within the structure is mostly gravel and cobble

Additional notes - Structure has bedrock grade controls downstream and within. The Haigh Road crossing is where the USGS gage site is located; the pressure transducer is located downstream of the structure where the bedrock grade control is found.

Priority for Replacement - Low

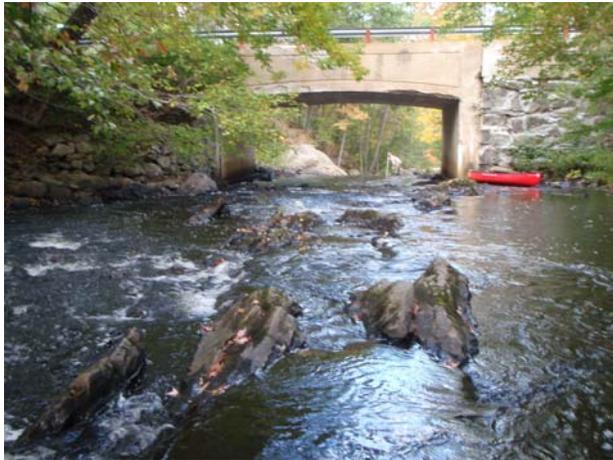
Bridge Inlet

Percent Bankfull Width – Significantly Undersized (46%)

Additional notes - Structure has bedrock grade controls within and the Crawley Falls are located downstream. Upstream of the structure the channel is narrowly confined by the valley, the increase in stream power caused by the valley setting may be responsible for some of the deterioration of the wing-walls/abutments.

Priority for Replacement - Moderate

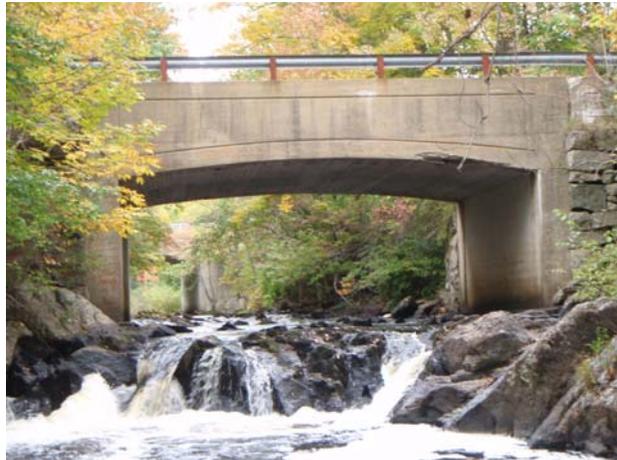
Bridge Outlet; Crawley Falls

Sediment Type in Structure - Sediment within the structure is mostly bedrock with loose, coarser material on top

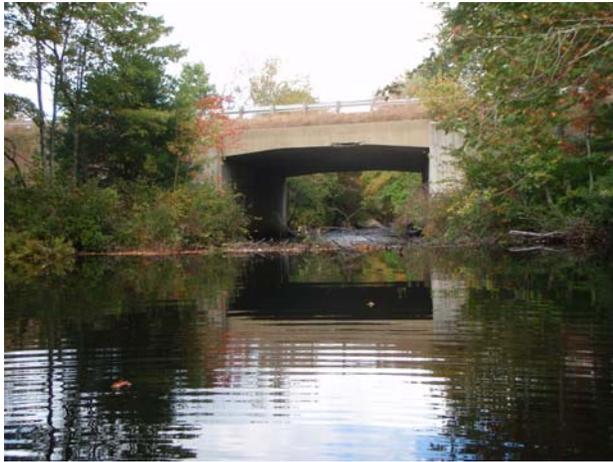
Bridge Inlet; Beaver Dam

Percent Bankfull Width – Significantly Undersized (47%)

Additional notes - Structure appears to be new, but is still undersized. Water upslope of the structure has been impounded recently by a beaver dam that is built on coarser boulder materials piled near the inlet.

Priority for Replacement - Low

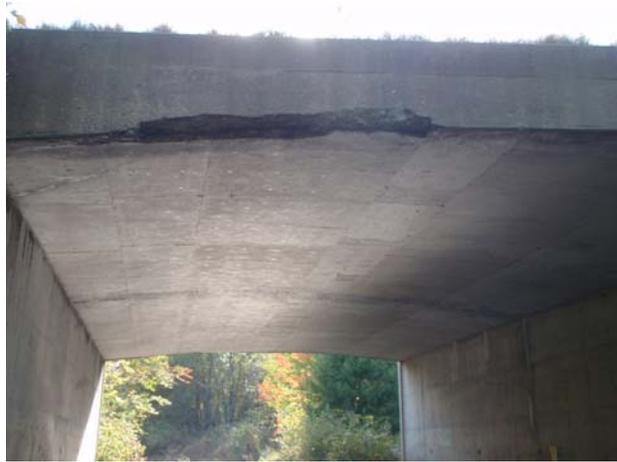
Bridge Outlet; Concrete Deterioration

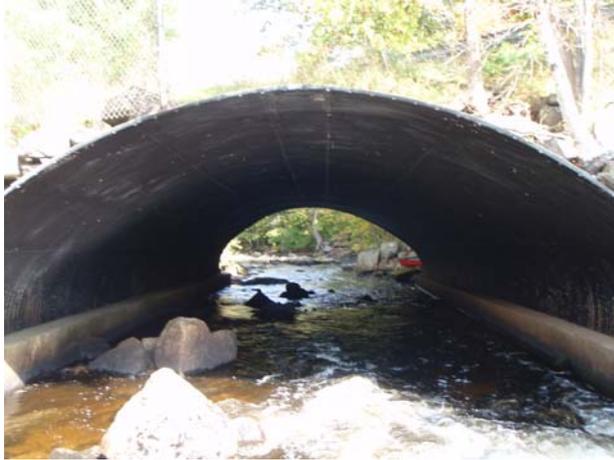
Arch Inlet

Percent Bankfull Width – Significantly Undersized (48%)

Additional notes - Large arch structure with limited problems. The mill withdrawal and dam is located about 75 feet upstream of the inlet. The new penstock is located on the right bank and the old is located on the left bank, both outflows come into the channel immediately upslope of the arch. The extent of modifications to the channel flow and discharge at this site is not known.

Priority for Replacement - Low

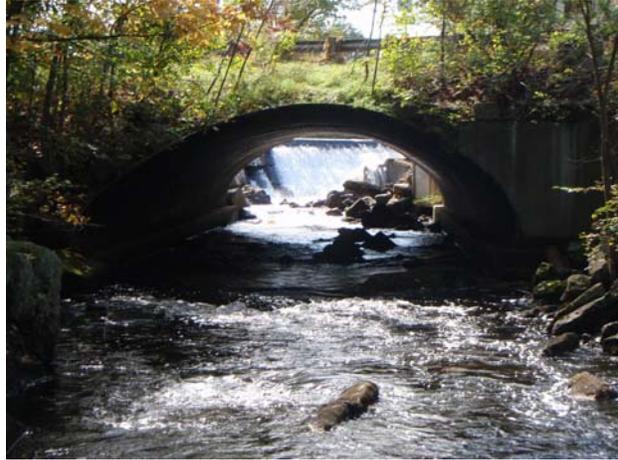
Arch Outlet; Dam Upstream

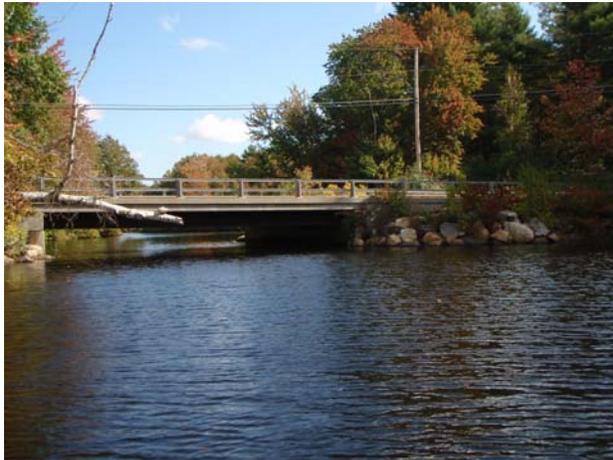
Bridge Inlet

Percent Bankfull Width – Undersized (63%)

Additional notes - Structure has very low clearance from the height of the water surface to the bottom support beam (3.5 ft). However, the channel is impounded from the dam downstream so flows through the structure and flood capacity is controlled by the dam, making the flood capacity data for flood events an approximation under normal hydrologic conditions.

Priority for Replacement - Low

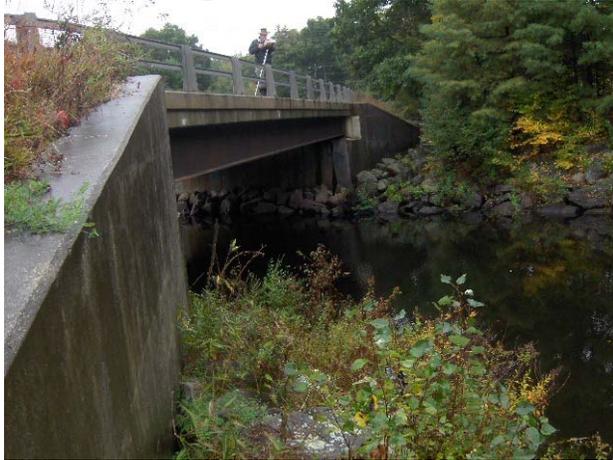
Bridge Inlet

Erosion and Armoring – No bank erosion upstream and low bank erosion downstream; armoring is intact both above and below the structure

Additional notes - Structure has some alignment issues, but is new, robust and stable.

Priority for Replacement - Low

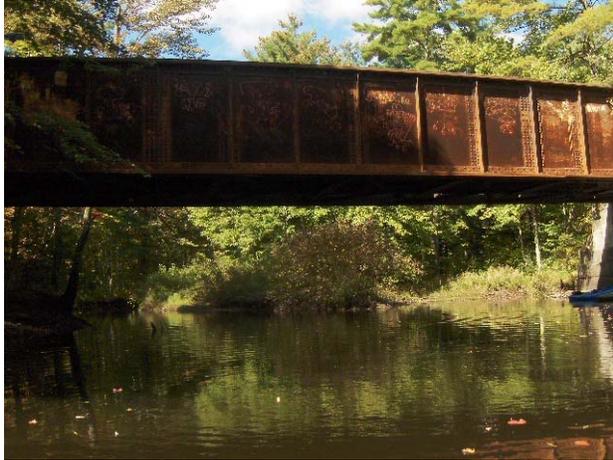
Bridge Inlet

Erosion and Armoring – Bank erosion is high upstream and low downstream of the structure; armoring is intact both above and below the structure

Additional notes - Old structure, but very robust and stable; some erosion upstream

Priority for Replacement - Low

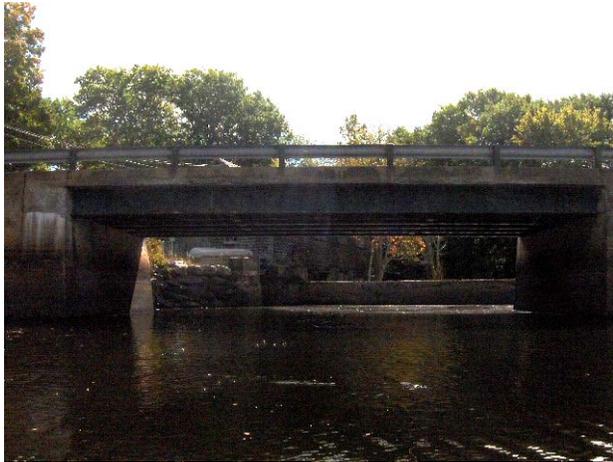
Bridge Inlet

Percent Bankfull Width - Undersized (67%)

Additional notes - Old structure (built in 1941) with some structural issues. Dam owner reports water spilling over road during floods of 2005 and 2006

Priority for Replacement - Low

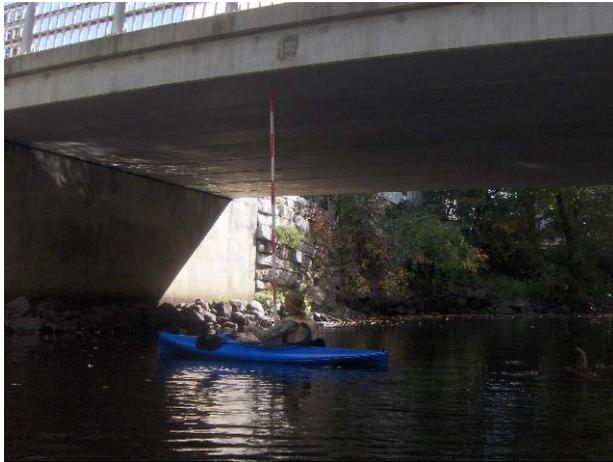
Bridge Inlet

Percent Bankfull Width – Undersized (71%)

Erosion and Armoring – High bank erosion upstream and none in immediate vicinity downstream; hard bank armoring above and below intact

Priority for Replacement - Moderate

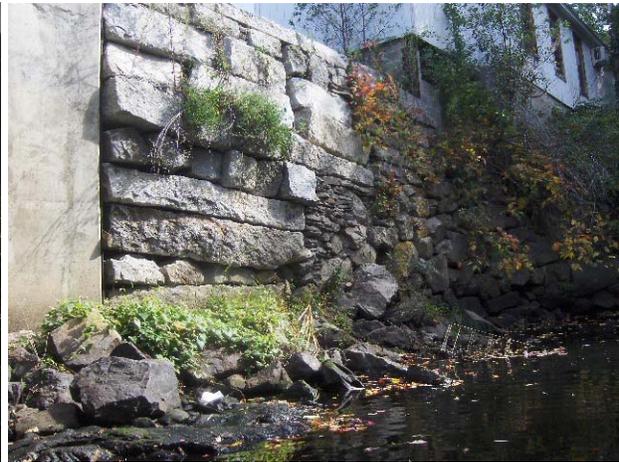
Stone Wall and House on Bank below Bridge

Additional note - Large amounts of hard bank armoring and riprap could be impacting downstream channel; structure largely stable
