Resilient Tidal Crossings

*An Assessment and Prioritization to Address New Hampshire's
Tidal Crossing Infrastructure for Coastal Resilience*

May 2019

Prepared in partnership with:
NHDES Coastal Program – Water Division
The Nature Conservancy
University of New Hampshire

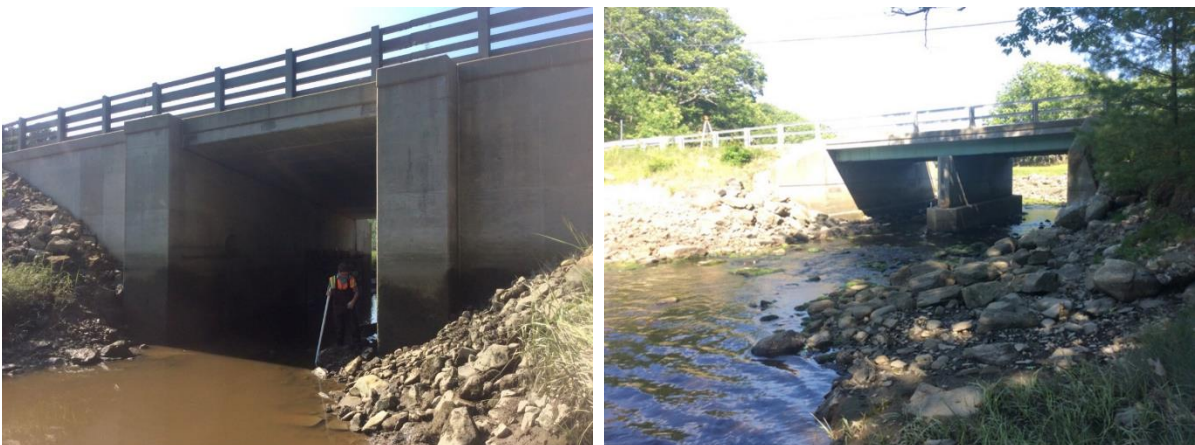
Figure 21. Crossing #95 at Johnson Creek on Route 4 (L), Crossing #60 at Berry’s Brook on Brackett Road in Rye (R). Both crossings received low priority replacement scores for Overall Combined, demonstrating a high degree of resiliency.

Despite having sufficient vertical capacity, the majority of the most resilient crossings still have insufficient horizontal capacity. As indicated in **Section 4.2 Tidal Restriction Evaluation**, 98 assessed tidal crossings have insufficient structure opening width, which has likely resulted in severe channel scour conditions at 100 crossings. Project results also show that a site can have a tidal restriction in the form of insufficient structure width and still be resilient, especially if tidal range is not significantly affected and scour isn't compromising the structure's condition.

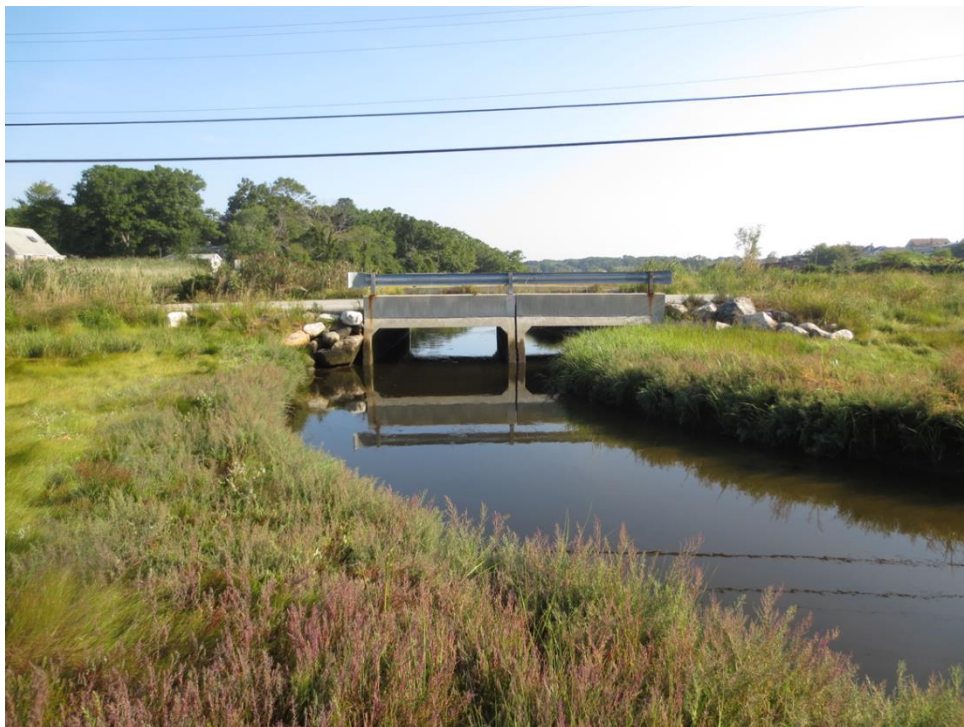
Figure 22. Crossing 54 at Parsons Creek and Wallis Road is a restoration site that received good scores for tidal range, vegetation, salt marsh migration; however, the road is very low in elevation and subject to periodic inundation and thus received high inundation risk scores.
