Furnace Brook

Watershed-Based Restoration Plan

March 2010

FB Environmental Associates, Inc.

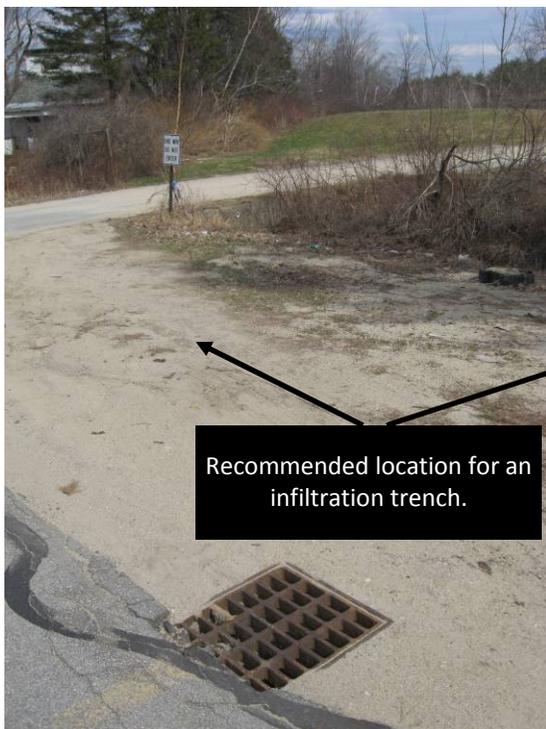
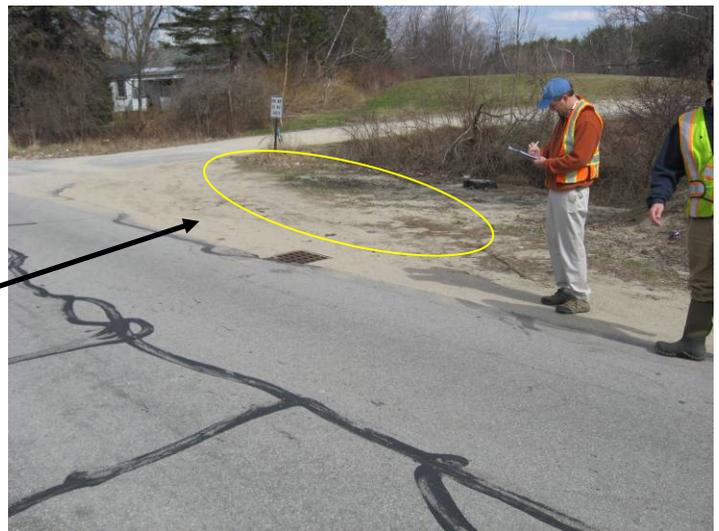
SITE RW1 (B): TEMPLE RD.

Problems: Runoff from Temple Rd. is entering Willow Brook due to a lack of an appropriate system to divert or absorb runoff. Brook also lacks a healthy buffer of vegetation.

This image highlights the unprotected banks of Willow Creek. Install native riparian vegetation to increase bank stability and increase absorption.

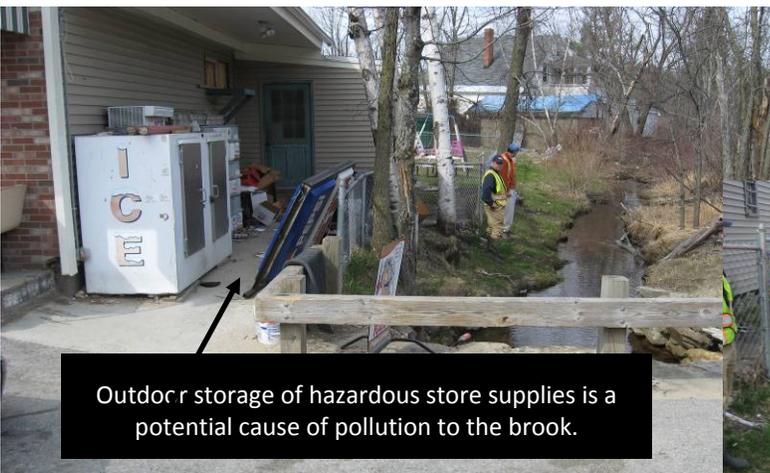
Outdoor storage of hazardous store supplies is a potential cause of pollution to the brook.

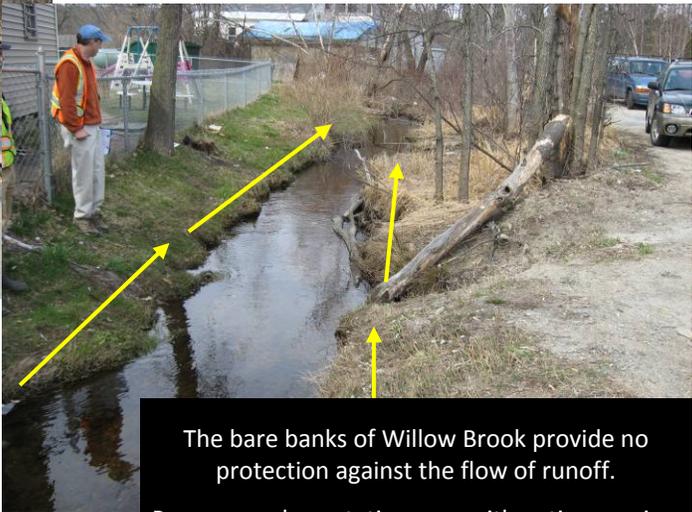
The bare banks of Willow Brook provide no protection against the flow of runoff.
Recommend vegetating area with native species.

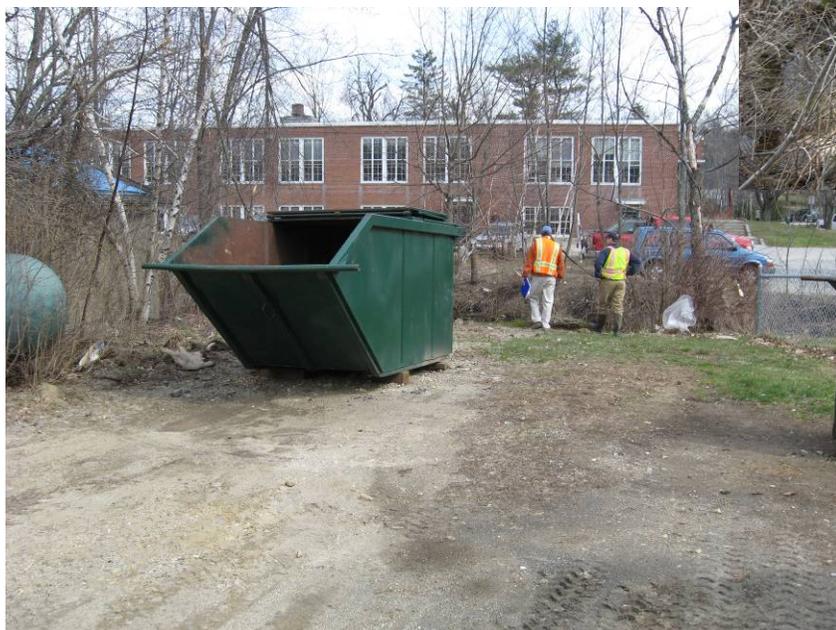
Poorly maintained dumpster area results in trash entering brook.

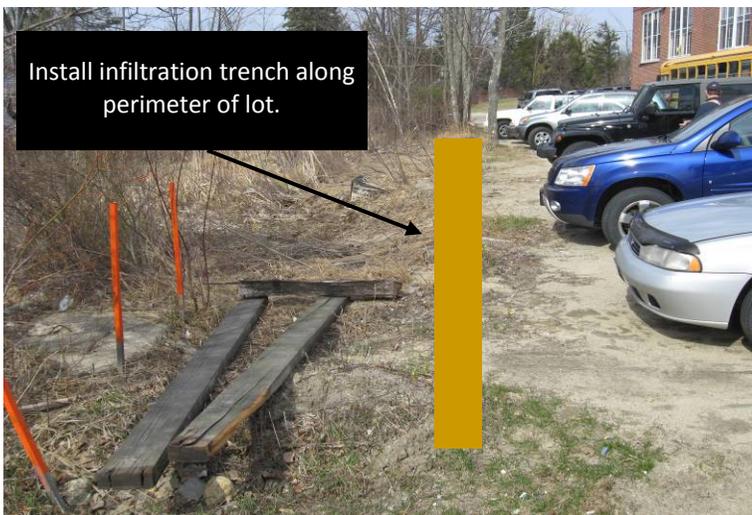
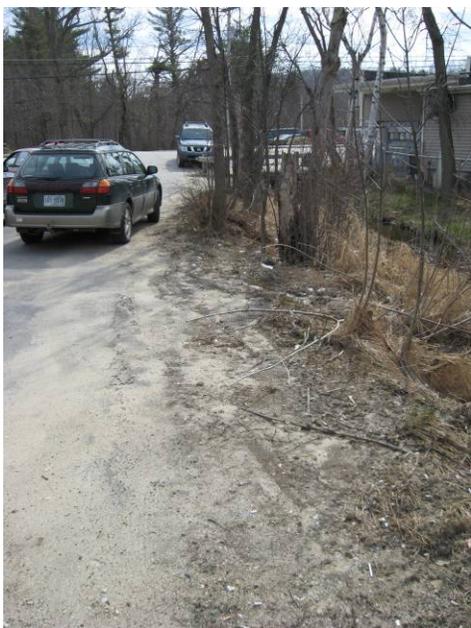
Lack of appropriate buffer between parking lot and brook results in runoff traveling unobstructed towards the water.

Sheet flow across parking area moves sediment down slope and towards brook.

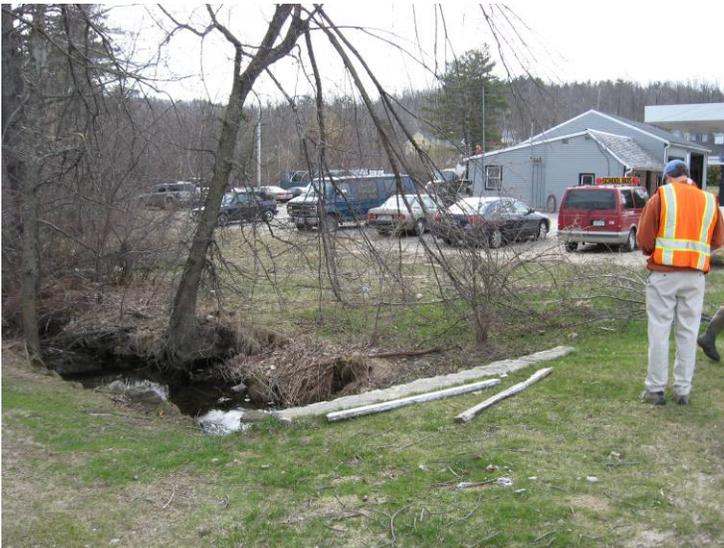
SITE RW1 (E): TEMPLE RD.

Problems: The parking lot of the Mobil Station is very close to Willow Brook and delivers contaminated runoff from the parking lot to the brook due to a lack of any type of buffer.

View of Mobil Gas Station parking area, next to Willow Brook. Installing a vegetated buffer will reduce the ability of stormwater to enter the brook.

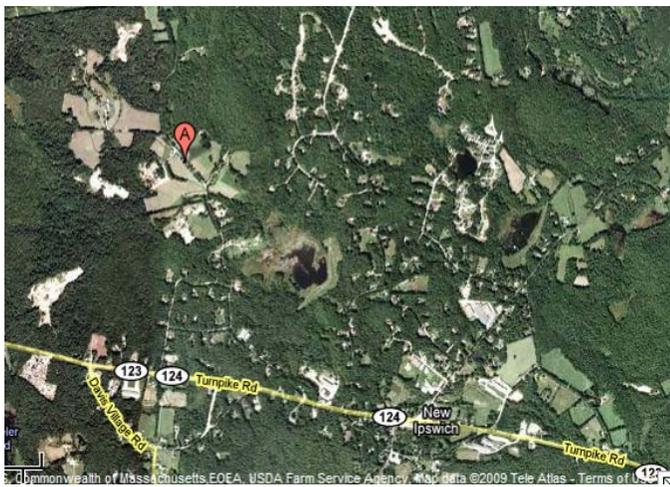
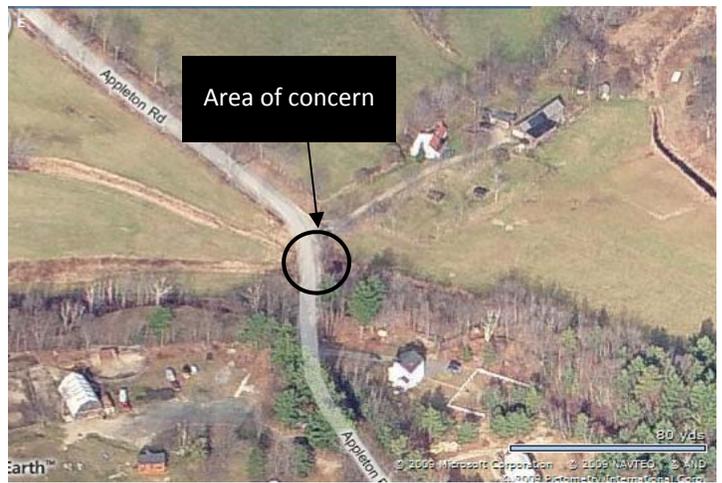
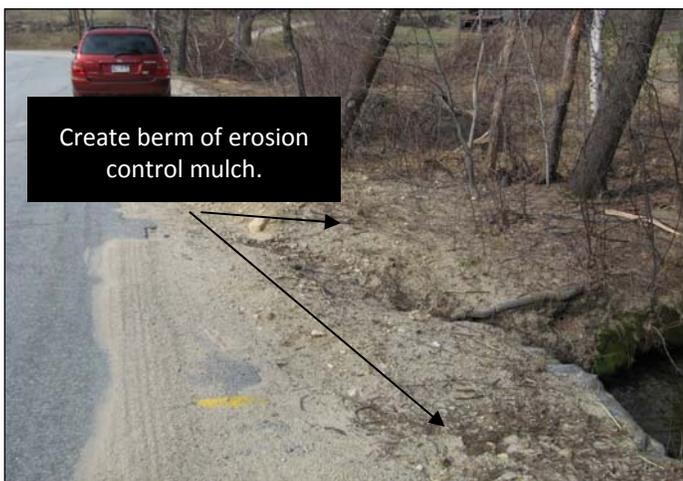
SITE RW3: APPLETON RD.

Problems: Excessive sediment build-up on road. Sediment then enters the brook via severely eroded banks surrounding the culvert.

Built up sediment along roadway enters brook through unprotected areas around culvert.

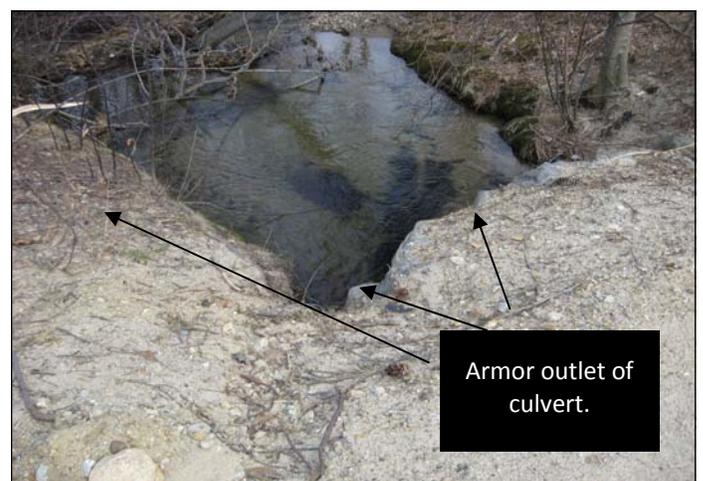
Evidence of severe erosion around mouth of culvert.

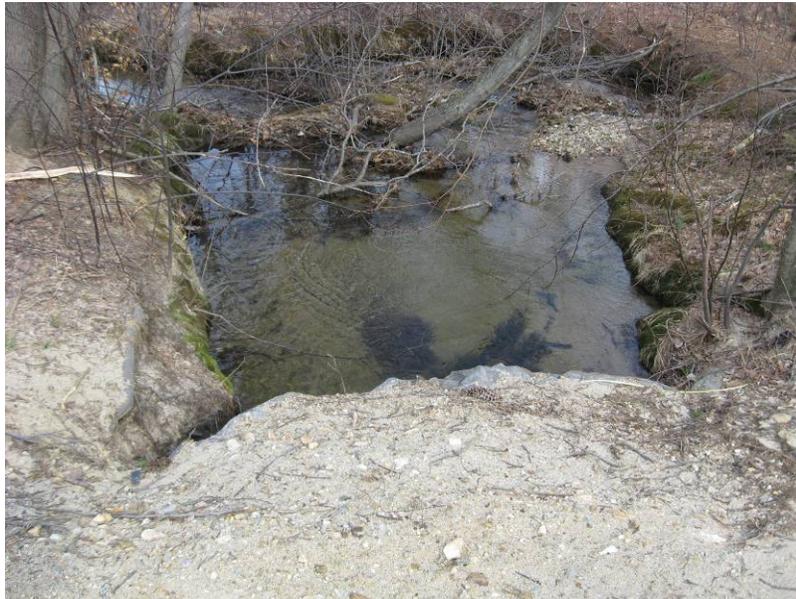
SITE RW3: APPLETON RD.

Erosion evident around mouth of culvert and surrounding banks.

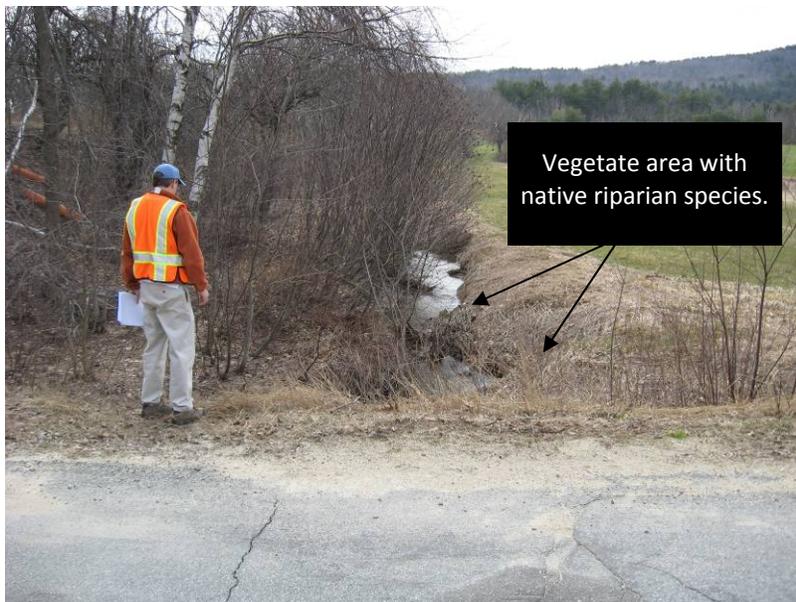
Denuded banks of the brook are more susceptible to erosive action. Installation of native plant species would help support and stabilize this area.

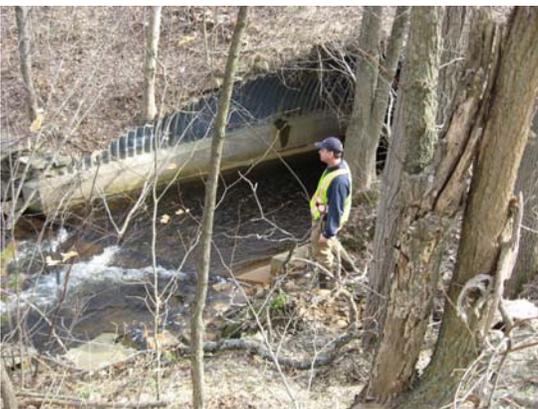
SITE RW4: OLD TENNEY RD. - RTE. 124

Design of culvert needs to be re-assessed for fish passage.

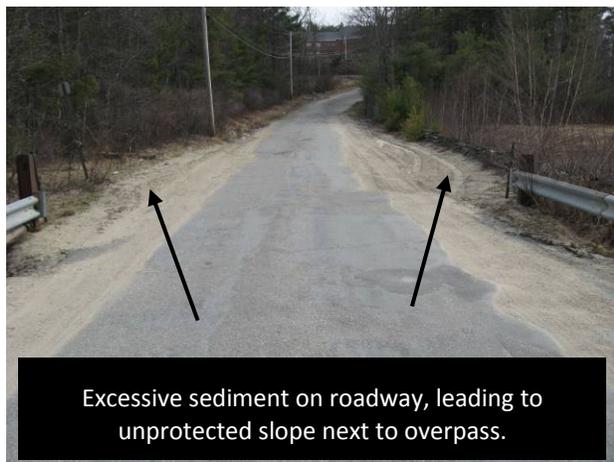
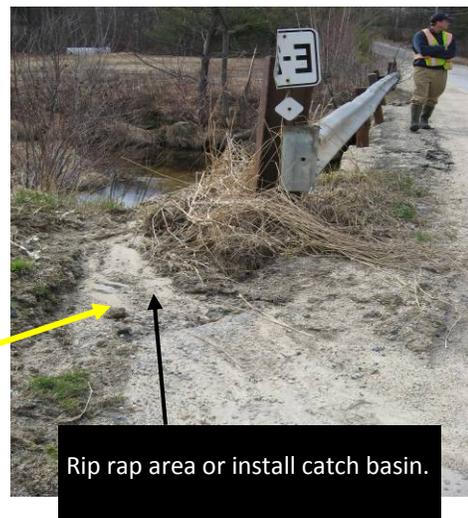
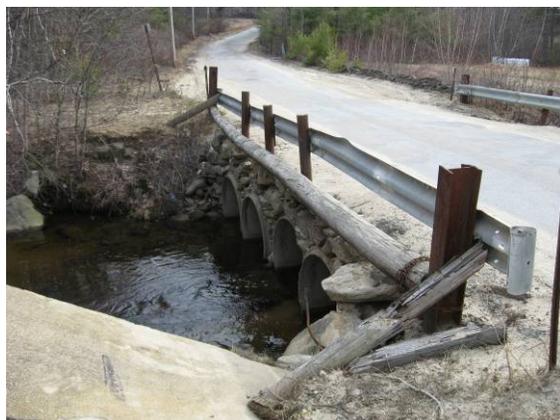
SITE RW8: TRICNIT RD.

Problems: Severe erosion of ditch lining the roadway, resulting in sediment deposition into brook. The unprotected areas around the overpass and the slope down to the brook are prime areas for sediment transport into brook.

This image provides visual evidence that brook is susceptible to runoff from both sides of overpass.

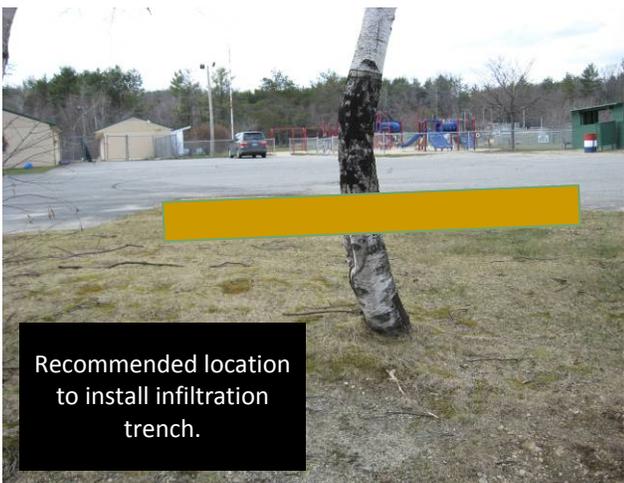
SITE LT2: TOWN OF NEW IPSWICH BALLFIELD

Problems: Town of New Ipswich ball field and swimming pool parking lots are immediately adjacent to Furnace Brook. Sediment is flowing off parking lot , across grassy area and entering Furnace Brook by way of a severely eroded gully.

View of parking lot, lacking an appropriate buffer to the brook.

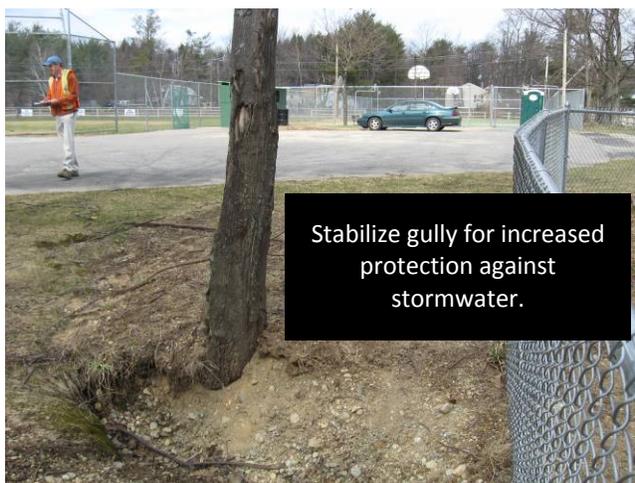
SITE LT2: TOWN OF NEW IPSWICH BALLFIELD

Severe erosion of this gully increases flow of runoff to the brook.

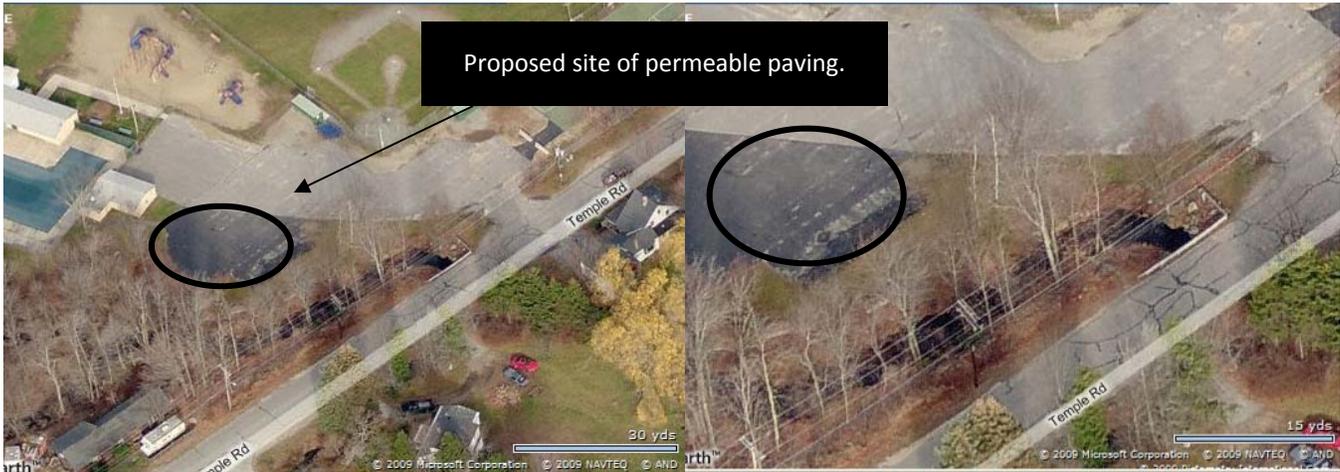
Image shows the location of the parking lot in respect to the brook. Installation of some type of permeable paving will assist in reducing the flow of runoff to the brook.
