# **BEAVER BROOK RESTORATION PLAN**

## **STREAM MORPHOLOGY, WILDLIFE HABITAT, AND LAND USE ASSESSMENT**

## **KEENE, NEW HAMPSHIRE**

**May 2009**

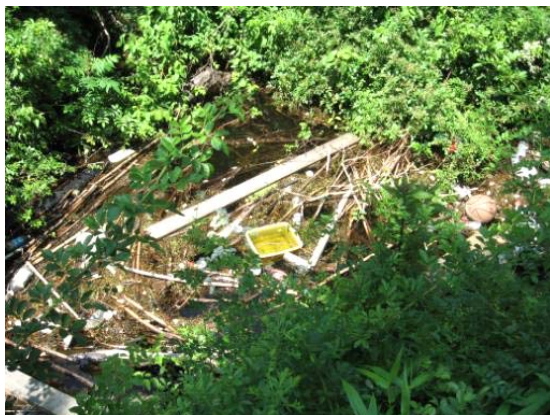
Parcel 98g

More specifically, a number of obstructions were observed along the brook, which has constrained flow of water or have been sources of materials that can consume oxygen as they decompose. Some of the obstruction to stream flow is the result of deposition of various materials in the stream, which included trash and yard waste.

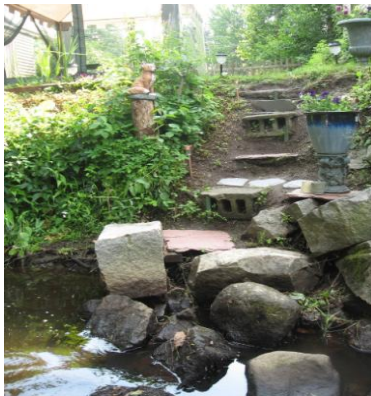
Parcel 121

Another set of land-use activities observed which can impact water oxygen content, directly or indirectly are observed access points to the stream from adjacent landowners. These paths to the stream provide an opportunity for bank erosion and potential flow of BOD materials and other non-point source pollutants into the stream. In addition, by compromising the integrity of the streambank, such stream access points can exacerbate bank erosion. The erosion can contribute to nutrient loading into the aquatic habitat, as well as depositional damming and ponding further down stream.

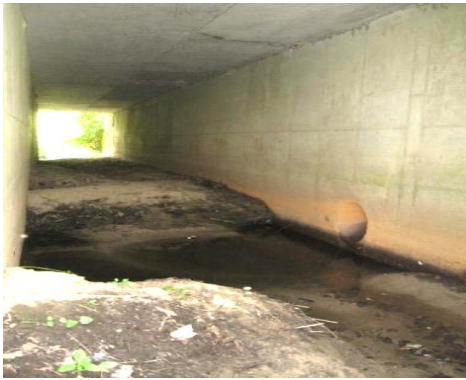
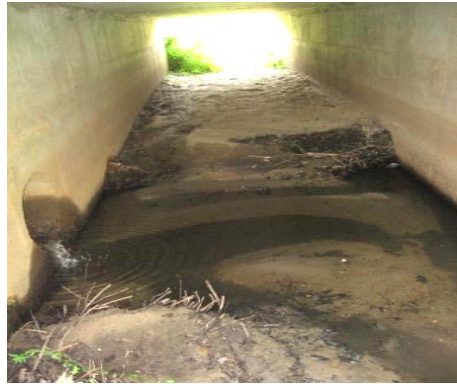
### Marlboro Bridge Crossing

At the outfall of the storm drain pipes (Exhibit 27), there was significant build-up of sediment that has created sediment dams and allow water to pool upstream. This condition is called shoaling, and in some cases appears to be exacerbated by other obstructions in the stream.

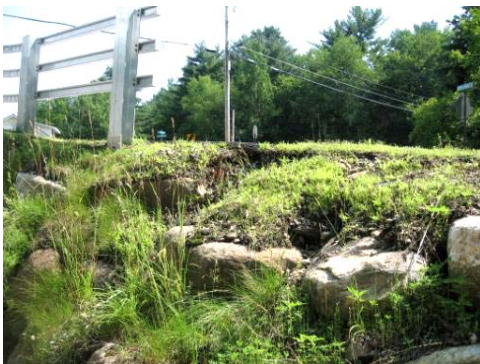
### Upper Knight Street

An additional contribution of sediment to the shoaling of waters along the brook could be occurring due to deterioration of road and bridge shoulders that cross, or run parallel to, the stream. Depending on the bank vegetation structure and soil type, such diversion of road-water over a bank can quickly begin to cut and erode the material.

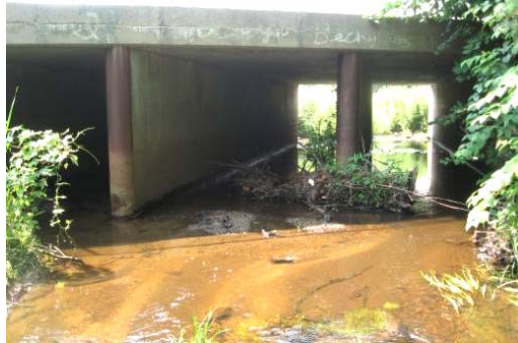
## Baker Street Crossing

The build-up of sediment shoals result in ponded water, which in turns reduces stream aeration. In addition, during summer months, as the water crosses these shoals the flow is quite shallow. This shallow water, if not shaded, will quickly heat, thus reducing its ability to hold oxygen. Also such shallow flows can limit movement of aquatic species along the brook.
