# ENVIRONMENTAL Fact Sheet

WMB-CP-14

## NH Salt Marsh Restoration: Little River Salt Marsh, N. Hampton

**Type of Project:** Tidal Restriction Removal

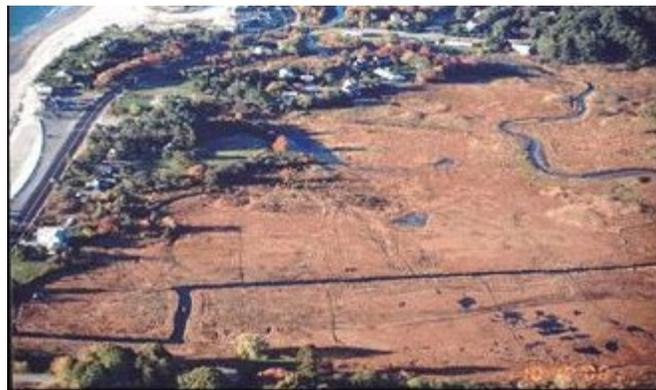
*Little River Pre-Restoration Aerial – October 2000*

**Tidal Restriction.** For over a century, there has been inadequate salt water flow into the marsh. Little River salt marsh deteriorated because it lacked a connection to the ocean of sufficient size to allow adequate tidal flow to

the marsh. Without tidal flow the overall health of the marsh is reduced.

In 1890, residents installed a culvert known locally as "the trunk" near the fish houses at Little Boars's Head. This was replaced by a 30-inch culvert in 1929 and with a 48-inch culvert in 1948. All of these early culverts were too small to allow adequate tidal flow into the marsh.

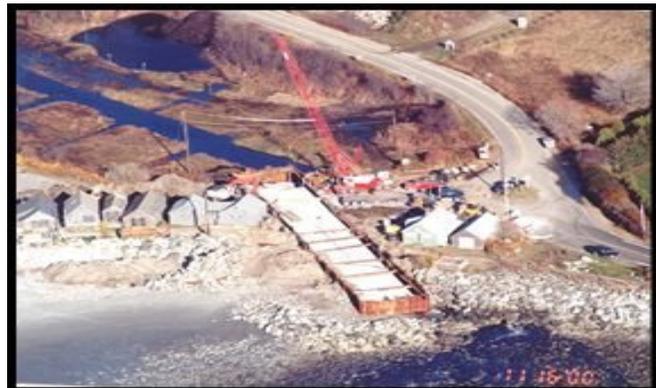
*Little River Culvert Replacement –  
November 2000*

In the spring of 2000, the culvert at the Appledore Road crossing was replaced and in the late fall of 2000, the culvert at the Route 1A crossing was replaced. These new culverts seem gigantic in proportion to the old culvert, emphasizing the restriction to flow that had been ongoing for years. To accommodate increased flows in and out of the marsh, portions of the Little River channel were also enlarged.
