ENVIRONMENTAL Fact Sheet

CO-GEO-10

Fluvial Geomorphology and Stream Crossing Assessments

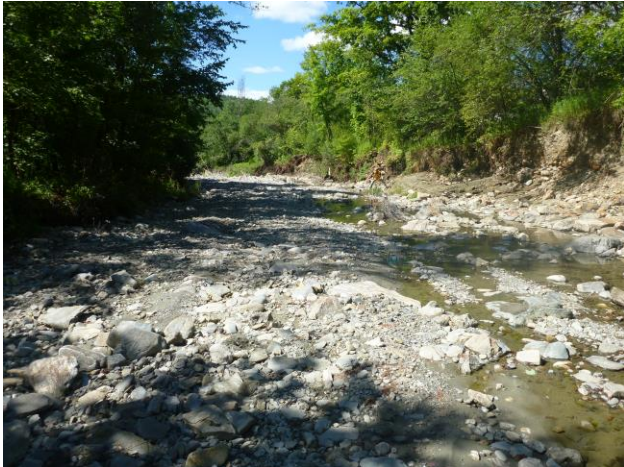
Since Irene, New Hampshire has experienced continual reminders that brooks in small watersheds can flood and cause erosion damage if the right ingredients come together. In 2012, a stationary thunderstorm produced an estimated eight inches of rain in the Westmoreland area, leading to impacts on nearby streams (photo at left). This same area experienced further issues a year later in 2013, at the same time that widely-reported damage occurred on Slayton Hill Road in Lebanon. A year later, in 2014, staff responded to concerns in the Woodstock and Lincoln areas. NHGS continue to receive phone calls and emails from communities and citizens
