## The Co-op Market, Hanover

### Overview

**Site Profile:** Former Lyme Road  
Exxon service station

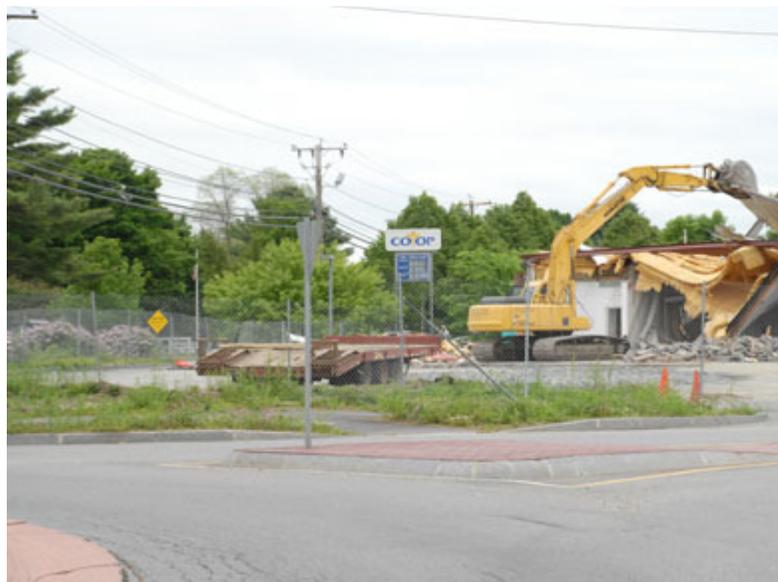
Demolition of the building, tanks previously removed.

DES and the Co-op decided on the following approach to address the site contamination: delineation of soil contamination, concurrent removal of the tanks and hot spot soil contamination, and installation of a passive vapor recovery system that could be converted to an active recovery system, if necessary. In March 2008 the soil delineation was completed. This facilitated soil removal and project planning. From April 28 to May 2, 2008, two 8,000 gallon underground storage tanks and the soil hot spot (125 tons) were removed. The passive vapor recovery system was designed and installed concurrent with the building construction during the summer of 2008. Monitoring of the passive recovery system has documented the collection and exhaust of gasoline vapors from beneath the building. The passive vapor recovery system has worked very well and there has been no need to convert it to an active system. Groundwater monitoring wells were installed to assess groundwater quality based on the results of the soil delineation sampling and collection of a groundwater sample from an existing monitoring well. Groundwater did not meet ambient groundwater quality standards initially, but subsequent

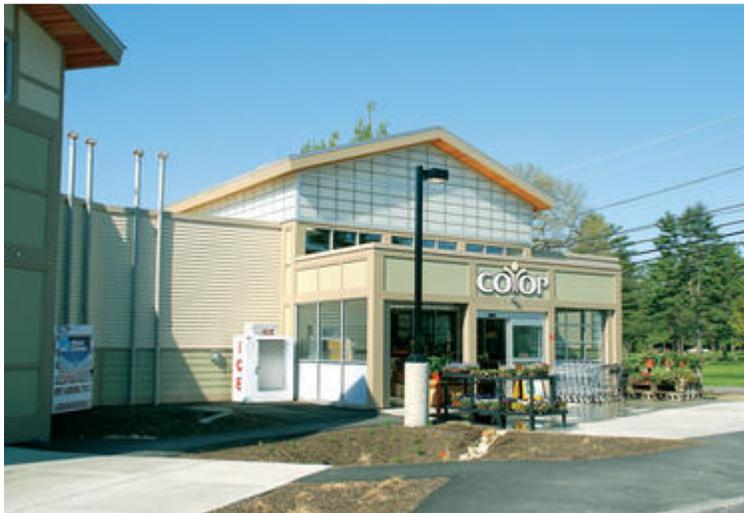
Finished Project, passive recovery vents visible on the left side of the building.

- Design and installation of a passive venting system.
- Hot spot soil removal (125 tons).
- Comprehensive site investigation and groundwater monitoring program completed.
- The property was successfully redeveloped into a \$2.3 million grocery store.
