REPAIR OF MENDUMS POND DAM

Public Information Meeting Town of Barrington August 3, 2015

James W. Gallagher, Jr., P.E
Chief Engineer
Dam Bureau
271-1961
James.Gallagher@des.nh.gov

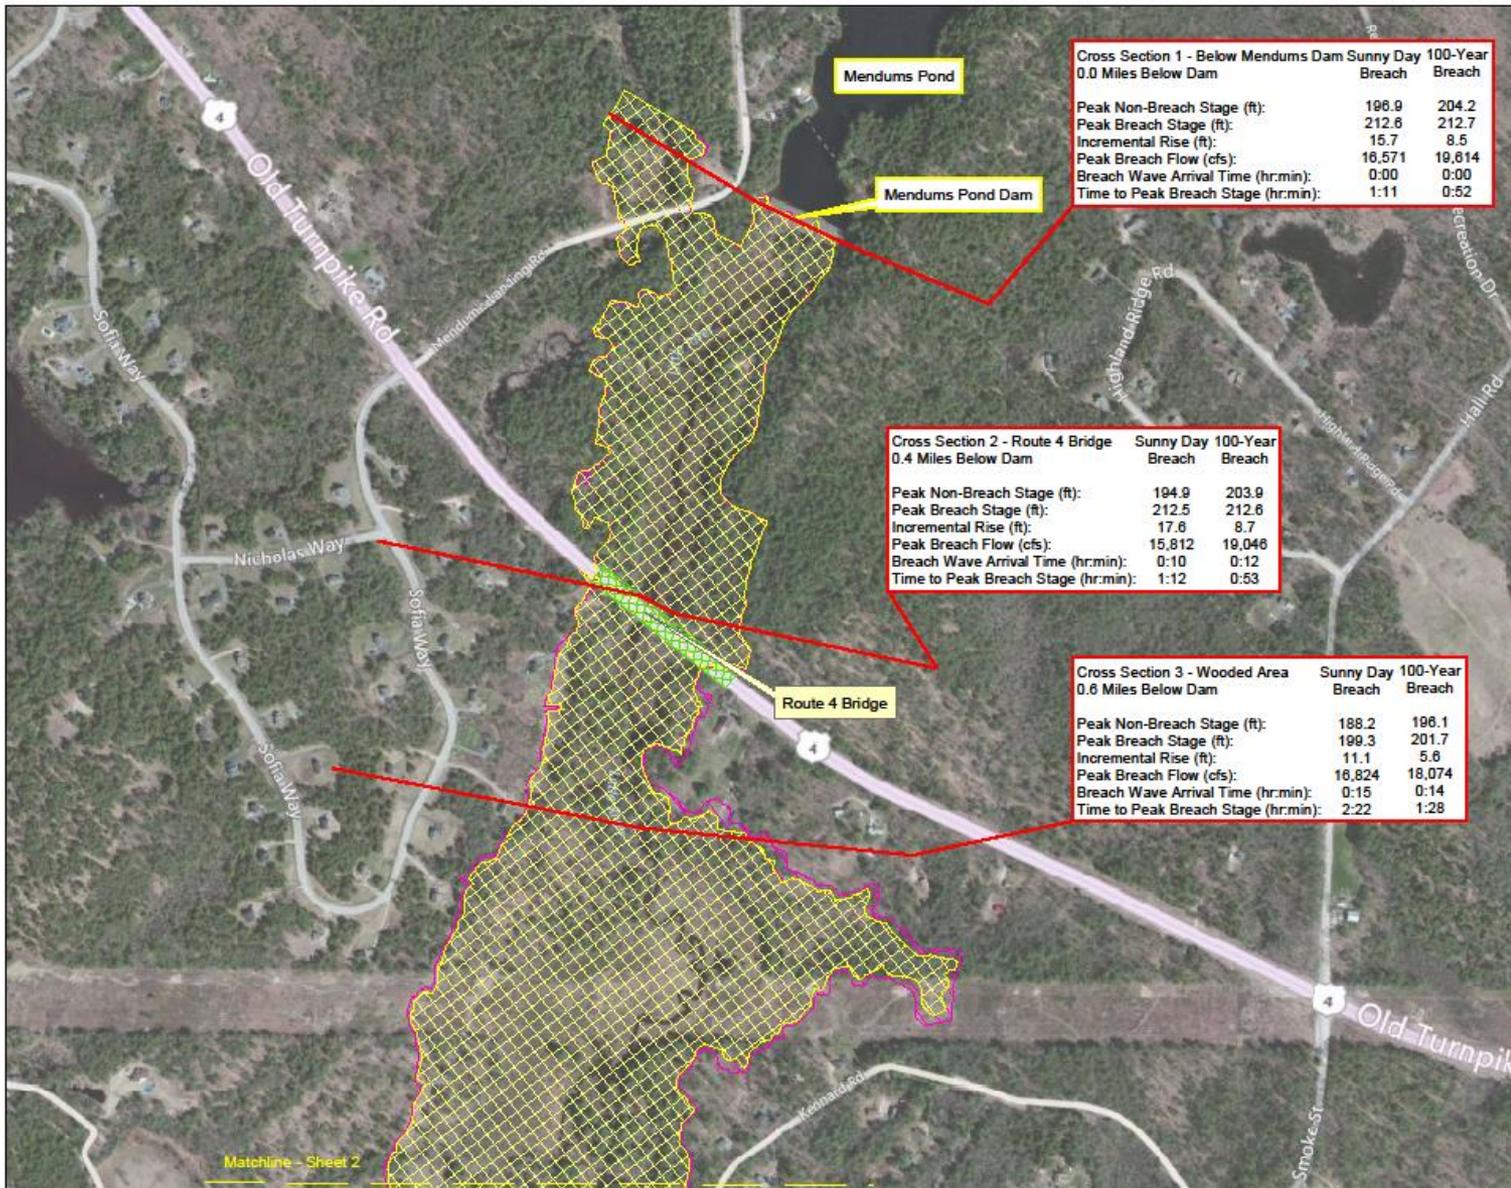
INUNDATION MAP 1 OF 8

Cross Section 1 - Below Mendums Dam Sunny Day 100-Year
0.0 Miles Below Dam

Breach	Breach
Peak Non-Breach Stage (ft):	196.9	204.2
Peak Breach Stage (ft):	212.6	212.7
Incremental Rise (ft):	15.7	8.5
Peak Breach Flow (cfs):	16,571	19,814
Breach Wave Arrival Time (hr:min):	0:00	0:00
Time to Peak Breach Stage (hr:min):	1:11	0:52

Cross Section 2 - Route 4 Bridge Sunny Day 100-Year
0.4 Miles Below Dam

Breach	Breach
Peak Non-Breach Stage (ft):	194.9	203.9
Peak Breach Stage (ft):	212.5	212.6
Incremental Rise (ft):	17.6	8.7
Peak Breach Flow (cfs):	15,812	19,046
Breach Wave Arrival Time (hr:min):	0:10	0:12
Time to Peak Breach Stage (hr:min):	1:12	0:53

Cross Section 3 - Wooded Area Sunny Day 100-Year
0.6 Miles Below Dam

Breach	Breach
Peak Non-Breach Stage (ft):	188.2	196.1
Peak Breach Stage (ft):	199.3	201.7
Incremental Rise (ft):	11.1	5.6
Peak Breach Flow (cfs):	16,824	18,074
Breach Wave Arrival Time (hr:min):	0:15	0:14
Time to Peak Breach Stage (hr:min):	2:22	1:28

- Matchlines
- Cross Sections
- Affected Structures
- Sunny Day with Breach
- 100-Year with Breach

NOTE:
THE METHOD, PROCEDURES, AND ASSUMPTIONS USED TO DEVELOP THE FLOODED AREA, THE LIMITS OF FLOODING SHOWN AND FLOOD WAVE TRAVEL TIMES ARE APPROXIMATE AND SHOULD BE USED ONLY AS A GUIDELINE FOR ESTABLISHING EVACUATION ZONES. ACTUAL AREAS INUNDATED WILL DEPEND ON ACTUAL BREACH CONDITIONS AND MAY DIFFER FROM AREAS SHOWN ON THE MAP.

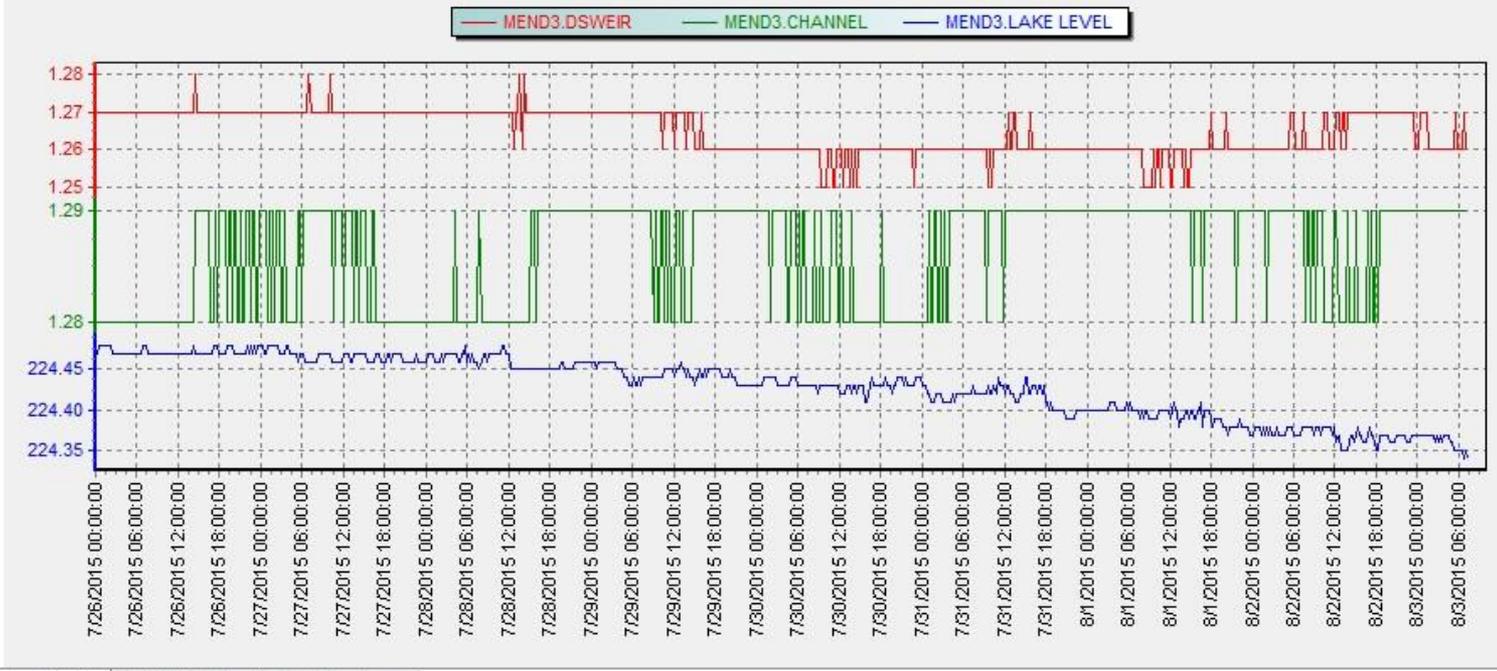
StationID	SensorName	LastUpdate
MEND3	DSWEIR	8/3/2015 7:23:30 AM
MEND3	CHANNEL	8/3/2015 7:23:30 AM
MEND3	LAKE LEVEL	8/3/2015 7:23:30 AM

Last Week
From: 7/26/2015 12:00:00 AM
To: Now
8/ 3/2015 9:56:33 AM
Retrieve

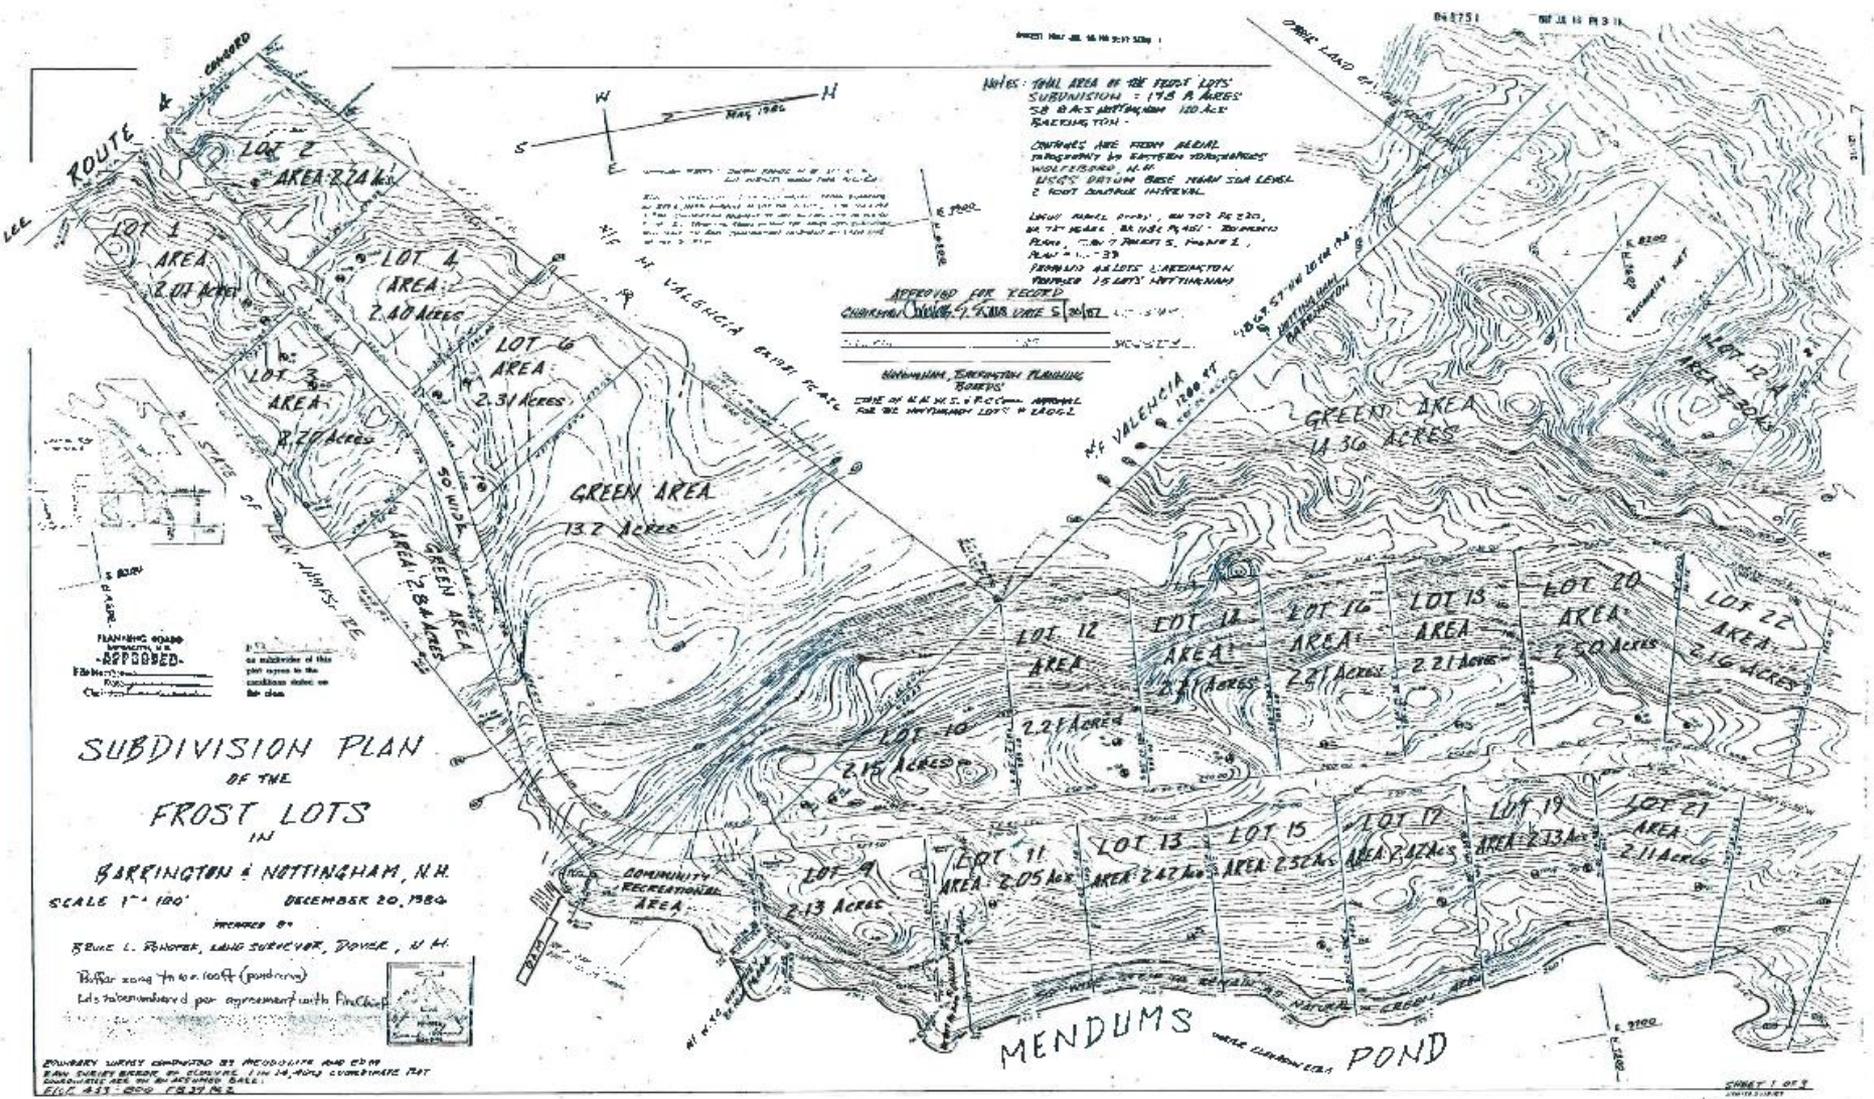
NOTES: TOTAL AREA OF THE FROST LOTS SUBDIVISION = 178.8 ACRES
 58.0 ACRES BARRINGTON 120.8 ACRES NOTTINGHAM

CONTROLS ARE FROM AERIAL PHOTOGRAPHY BY EASTMAN PHOTOGRAPHIC WORKS, BARRINGTON, N.H. 1984. ELEVATION DATUM IS MEAN SEA LEVEL. 2 FOOT CONTOUR INTERVAL.

LOT 10, 11, 12, 13, 14, 15, 16, 17, 18, 19, 20, 21, 22, 23 ARE 100' WIDE. 20' BUFFER ZONE TO 100' (PONDING). LOTS TO BE NUMBERED PER AGREEMENT WITH PINCHOT.
