Comprehensive Environmental Inc.

Study of Urban Non-Point Source Pollution Witches Brook East Subwatershed

**PENNICHUCK WATER WORKS
SEPTEMBER 2001**

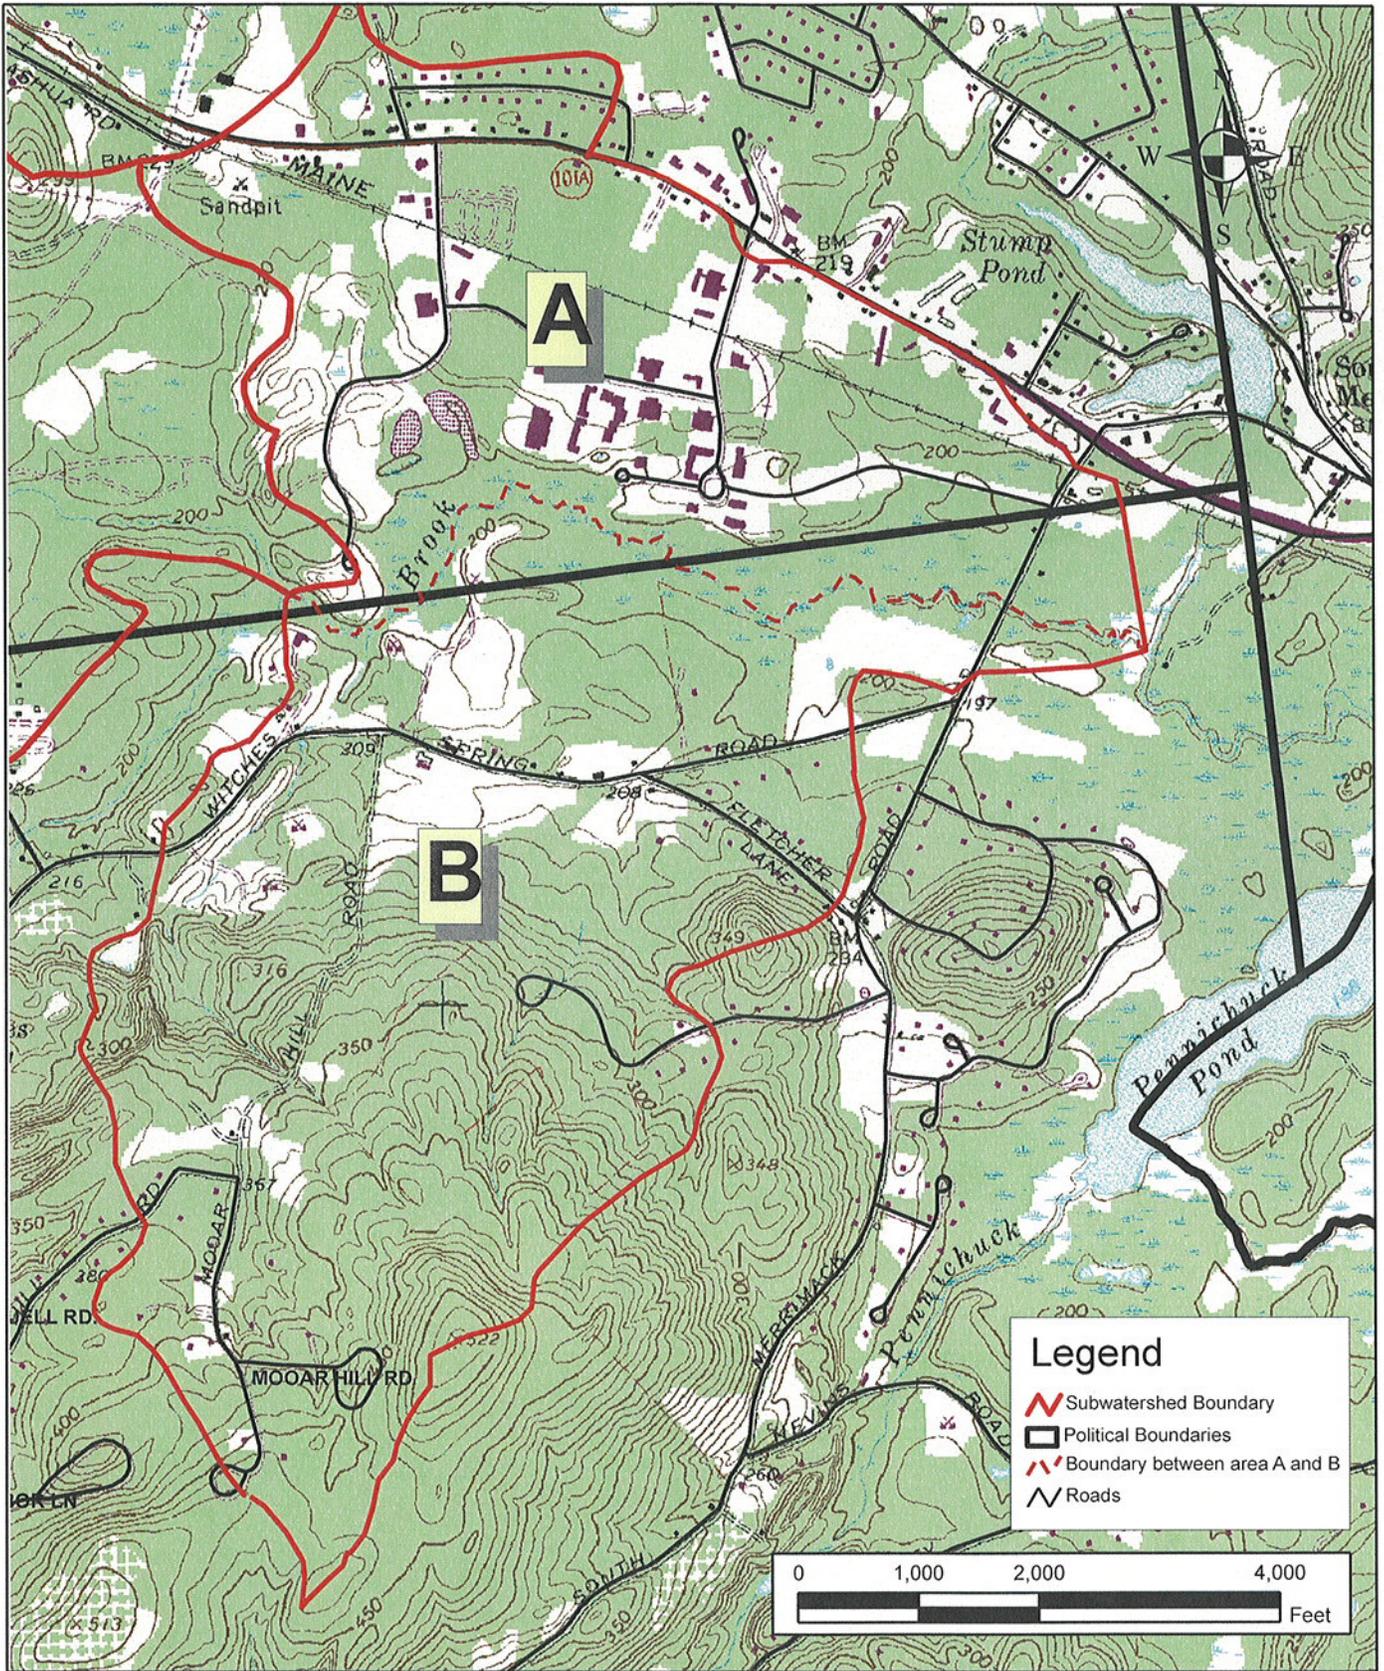
Figure 2-1. Witches Brook East Subwatershed. Areas A and B.

The Witches Brook East Subwatershed consists of two major drainage areas, designated areas A and B (Figure 2-1), which correspond with the two major distinctions in development density throughout the subwatershed and the major patterns of runoff to Witches Brook. Area A has a greater density of development. Area A extends from Route 101A south to Witches Brook and east from the intersection of 101A and Old Nashua Rd. to the eastern boundary of the WBE Subwatershed. Area B consists of low-density residential development that extends from the southernmost tip of the WBE Subwatershed north to Witches Brook. Below is a more detailed description of each drainage area. Descriptions of specific sites of water quality concern within the two areas are also detailed.

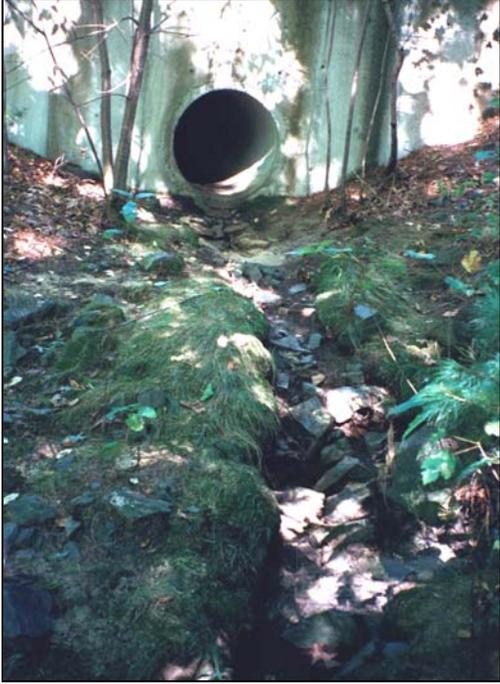
There is a 24” discharge near a portion of vacant land at the western portion of Columbia Drive. This discharge collects runoff from Columbia Drive and three businesses along Columbia Drive. The outlet discharges into a wetland area that drains to form a tributary to Witches Brook (refer to site A-1 on Figure 2-2). The riprap on the steep slope below has been pushed to the side and is heavily scoured (Figure 2-3). There is a large sediment delta that has extended into and smothered the wetland area (Figure 2-4). Due to heavy flows, much of the sediment discharged from this outlet is no longer being trapped by the wetland area and now flows into the tributary. There are visible signs of scouring and sedimentation of the tributary (Figure 2-5 shows the receiving tributary).

Figure 2-3. Swale scouring below discharge.

Concerns of sediment transport to wetlands and eventually Witches Brook from site A-1 (Columbia Drive) and to a lesser extent the Atomic Ski site (see 3.2 Secondary Water Quality Improvements) can be addressed through the installation of an infiltration basin downstream of both. Figure 3-1 shows a conceptual drawing of the proposed basin and Figure 3-2 indicates a suggested location on that parcel (Town of Amherst, Lot 28-15).

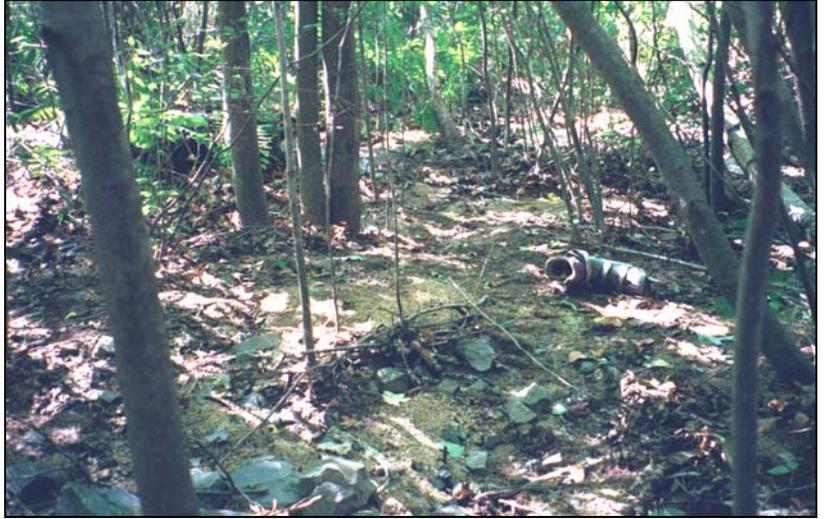
Figure 2-4. Sediment delta extending into wetland area.

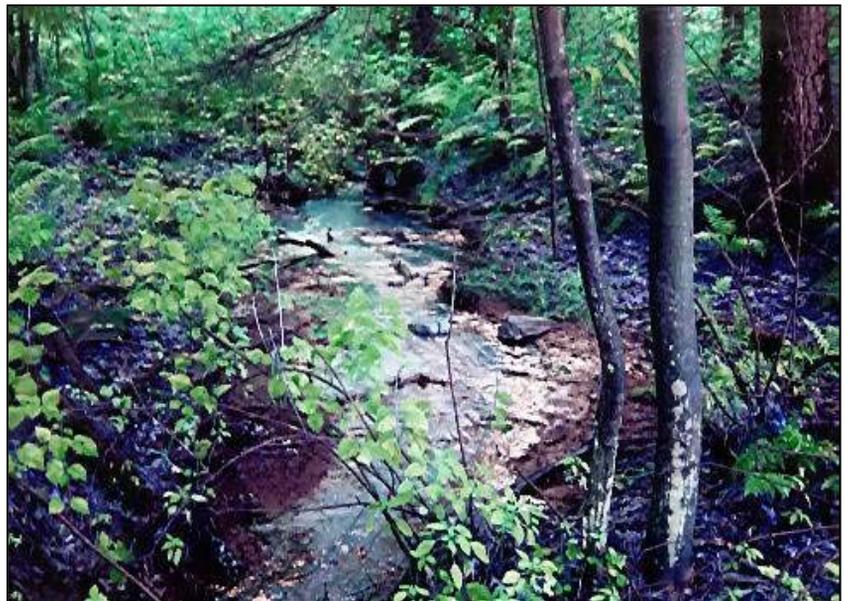
Figure 2-5. Tributary receiving discharge.

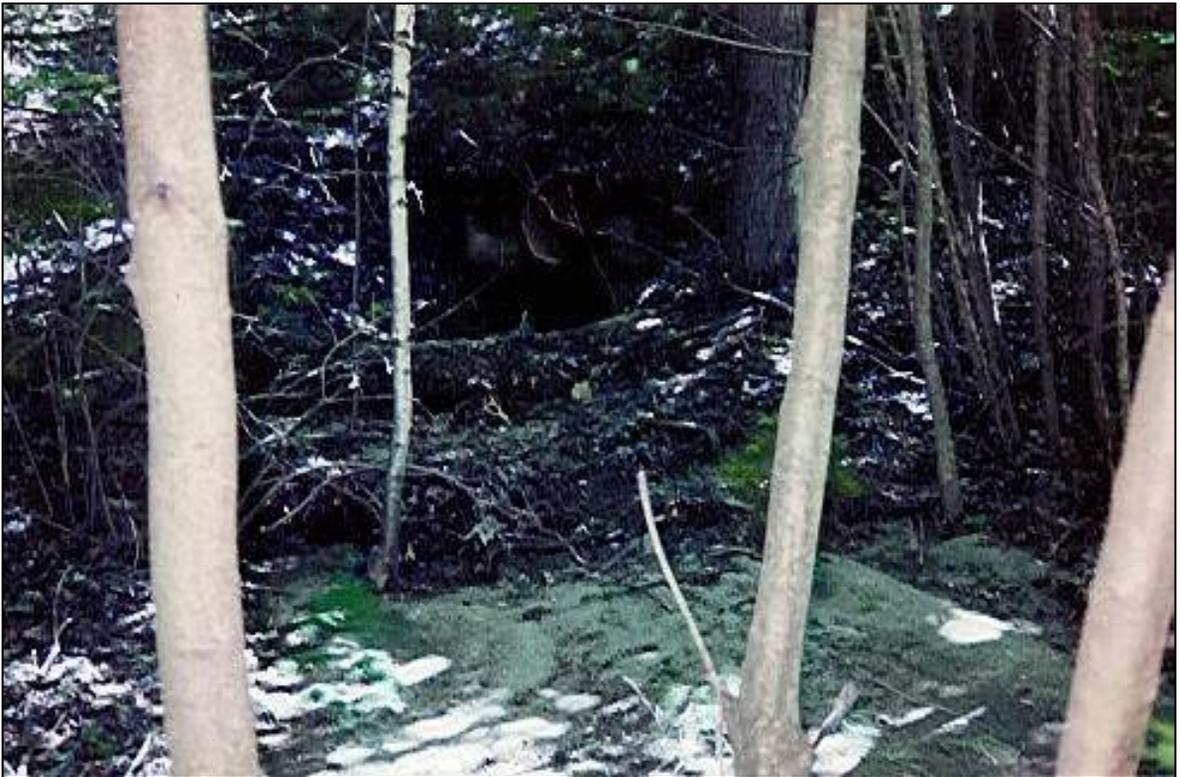
H&M Metals is located east and adjacent to the Atomic Ski Warehouse on Columbia Drive Extension (refer to A-2 on Figure 2-2). This facility includes a large (92,600 S.F.) building with an additional 78,700 square feet of paved parking and drives. Multiple storage trailers are parked on the rear of the site. Runoff from portions of the building and parking area discharges through a 24” pipe at the southwestern portion of the site and feeds the same tributary mentioned in 2.1.1. The area immediately below this outlet is scoured from heavy flows and there is a large sediment delta that extends into the tributary (Figure 2-6).

Figure 2-6. View of the scoured swale and sediment delta below discharge.

The site plan shows a small detention basin referred to on the plans as a stillings basin (see Figure 3-5). It is clear from this feature's name and design that the intent was not only to attenuate runoff flows, but also to settle out particles entrained in the runoff. Had this stillings basin been installed (and maintained), it is likely that scouring and sediment deposition downgradient of the discharge would not be a significant issue.

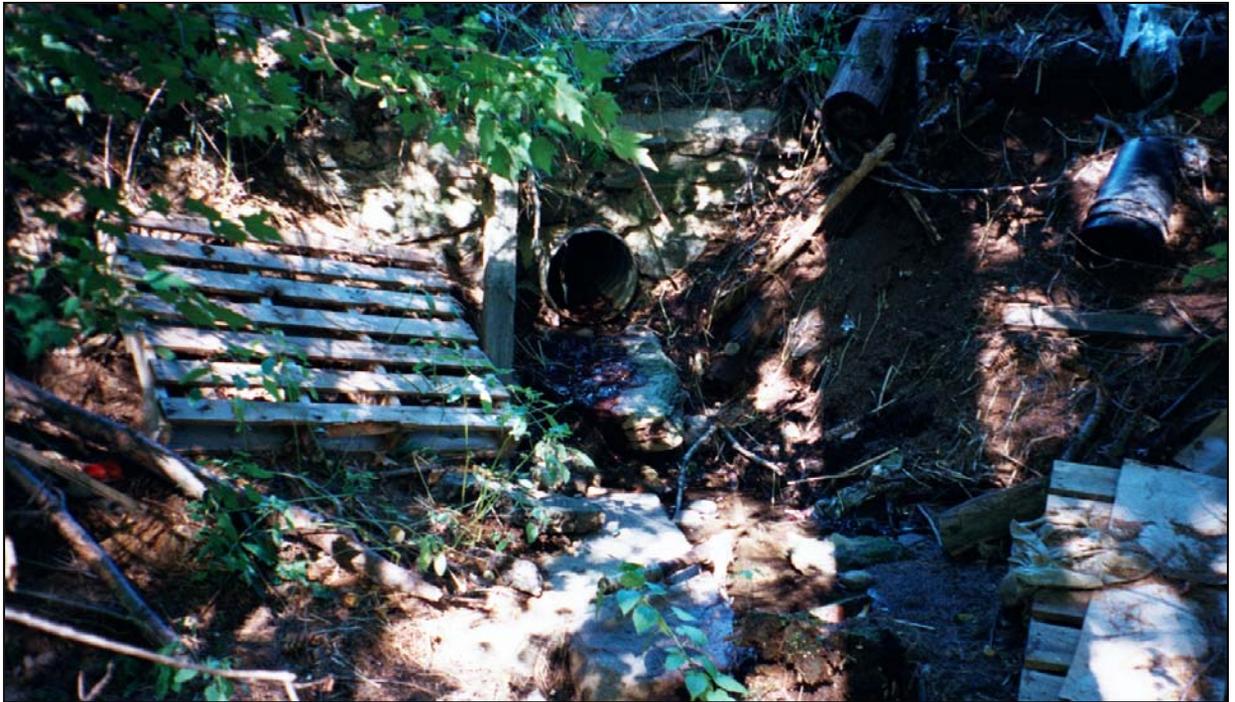
The first is a 15” discharge that collects runoff from the parking area and building at 13 Columbia Drive. The discharge flows through a forested area immediately below the steep grade to a lowland wetland area that eventually drains to Witches Brook. The area immediately below the discharge is heavily scoured (Figure 2-7) with sediment deltas downgradient, extending into the forested area (Figure 2-8), within 75 feet of the brook.

Figure 2-7. View of scoured area below discharge.

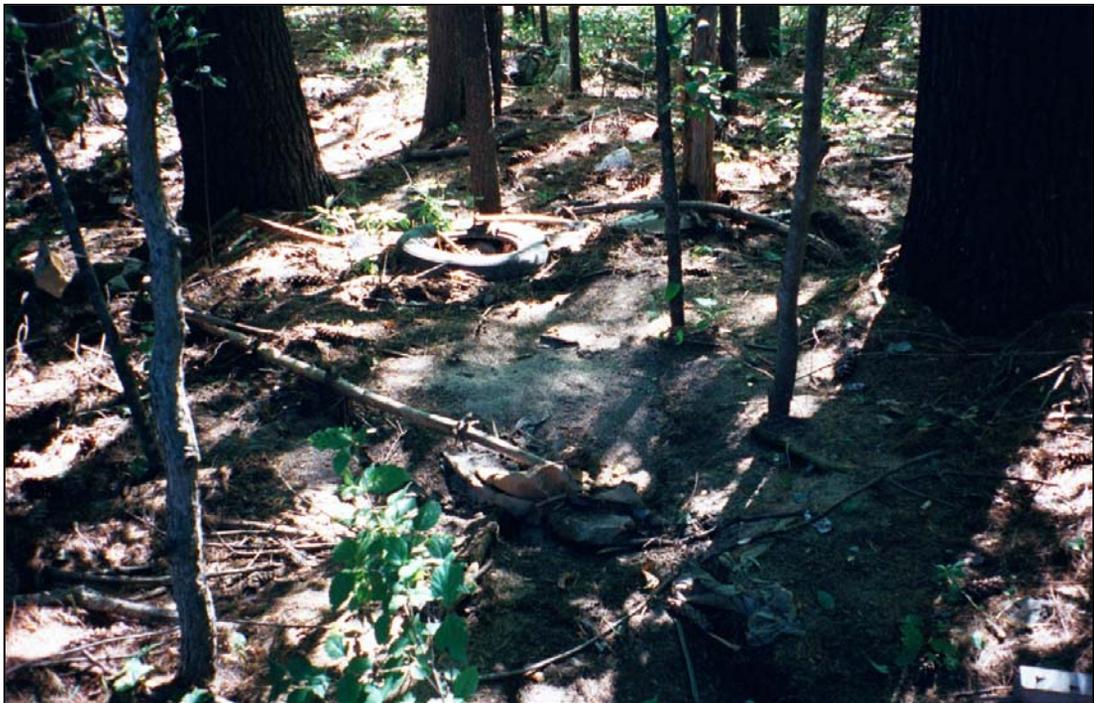
Figure 2-8. View of sediment delta extending into the forested area.

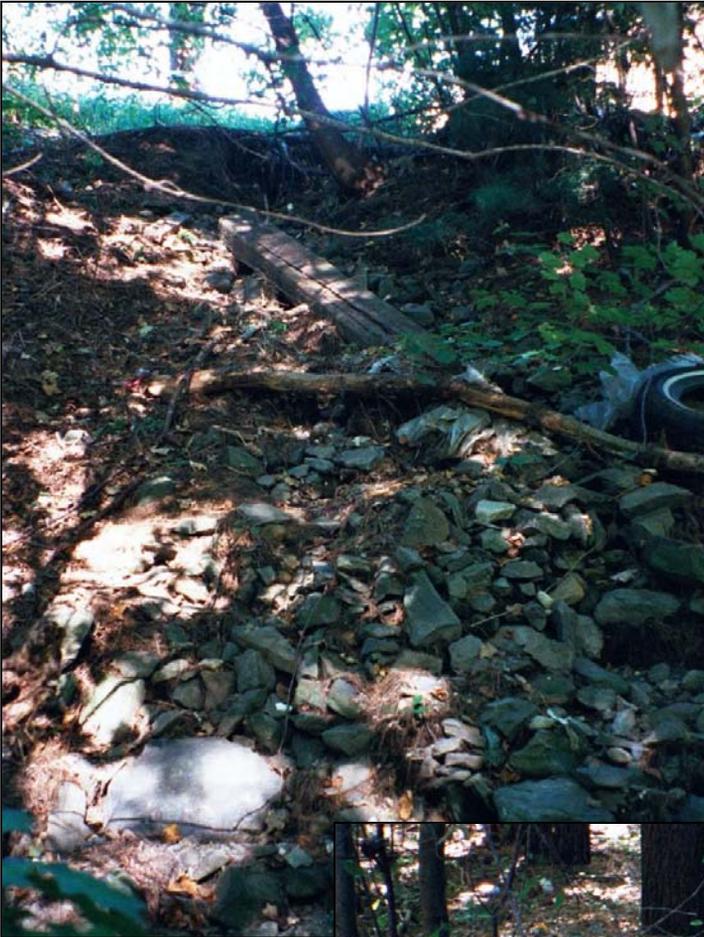
runoff from a portion of the Norwich Building parking area and enters a riprap swale (Figure 2-9) at the southwest corner of the property. The short swale (~30') discharges into the same forested area as the aforementioned pipe and similar scouring and sediment deposits were observed (Figure 2-10).

Figure 2-9. View of riprap swale.

Proposed at the western discharge is a three-foot deep stone filled infiltration strip (see Figure 3-3) to be located along the edge of the paved delivery access at the top of the bank (refer to Figure 3-4). A pre-filter could be made by installing a layer of filter fabric under the top six inches of stone so that the sediment and debris removal activities would only require that the top 6 inches be dug up rather than the whole trench when full. Alternatively, a biolog prefilter could be installed that would allow the sediment to be trapped just upgradient. When it is time to clean up the sediments, the lightweight biolog could be moved out of the way to facilitate either mechanical or hand sweeping of the sediments. An at-

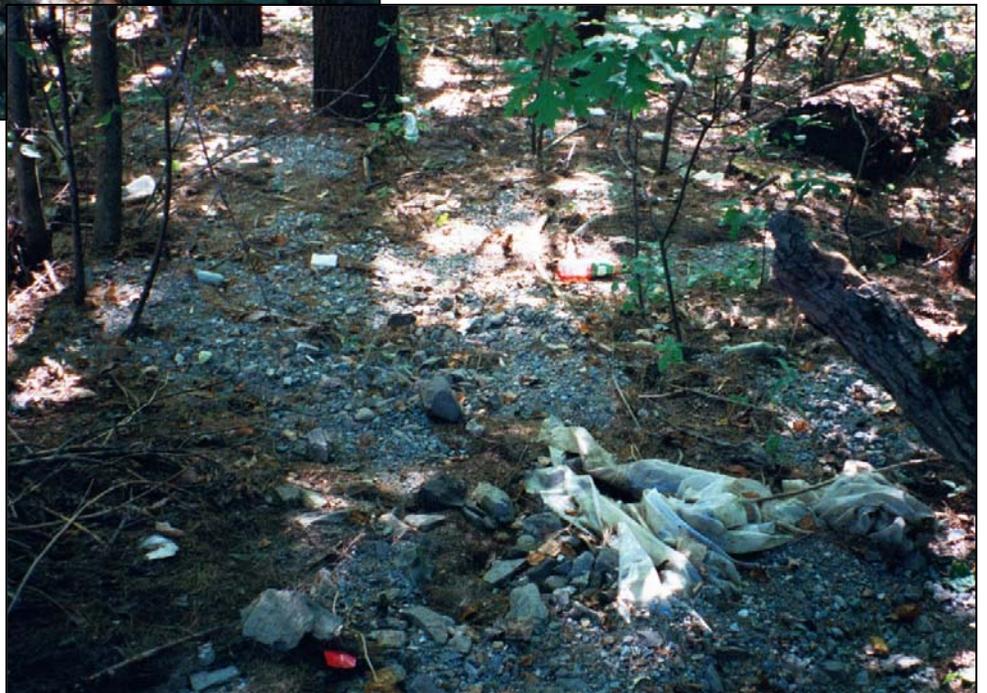
Figure 2-10. View of scouring and sediment deltas below swale.

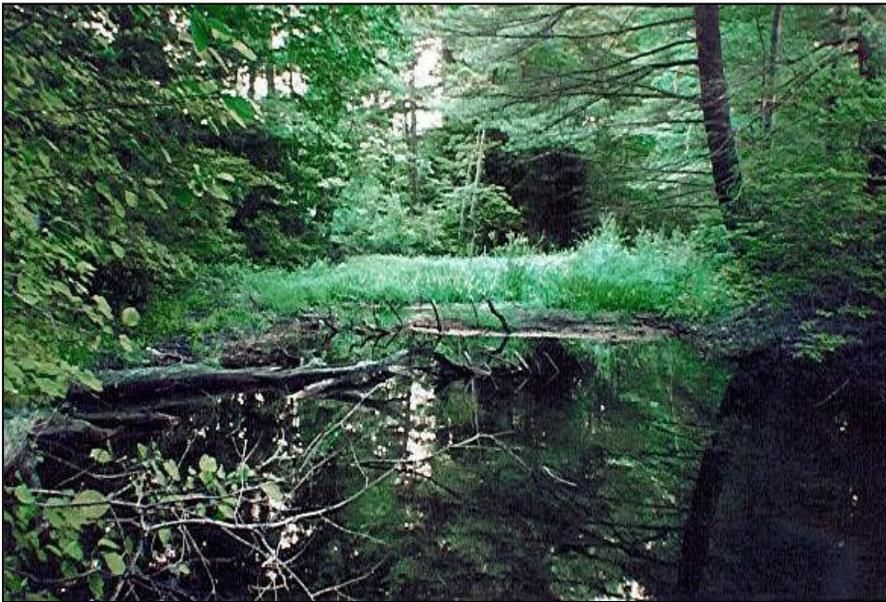
Mooar Hill Road Brook flows into a wetland area (refer to B-1 on Figure 2-11) near Witches Spring Road and continues along Witches Spring Road to a small pond area where significant infilling was observed (Figure 2-12). This natural detention area is filled in with sediment and detritus and probably lacks the ability to trap sediment from the Brook and upstream areas or from Witches Spring Road.

Figure 2-12. Infilling observed at detention area along Witches Spring Road.

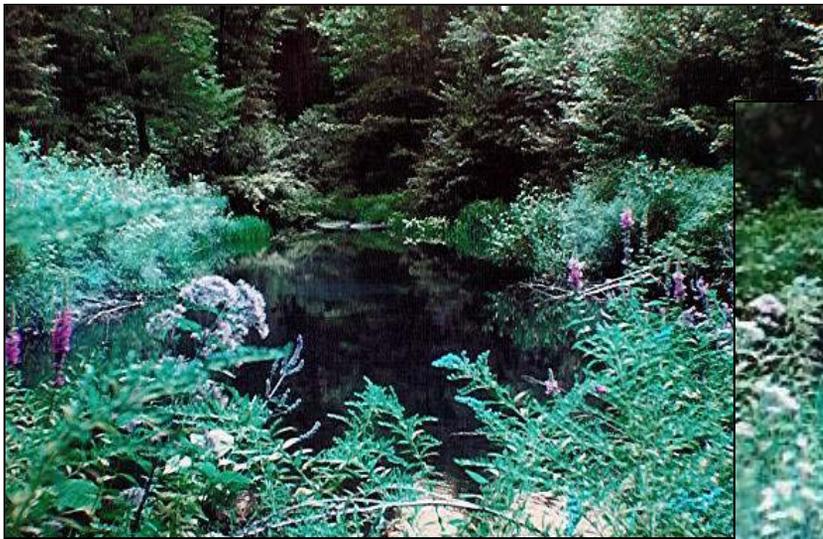
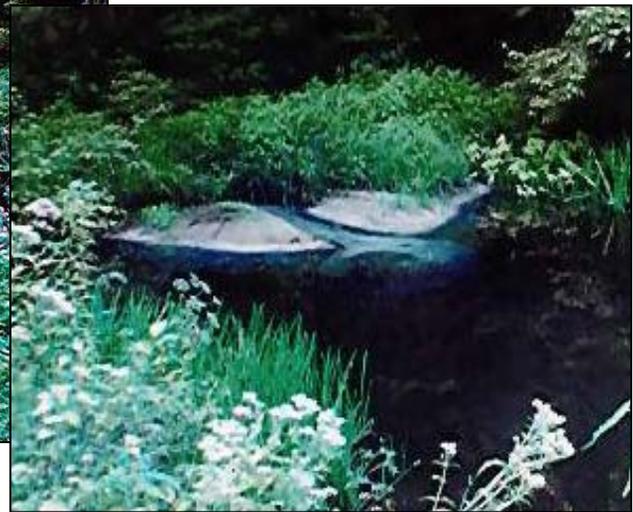
The Brook continues east, parallel to Witches Spring Road to a small pond where there is an additional inlet from an isolated wetland area upgradient of the pond. There is a large sediment delta immediately below this inlet (Figure 2-13). The small pond serves as a sediment trap from these two inlets; however, it appears that the pond may be nearing the end of its useful life due to the large sediment delta already present. Once the pond has reached capacity, sediment will eventually travel through the detention area and continue downstream to Witches Brook.

Figure 2-13. View of sediment delta at pond adjacent to Witches Spring Road.

(Close-up view of sediment delta)

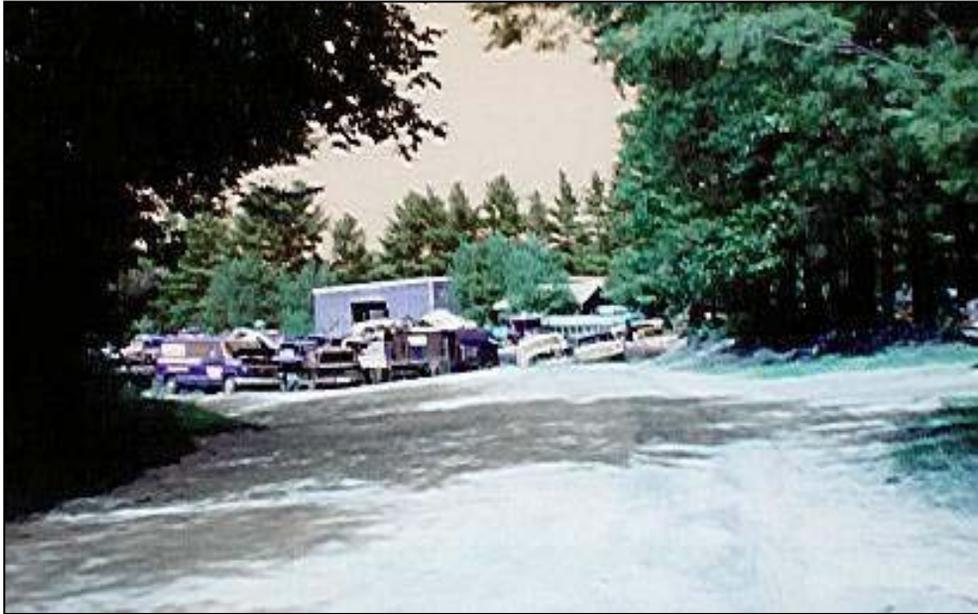
There is a junkyard located along Witches Brook at the westernmost boundary of the WBE subwatershed (Figure 2-14). The junkyard extends to within 200 feet of the Brook in some areas, beyond which is mostly wetlands and forested or grassy areas. Land disturbance, associated with the junkyard, to the west of the WBE subwatershed boundary extends to the edge of the Brook in one area (Figure 2-15). There is no evidence of stressed vegetation or other impacts to the adjacent wetland and/or grassy and forested areas. Because the junk sits in the open on bare ground and the underlying soils are sandy, the junkyard appears to present more of a potential groundwater threat. Nonetheless, local groundwater is associated with Witches Brook, making the junkyard a threat to water quality.

Figure 2-14. View of junk yard adjacent to Witches Brook.

According to local officials the junkyard located on the Hollis/Amherst town line has been in existence for quite a while and likely predates zoning controls. This junkyard is therefore not subject to these controls and is considered “grandfathered”. This does not relieve them of state and federal compliance to run a clean operation, however inspections from these non-local agencies tend to be lacking.

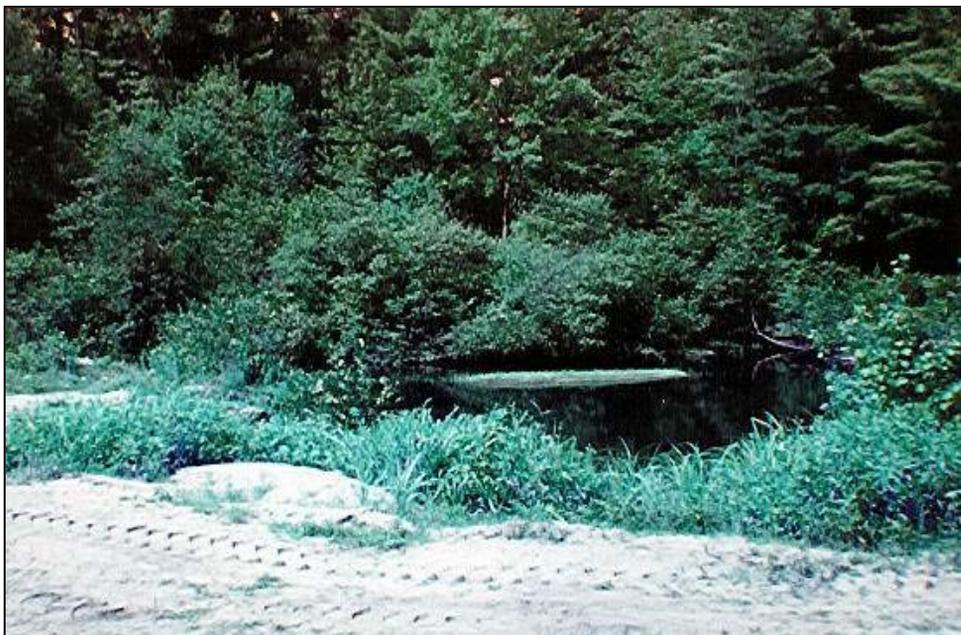
Figure 2-15. View of land disturbance adjacent to Witches Brook.

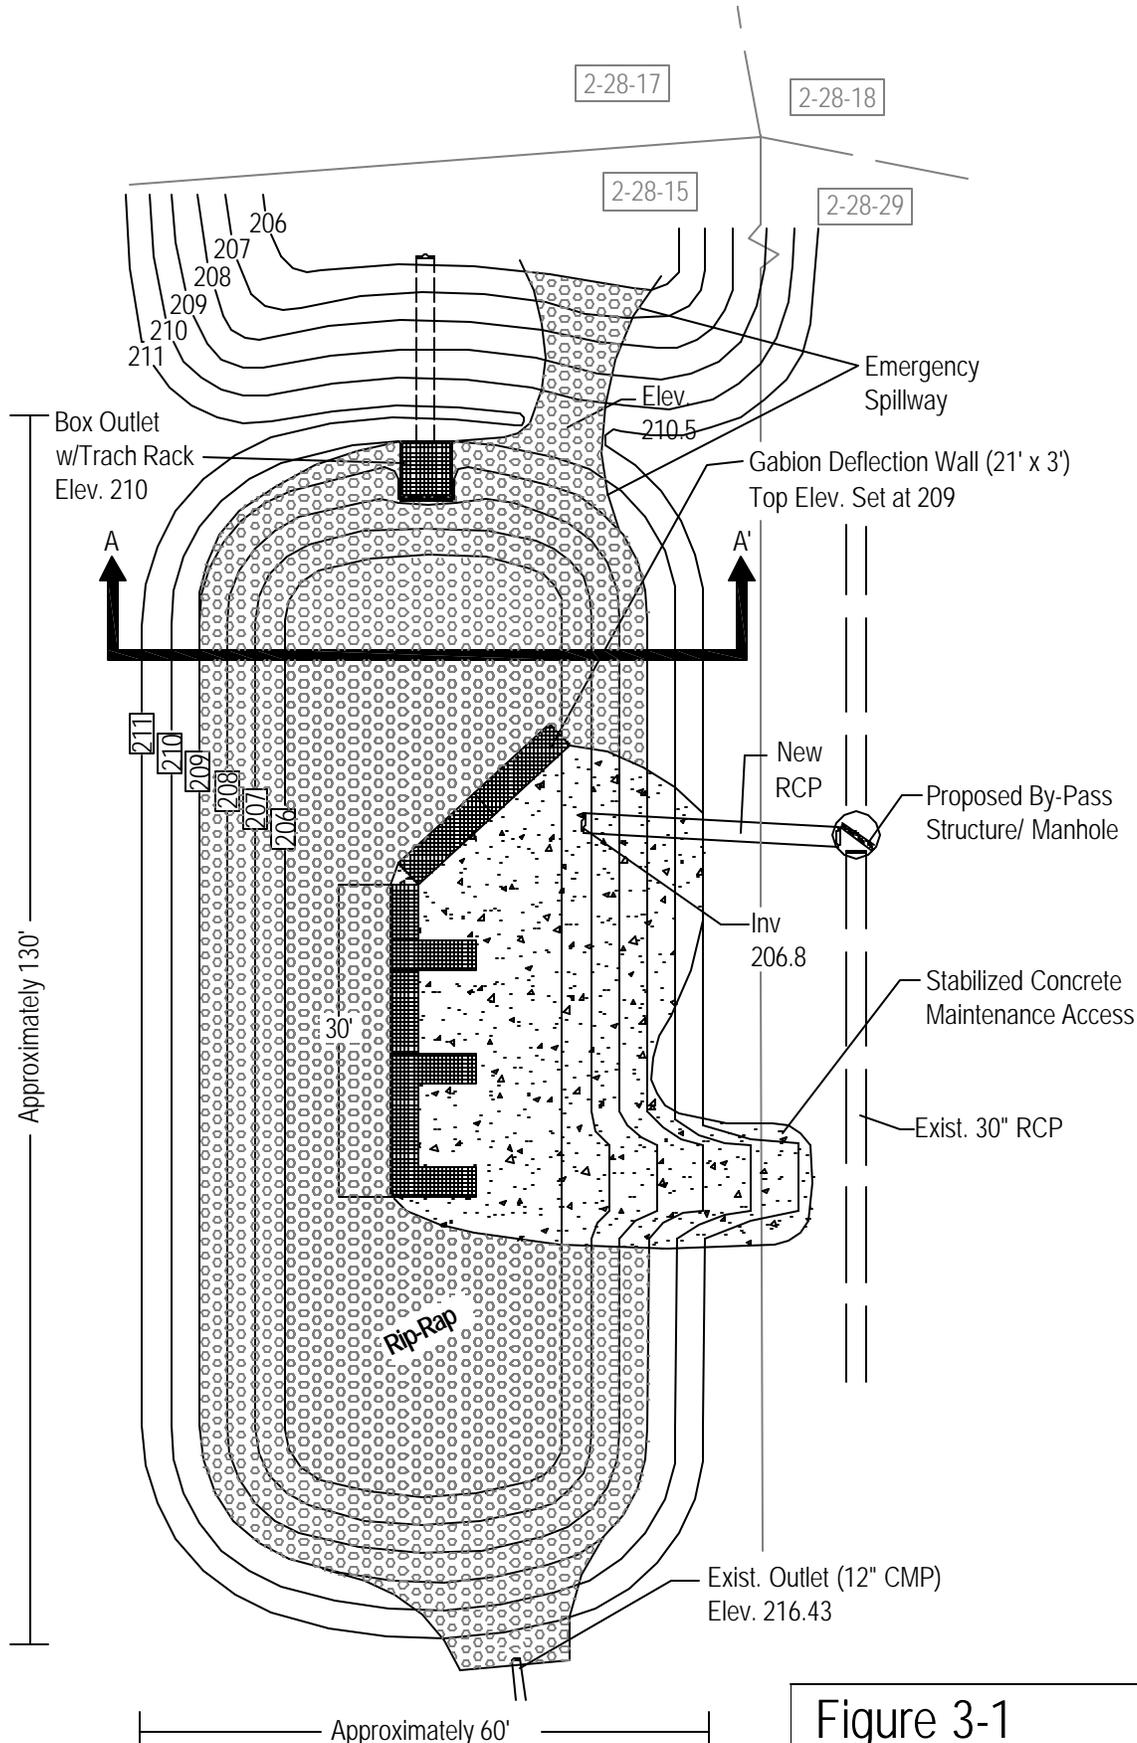
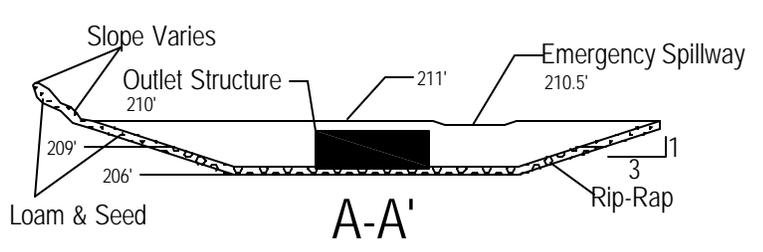
Figure 3-1
Proposed Infiltration Basin at Columbia Drive Discharge

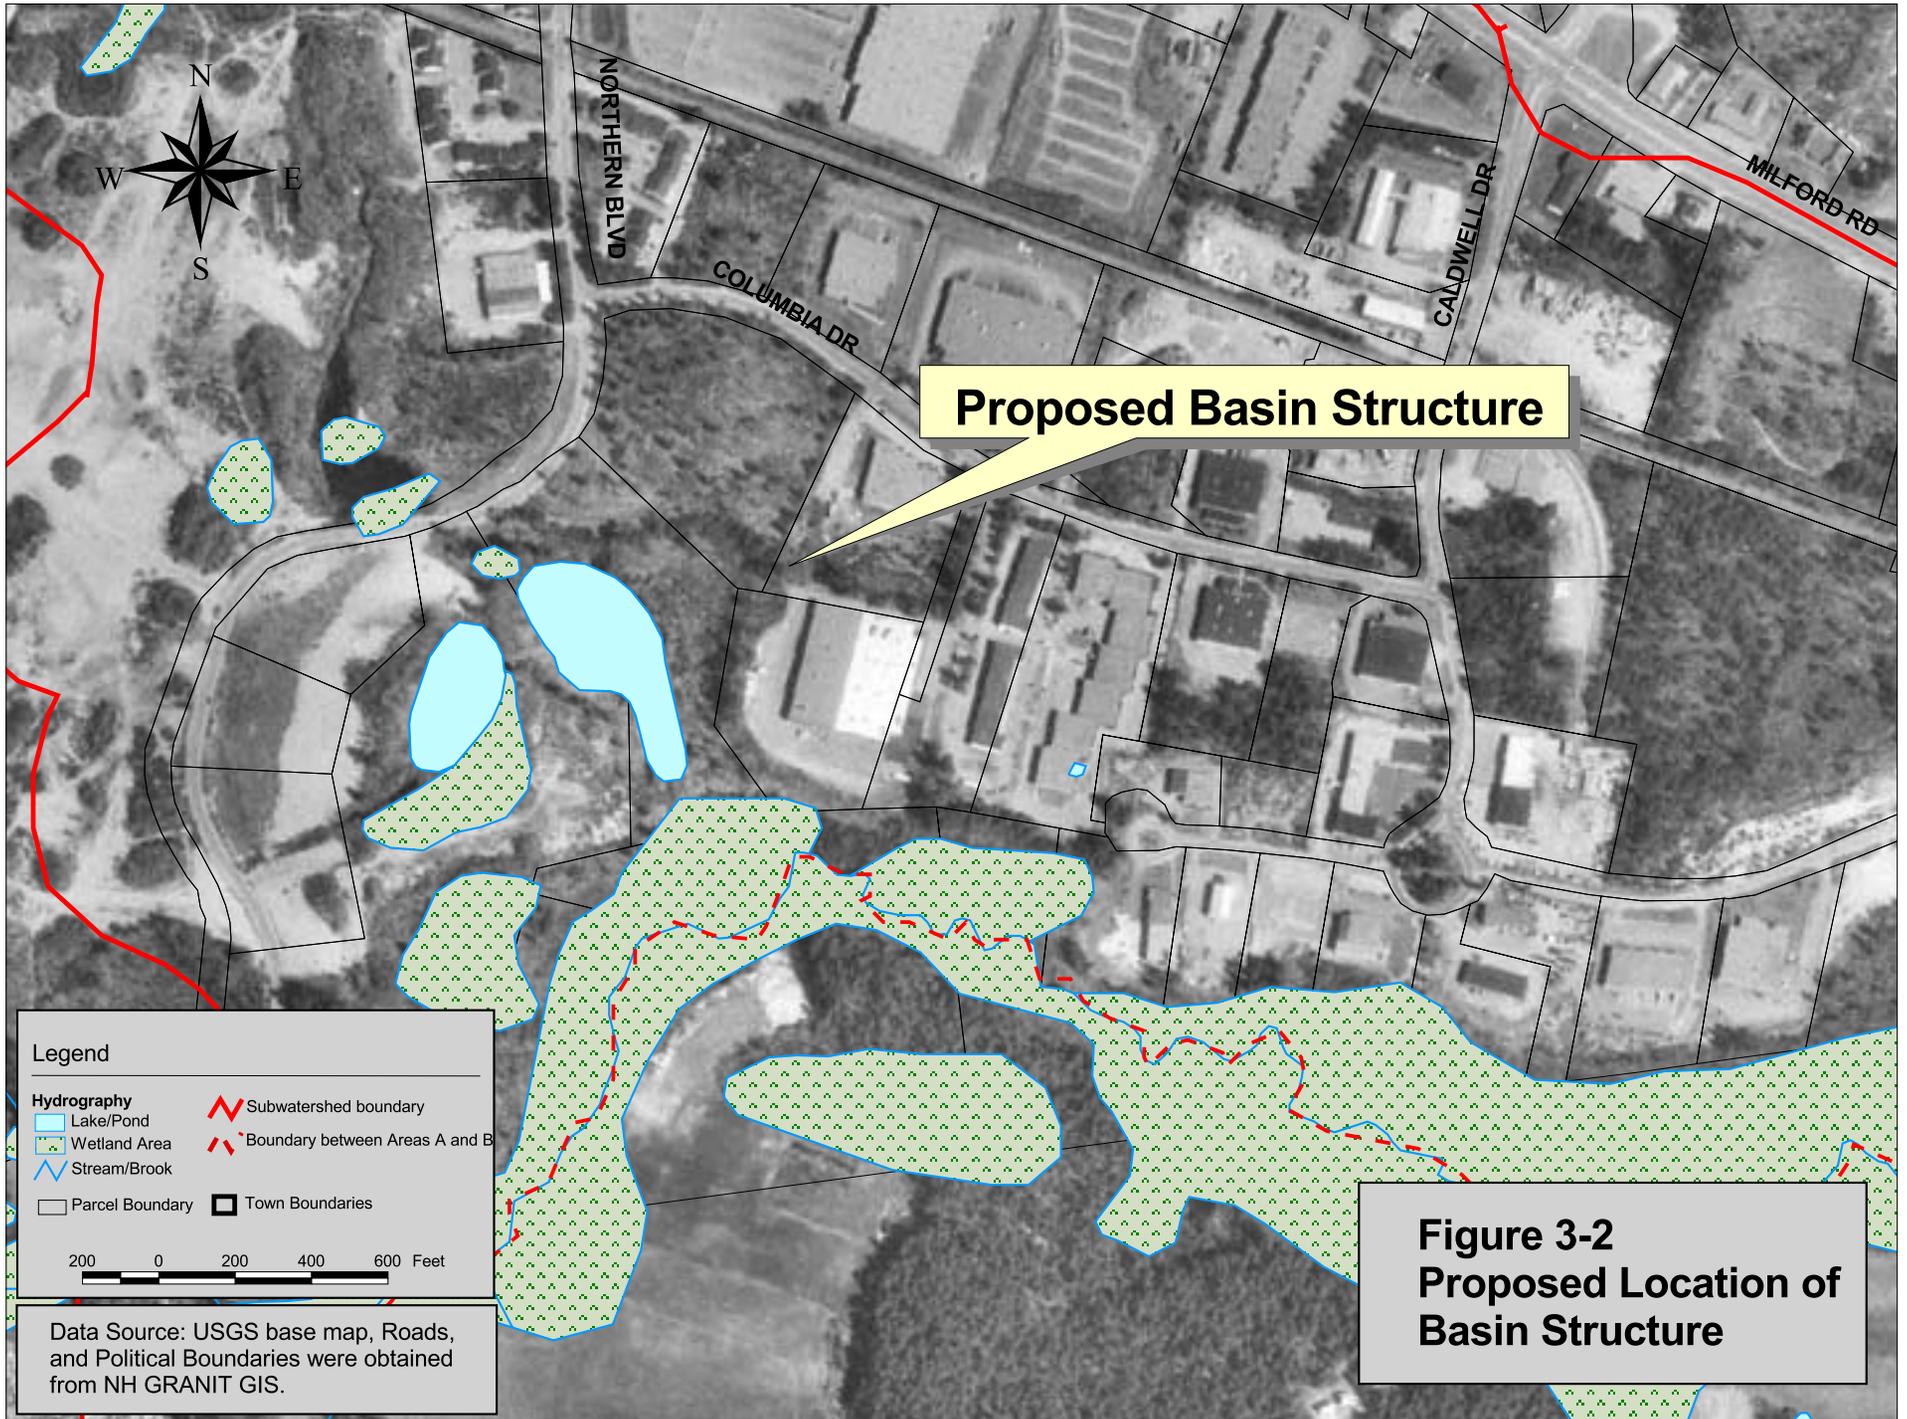
**Figure 3-2
Proposed Location of
Basin Structure**

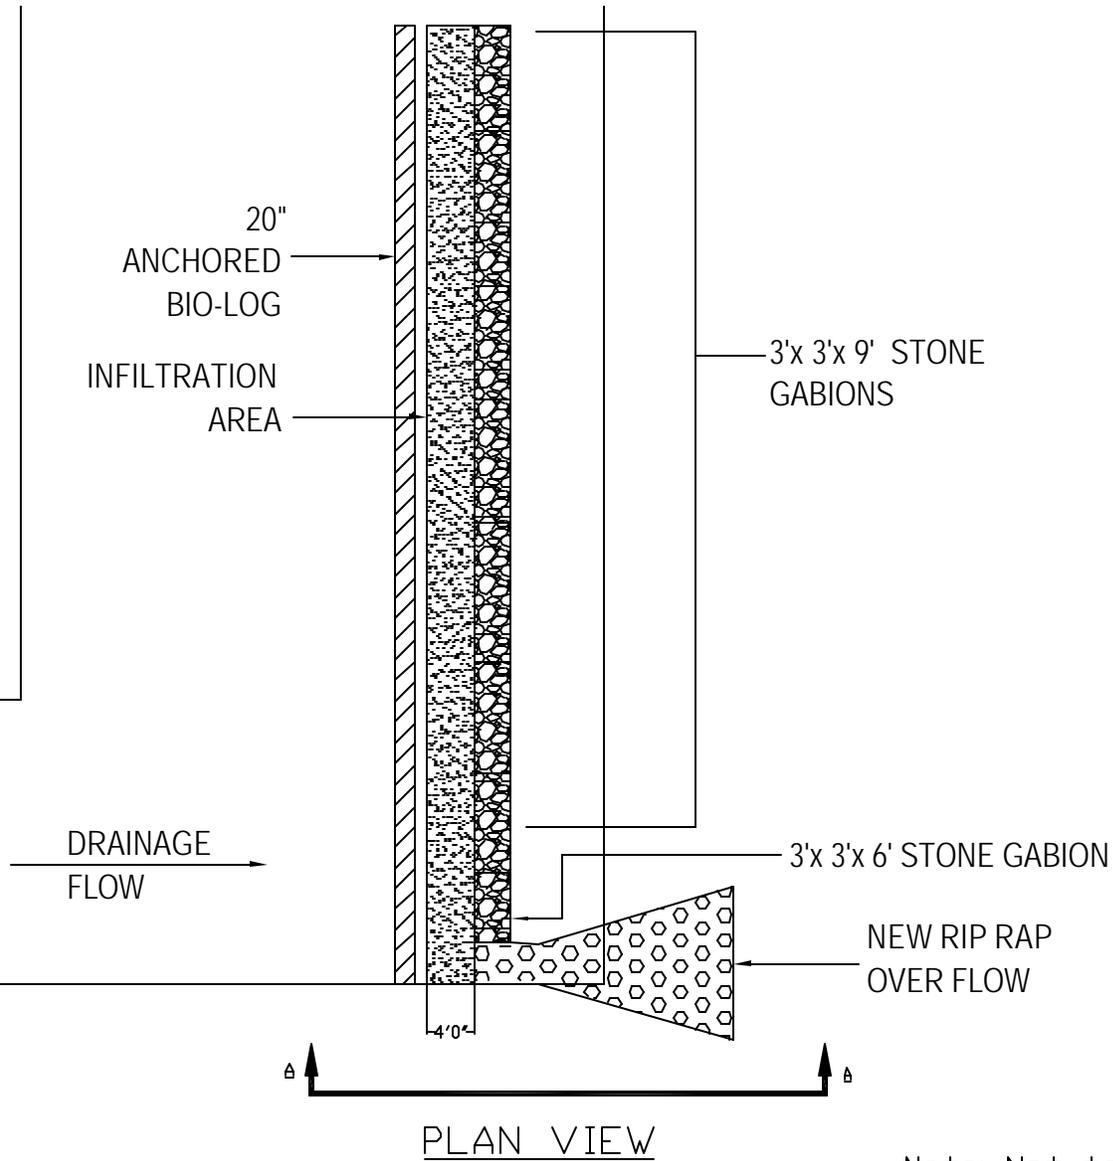
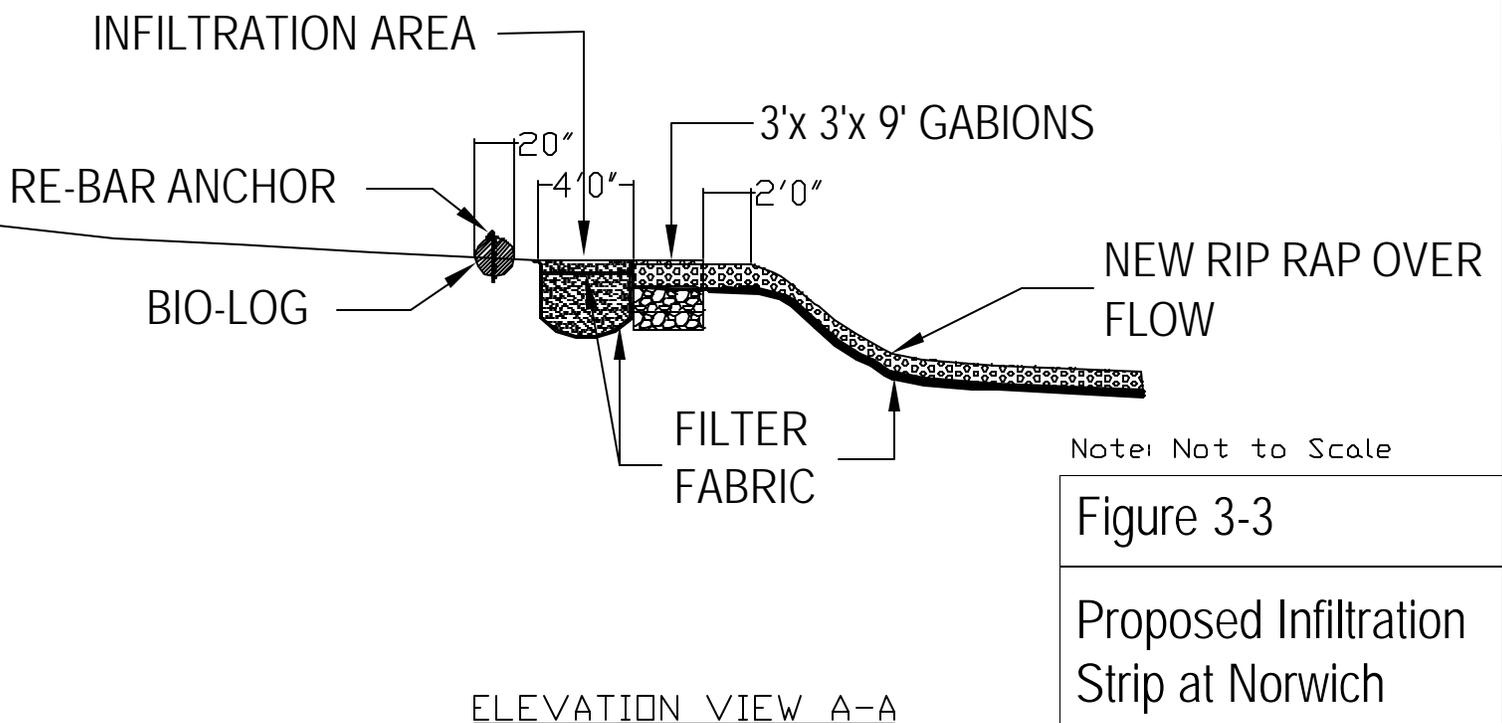
Figure 3-3

Proposed Infiltration Strip at Norwich Property

grade gabion backing wall would serve to provide a pervious bank support.

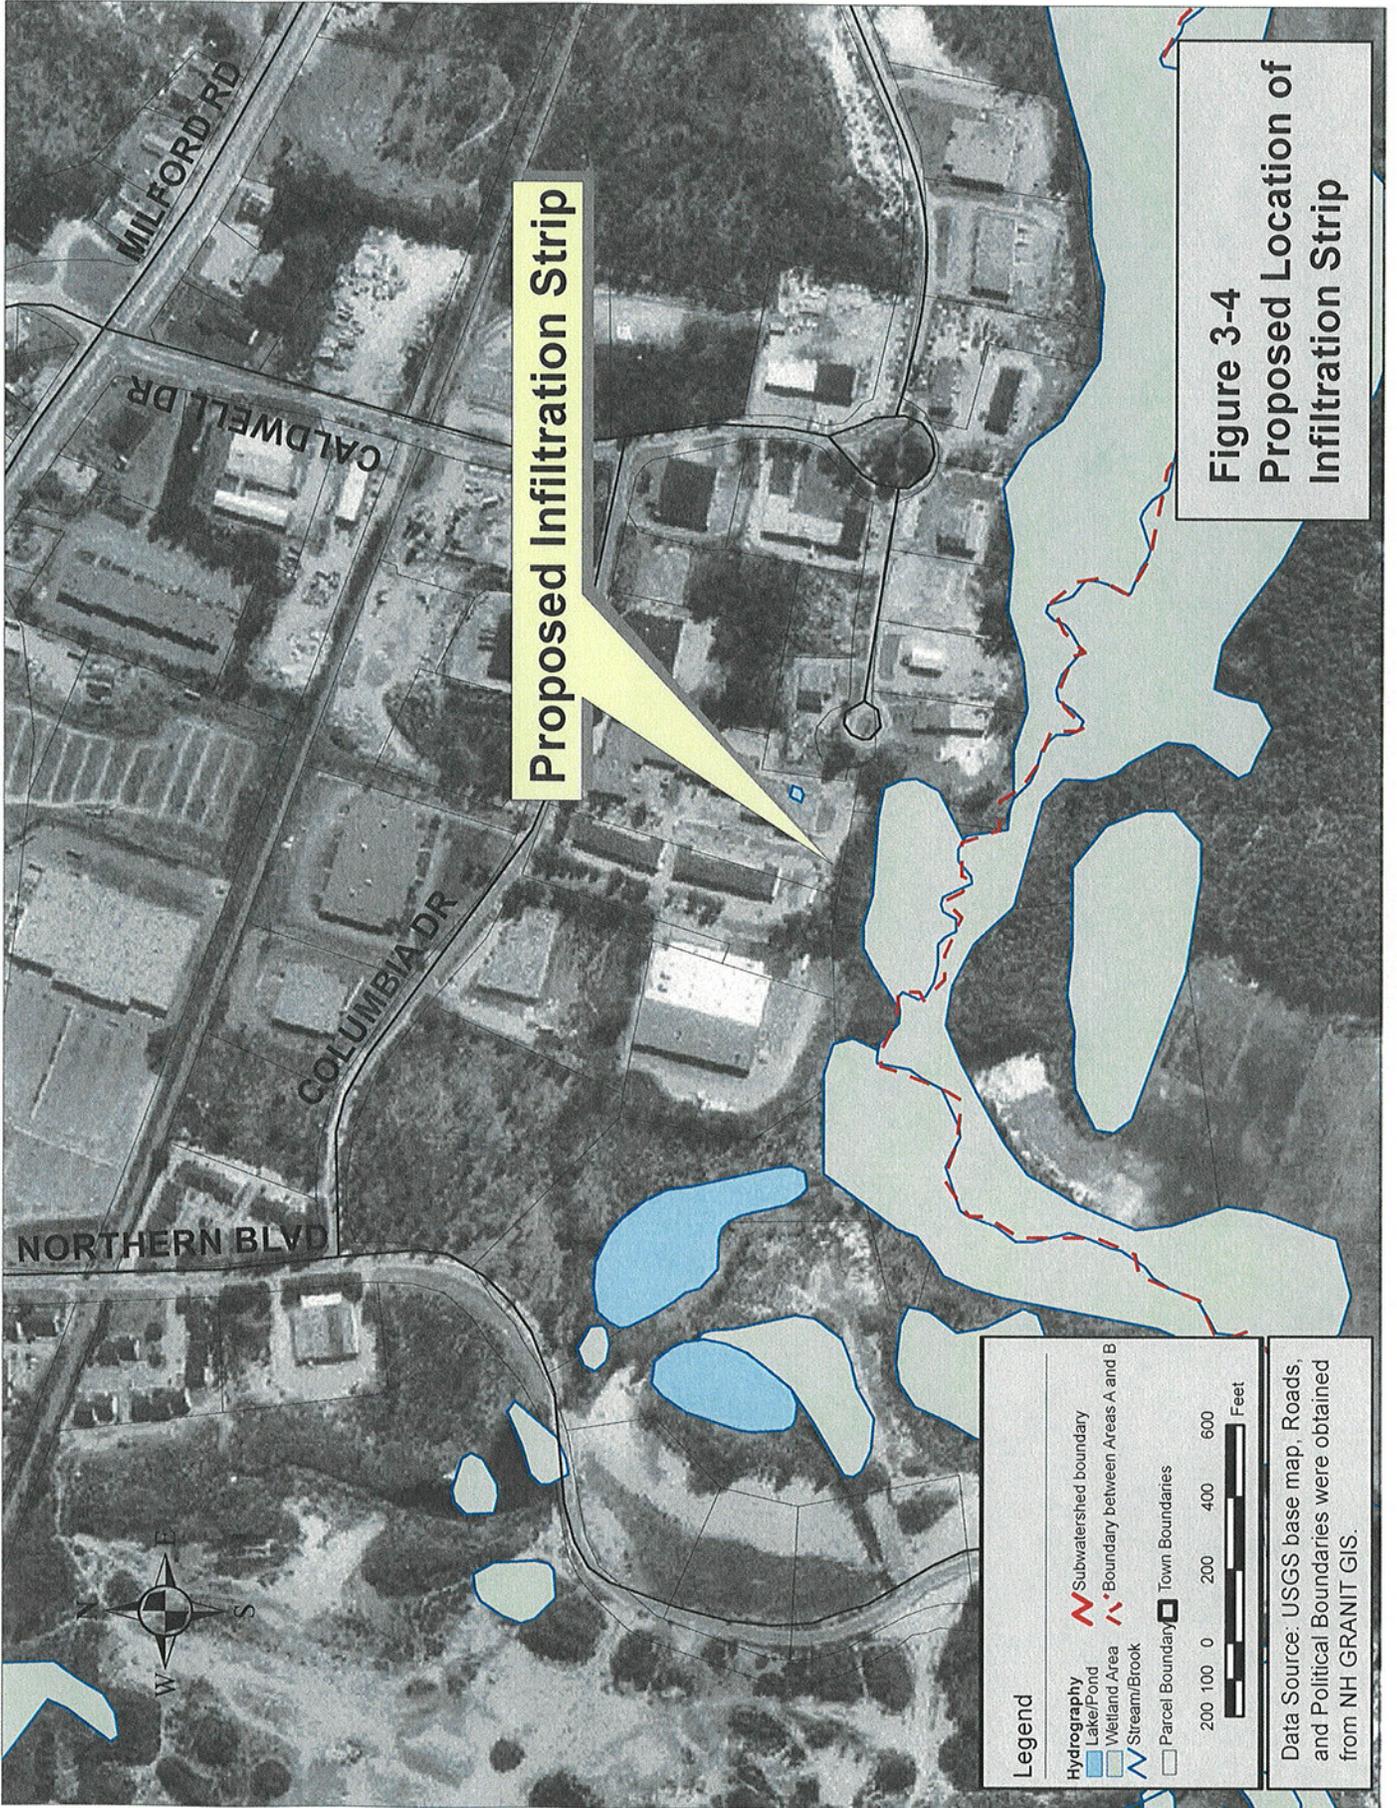
**Figure 3-4
Proposed Location of
Infiltration Strip**

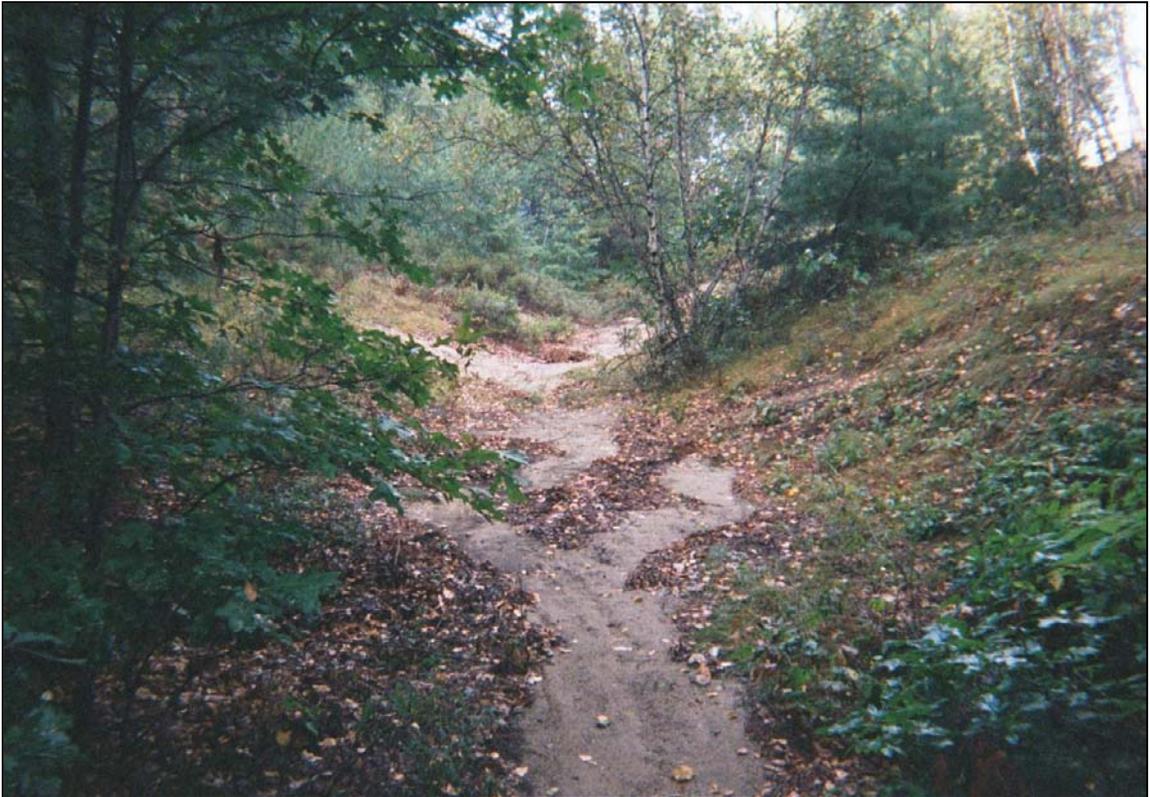
This site is a distributing warehouse located at 9 Columbia Drive. There is a 12" discharge at the southern portion of the site that collects runoff from the building and parking areas and travels through a 175 foot sandy swale adjacent to the Columbia Drive discharge mentioned in Section 2.1.1 (Figure 3-6 shows the swale area). The swale is currently in good condition and probably infiltrates most small rainfall events. During larger events however, it likely contributes to the heavy flow and scouring observed in the tributary below. The large sandy swale area provides a good location for the infiltration basin mentioned in Section 3.1.1 and as such, the discharge at this site should be incorporated into the design. As proposed in Section 3.1.1 the structure has been designed to capture the Atomic drainage.

Figure 3-6. View of the sandy swale (looking upstream) behind the Atomic warehouse.
