Comprehensive Environmental Inc.

Study of Urban Non-Point Source Pollution Witches Brook East Subwatershed

**PENNICHUCK WATER WORKS
SEPTEMBER 2001**

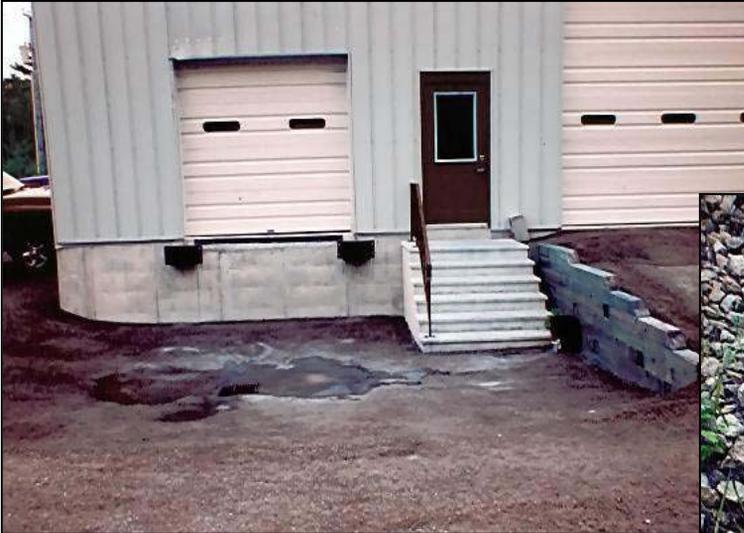
Figure 3-7. View of catch basin and contributing drainage area.

There is a 6" PVC discharge adjacent to Witches Brook behind the J.R. Poirier Tool and Machine Company property located on Manhattan Drive in drainage area A. This discharge is from runoff collected at a single catch basin from the parking area around the loading dock at the southwest corner of the building (Figure 3-7). At the time of inspection, there was a milky white substance at the point of discharge that appeared to be some type of detergent or paint (Figure 3-8). It appears that the area surrounding the catch basin is occasionally used as a washout area. Discharges from this pipe flow over a grassy area that is contained by a deteriorating row of hay bales approximately 50 feet from the brook (Figure 3-9). Vegetation in this area did not appear stressed despite the unusual liquid present. Nonetheless, periodic sampling of this effluent is recommended and at the very least educational materials already developed by Pennichuck should be given to employees. Perhaps a non-confrontational site visit to explain the importance of their role in protecting water quality is warranted.

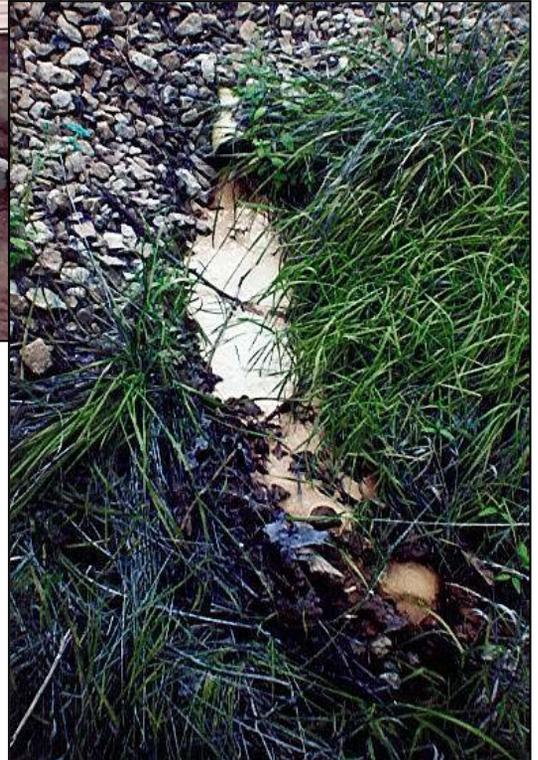
Figure 3-8. View of effluent observed at outlet location.

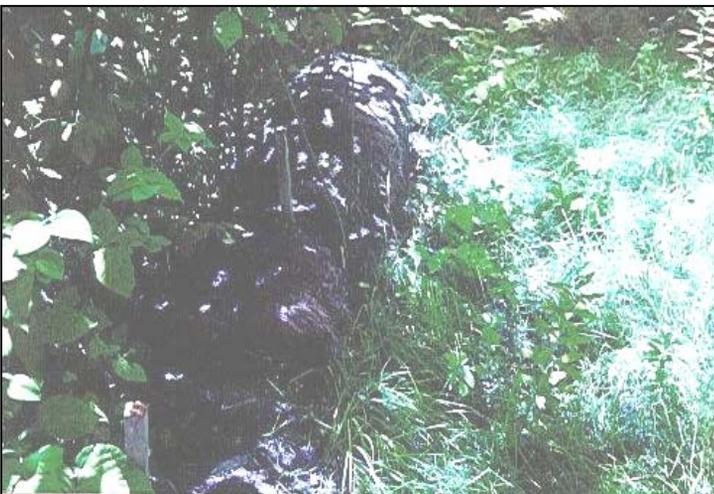
Figure 3-9. View of hay bales adjacent to Witches Brook.

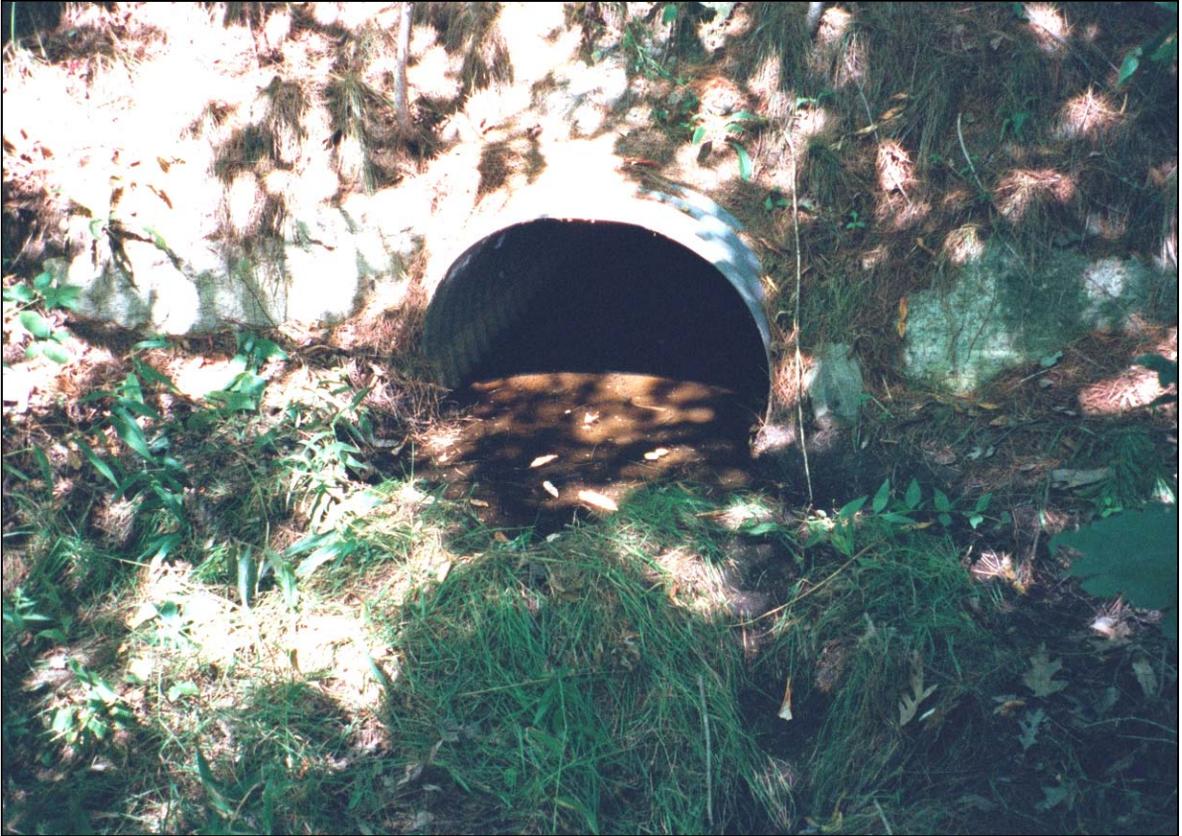
Figure 3-10. View at outlet location.

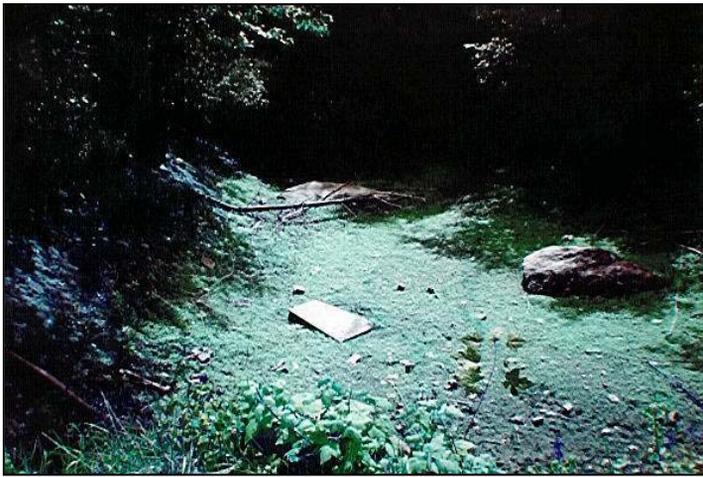
Figure 3-12. Example of detention area for brook.

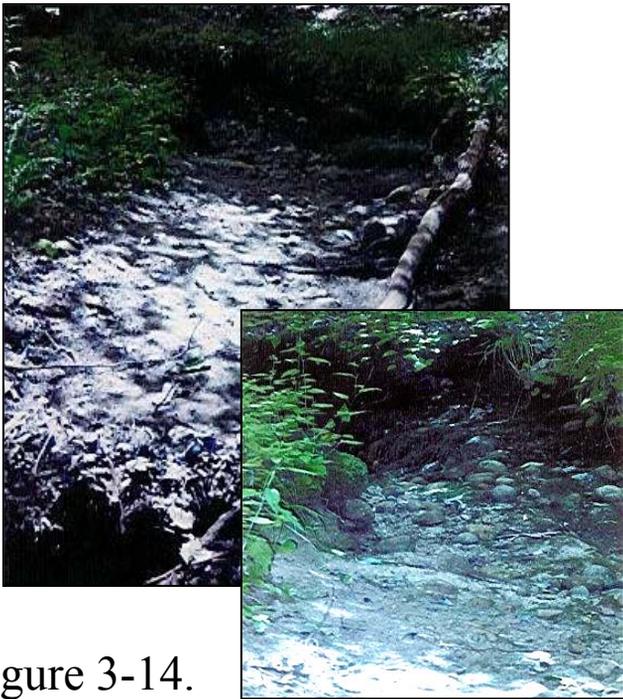
The Mooar Hill Road area, including Sargent Road, contributes significant drainage to the Brook named as Mooar Hill Road Brook. The upper portion of the Brook does not flow during dry weather conditions, however, the steep grade of this area leads to significant flows during rain events, despite the relatively small percentage of impervious surfaces in the area. Drainage flows through a few detention areas (Figure 3-12) before it connects with Mooar Hill Road Brook just before the Brook passes under Mooar Hill Road. From this point, the land surrounding the Brook is considerably steep (See Figure 3-13 for view of steep terrain), lending to heavy bank cutting during storm events (Figure 3-14 shows bank cutting). Future development in this area will lead to even greater flows and bank cutting/ erosion downstream (see discussion in Section 3.14).

Figure 3-14. Example of bank cutting/ erosion along brook.

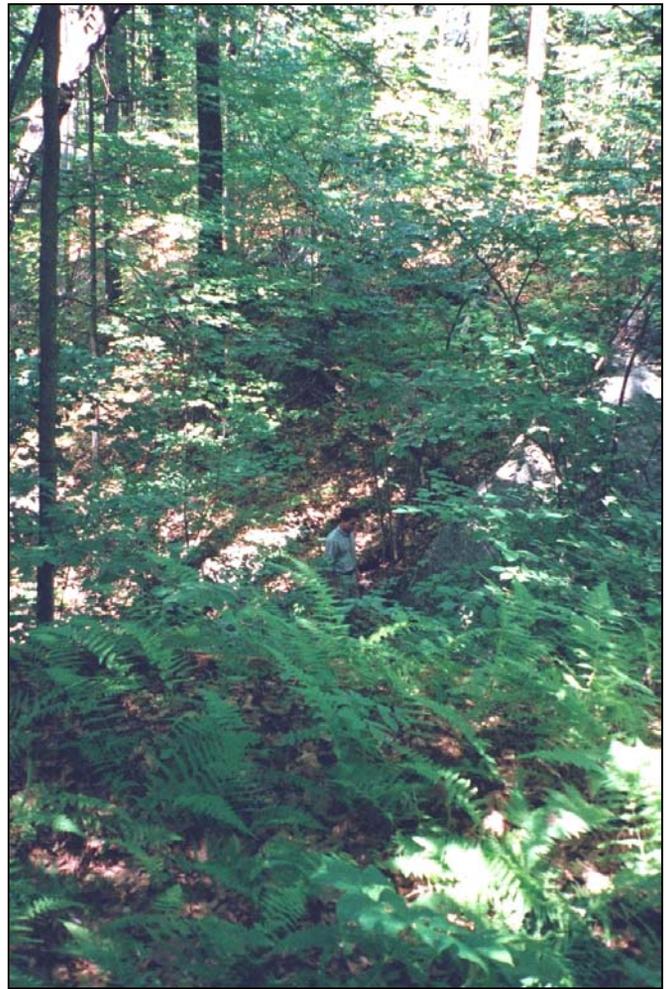
Figure 3-13. View of steep terrain along brook. The CEI employee in the center of the photo is standing in the streambed to provide a sense of scale.

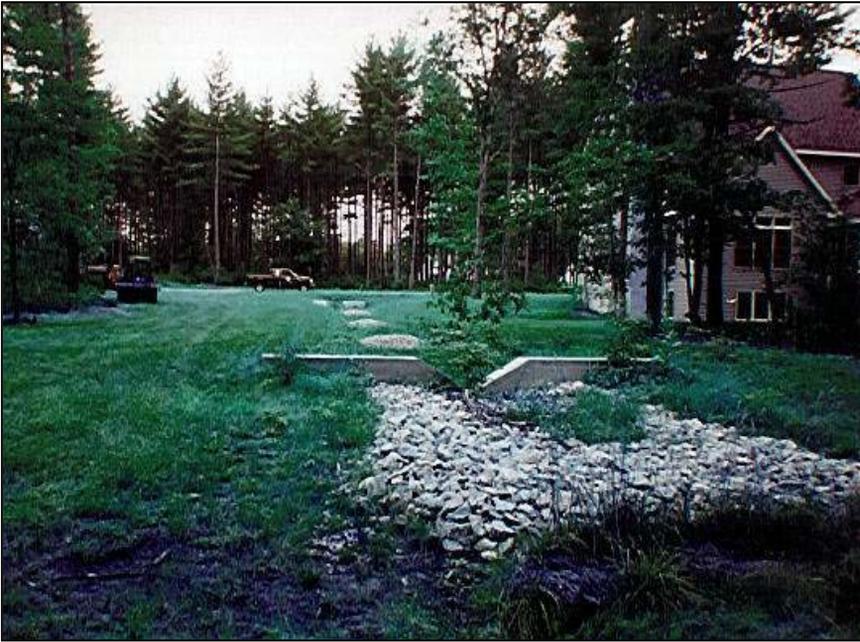
Numerous BMPs (Figure 3-15) were observed as part of the drainage system for the road and residential lots. However, due to construction activities and associated sedimentation, these BMPs need to be cleaned out (Figure 3-16) and readied for their design purpose of handling typical, post construction levels of residential pollutants once construction is complete.

Figure 3-15. Example of BMP observed at the new development along Emerson Road.

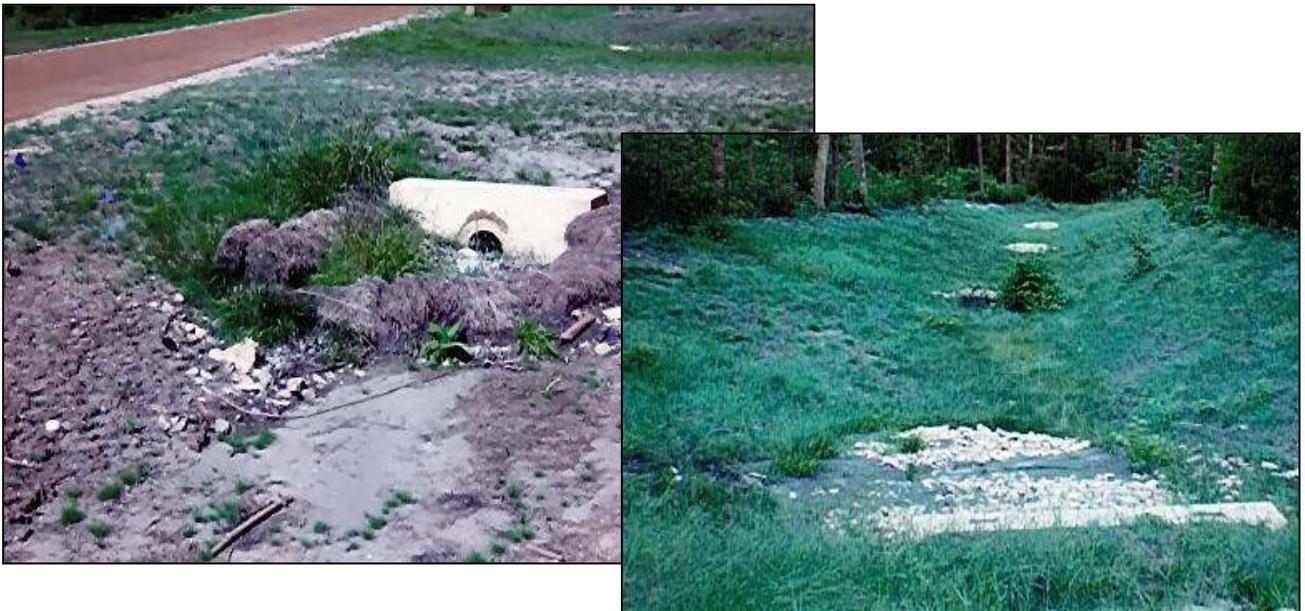
Figure 3-16. Examples of sedimentation issues during construction.

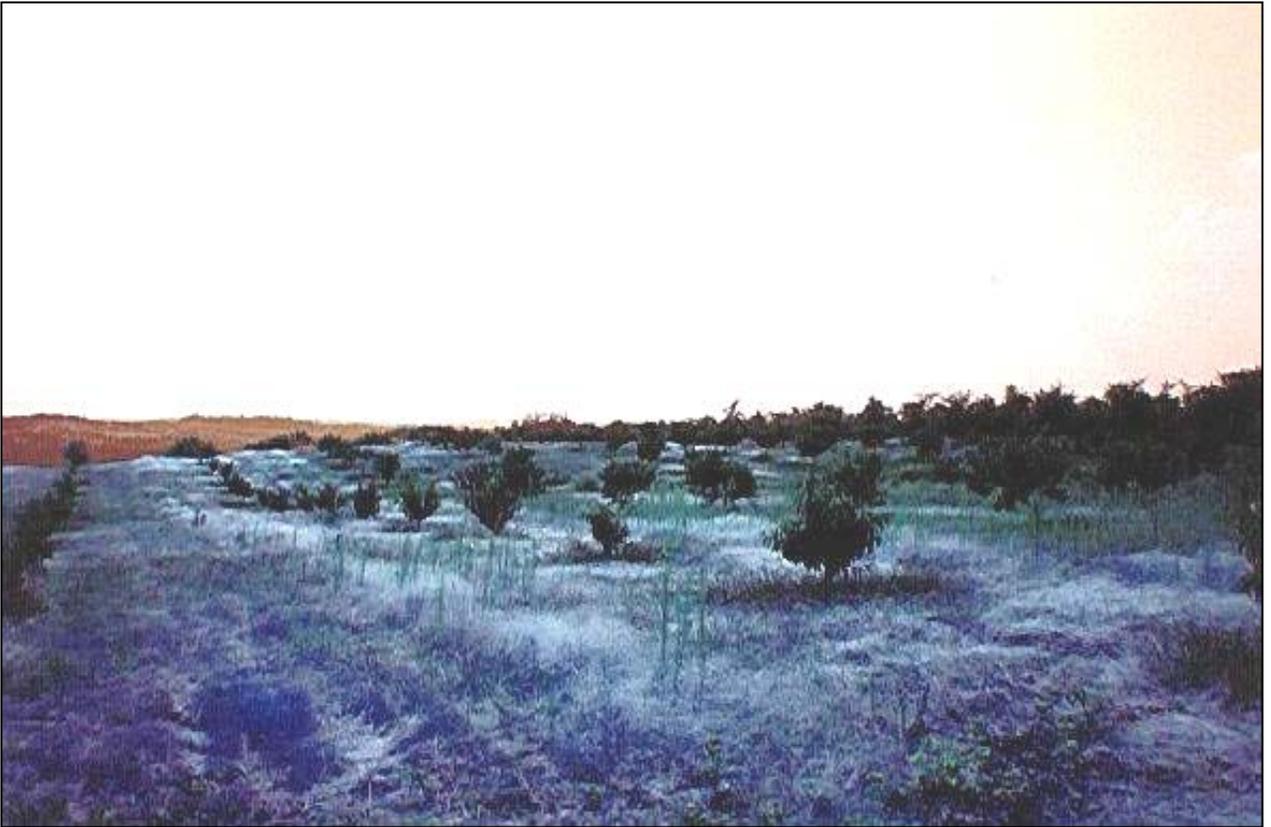
The apple and peach orchard (Figure 3-17) located at the southernmost portion of drainage area B is Woodmont Orchards. The orchard is a potential source of pesticides and fertilizers that may enter Hill Road Brook in the event of a spill or inappropriate application equipment washout. The orchard is expanding, meaning that the use of such chemicals will likely increase. This orchard was sent an educational brochure pertaining to agriculture developed by Pennichuck Water Works. A follow up call or site visit may be helpful (see footnote below) in reminding them of the importance of safe handling and disposal of pesticides and fertilizers.

Figure 3-17. View of apple and peach orchard at the southern tip of the WBE Subwatershed.
