Parsons Creek Watershed Based Plan

May 2011

Prepared by:
FB Environmental Associates, Inc.
97A Exchange St., Suite 305
Portland, ME 04101

PARSONS CREEK WATERSHED BASED PLAN

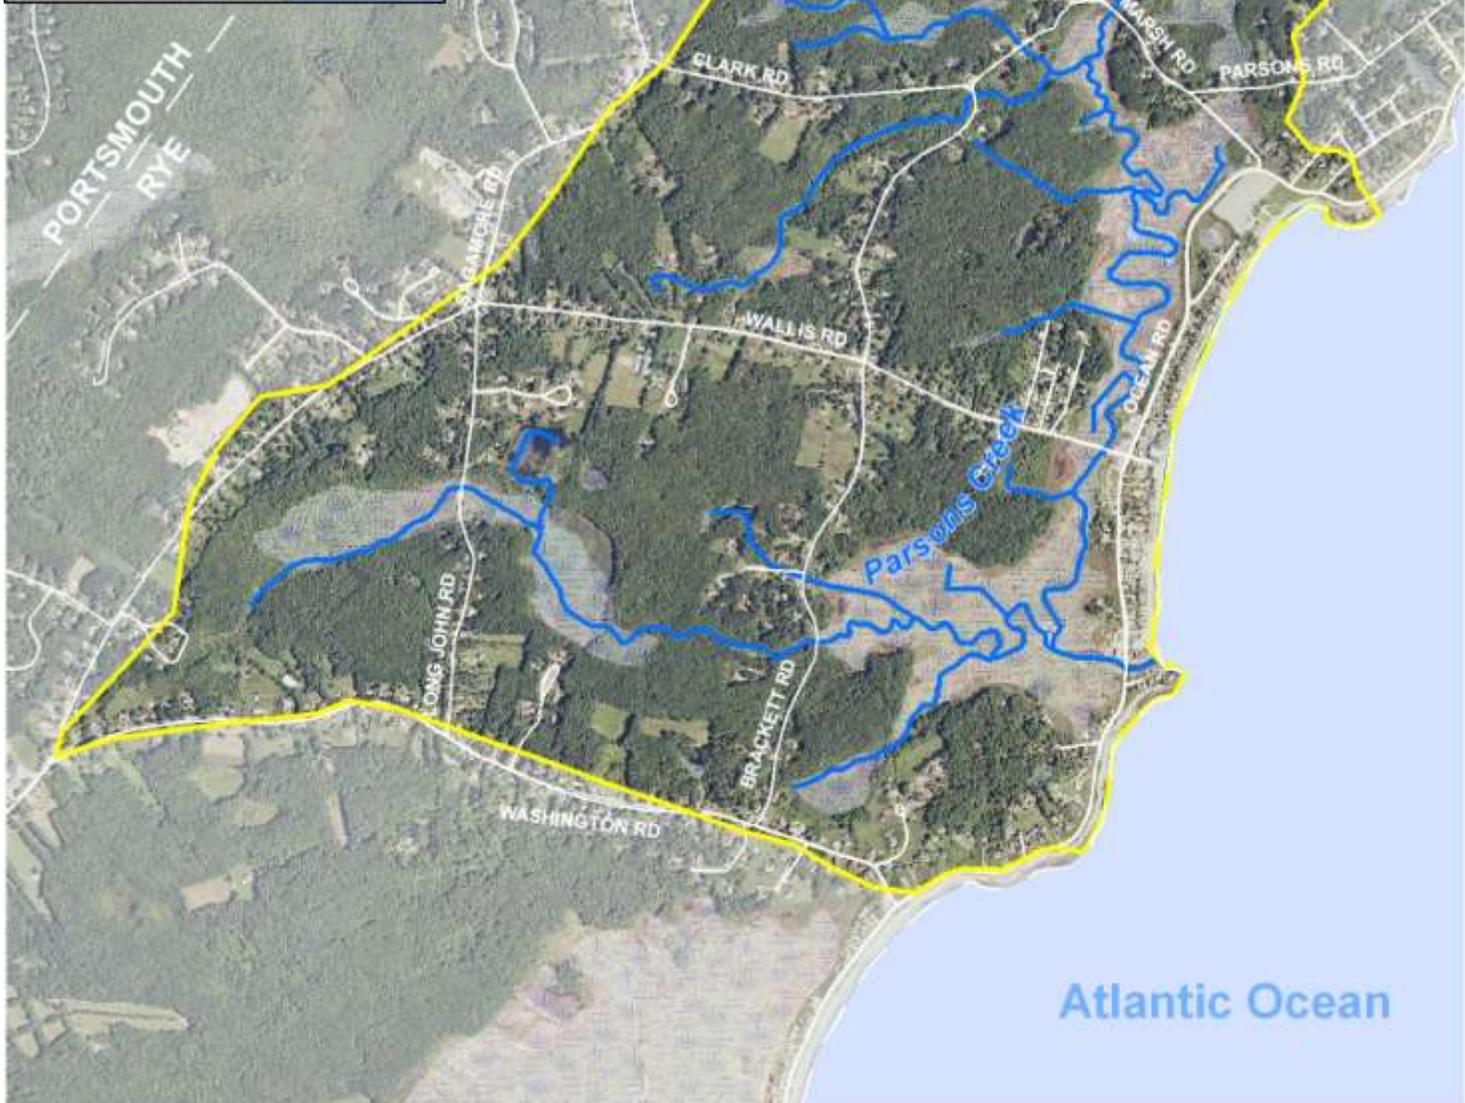
Parsons Creek Watershed, Rye, NH

- Stream
- Watershed Boundary (2.3 sq. mi.)
- Wetland

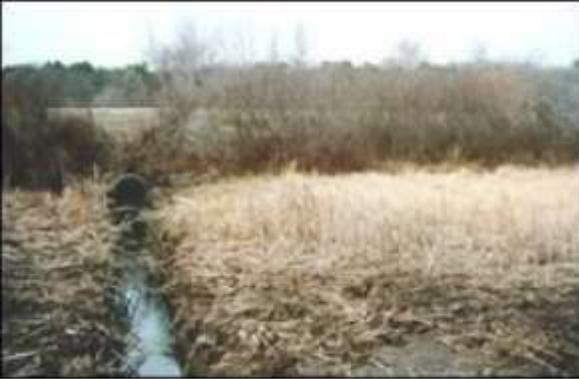
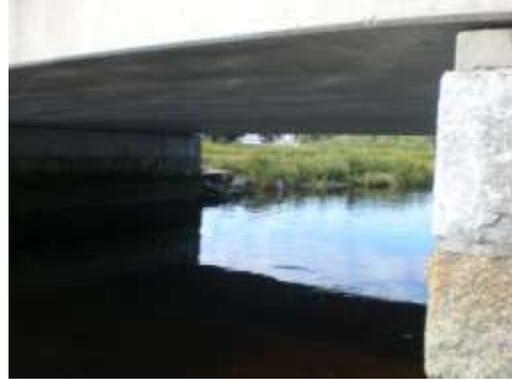
The mouth of Parsons Creek before (left) and after (right) the 1997-1999 tidal restriction removal project.

In 1999, the town completed a tidal restriction/invasive species removal project in the main salt marsh of Parsons Creek. This project, in partnership with the NH Coastal Program, removed and replaced three tidal restrictions throughout the main marsh area. Most importantly, the culvert under Route 1A was replaced with a bridge which reestablished the mouth of Parsons Creek. The bridge significantly increased tidal flow and reduced flooding of properties next to the marsh. Routine post-project monitoring has shown that natural vegetation is returning to the marsh due to the increased tidal flow and the marsh is regaining stability.

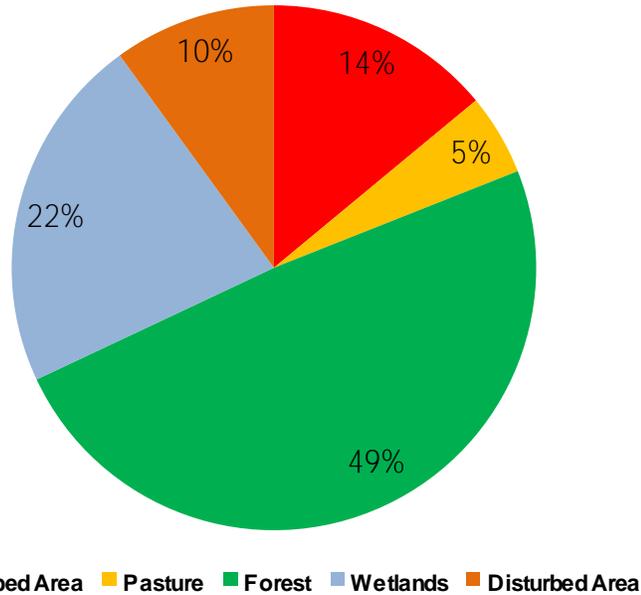
Figure 2.2 Pie Chart of Land Uses in Parsons Creek Watershed

Analysis using the 2001 New Hampshire Land Cover layer provided by New Hampshire's Statewide Geographic Information System (GIS) Clearinghouse (GRANIT) shows that land uses in the Parsons Creek watershed are predominantly woods and wetlands (Figure 2.2). Forested lands, made up of mixed forest types including oak, beech, pine, and hardwoods, accounts for 49% of land use area. Tidal wetlands dominate the coastal areas and account for 9% of the total 22% of wetlands in the watershed. The remaining 29% of watershed area is comprised of other land covers types, such as developed area, disturbed area, and hay/pasture.

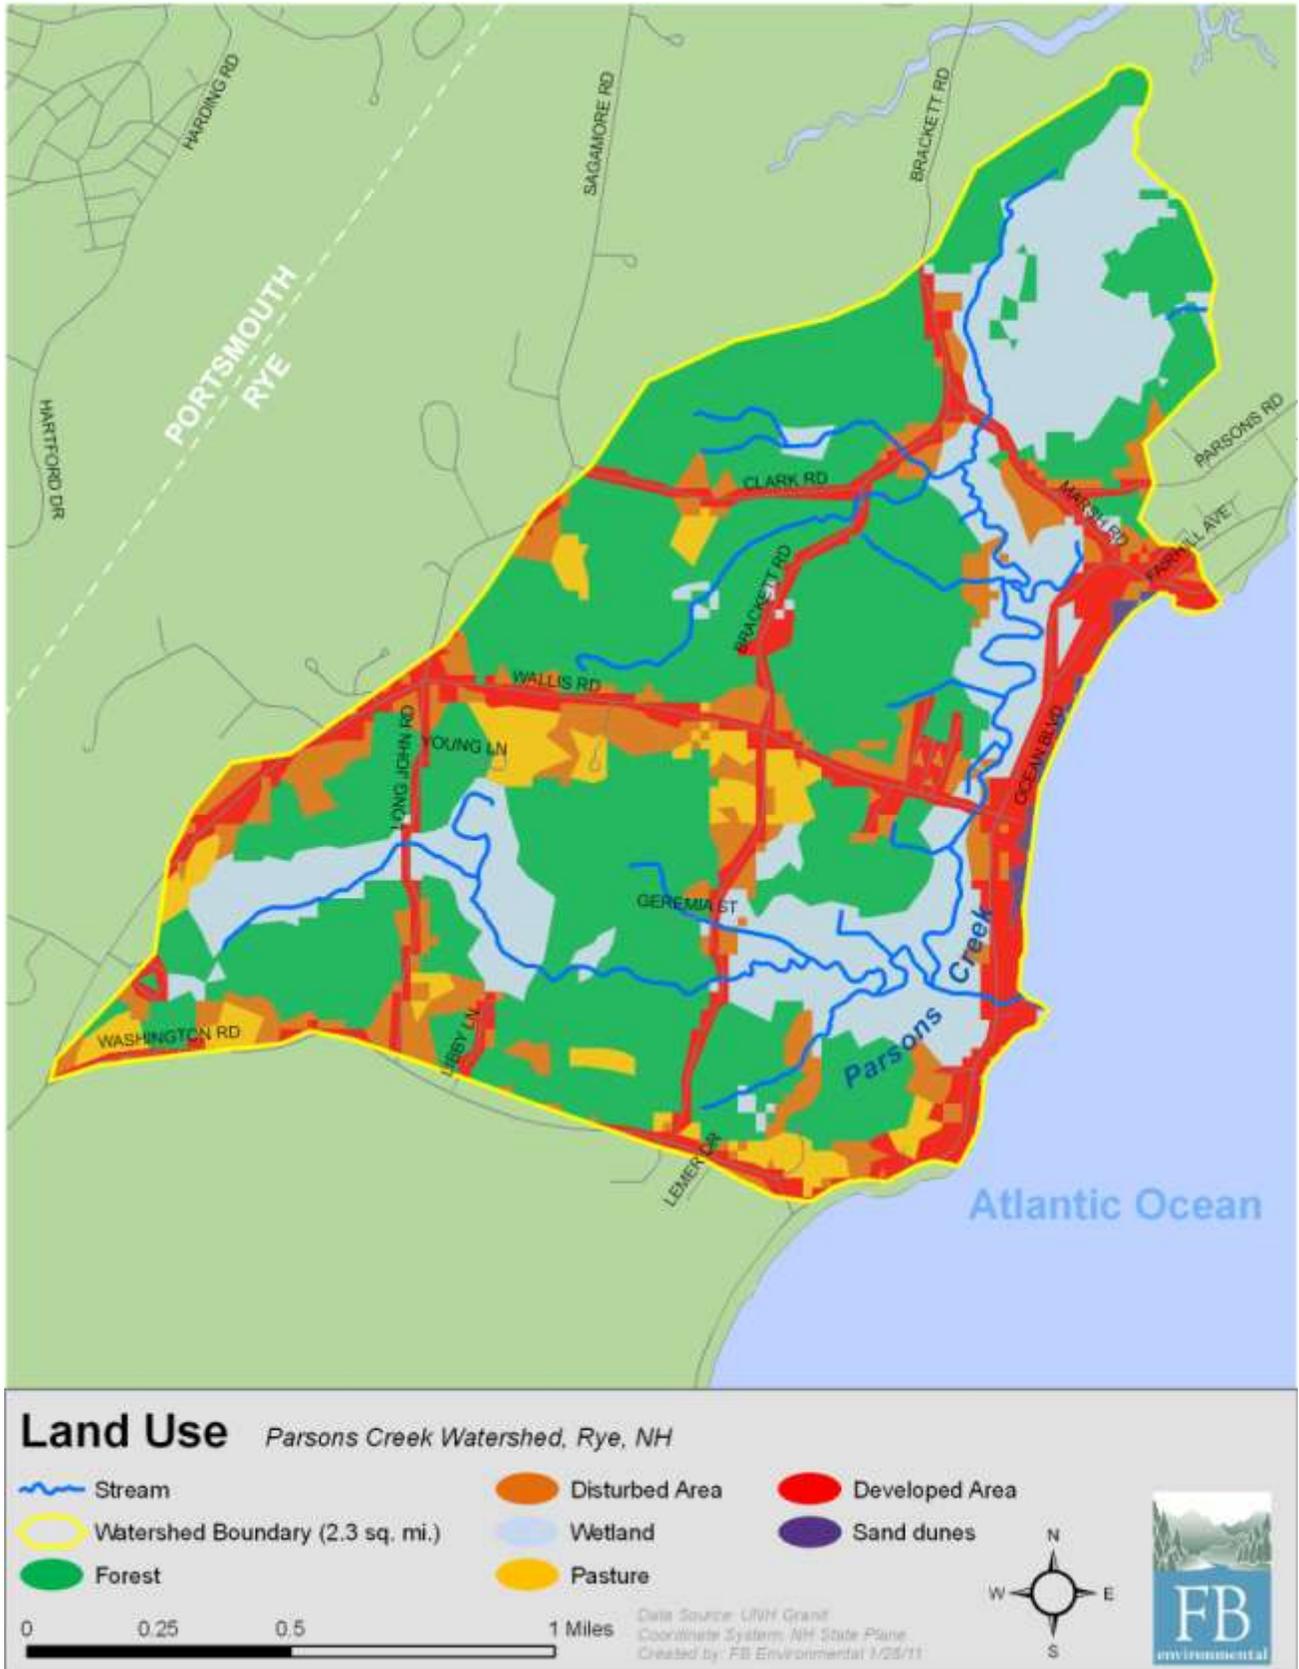
Figure 2.3. Map of Land Use in the Parsons Creek Watershed

The forest land is located in large habitat blocks inland from the coast and is separated only by roads and minimal development (Figure 2.3). Wetland areas wind through the forests following the course of Parsons Creek. The northern branch headwaters, above Brackett and Marsh Roads, make up the largest area of wetlands in the watershed. Development is concentrated near the coastline and Route 1A as well as other major roads. Agriculture is scattered throughout the southern half of the watershed along Wallis and Washington roads. Most agriculture in the watershed consists of cropland and pasture.

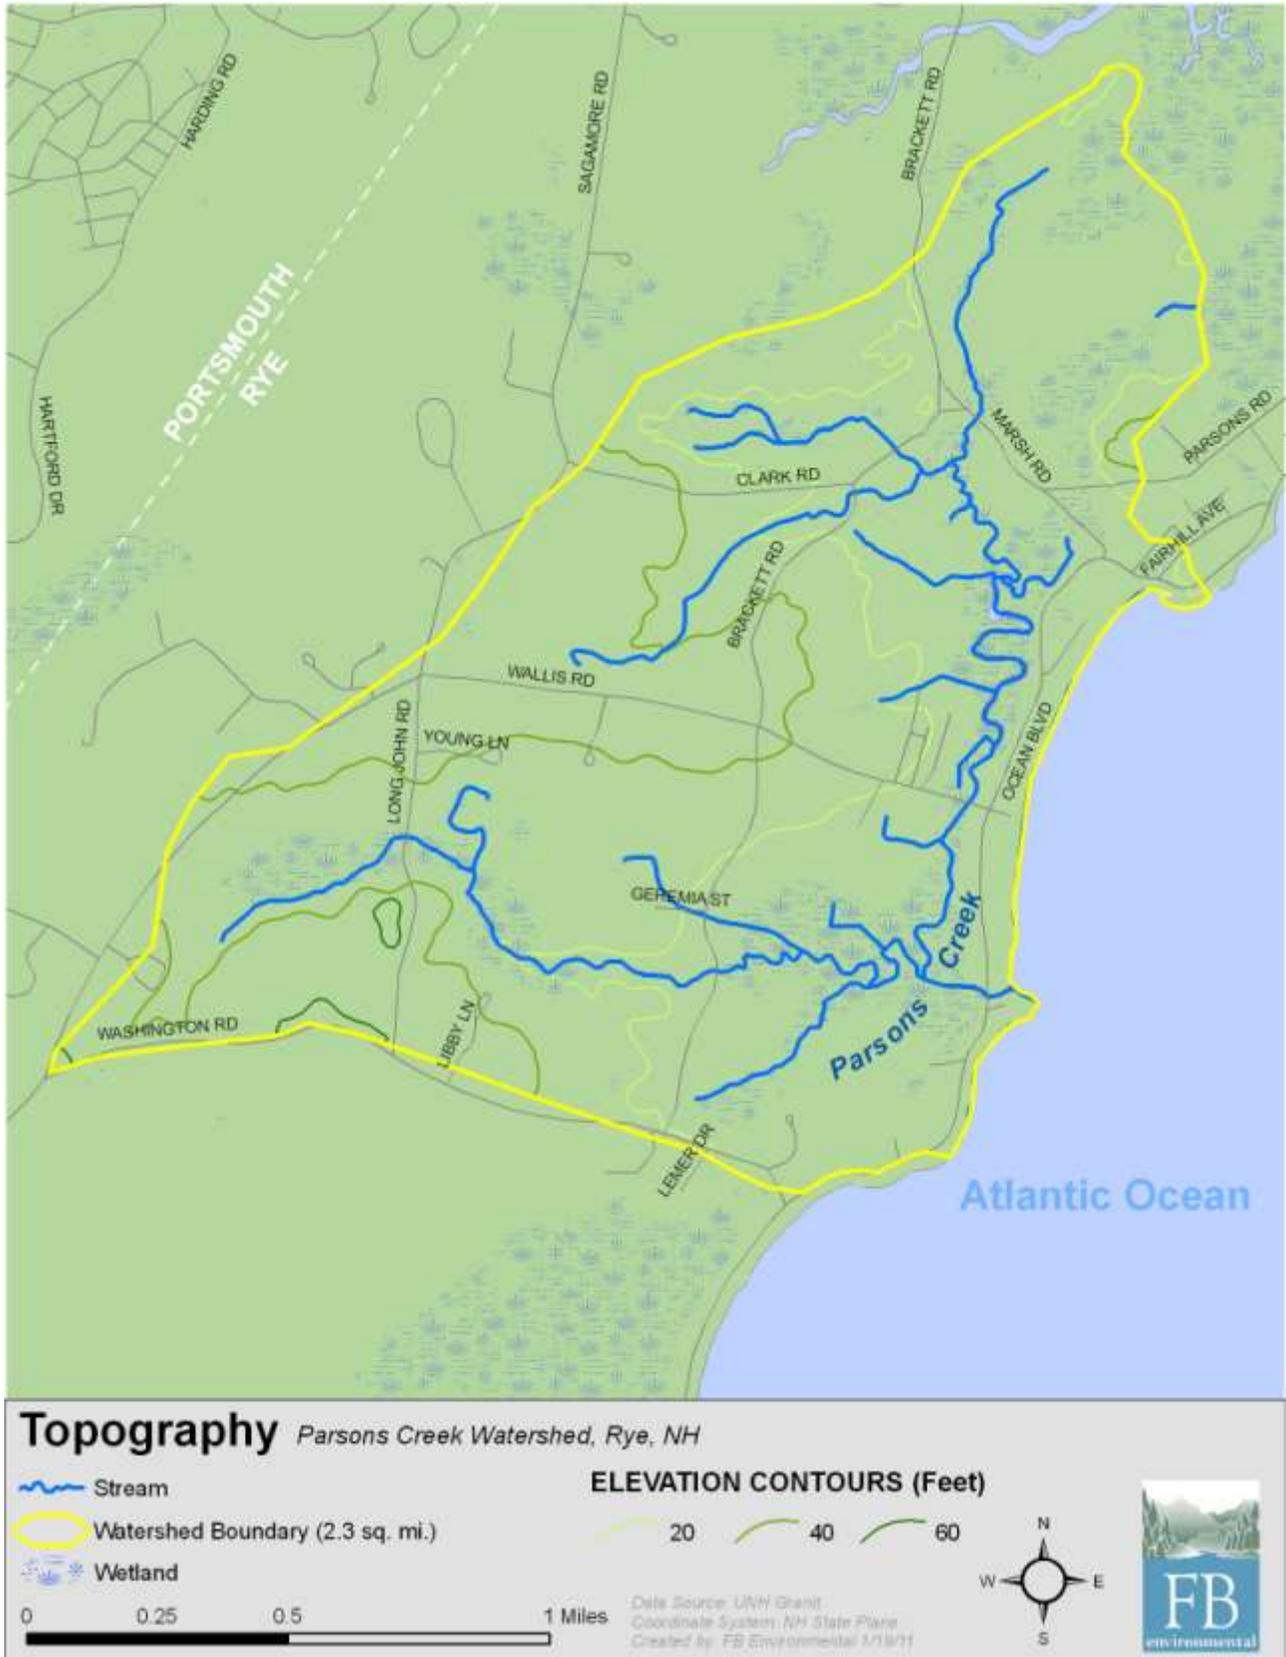
Figure 2.4. Map of Topography in the Parsons Creek Watershed

Both branches of Parsons Creek exhibit similar morphology. Headwater streams begin in marsh areas and flow through low density residential neighborhoods. The northern branch of Parsons Creek has more open freshwater marsh with grasslands, unlike the western branch that is composed of forested wetland and smaller channels. A majority of the stream length is well buffered by forested habitat and far from buildings. There is little open water in the watershed but the marsh channels are broad and very slow moving in the northern branch. Large open marshes in the watershed are mostly conserved for bird habitat, such as Massacre Marsh at the downstream end of the western branch of Parsons Creek and Wallis Marsh. The watershed itself varies little in elevation from headwaters to the ocean outlet.

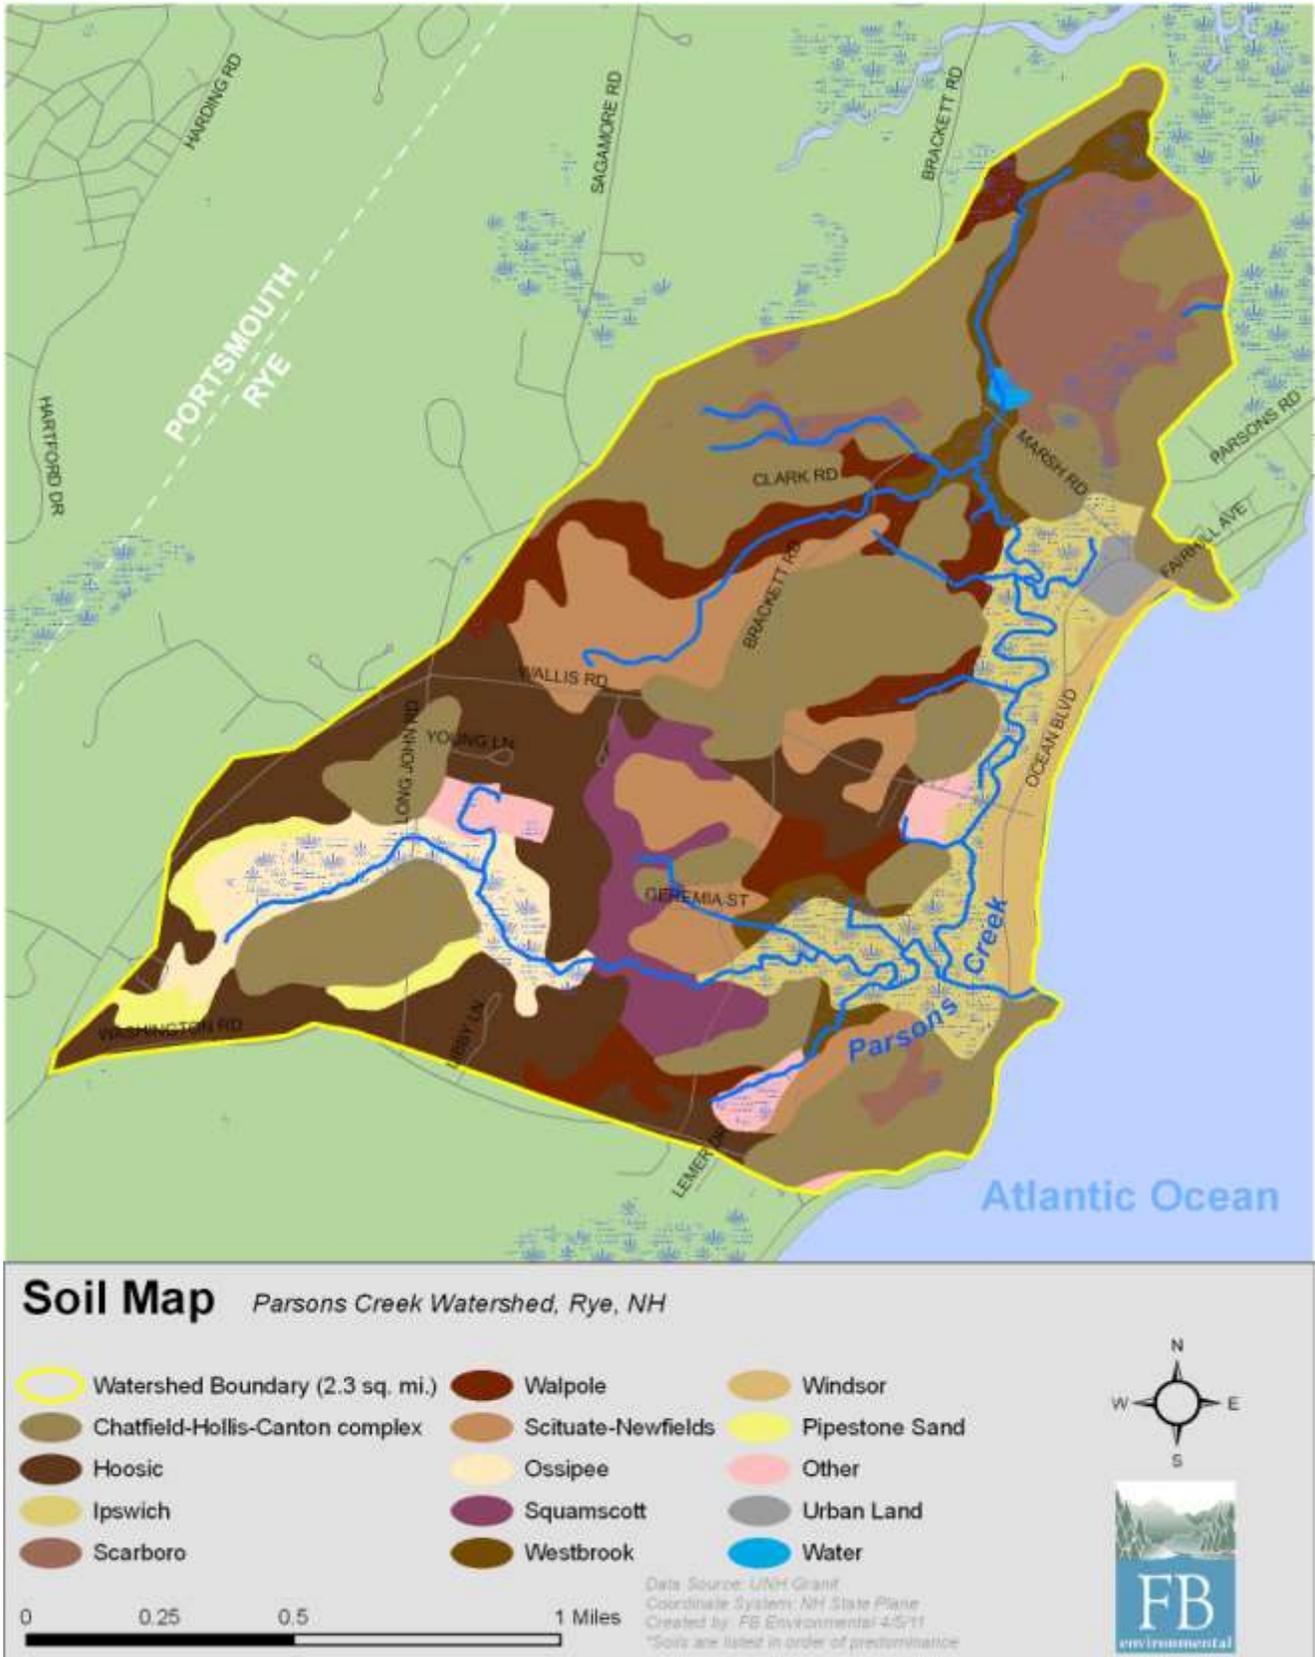
Figure 2.5. Map of Soils in the Parsons Creek Watershed

Most soils in the watershed are mapped as fine sandy loam or muck. Wetland areas in the tidal marsh are primarily Ipswich mucky peat, a poorly drained salt grass habitat that is rich in organic matter deposits and salt (Figure 2.5). Along the northern branch of Parsons Creek, soils transition to Westbrook mucky peat which gives way to Scarboro muck in the headwaters above Marsh Rd. Scarboro muck is created by glacial deposits and decaying organic matter in shallow depressions where the water table is at or near the surface. Ossipee mucky peat is found beneath the headwaters of the western branch and is created from plant and woody debris. This soil is also very poorly drained and characteristic of a wooded wetland (NRCS, 2010).

Non-wetland soils in the watershed transition from rocky, loamy soils in the north to fine sandy soils in the south. Chatfield-Hollis-Canton soils dominate the northern end of the watershed. They are well drained soils with a sandy loam texture and glacial till deposits. Most forested areas in the watershed are found on these soils. Woodlands are also found on Hoosic soils in the southern end of the watershed. Hoosic soils are found on gently sloped terrain and are composed of glacial outwash. Glacial outwash creates excessively dry, sandy soils with small gravel sized rocks. Areas with this soil are typically used as farmland but can host a wide variety of hardy trees such as sugar maple, oak, and hickory. Land uses on this soil in Parsons Creek watershed are primarily developed.

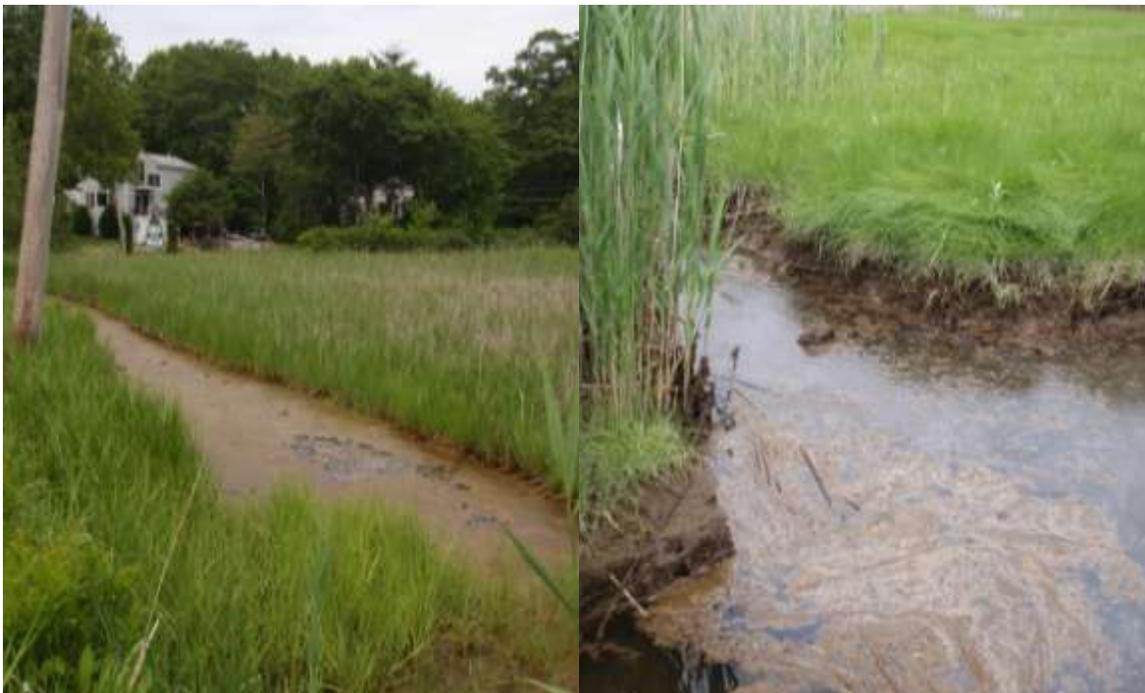
Both photos above show sample site BCH 11 during routine sampling on June 16, 2010. BCH 11 was above EPA water quality criteria during all sampling events. (photo: Megan Cook, NH DES)

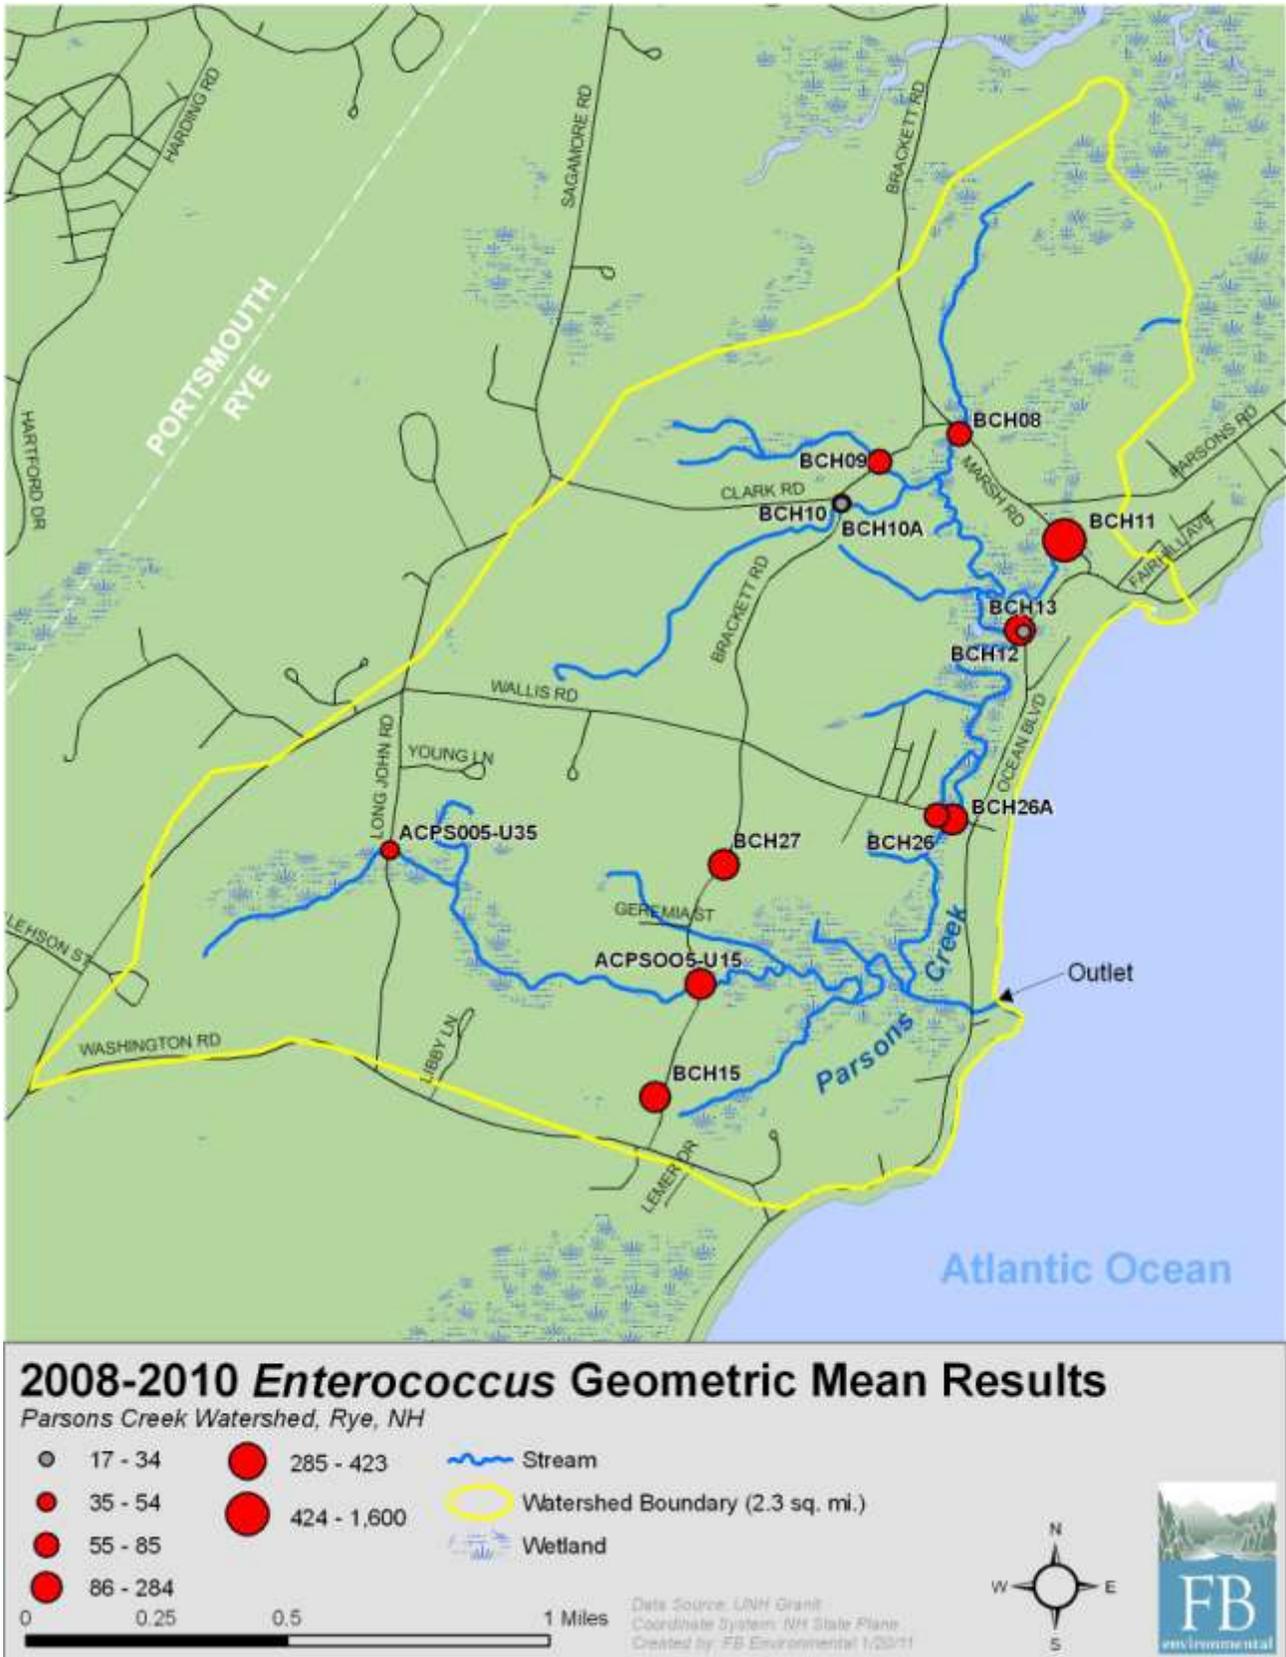
Figure 3.2. Map of Enterococci Sampling Locations and Geometric Means

Bacteria levels in Parsons Creek range from <9 to 19,700 colonies/100 mL (Table 3.3). Of the 15 sites sampled since 2009, all have at least one sample that exceeds 104 col/100mL, the most strict state instantaneous standard for **Enterococci involving primary human contact**. **BCH 11, the headwaters of Parsons Creek's northern branch, far exceeded State standard in all sampling events regardless of weather conditions and had the largest single sample result of 19,700 col/100 mL.**

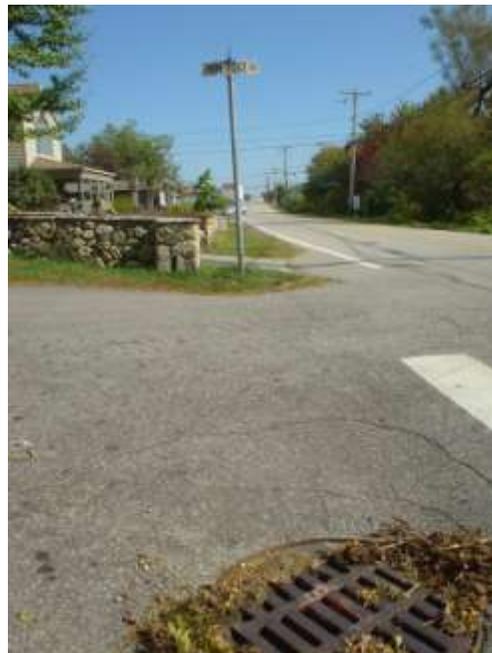
Catch basin with debris at the corner of Park Ridge Rd

The September 29 survey focused on the storm drain network and followed **the Town of Rye's MS4 map of stormwater infrastructure**. During the survey, a few catch basins were observed to be plugged with sediment or organic matter, but most allowed water to drain freely.

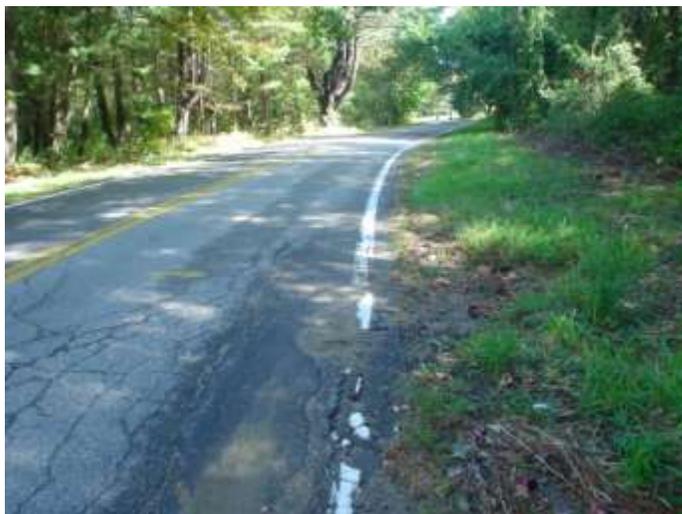
Sediment along a road side near a catch basin, indicated by a yellow arrow. Sediment is a carrier of both bacteria and nutrients.

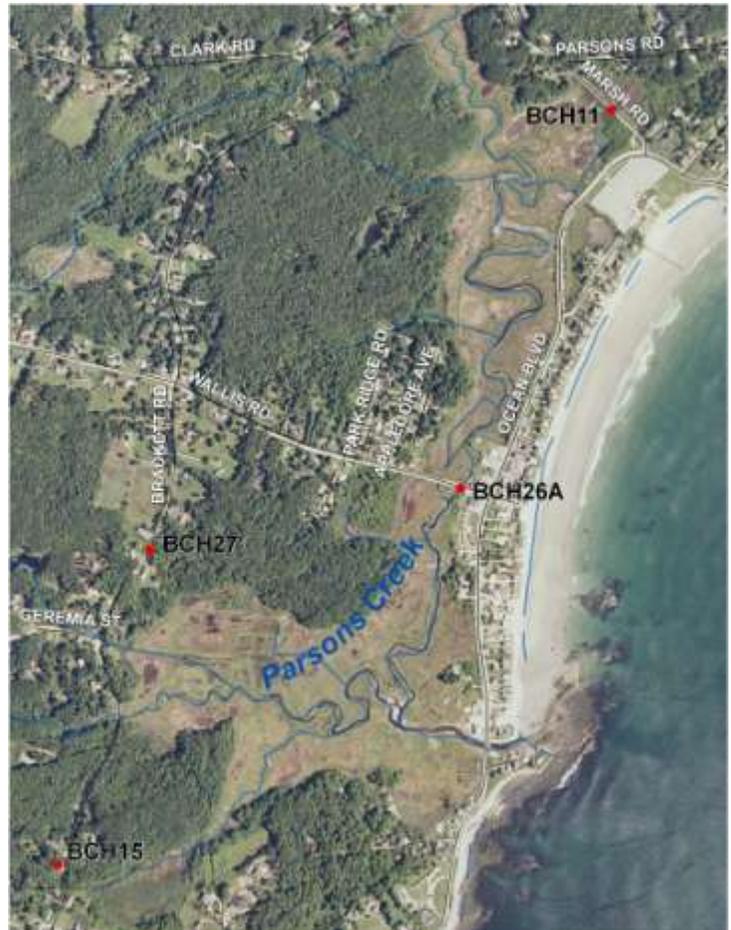
Figure 4.1. Map of hotspots explored in the Parsons Creek watershed during the November 16, 2009 watershed survey.

exceedances of the Enterococci bacteria standard (104 Enterococci counts/100mL) were observed at 4 locations in the Parsons Creek watershed: site BCH11, site BCH15, site BCH26A, and site BCH27. The results from that sampling event were used to target these specific areas during the survey. A summary of observations obtained upstream of each of the four high bacteria sample sites (Figure 4.1) is provided below.

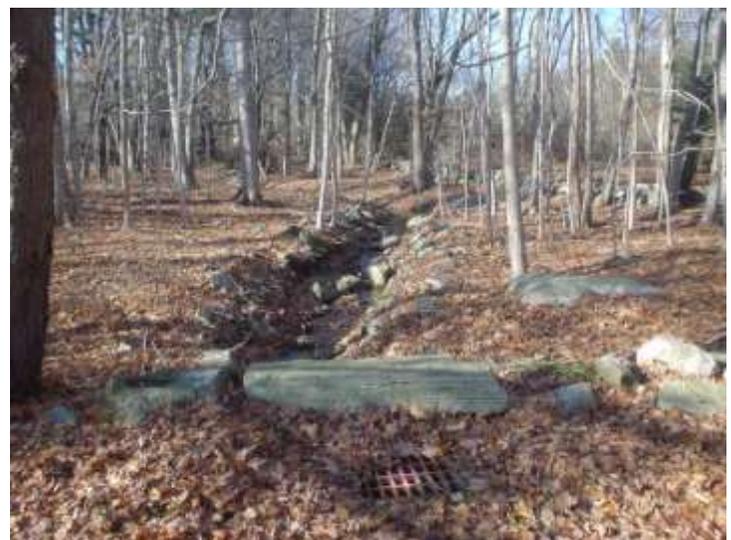
Storm drain seen beside a wooded tributary to Parsons Creek at BCH15.

- A bacteria measurement of 6,200 counts/100mL was collected at site BCH15, the southernmost sample site on Brackett Rd.
- The entire stream corridor from the pond to Wallis Road is thickly wooded.
- There were no clear signs of human-sources of bacteria-related contamination. Wildlife is a possible source.

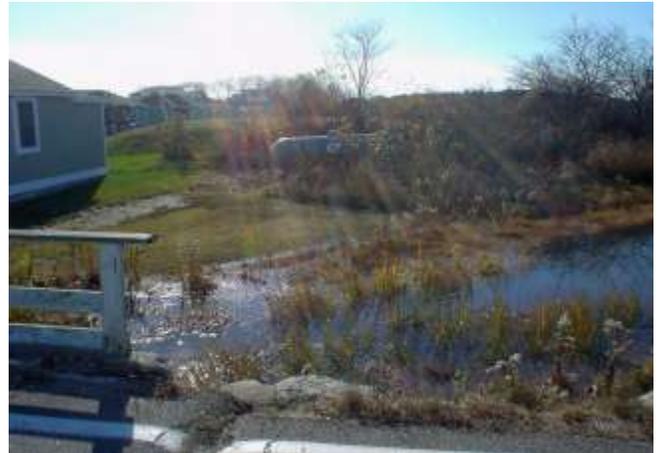
Proximity of development, including septic disposal fields, to Parsons Creek at BCH26A

- Enterococci levels of 5,100 counts/100mL were measured during wet weather survey of late October, 2009, at Site BCH26A.
- A portable toilet was observed directly adjacent to the stream channel just upstream of the bridge. The portable toilet is a potential bacteria source itself, but may also indicate an inadequate or malfunctioning wastewater system at one of the nearby buildings.
- In the same parking lot, a dumpster was observed situated about 15 m from the tidal channel representing another potential pollutant source.
- Given the close proximity of some buildings to the marsh in this area, their poor condition, and the indication of septic systems behind them, these properties may be considered a possible source of bacteria to Parsons Creek.

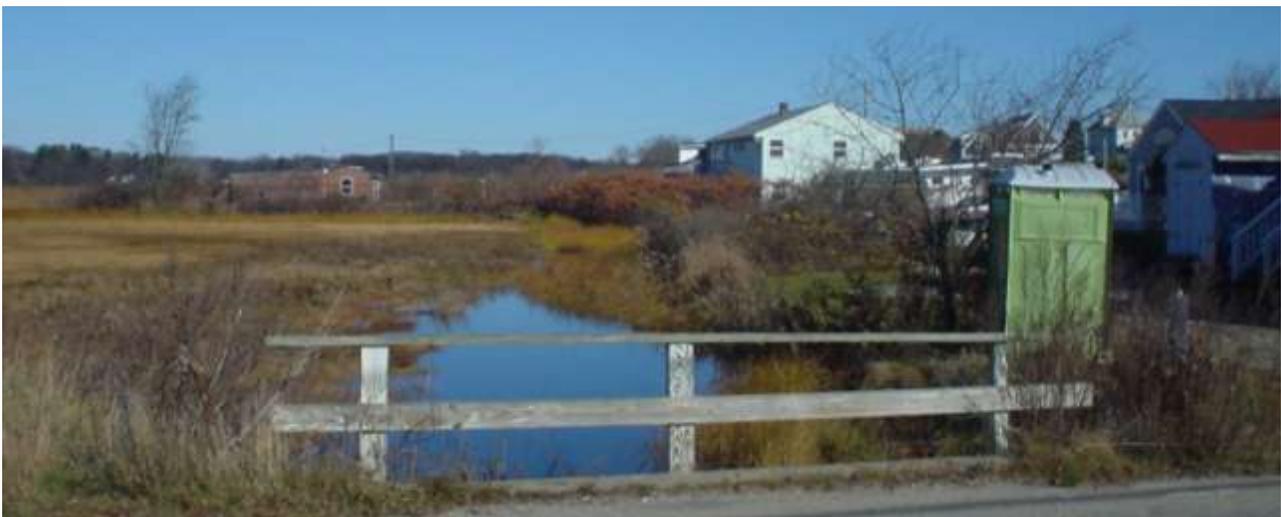
Buildings and a portable toilet immediately adjacent to Parsons Creek at BCH26A.

- Abandoned pet waste observed near site BCH11.
- Lack of vegetated buffer surrounding the marsh at BCH11 between lawn and tidal waters.
- Commercial buildings without vegetative buffer next to BCH26A.
- Storm drains piped directly to surface waters from neighborhood northwest of BCH26.
- Lack of vegetated buffer surrounding the marsh at BCH26 between lawn and tidal waters.
- Storm drains piped directly to surface waters from Brackett Road near BCH10 and 10A.
- Residential neighborhood with storm drains piped to streams at BCH27.
- Portable toilet and dumpster within 20 feet of tidal waters adjacent to BCH26A.

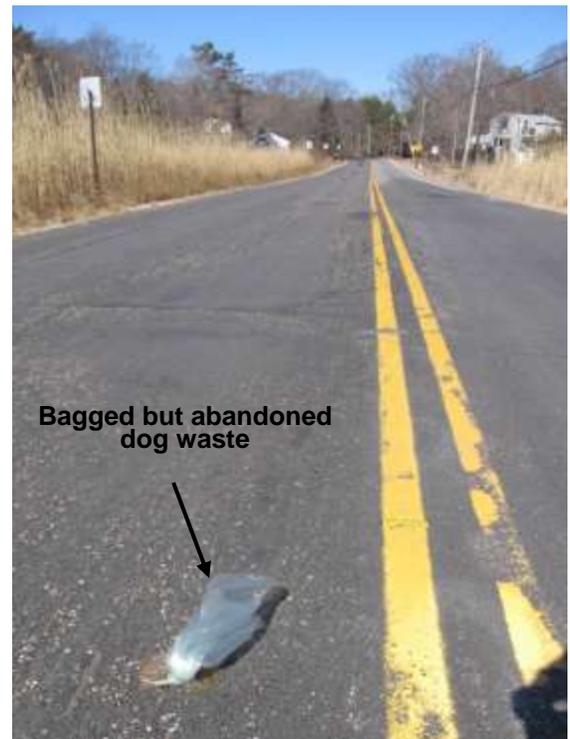
Developed area runoff can wash bacteria into Parsons Creek. The presence of bagged but abandoned waste near site BCH11 suggests current management measures are only partially successful.

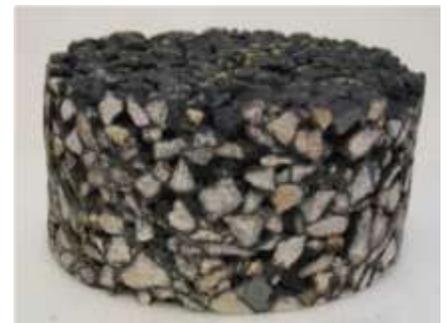
Pervious pavement allows water infiltration and reduction in winter road sand and salt necessary to keep roads clear.

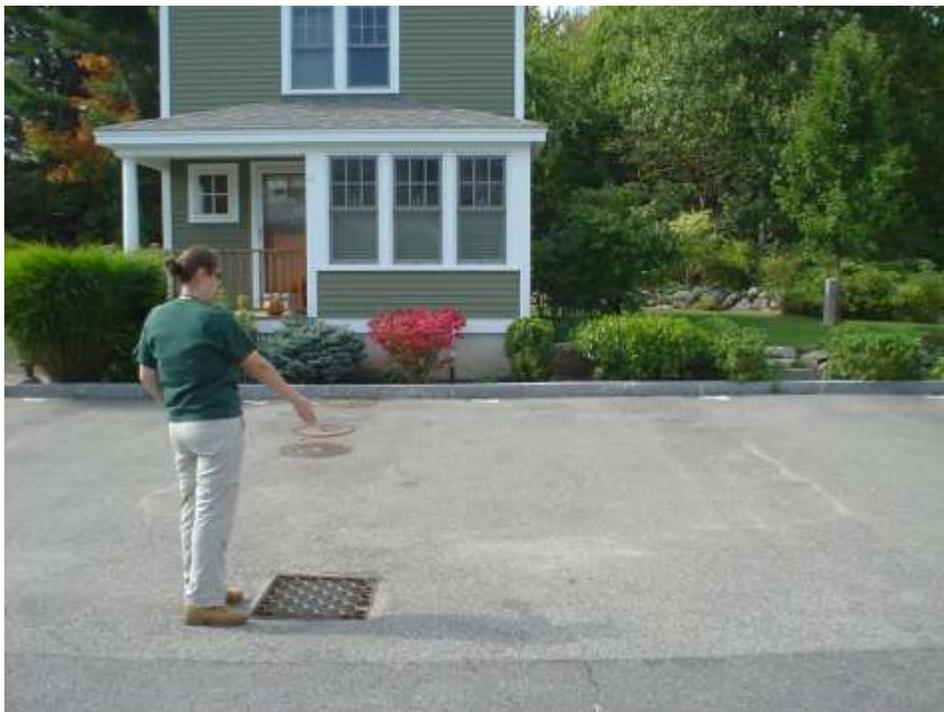
Storm drain in the parking area of a residential development that catches untreated area runoff.

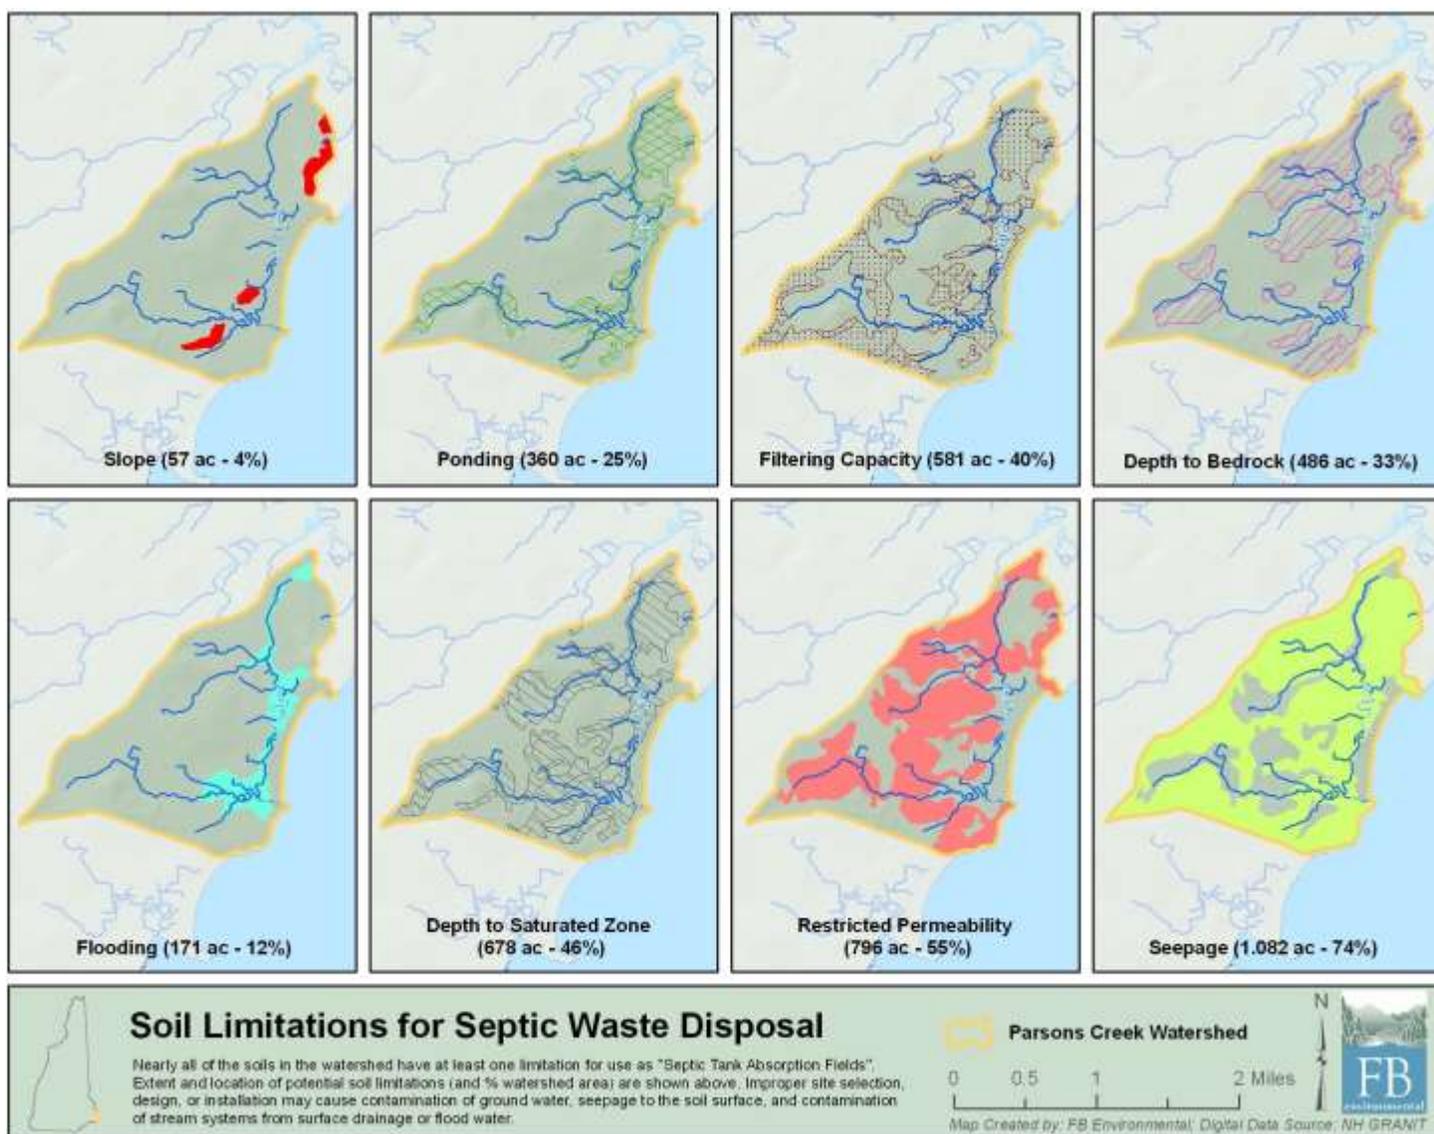
Figure 1: Parsons Creek watershed soil limitations for septic system, as indicated by the Natural Resource Conservation Service.

Where soils are underlain by loose sand and gravel or fractured bedrock at a depth of less than 4 feet below the distribution lines, the absorption field may not adequately filter the effluent, particularly when a system is new; consequently, ground water supplies may be contaminated.

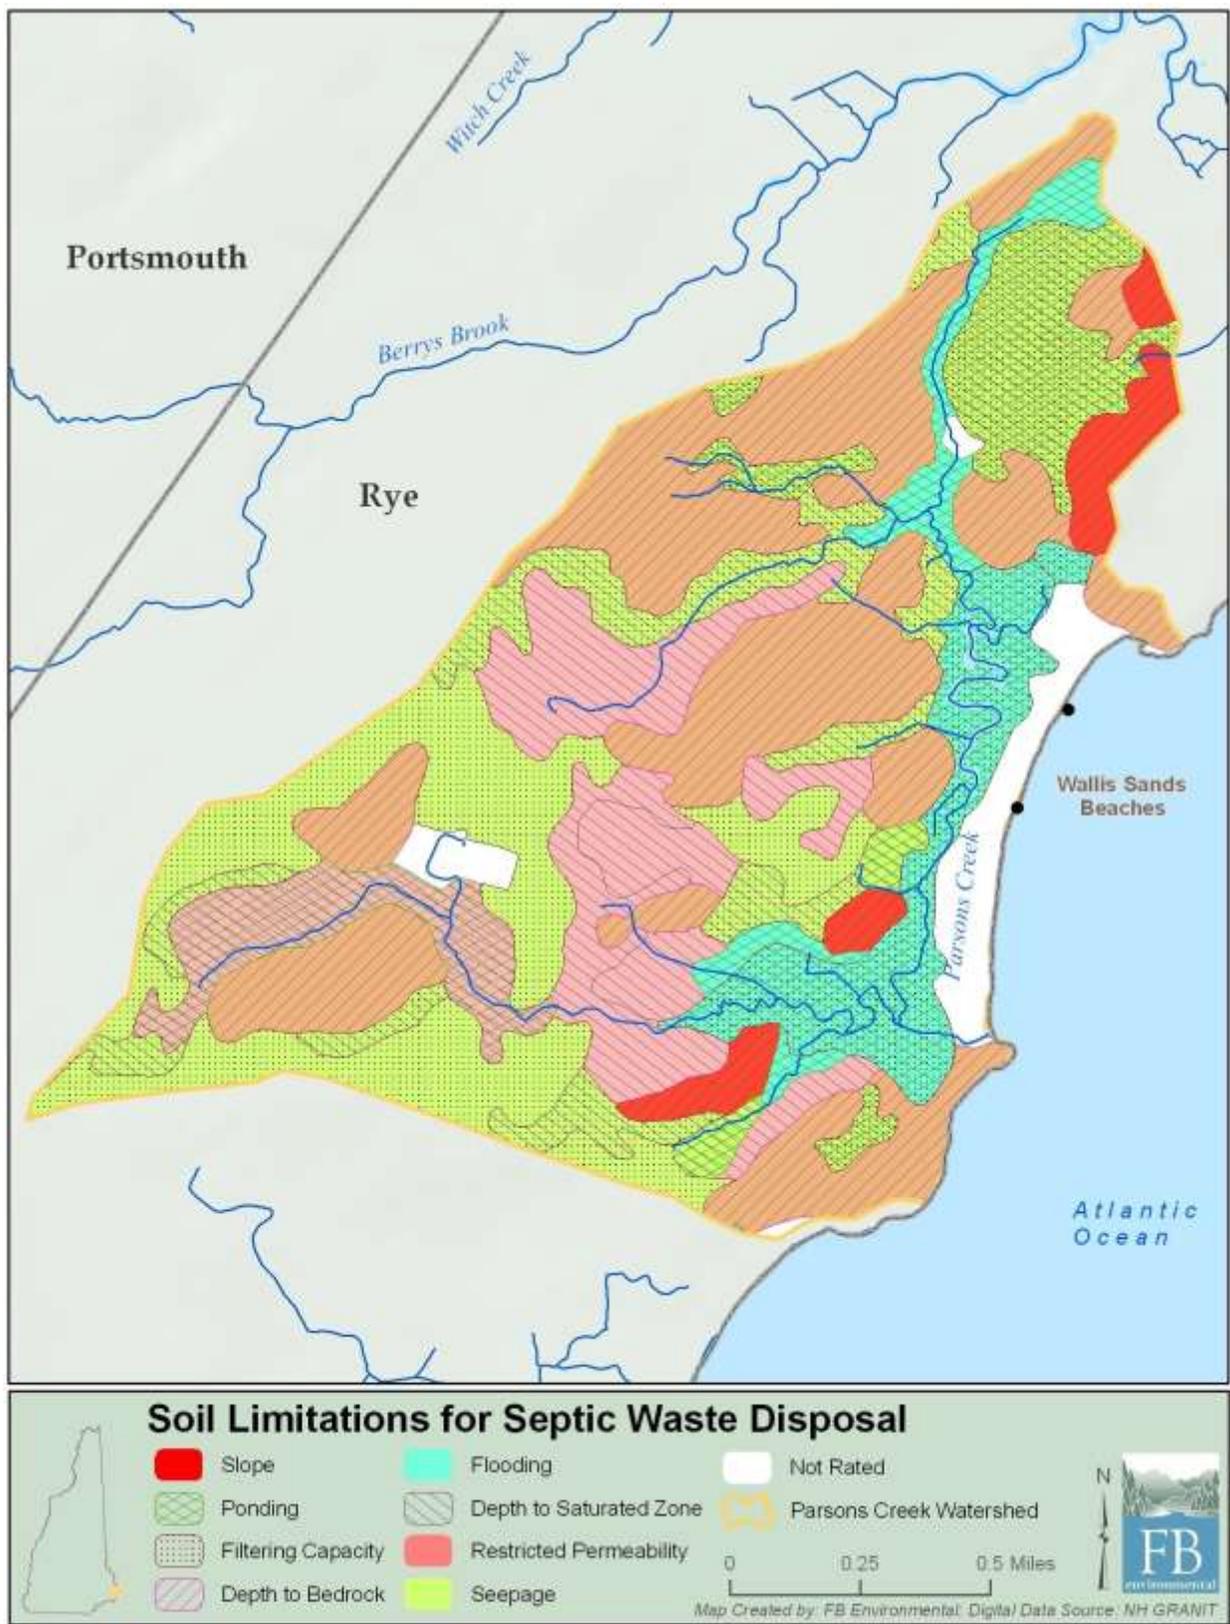
Figure 3: Parsons Creek septic disposal soil limitations, note the overlapping limitations in many areas.

8. **Restricted permeability:** The soil horizon with the minimum K_{Sat} governs the rate of water movement through the whole soil. When this rate is low, transmission of fluids into and through the soil is impeded and runoff, infiltration, and percolation of pollutants may result in environmental, health, and performance concerns. This limitation is present for 57% of the Little River soils and 55% of the Parsons Creek soils.
