Parsons Creek Watershed Based Plan

May 2011

Prepared by:
FB Environmental Associates, Inc.
97A Exchange St., Suite 305
Portland, ME 04101

PARSONS CREEK WATERSHED BASED PLAN

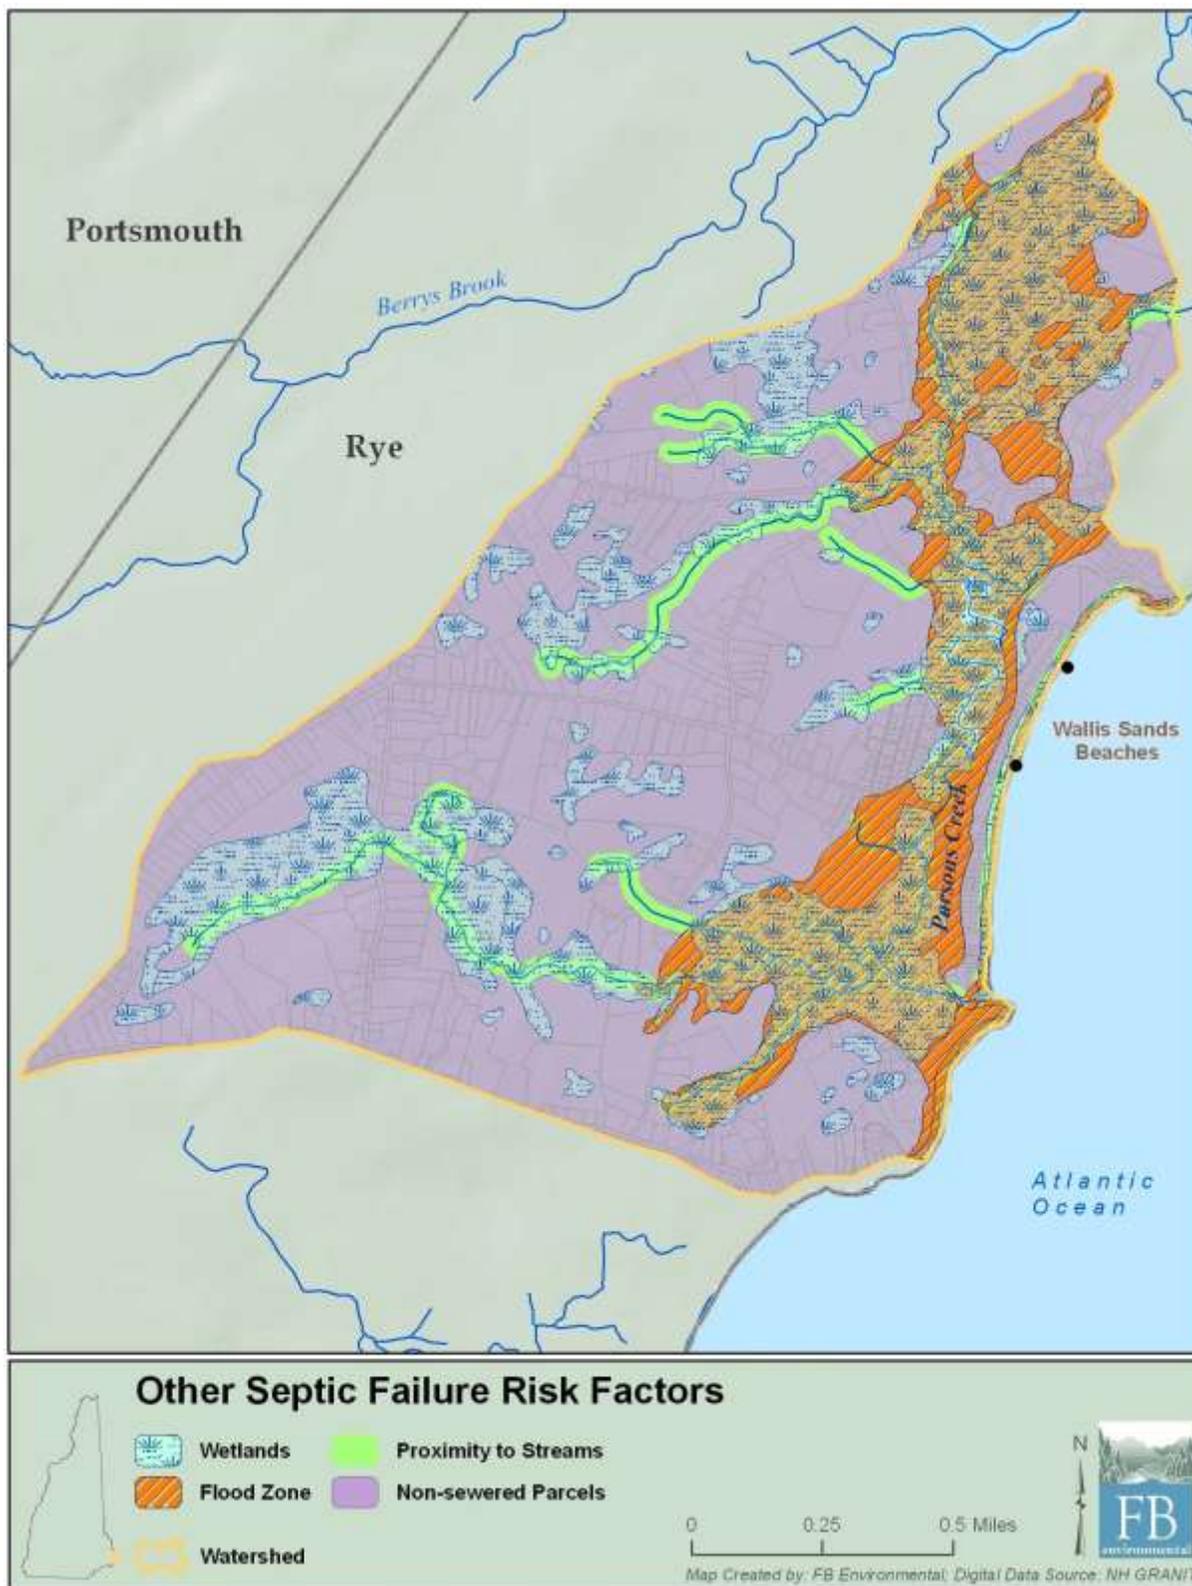
Figure 5: Parsons Creek watershed factors (beyond soils) contributing to risk of water quality contamination from malfunctioning septic systems.

- Proximity to Streams: All streams in the watersheds were buffered by 100 feet, the average setback distance required in New Hampshire. Within these areas, there is increased potential for bacterial contamination from septic failure due to stormwater runoff and astronomically high tides.

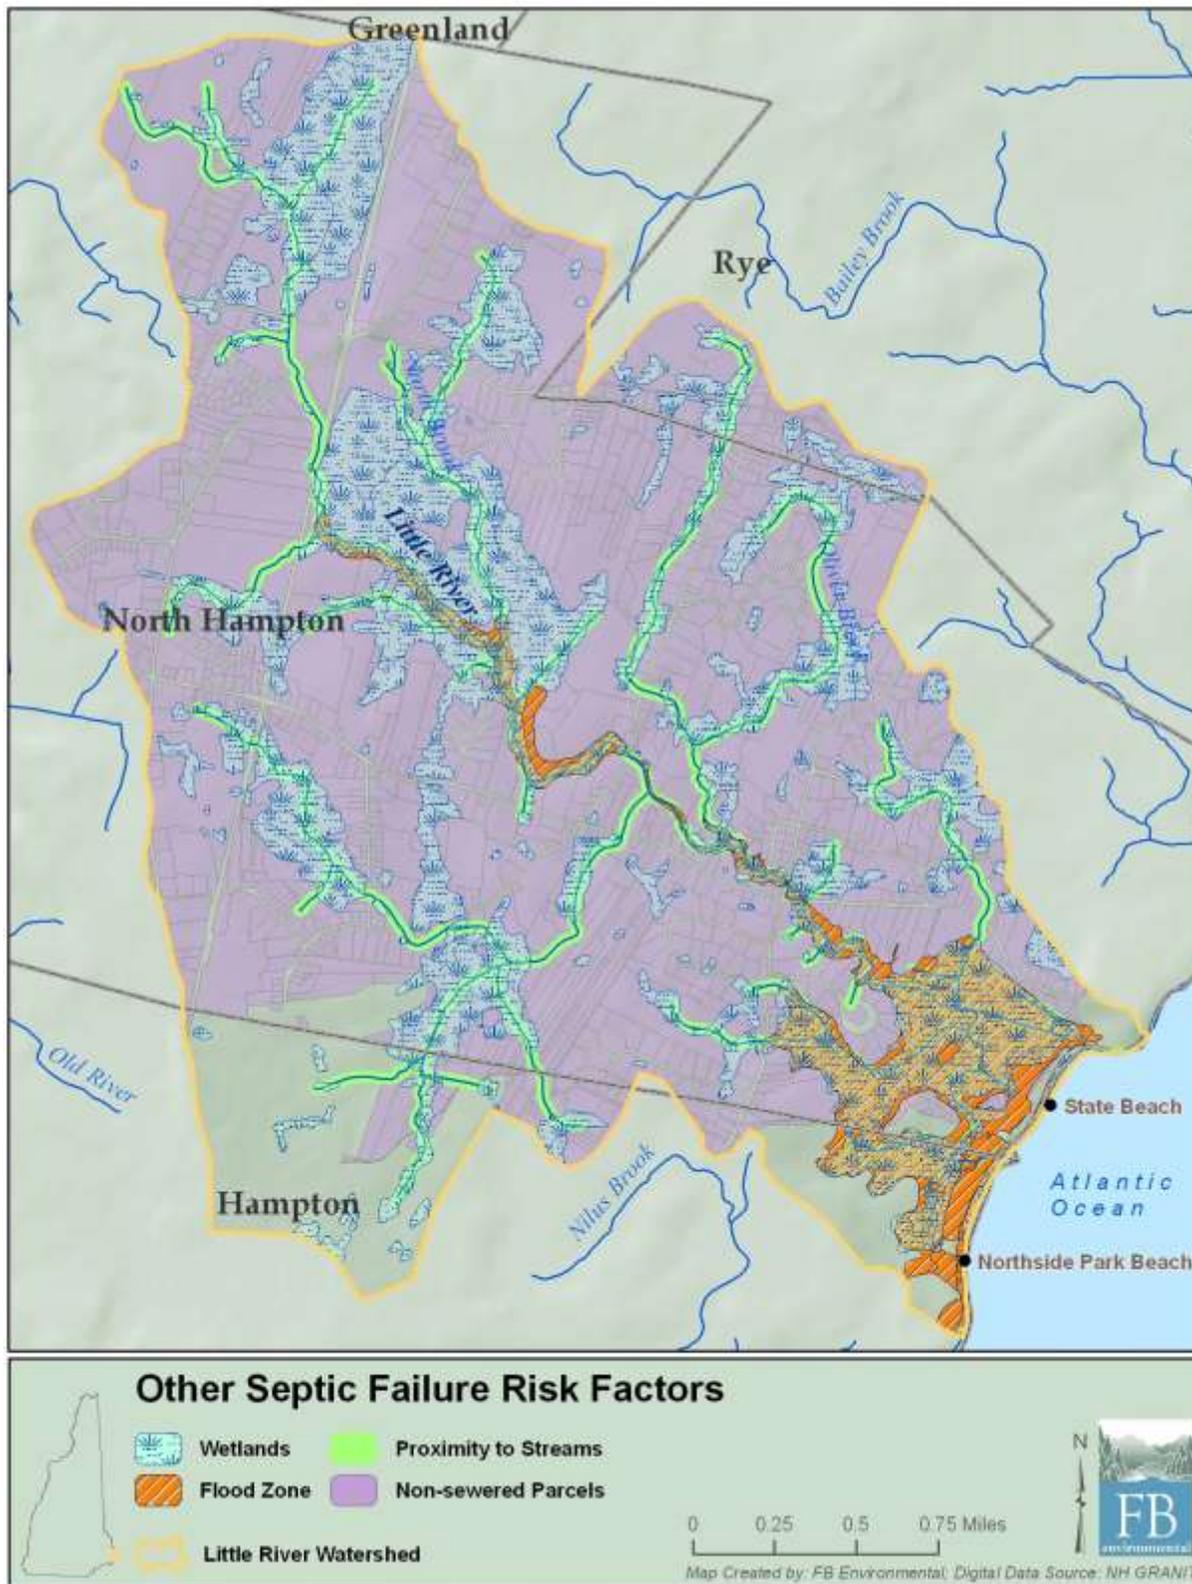
Figure 6: Little River watershed factors (beyond soils) contributing to risk of water quality contamination from malfunctioning septic systems.

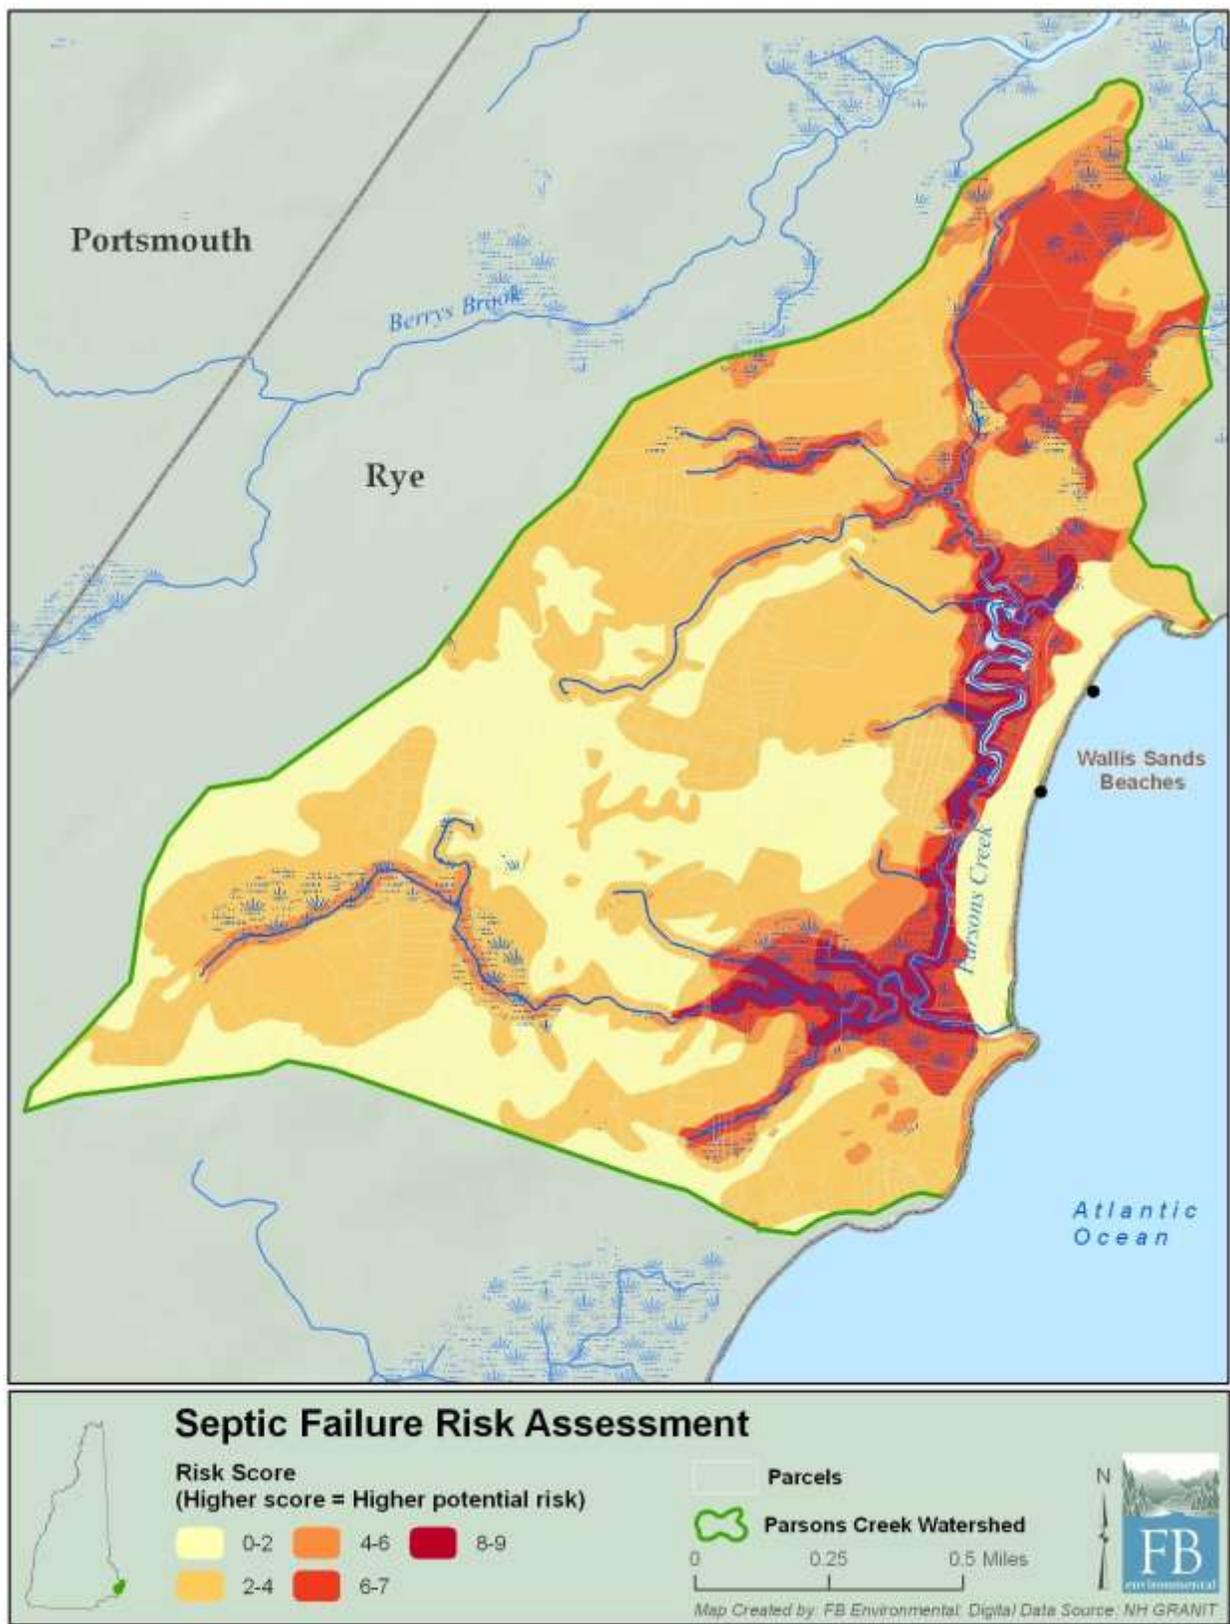
Figure 7: Parsons Creek watershed overall septic systems risk assessment.

After assigning risk scores, all data layers were overlaid to create a composite risk map. Risk scores for overlapping criteria were summed to create a single risk factor for each area of intersection. Final risk factors ranged from 0 to 9, with 9 representing the greatest potential risk. Since the majority of soils in the watersheds are not well suited for septic systems, the primary determinant in identifying the greatest risk potential from bacterial contamination from septic failure risk was proximity to freshwater streams, estuaries, wetlands and flood hazard areas.

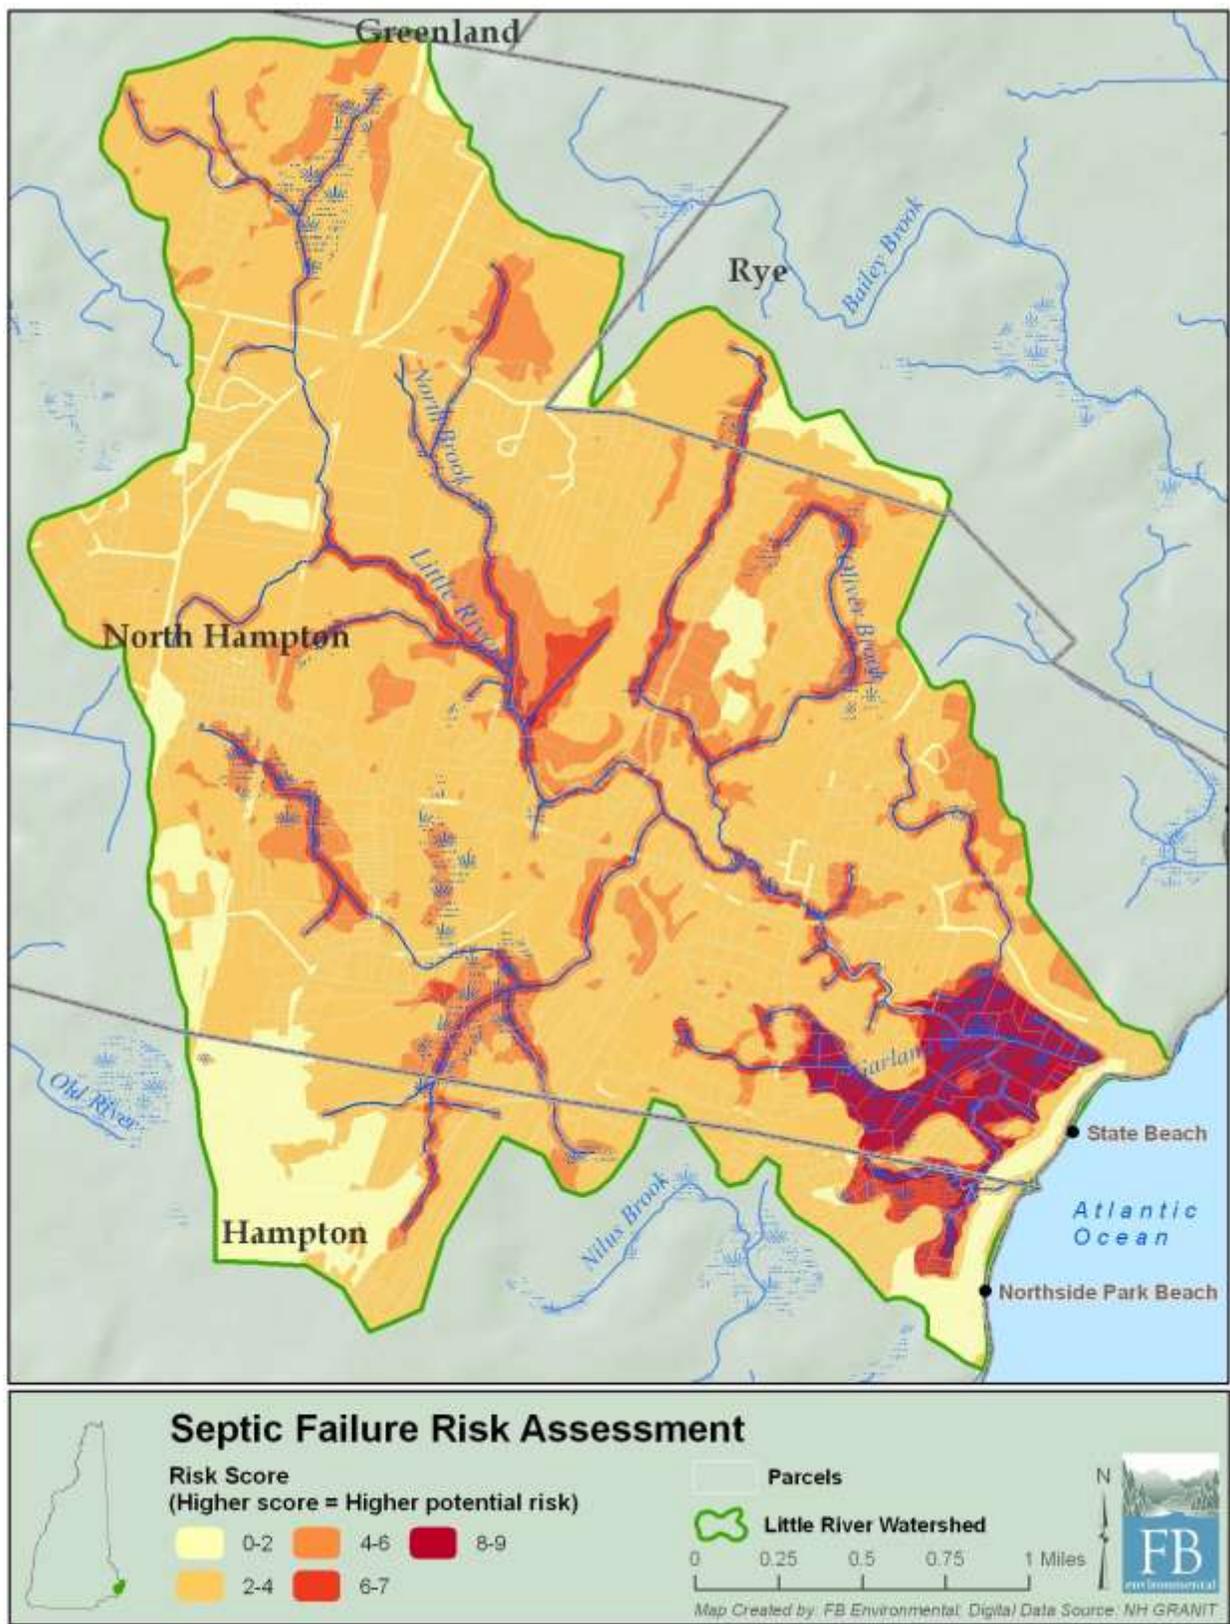
Figure 8: Little River watershed overall septic systems risk assessment.

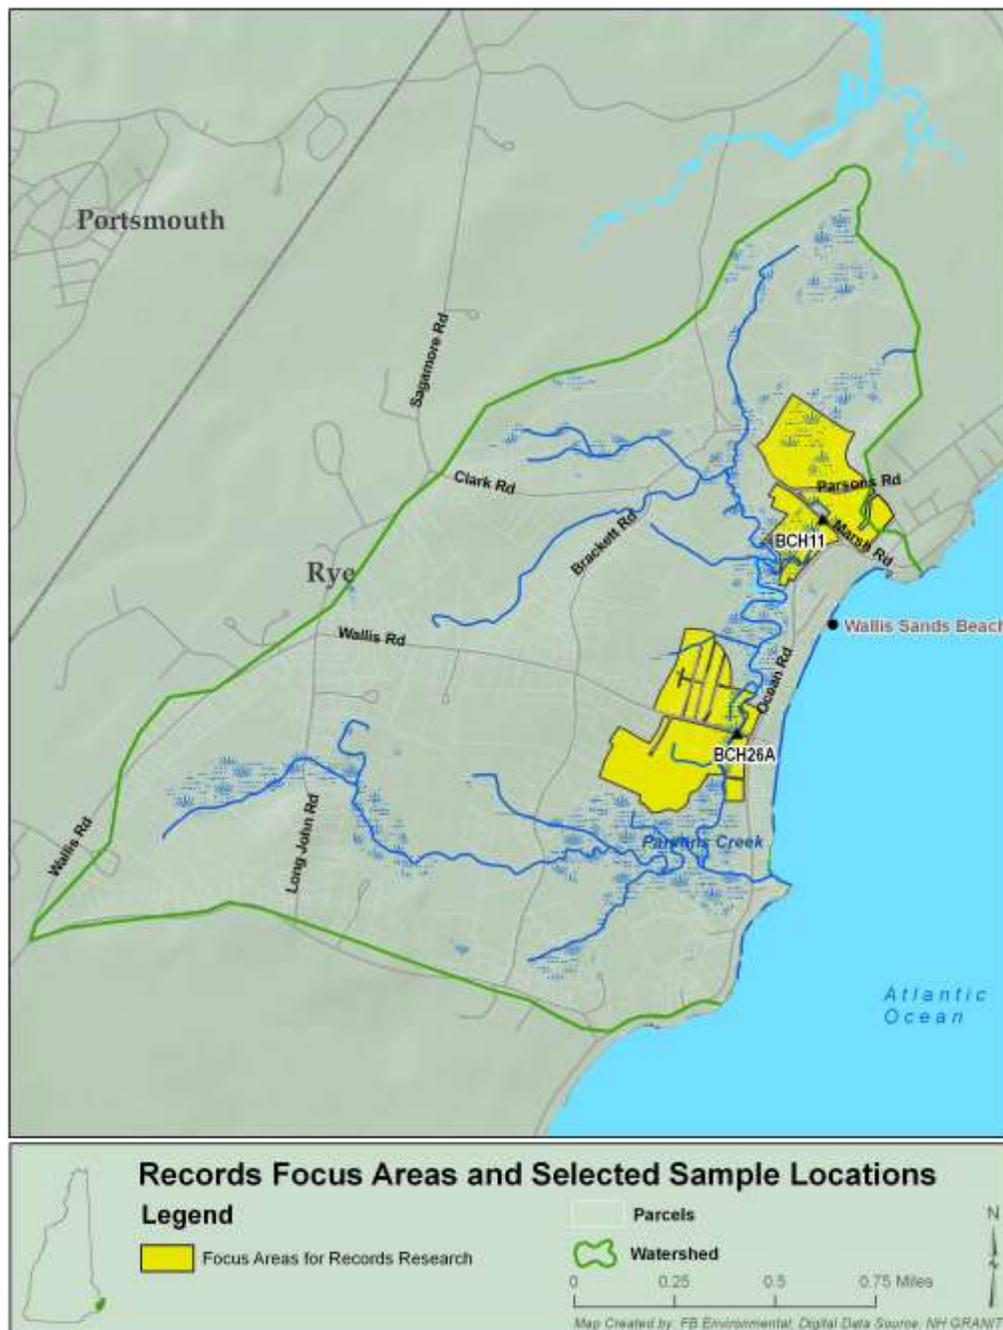
Figure 9: Focus areas for records research in Parsons Creek watershed.

- BCH11, along Marsh Rd in Rye.
- BCH26 and BCH26A, at the intersection of Wallis Rd and Ocean Rd in Rye, including the neighborhood just west of this intersection.
- BCH25, Appledore Ave in North Hampton.
- BCH18 and BCH19, along Lafayette Rd / US Route 1 in North Hampton.

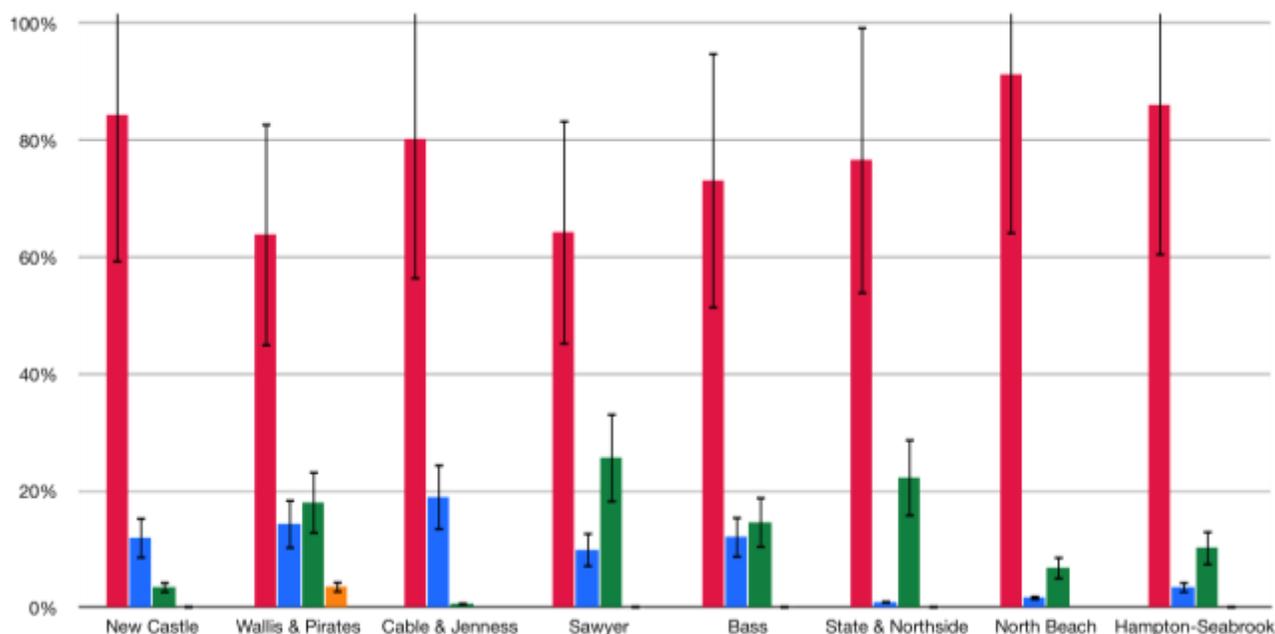
Figure 11: Estimated Bacteria Loads: Percentage of Each Type by Watershed.

Figure 16 provides estimated percentages of each type of bacteria load for each watershed. Developed area runoff is estimated to be the largest bacteria source in all of the study area watersheds (as shown in red below) ranging from 64% to 91%. Developed area runoff contributions originate in roadways, in yards, with pets, in illicit storm drains, and from other sources. Failing septic systems (blue) and wildlife (green) are also estimated to be significant in most watersheds. Failing septic systems are estimated to range from 1% to 19%, with larger estimated loads in unsewered communities. Farm animals are estimated to be significant only in the Wallis & Pirates Cove watershed with a 4% estimated contribution.
