Little River Watershed Based Plan

May 2011

LITTLE RIVER WATERSHED BASED PLAN

Prepared by FB Environmental Associates, Inc.
in cooperation with the Towns of North Hampton, Hampton, and Rye, and
New Hampshire Department of Environmental Services

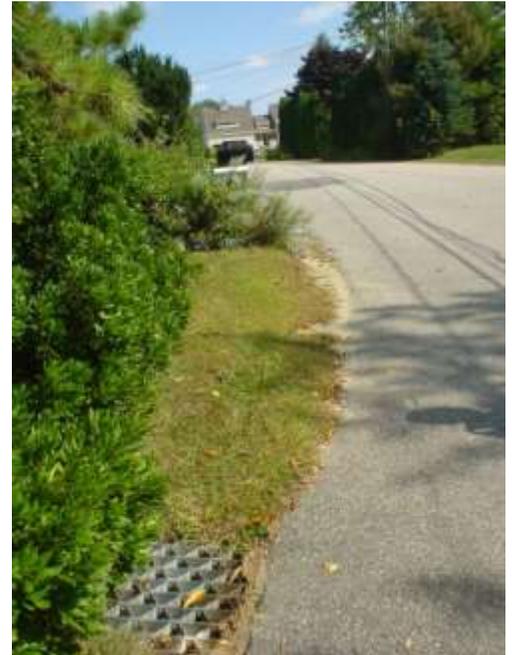
Basins catch stormwater that carries pollutants to Little River.

Much of the stormwater is first collected in catch basins in streets, driveways, and parking lots, then carried to the river via storm sewers. The watershed towns, and all municipalities whose storm sewers discharge to streams, must obtain and comply with a Municipal Separate Storm Sewer (MS4) permit from the US EPA for these stormwater sources. Municipalities there are granted MS4 permits on the condition that they implement control measures, or best management practices (BMPs), that work in a variety of ways to reduce the pollutants carried within storm sewers. The types of control measures are:

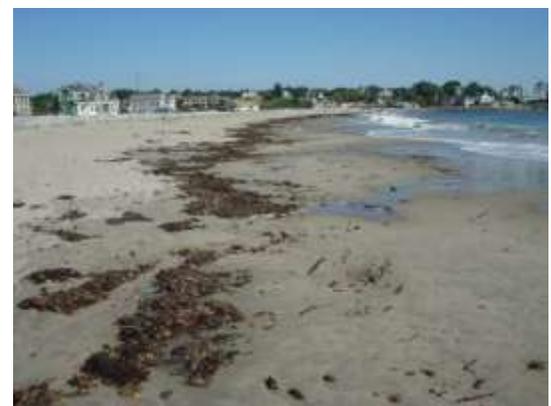
The NH DES Beach Program monitors three stations on State Beach.

NH DES Beach Program monitors for Enterococci bacteria at three different sites at North Hampton State Park Beach (referred to as State Beach). The outlet of Little River to the Atlantic Ocean is at the northern edge of the beach. The river was believed to be a major contributor of bacteria to State Beach. As a result, NH DES Beach Program began to sample for bacteria upstream from the beach outlet, at specific locations on Little River. In 2009, ten sampling stations were created on Little River. These inland watershed bacterial sampling stations provide the data NH DES Beach Program needed to conclude that Little River is a major conduit of bacteria to State Beach.

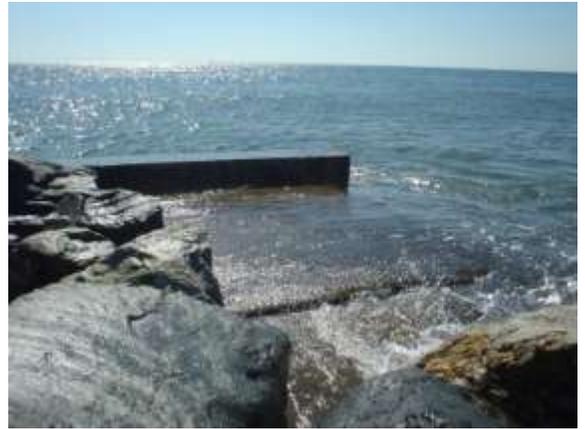
The outlet of Little River during high tide at State Beach.

- The outlet of Little River was engineered to increase tidal influence and consists of 2 concrete box culverts under Ocean Boulevard near BCHSTBNHLIT (Figure 3.1)
- Little vegetated buffer was seen between homes and the estuary/river channel making waste disposal difficult. This was observed near sampling sites BCH25 and BCHSTBNHLIT.
- Improper pet waste disposal near State Beach despite clear signage.
- The second mouth (the breach) was blocked by sand, and water no longer reaches the ocean.

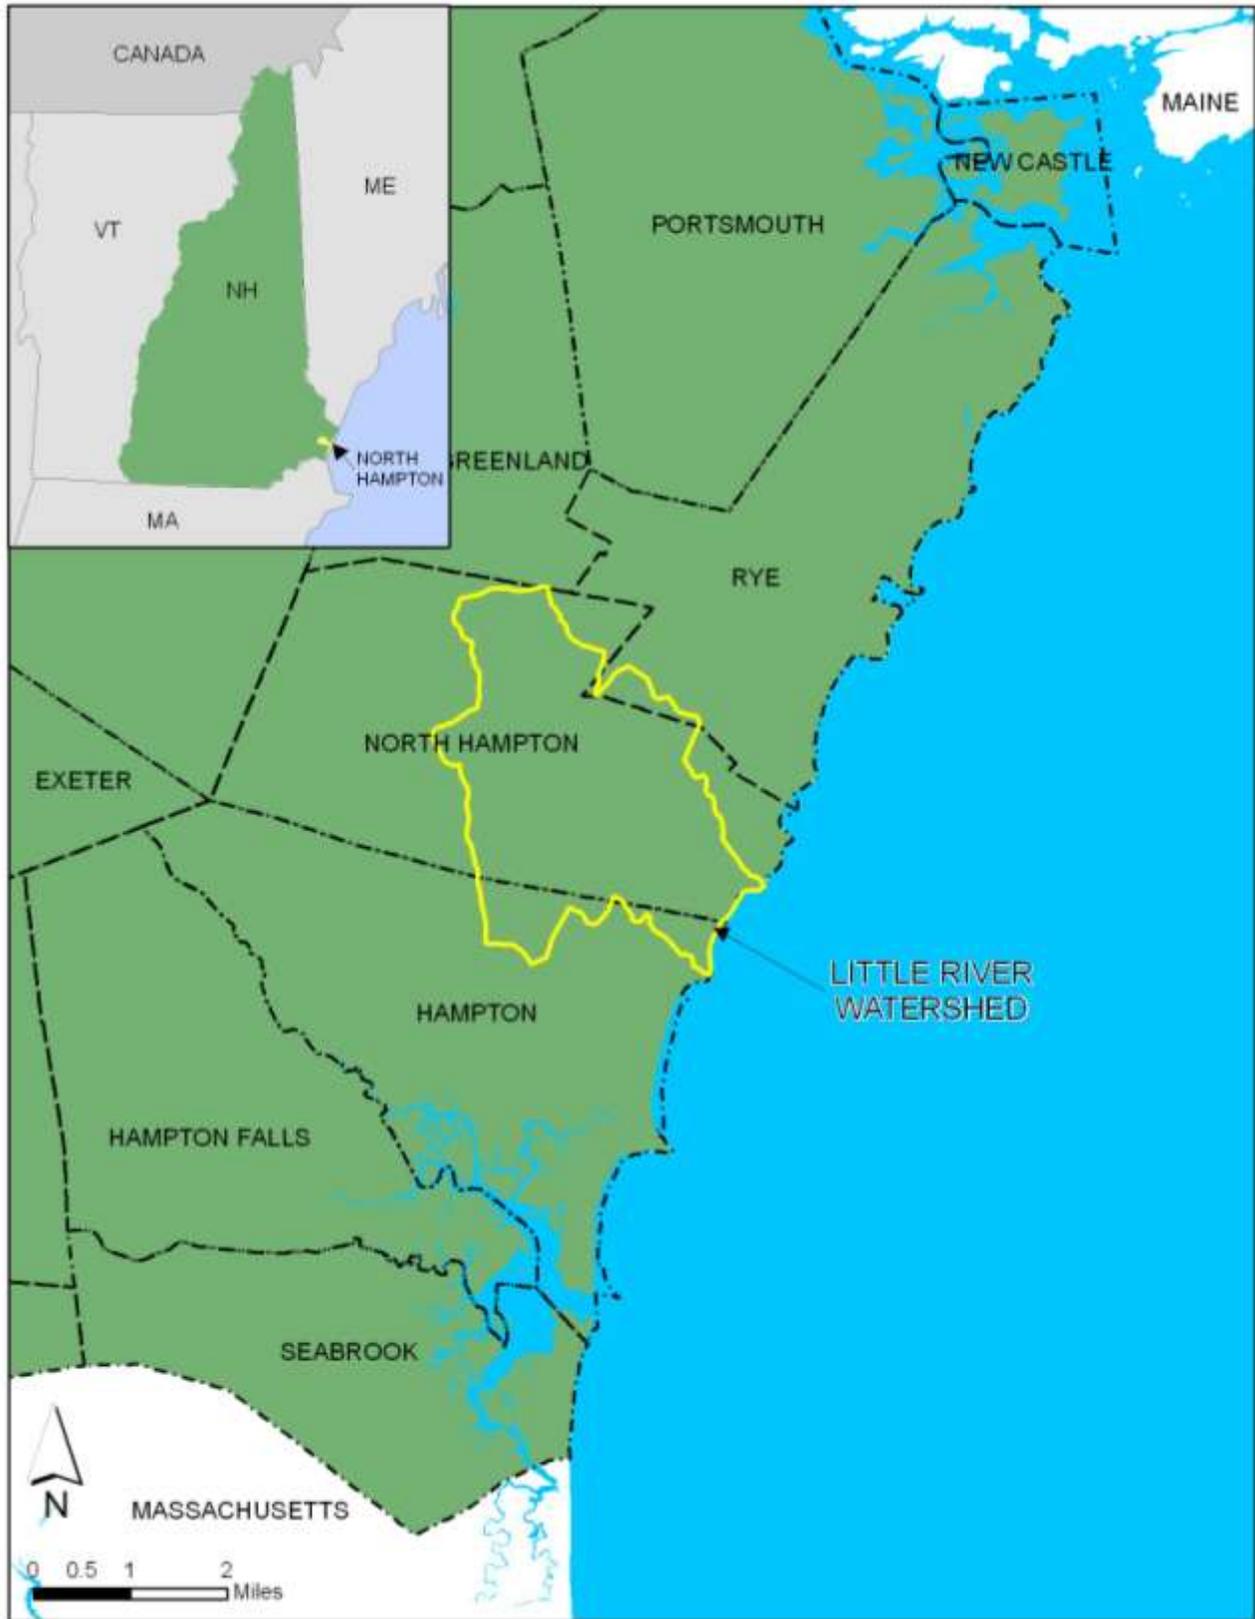
Figure 2.1. Location of Little River watershed in coastal New Hampshire

Little River is primarily located in North Hampton, New Hampshire, in Rockingham County. Other towns in the 7.68 sq. mi. watershed are Rye, Greenland, and Hampton (Figure 2.1). Little River begins above North Road near the Greenland border. Both Little River and North Brook flow into Mill Pond which is dammed above Mill Road. Little River flows from the outlet of Mill Pond and continues southeast towards the Atlantic Ocean. Two tributaries enter the main channel between West and Woodland Roads. Oliver Brook enters west of Woodland Rd. Past Woodland Rd the channel flows into a large estuary. Garland Brook enters the Little River from the south just before the river outlet under Ocean Boulevard.

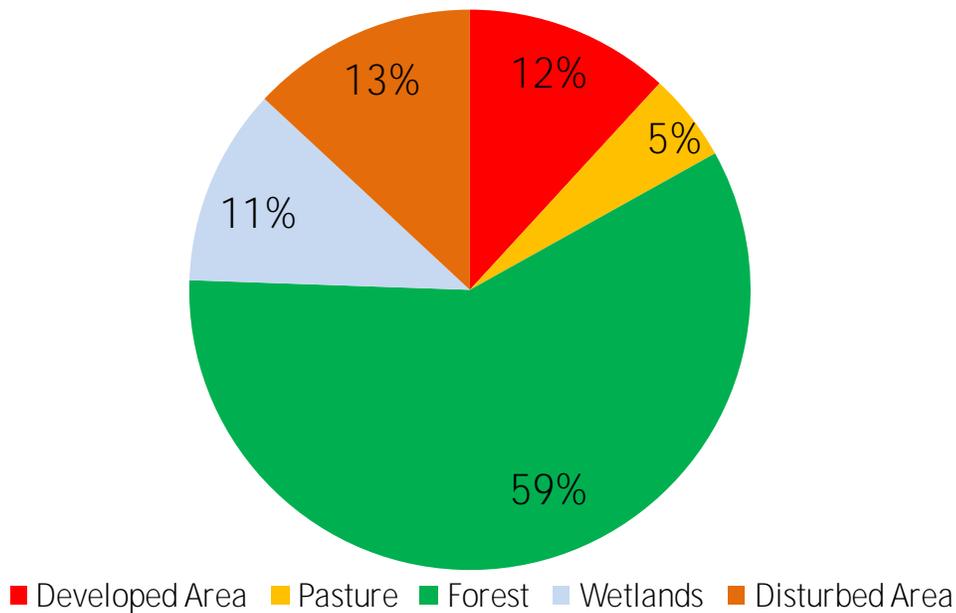
Figure 2.2 Pie Chart of Land Uses in Little River Watershed

land. The remaining 28% of watershed area is comprised of other land covers types, including developed area, wetlands, and pasture (Figure 2.2).

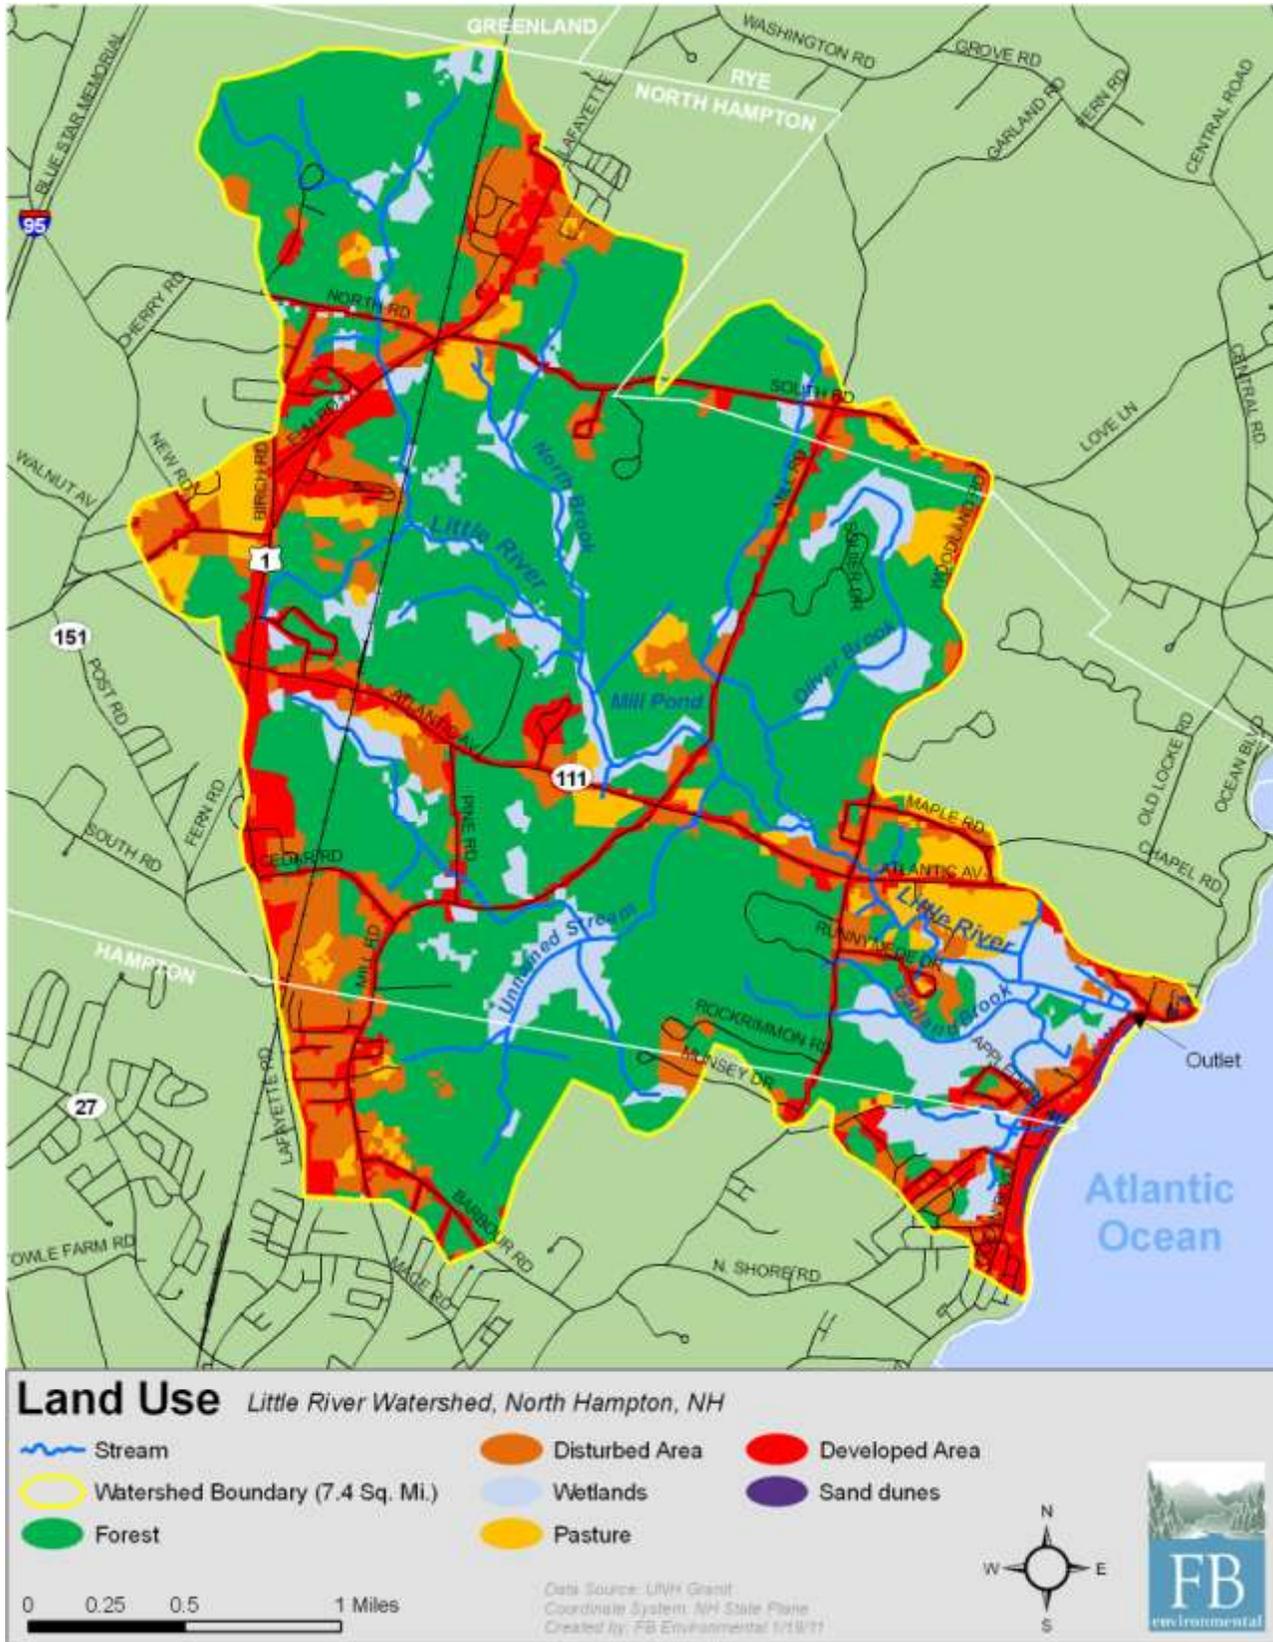
Figure 2.3. Map of Land Use in the Little River Watershed

The forest land is located in large habitat blocks inland from the coast and is separated only by roads and development (Figure 2.3). Forested wetland areas comprise most of the interior wetlands following the course of Little River. Development is concentrated near the coastline and Route 1, in the western area of the watershed. A majority of agriculture is fallow land and located around the intersection of Atlantic Ave and Maple Rd near the main tidal wetland.

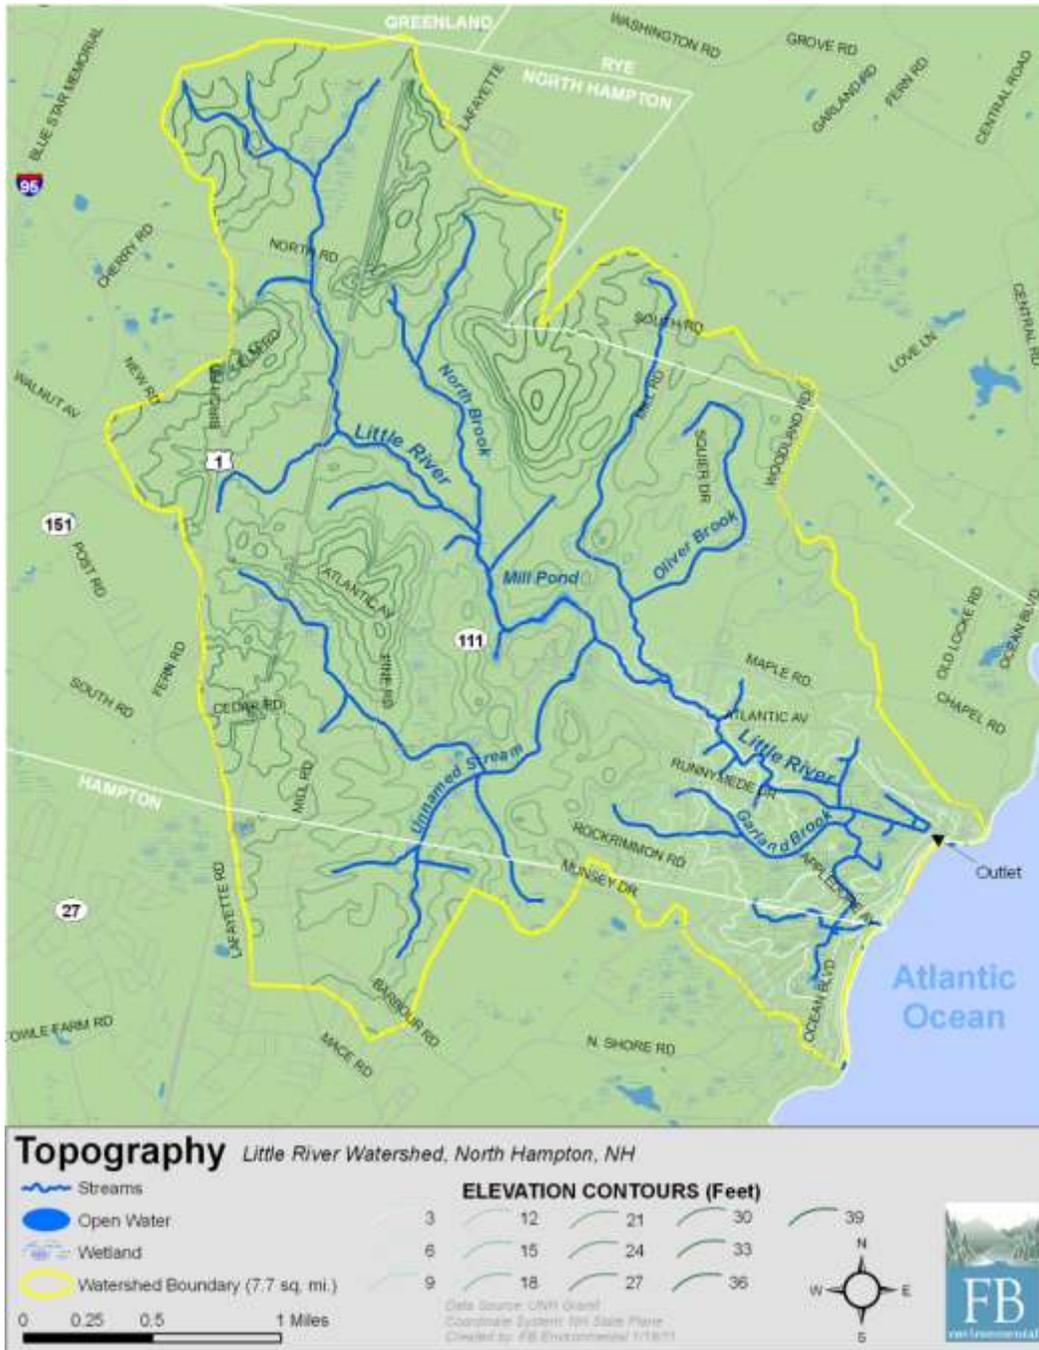
Figure 2.4. Map of Topography in the Little River Watershed

Topography in coastal New Hampshire is rolling hills and flat estuaries and marshes. Most watershed boundaries are aligned with roads. The highest point in the watershed, at 118 ft above sea level, is to the northeast of North Brook, between South and Mill Roads (Figure 2.4). The watershed generally slopes southeast, gradually declining in elevation to the tidal marshes.

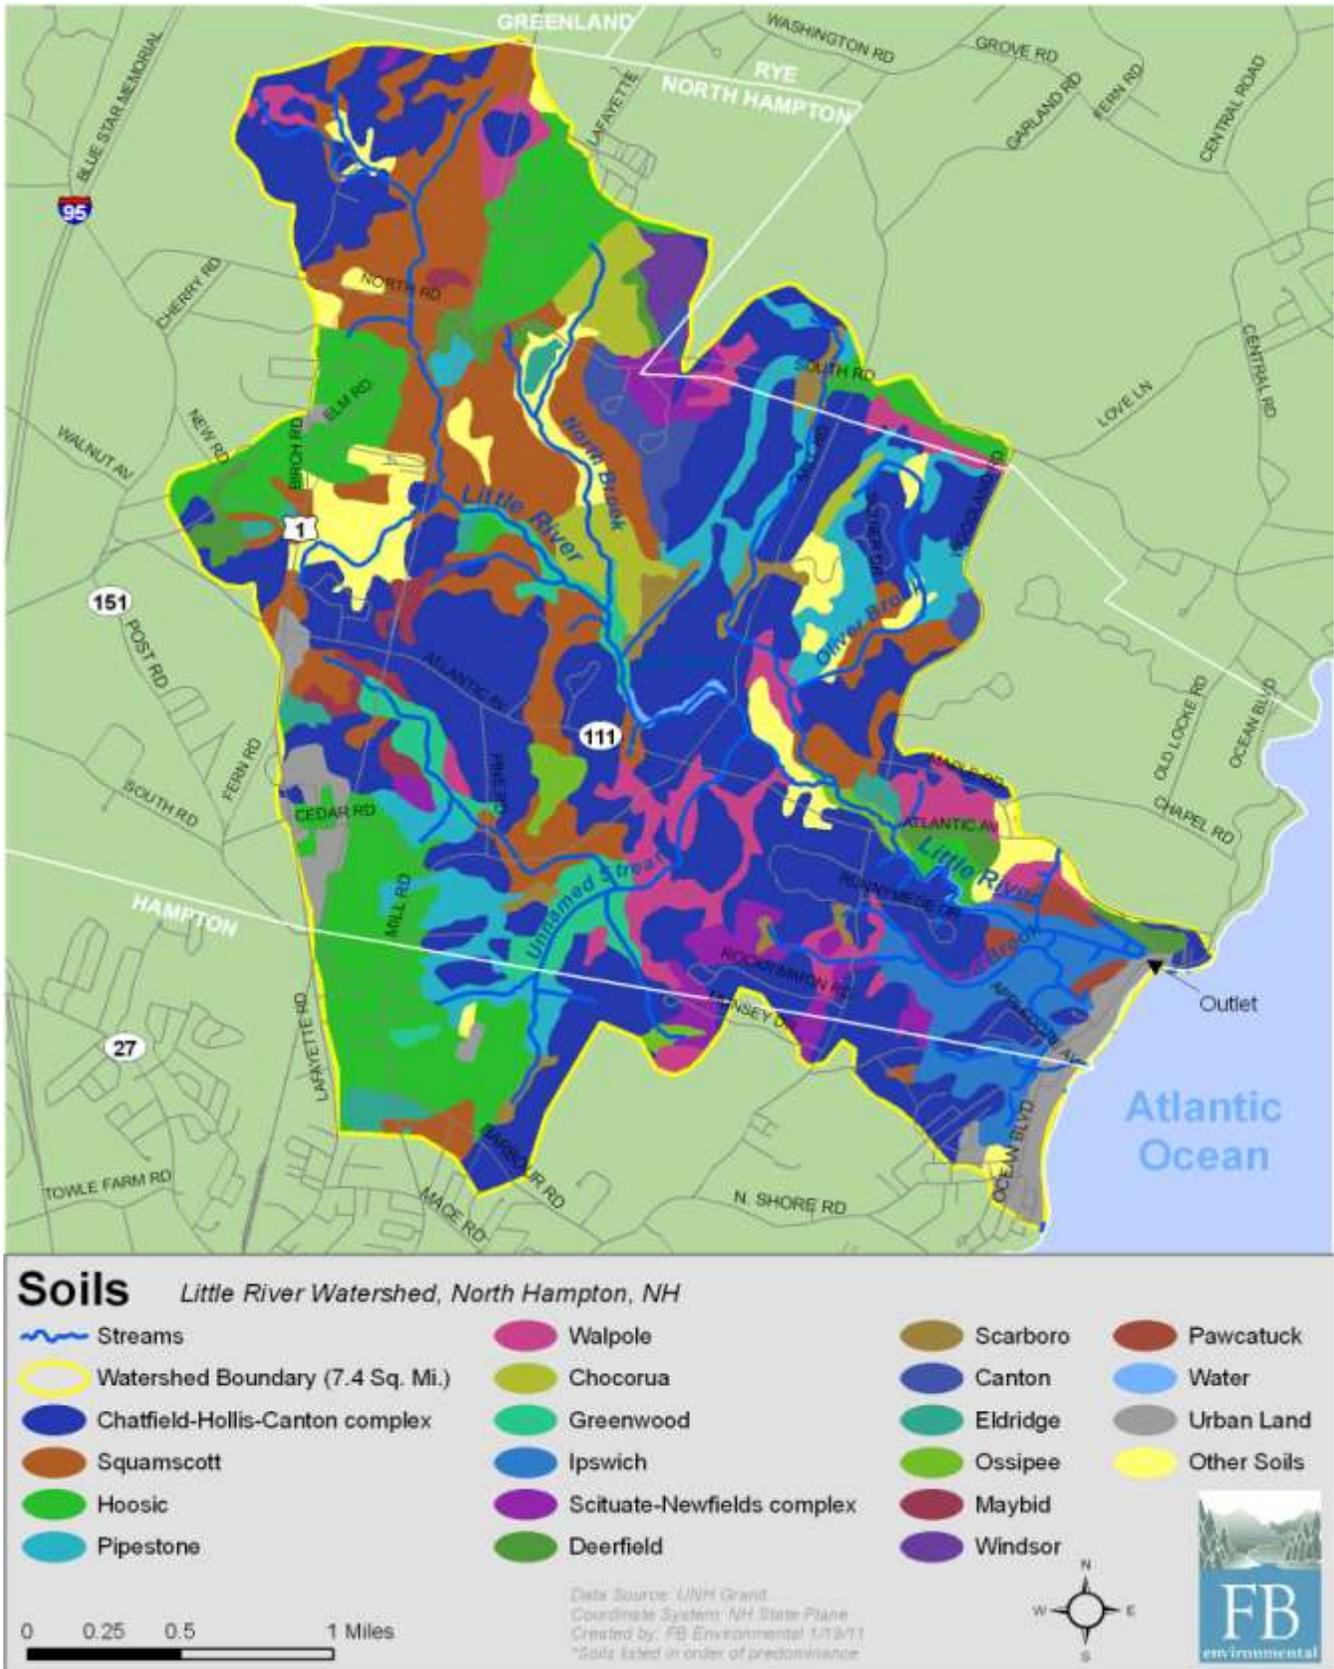
Figure 2.5. Map of Soils in the Little River Watershed

Non-wetland soils in the watershed transition from rocky, loamy soils in the north to fine sandy soils in the south. Chatfield-Hollis-Canton soils dominate the watershed. They are well drained soils with a sandy loam texture and glacial till deposits. Most forested areas in the watershed are found on these soils. Woodlands are also found on Squamscott and Hoosic fine sandy loam soils in the headwaters of Little River. Hoosic Complex soils also make up the developed beach area. Both Squamscott and Hoosic soils are found on gently sloped terrain and are composed of glacial outwash. Glacial outwash creates excessively dry, sandy soils with small gravel sized rocks. Areas with these soils are typically used as farmland but can host a wide variety of hardy trees such as sugar maple, oak, and hickory. Land uses on these soils in Little River watershed are primarily developed (Figure 2.5).

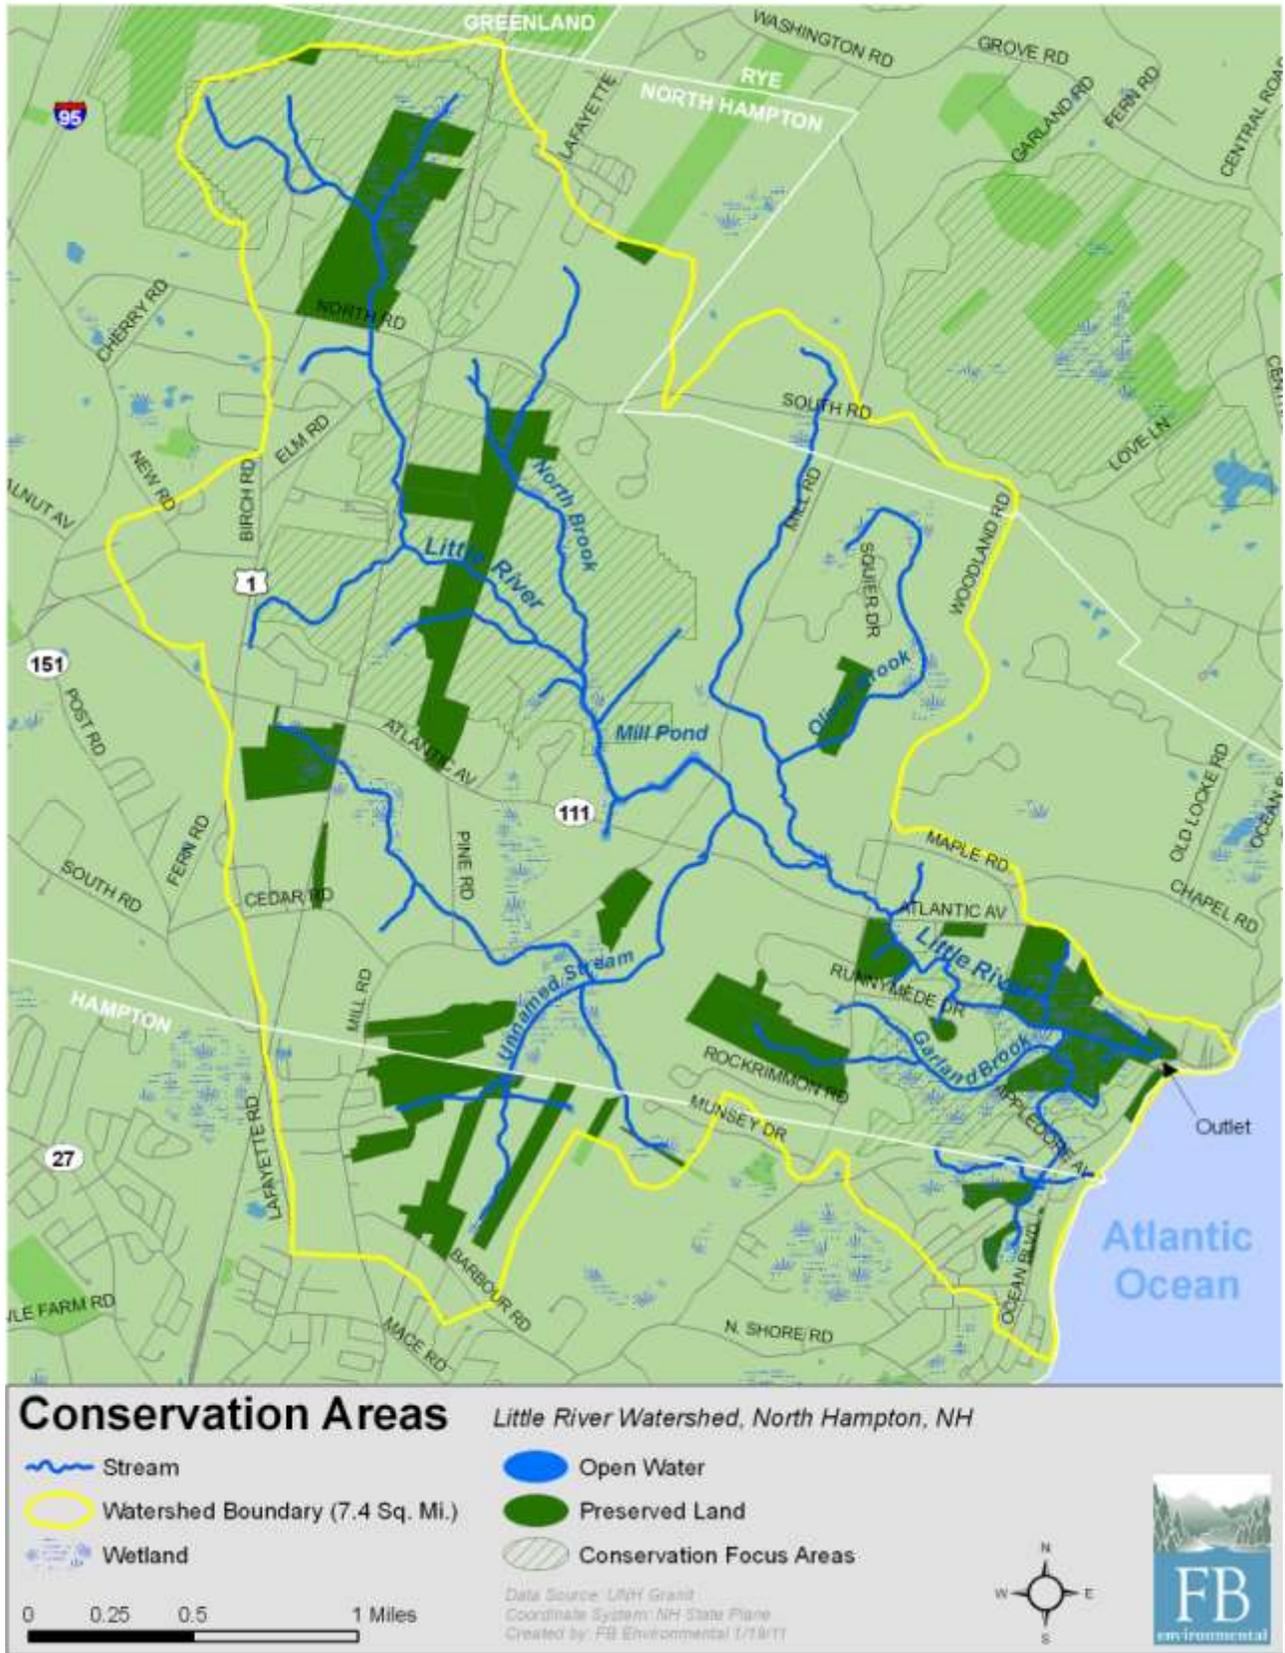
Figure 2.6. Map of Conservation Areas in Little River Watershed

- Upper Little River: above North Rd to outside of the watershed boundary (~327 acres)
- Middle Little River: where North Brook and Little River meet above Atlantic Avenue (~595 acres)
- Lower Little River: the main tidal marsh area, below Garland Brook (~196 acres)

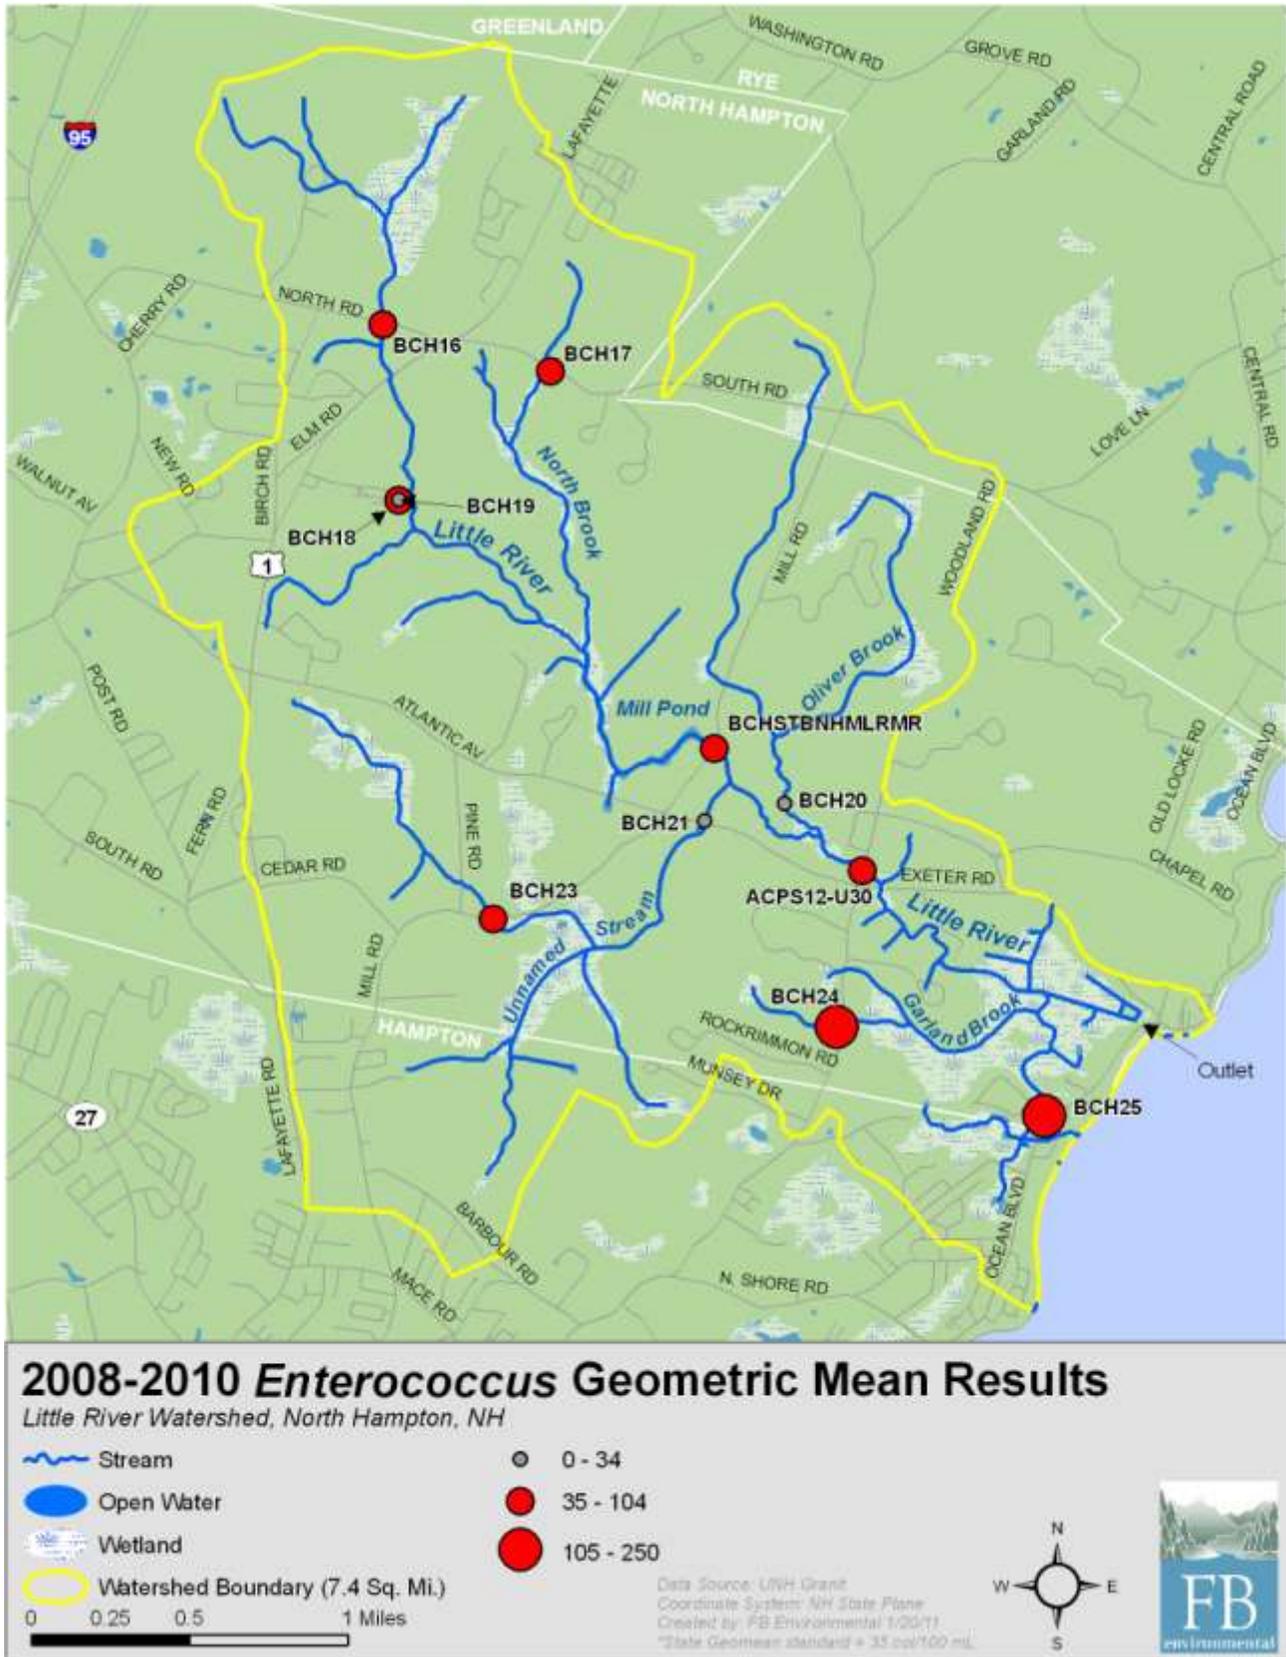
Figure 3.2. Map of Enterococci Sampling Locations and Geometric Means

Hot spots identified through bacteria sampling are BCH 24 and BCH25. BCH18 needs continued monitoring to determine if recent efforts to remediate a malfunctioning septic system have been successful. BCH23 also needs continued monitoring and site assessment to identify sources. Since the site was first sampled in 2009 each subsequent sampling has yielded a result higher than the previous sample. Please refer to Appendix B for full sampling results.

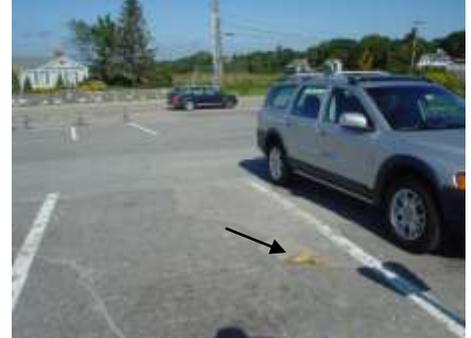
Bacteria sources, such as pet waste (bagged but abandoned), were noted at State Beach parking areas.

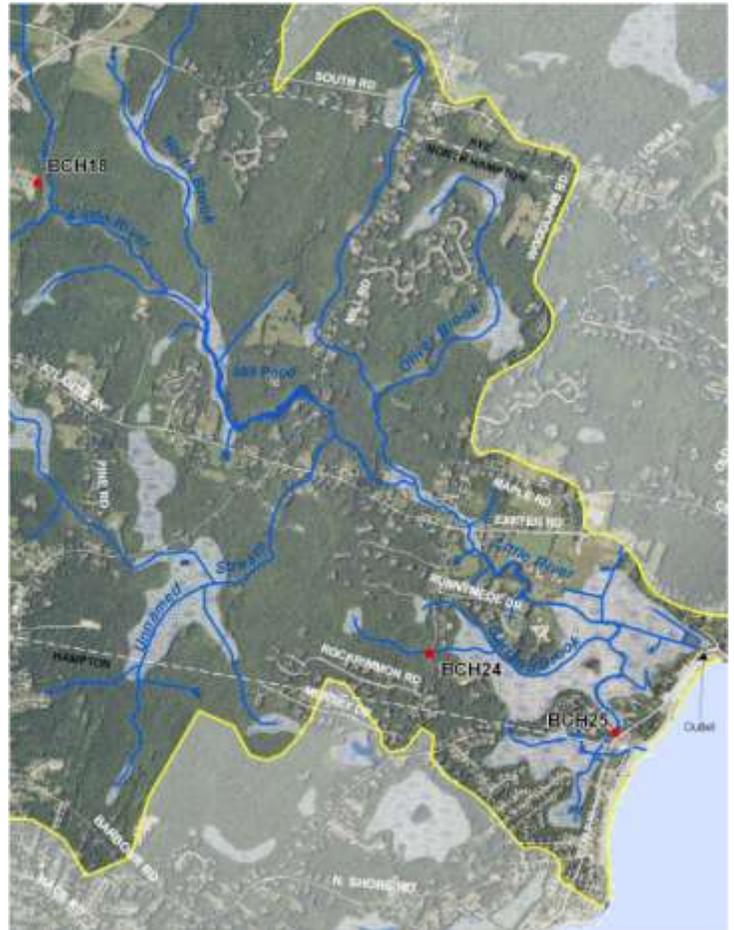
Figure 4.1. Map of hotspots explored in the Little River watershed during the November 16, 2009 watershed

The November 24, 2009, survey focused on identifying potential pollutant sources near locations where high bacteria counts had been observed in a late October, 2009, sampling event by NH DES staff. Order-of-magnitude exceedances of the Enterococci bacteria standard (104 Enterococci counts/100mL) were observed at 3 locations in the Little River watershed: site BCH24, site BCH25, and site BCH18. The results from that sampling event were used to target these specific

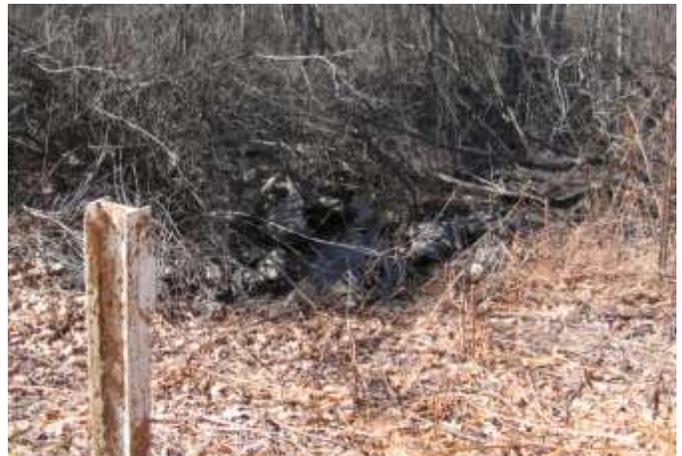
Wildlife most likely impacts bacteria levels at BCH24

- A bacteria measurement of 1,500 cnts/100 mL was recorded in October 2009 during wet weather.
- The upstream site is entirely forested wetland with very low density residential.
- There were no clear signs of human-sources of bacteria-related contamination. Wildlife is a possible source.

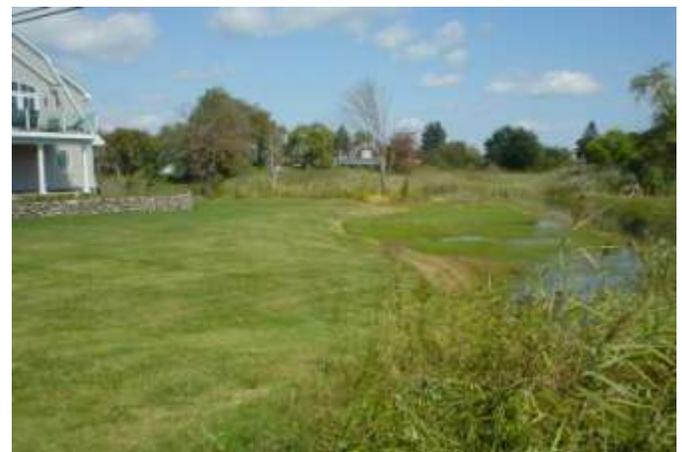
Tidal waters adjacent to mowed marsh grass near BCH 25.

- Enterococci levels of 260 counts/100mL were measured during wet weather sampling event in May 2010.
- New construction found directly adjacent to tidal channels with patchy vegetated buffers.
- Lawns appear to extend below the high water mark on to the marsh, as evidenced by tidal water rising through mowed areas.
- Given the close proximity of some buildings to the marsh in this area, these properties are considered a possible source of bacteria, as well as nutrients, to Little River.

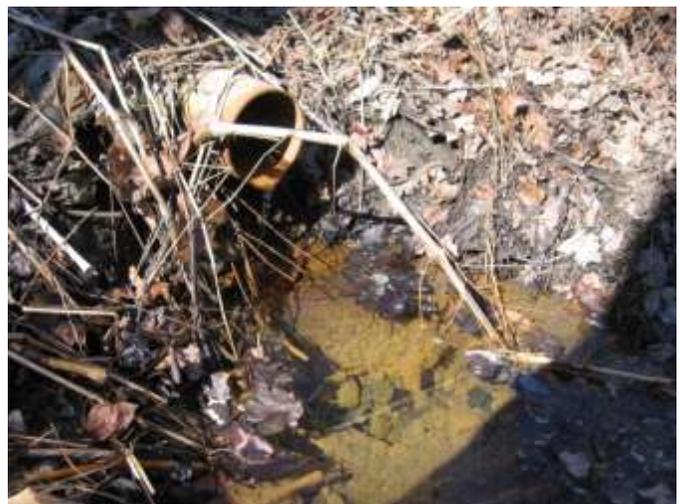
- A bacteria measurement of 6,000 counts/100mL Enterococci was collected during the early May 2010 wet weather sampling at Site BCH18.
- Biofilm was observed coating the pipe and discharge pool.
- The pipe is draining a residential mobile home park making wastewater and septic leachate a possible source of bacteria.

Pipe discharge in a wooded area near site BCH 18.

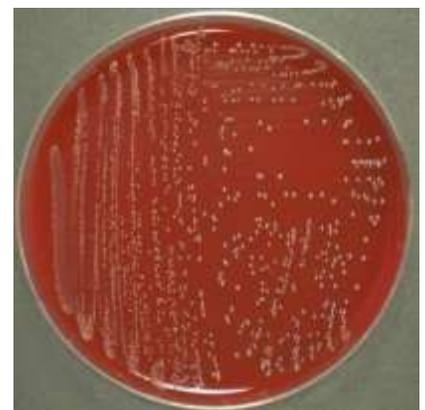
Enterococci bacteria on an agar plate

A combination of literature, scientific models, and on-the-ground observations were used to estimate bacteria loads. The NH DES Beach Program samples for Enterococci at the Little River stations which is used to indicate the current fecal coliform load in the stream. The indicator bacteria used for the annual estimates is fecal coliform (FC). FC is a more general indicator of bacteria concentrations and includes all bacteria most commonly found in the fecal matter of organisms. FC includes *E. coli* and Enterococci and has the greatest amount of available research and data to support current and future load estimation in Little River. Bacteria load estimates are provided on an annual basis (i.e., counts/year) to allow uniform comparison across source types. The method of bacteria load estimation was deterministic, meaning that potential sources were identified, estimated based on field reconnaissance and literature values, and then summed. The following types of bacteria sources were considered:

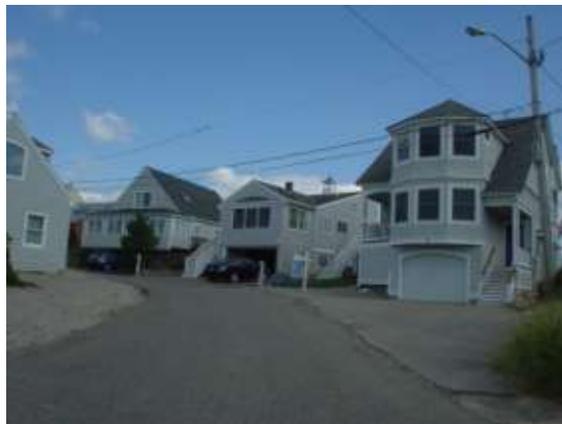
A lack of vegetation can allow stormwater to flow, unfiltered, into Little River from developed areas.

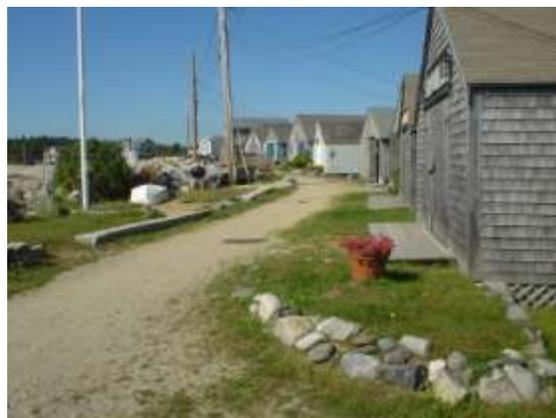
Seasonal cottages next to the Little River outlet have the potential to contribute a great amount of bacteria through sewage failures.

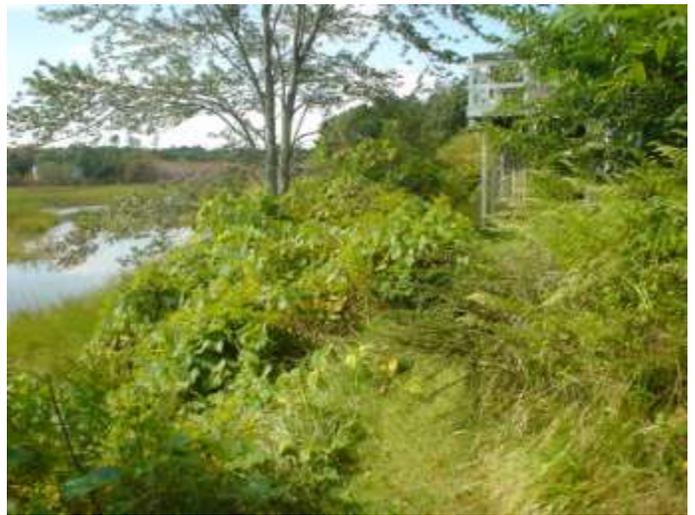
High density development close to marshes, such as those in the Fifield Island development, have the potential to contribute bacteria to surface waters and beaches in cases of septic malfunctions.

Within the watershed, specific areas of suspected malfunctioning systems were identified using several methods. First and foremost among indicators is high bacteria counts in nearby surface waters. Other indications of wastewater failure include soggy lawns where septic disposal fields are likely sited, wastewater odors, and disproportionately lush vegetation growth. In some cases, though, wastewater failure might go undetected if these signs alone are relied upon, because bacteria can be carried long distances in groundwater flow. The watershed is highly susceptible to wastewater failures (see appendix C), and much of the infrastructure appears to be over 25 years old. At that age, the septic system failure rate is dramatically higher than for systems less than 10 years old. A watershed-wide approach, such as mandatory pump-outs every three to five years would be a good way to begin to mitigate this source.

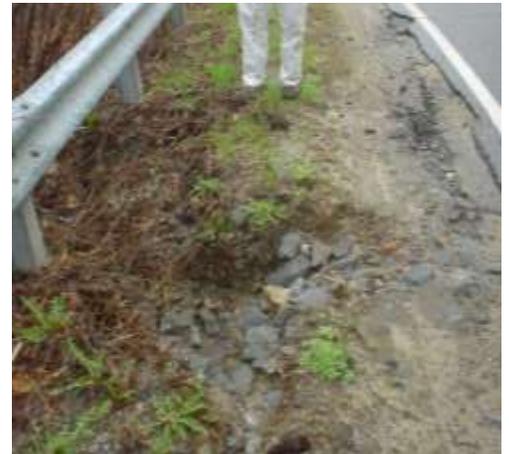
Road erosion into the stream near BCH24.

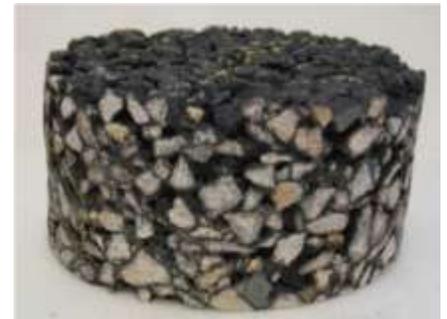
Pervious pavement allows water infiltration and reduction in winter road sand and salt necessary to keep roads clear.

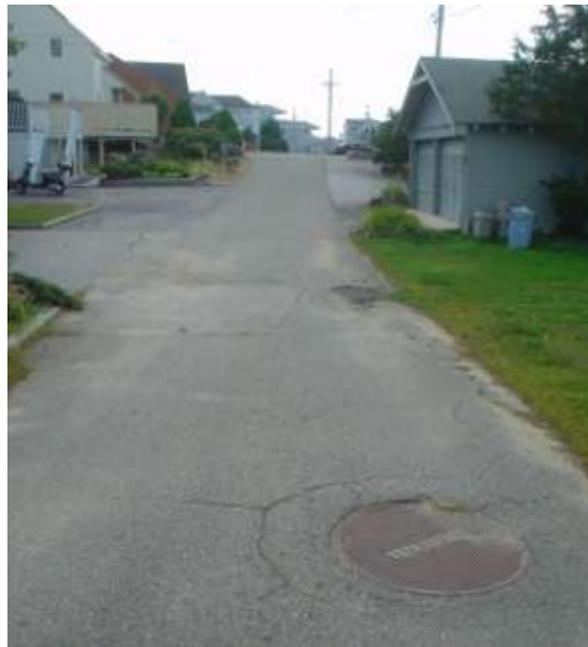
Developed area runoff can contribute nutrients, metals, and petroleum products, as well as bacteria to Little River and State Beach.

Most of the above pollutants are carried in developed area runoff, identified above as a bacteria source. While these pollutants are currently not monitored, there are spreadsheet models available that would estimate pollutant reductions of these additional pollutants based on the type of BMP installed.

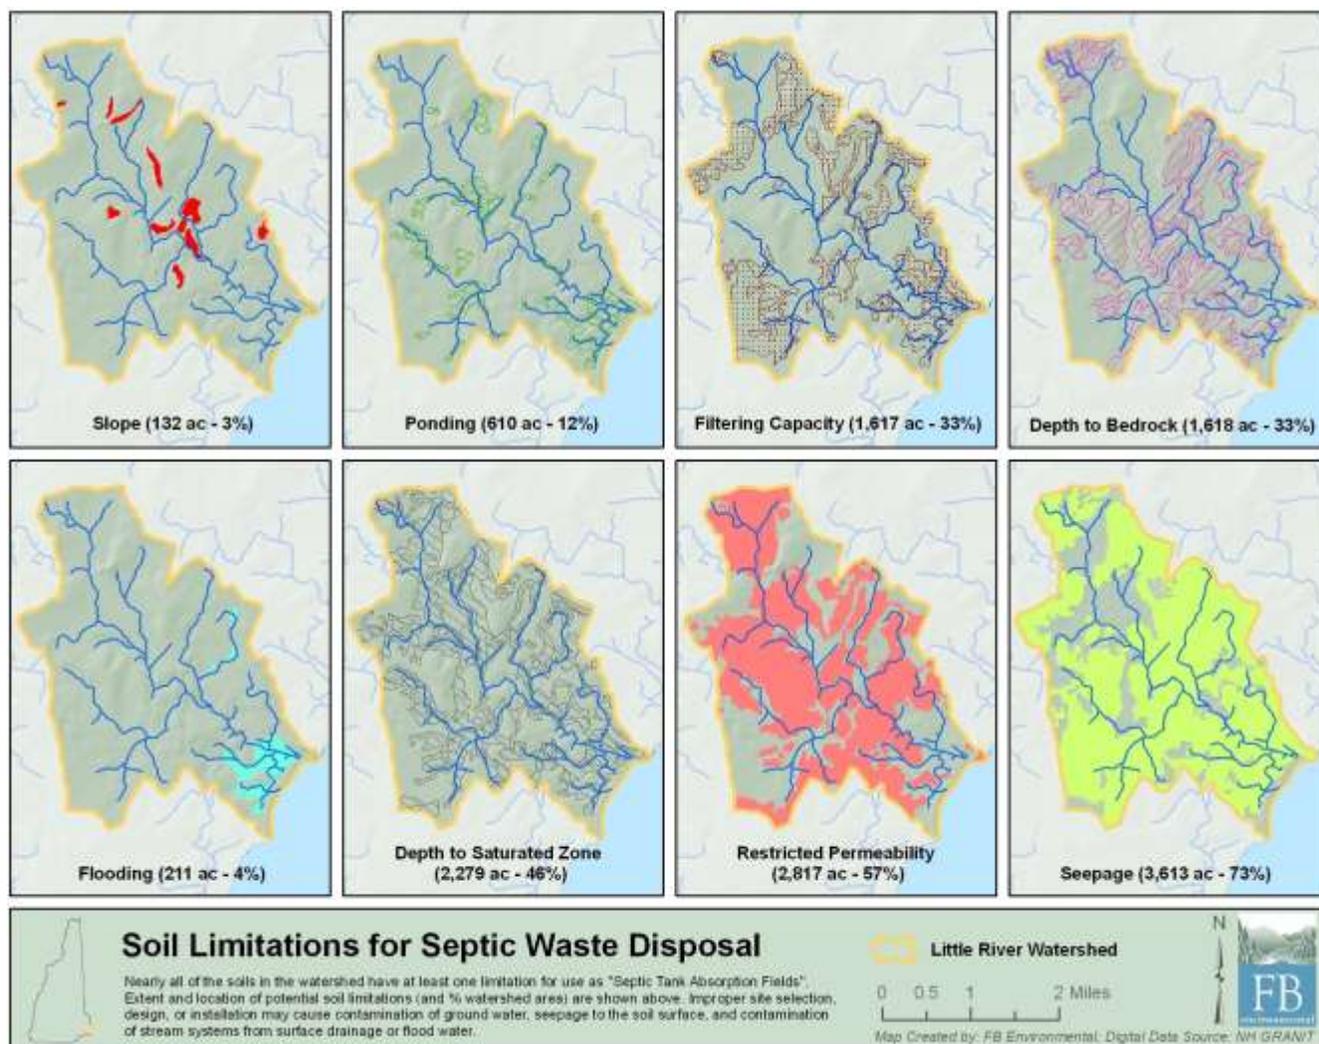
Where soils are underlain by loose sand and gravel or fractured bedrock at a depth of less than 4 feet below the distribution lines, the absorption field may not adequately filter the effluent, particularly when a system is new; consequently, ground water supplies may be contaminated.

Figure 2: Little River watershed soil limitations for septic system, as indicated by the Natural Resource Conservation Service.
