Little River Watershed Based Plan

May 2011

LITTLE RIVER WATERSHED BASED PLAN

Prepared by FB Environmental Associates, Inc.
in cooperation with the Towns of North Hampton, Hampton, and Rye, and
New Hampshire Department of Environmental Services

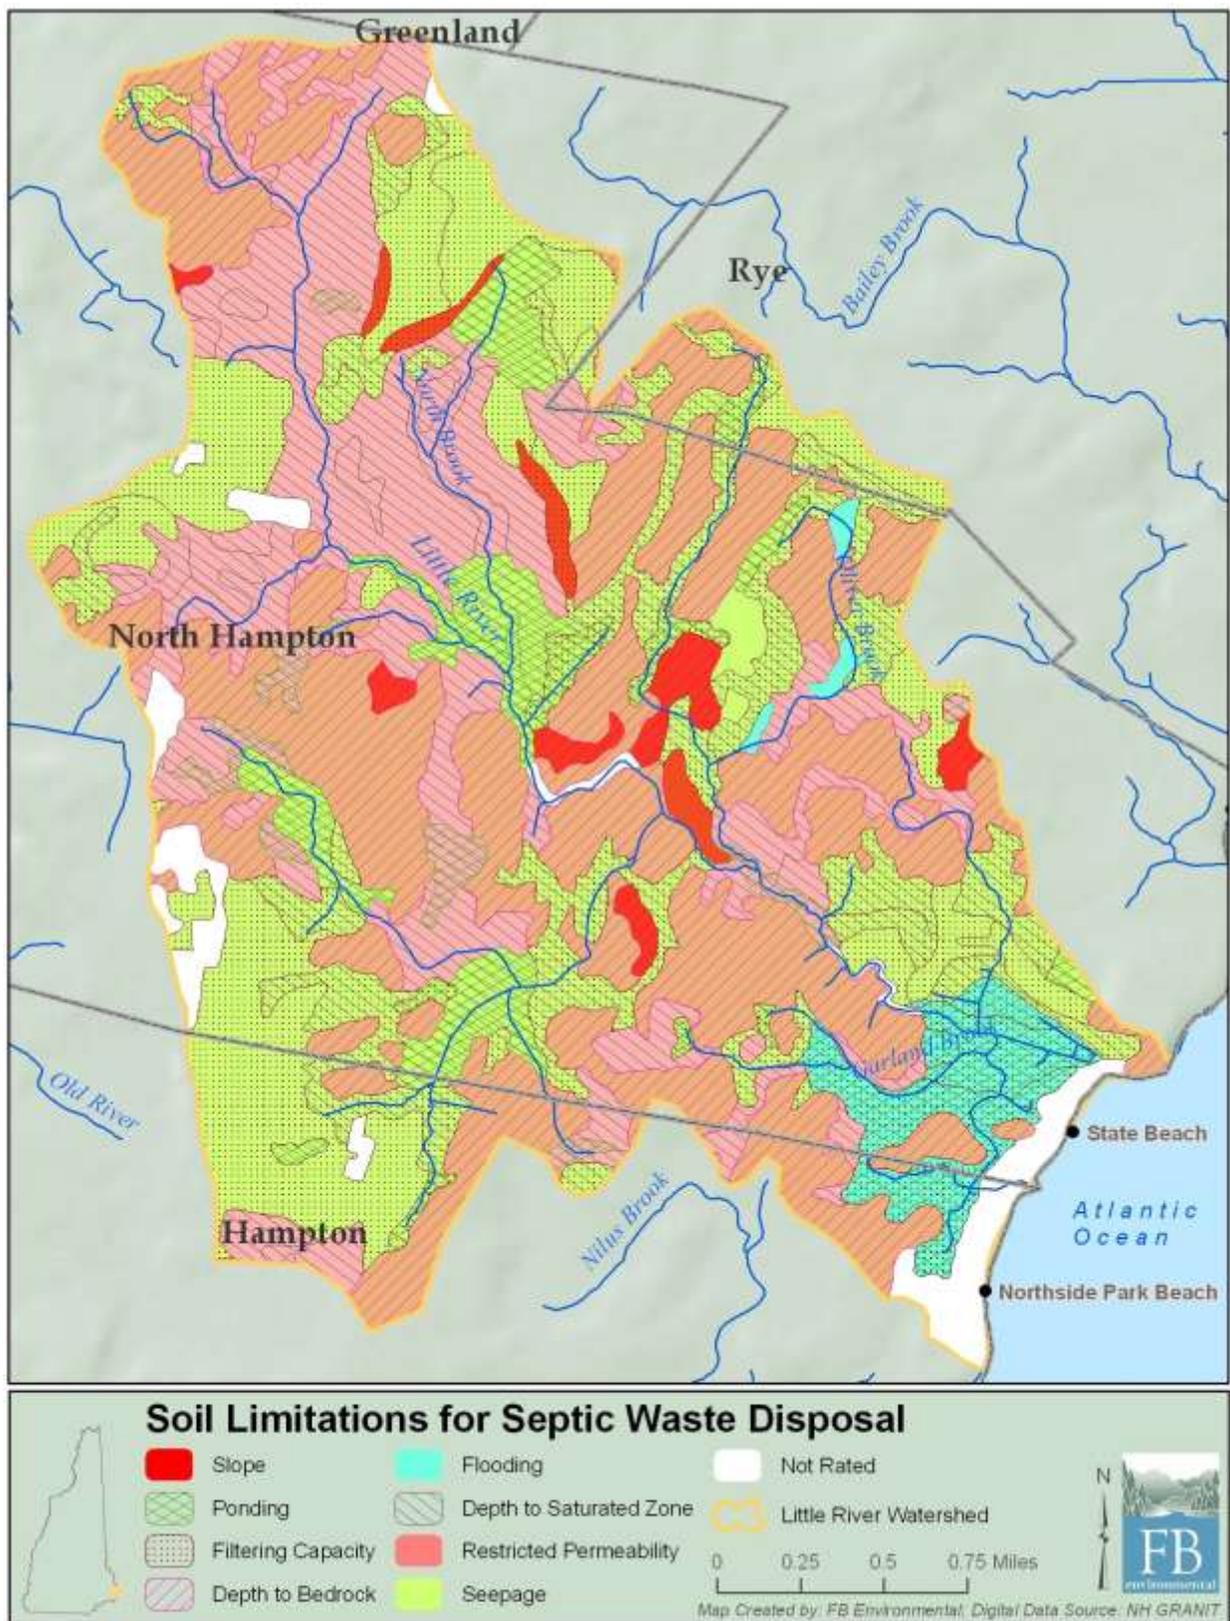
8. **Restricted permeability:** The soil horizon with the minimum K_{sat} governs the rate of water movement through the whole soil. When this rate is low, transmission of fluids into and through the soil is impeded and runoff, infiltration, and percolation of pollutants may result in environmental, health, and performance concerns. This limitation is present for 57% of the Little River soils and 55% of the Parsons Creek soils.

Figure 4: Little River watershed septic disposal soil limitations, note the overlapping limitations in many areas.

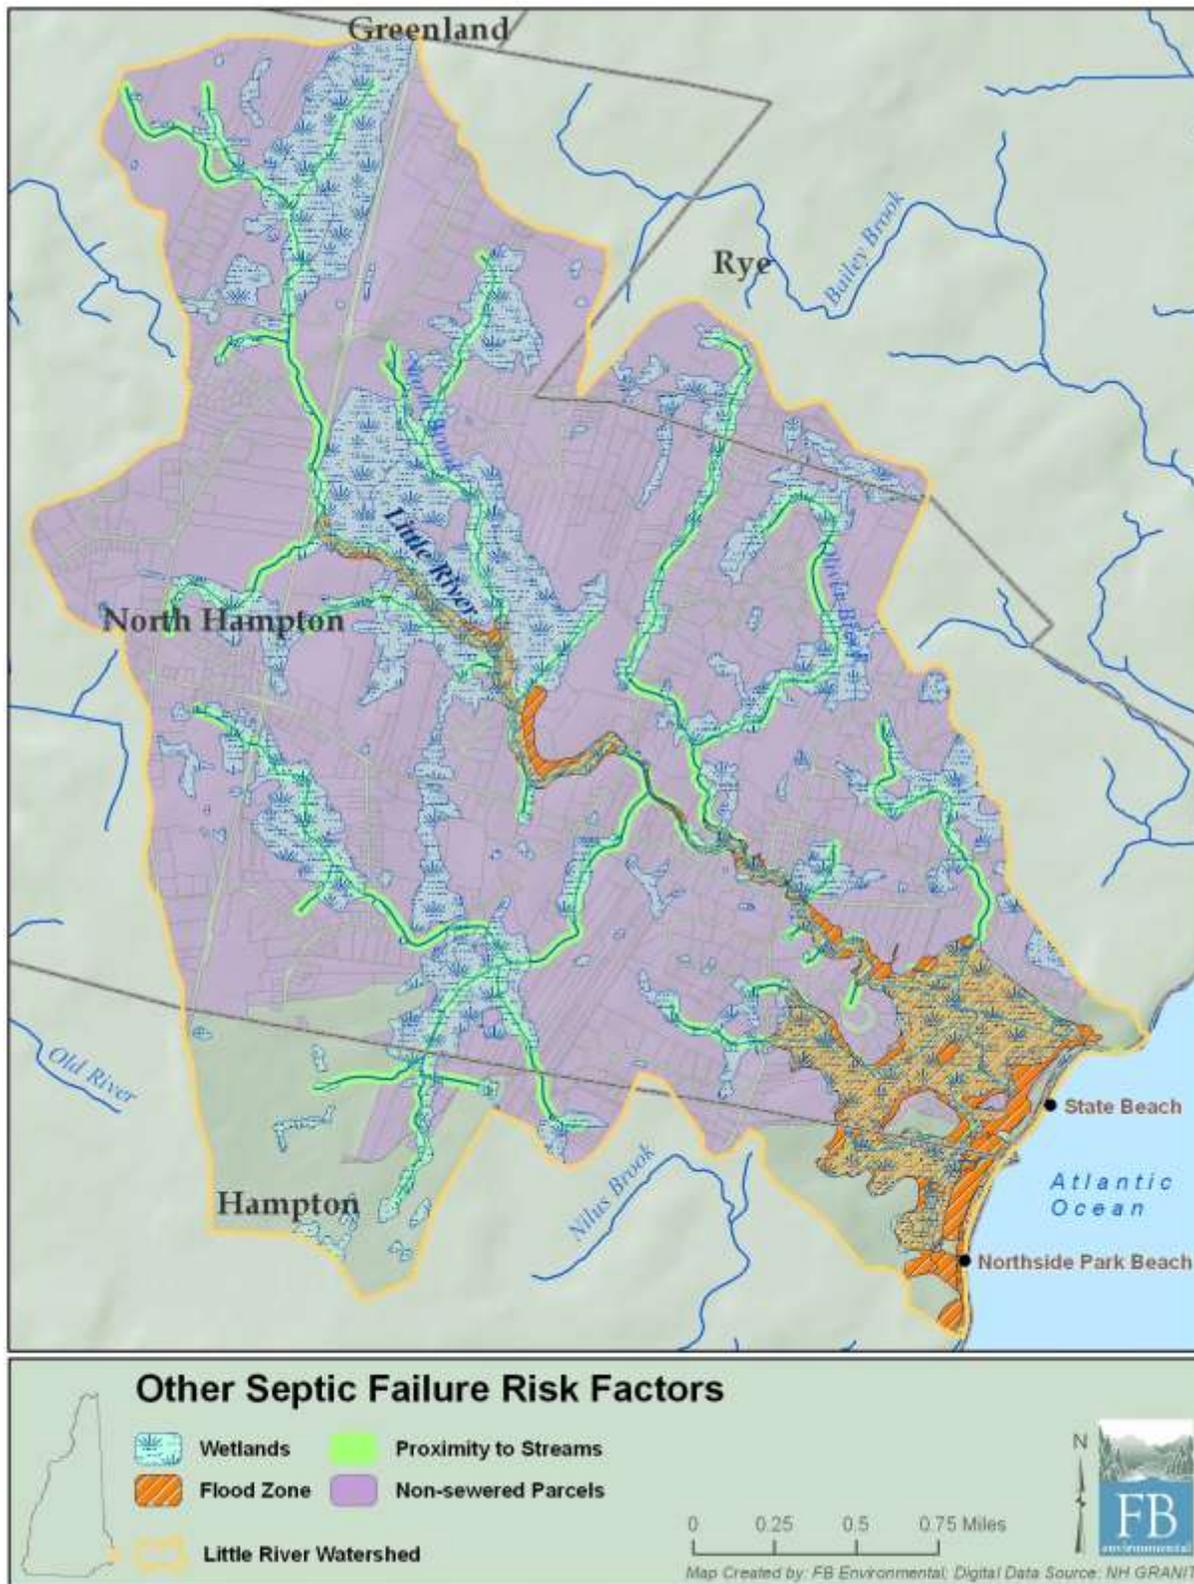
- **Proximity to Streams:** All streams in the watersheds were buffered by 100 feet, the average setback distance required in New Hampshire. Within these areas, there is increased potential for bacterial contamination from septic failure due to stormwater runoff and astronomically high tides.

Figure 6: Little River watershed factors (beyond soils) contributing to risk of water quality contamination from malfunctioning septic systems.

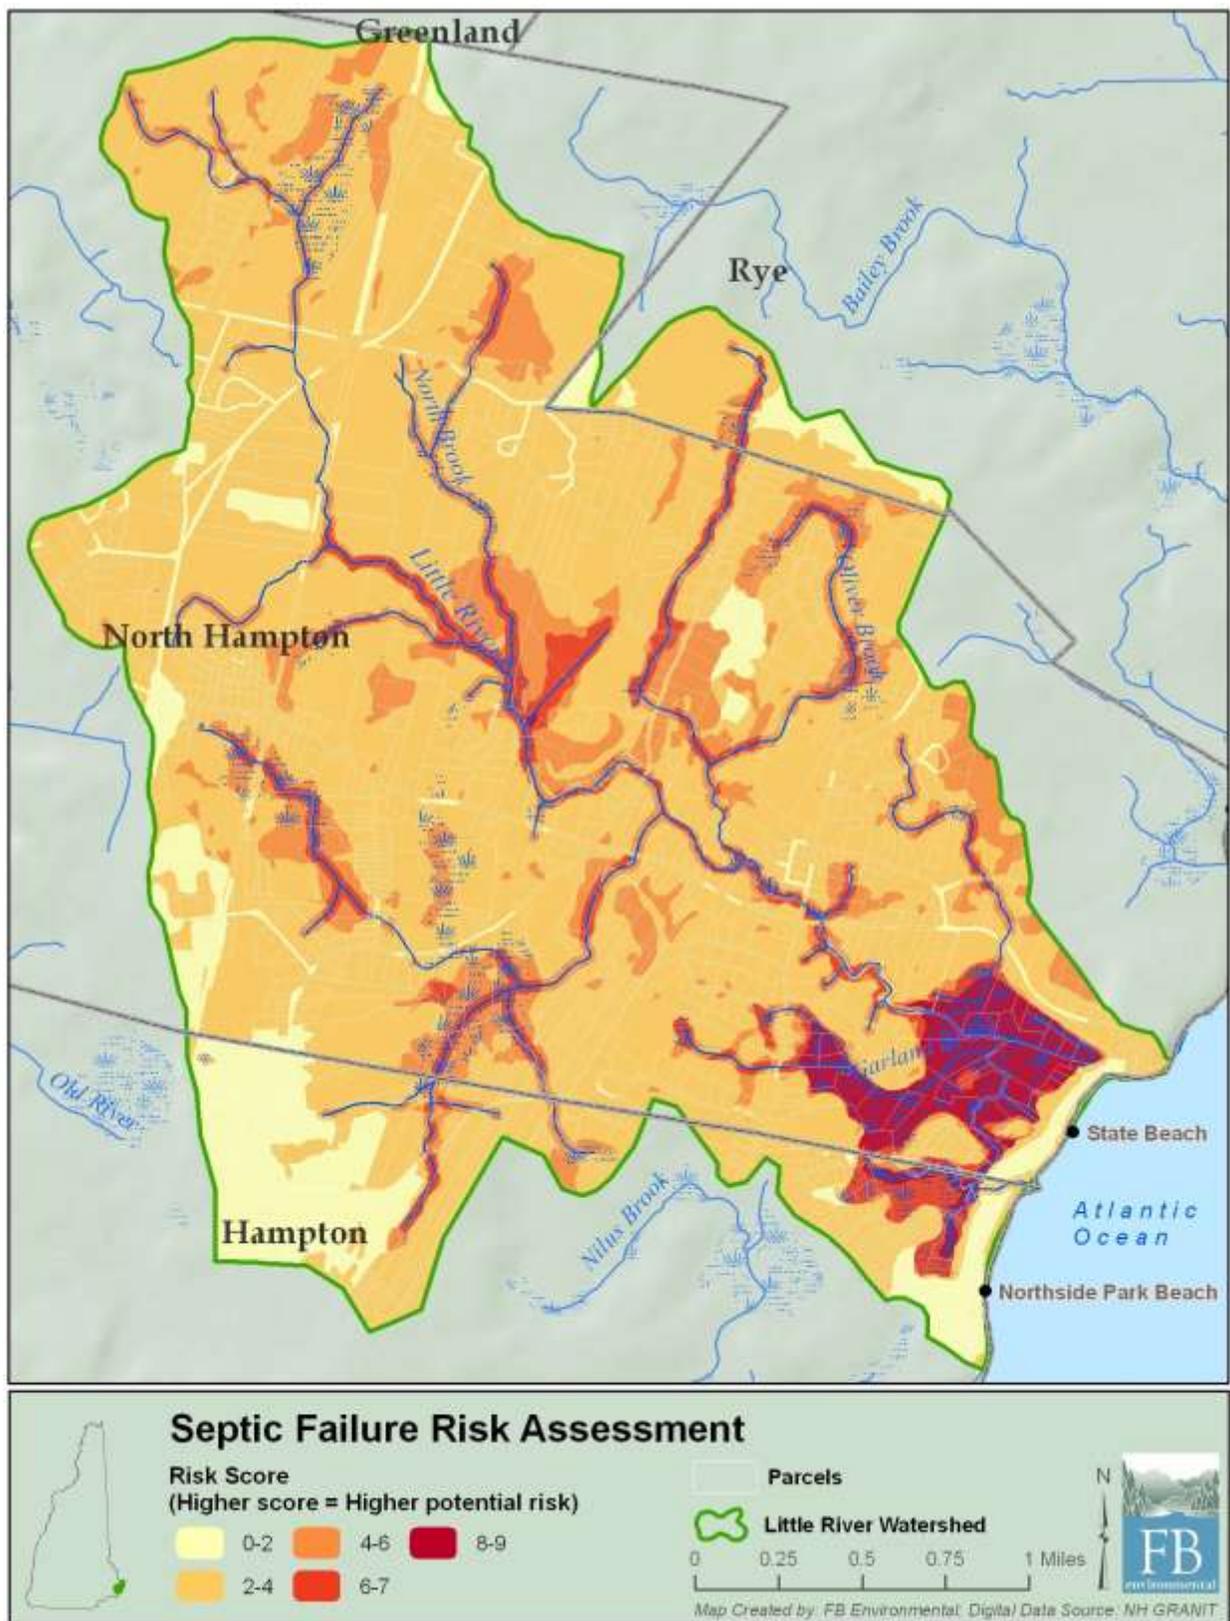
After assigning risk scores, all data layers were overlaid to create a composite risk map. Risk scores for overlapping criteria were summed to create a single risk factor for each area of intersection. Final risk factors ranged from 0 to 9, with 9 representing the greatest potential risk. Since the majority of soils in the watersheds are not well suited for septic systems, the primary determinant in identifying the greatest risk potential from bacterial contamination from septic failure risk was proximity to freshwater streams, estuaries, wetlands and flood hazard areas.

Figure 8: Little River watershed overall septic systems risk assessment.

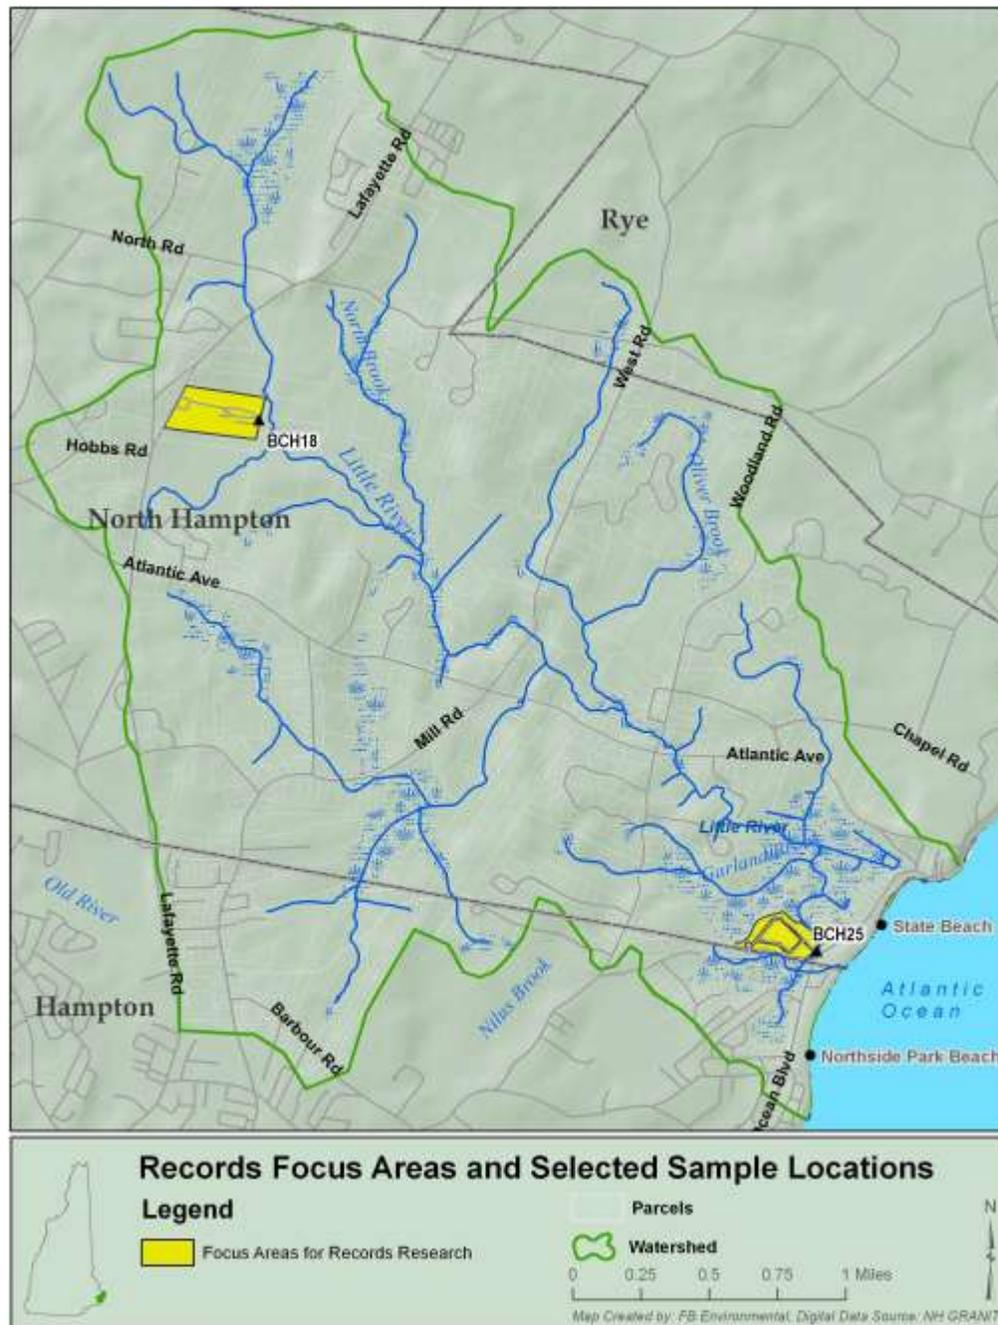
- BCH11, along Marsh Rd in Rye.
- BCH26 and BCH26A, at the intersection of Wallis Rd and Ocean Rd in Rye, including the neighborhood just west of this intersection.
- BCH25, Appledore Ave in North Hampton.
- BCH18 and BCH19, along Lafayette Rd / US Route 1 in North Hampton.

Figure 10: Focus areas for records research in Little River watershed.

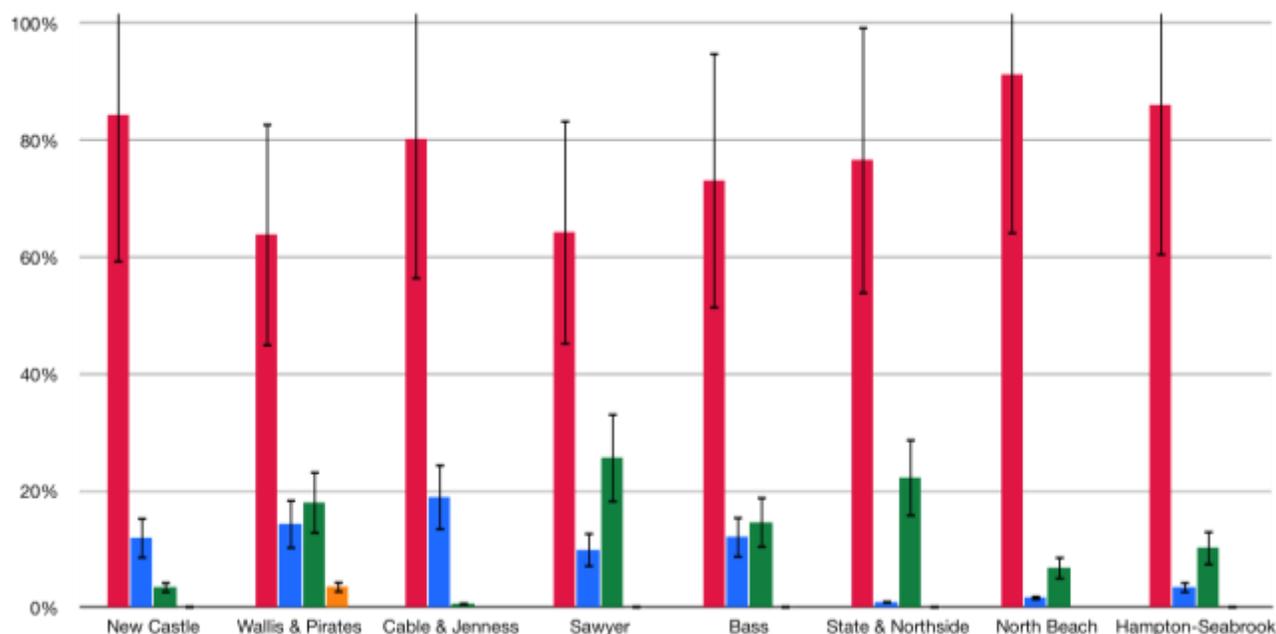
Figure 16 provides estimated percentages of each type of bacteria load for each watershed. Developed area runoff is estimated to be the largest bacteria source in all of the study area watersheds (as shown in red below) ranging from 64% to 91%. Developed area runoff contributions originate in roadways, in yards, with pets, in illicit storm drains, and from other sources. Failing septic systems (blue) and wildlife (green) are also estimated to be significant in most watersheds. Failing septic systems are estimated to range from 1% to 19%, with larger estimated loads in unsewered communities. Farm animals are estimated to be significant only in the Wallis & Pirates Cove watershed with a 4% estimated contribution.

Figure 11: Estimated Bacteria Loads: Percentage of Each Type by Watershed.
