MESSER POND WATERSHED-BASED IMPLEMENTATION PLAN

April 4, 2016

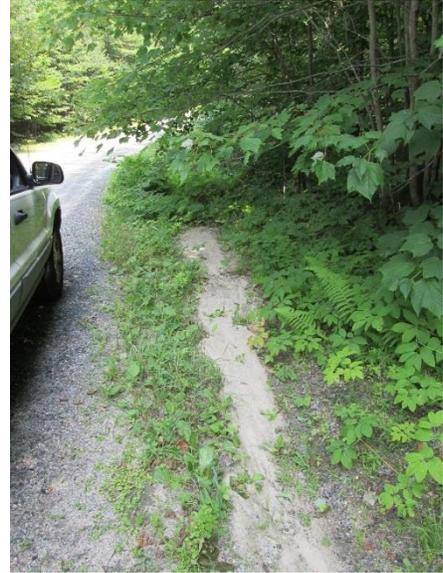
Photo 2-1

Forest Acres Road runs adjacent to residential homes located along the southern shoreline of the pond. It is a dirt road that is subject to sediment erosion following storm events, typical of dirt roads. Browns Brook, Nutter Brook, Haas Brook and an unnamed tributary all receive flow from I-89 and their watersheds and pass under Forest Acres Road via culverts. In order to prevent eroded road sediments and road sands/salts applied during the winter from entering the streams, the town has dug holes in the road shoulder on the up gradient sides of each stream essentially creating small 'settling basins', observed at Browns, Nutter and Haas Brooks in the recent past. Watershed survey observations indicated that these basins were very effective, however had reached their capacity and most likely weren't capturing any sediment once full.

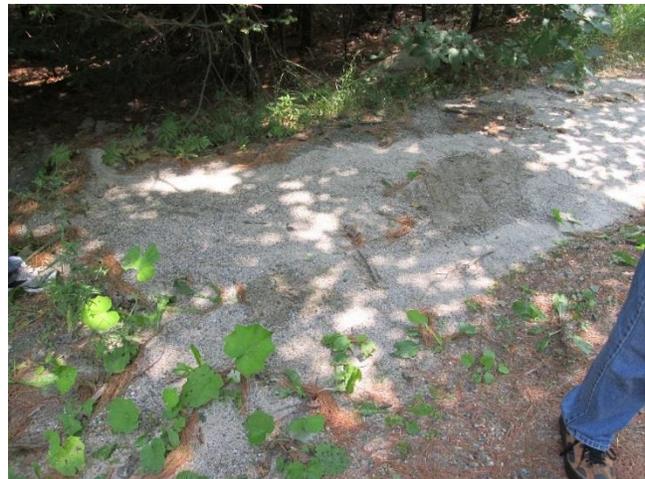
Photo 2-2

In addition to these settling basins a series of catch basins exist along the southern shoulder of Forest Acres Road. Slightly different from typical catch basins, these basins are constructed of solid concrete with a closed top but allow flow to enter the basins from the side of the basin, from the adjacent road swales. Although not opened during the watershed survey, it's suspected that these basins have a sump at the bottom (i.e. depth from the bottom of the structure to the bottom of the lowest invert out) which allows for some accumulation of sediment. The discharge location and sediment loading of these systems is currently unknown, however the town Department of Public Works (DPW) will be contacted prior to efforts regarding this BMP get underway.

Although an unknown at this time regular inspection and maintenance (if required) of the concrete catch basins is also recommended at the same frequency of the settling basins.

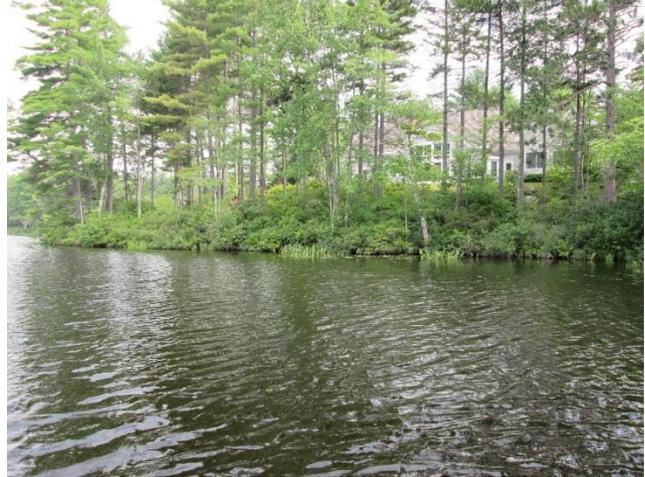
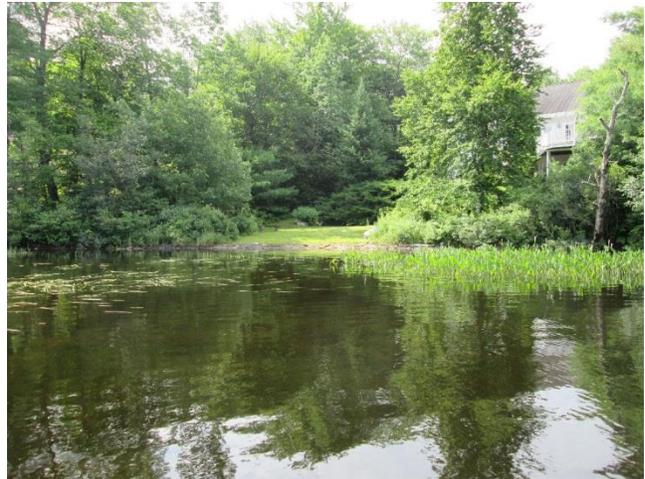
Messer Pond is a great example of natural shorelines – along with undeveloped properties, most shorefront homes have significant buffers that consist of native vegetation and features that provided for excellent filtering capacity of stormwater runoff (photo 5-1). However, during the Shoreline Survey a small number (2-3) of properties were observed either not to have buffers or to have property configurations that allow stormwater to runoff directly to the pond (photo 5-2).

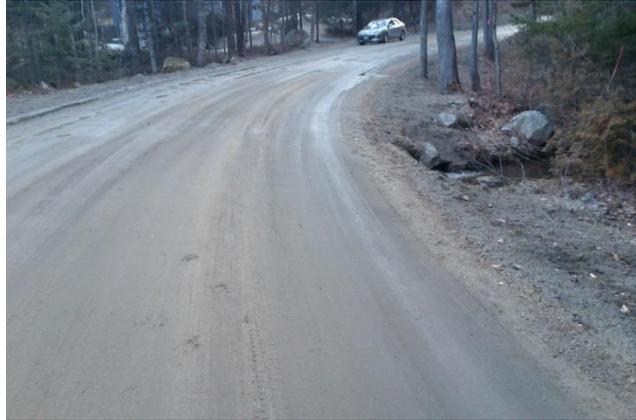
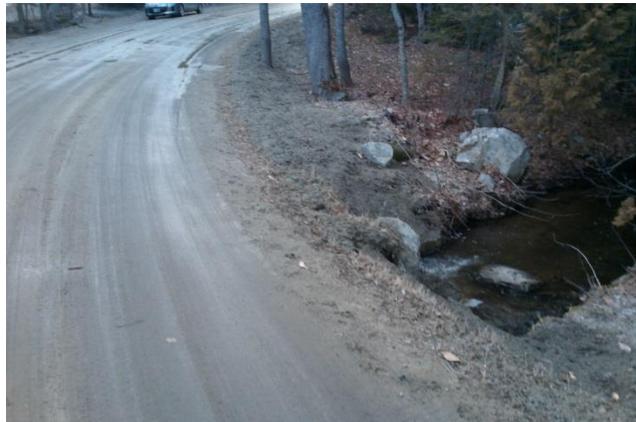
The proximity of Forest Acres Road to Browns Brook, particularly on the downstream side of the brook is close (*i.e.* within 3-5 feet); when visiting the site it is quite evident that there is a direct input of sediment, road salts and NPS from the road into the brook adjacent to the downstream end of the culverts (*i.e.* the edge of traffic travels less than 5-10 feet from the bank of the brook).

Install buffers or rain gardens within the right-of-way along both banks of the stream on the downstream side, using native vegetation. Target buffers that are at minimum 10 feet wide or rain gardens that will accommodate stormwater runoff and retention of sediment.

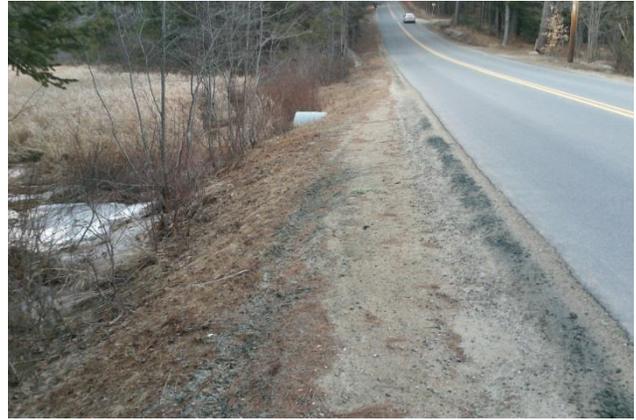
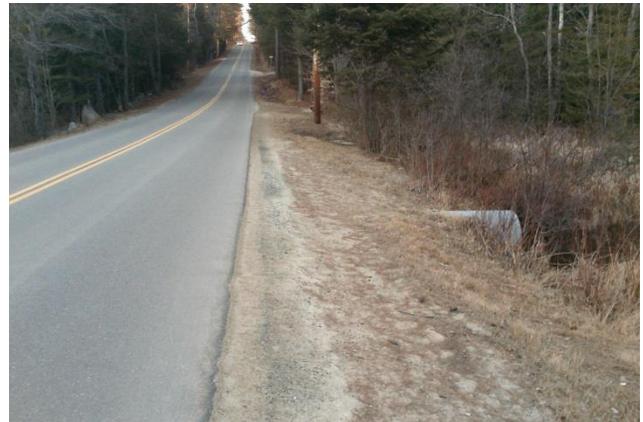
The proximity of County Road to County Road Brook on both sides of the road is close (*i.e.* approximately 8-10 feet); when visiting the site it is evident that there is a direct input of sediment, road salts and NPS from the road into the brook most likely on the upstream and downstream sides. This portion of County Road is the low point adjacent to a steep hill and it is suspected that some degree of runoff and NPS is entering the brook and likewise the associated wetland.

Install buffers within the right-of-way along each side of the road, using native vegetation. Since buffer width will be limited, plant selection and density should receive adequate attention for this BMP to be effective. Consideration of vegetation height and maintenance should also be considered with respect to maintenance and safety concerns.
