# Restoring Mill Pond East Washington, NH 2009

**Town of Washington,  
New Hampshire**

# Summary

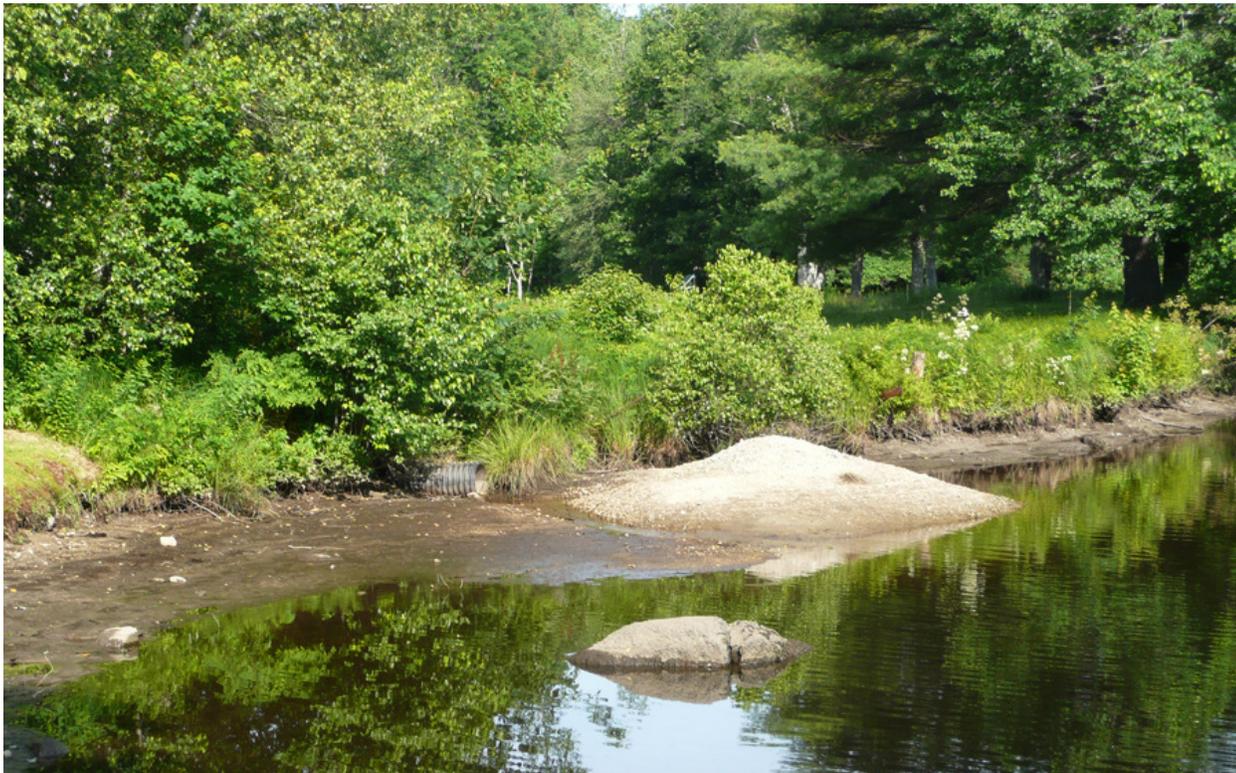
**Figure 1 -- Sediment accumulation in Mill Pond.**

Field reconnaissance in the watershed found one commercial dairy farm and several small livestock operations with sheep, horses, or cows. The DES report recommended fencing livestock out of water courses, providing alternative watering systems, and providing controlled stream crossings for livestock. Following community meetings and dialogue started by the selectmen and the conservation commission, the Town developed an implementation plan to install livestock best management practices (BMPs) at all locations, to install BMPs that deter waterfowl from nesting near ponds and watercourses, and to address sediment deposition (see Figure 1) by designing stormwater BMPs along Purling Beck Road.

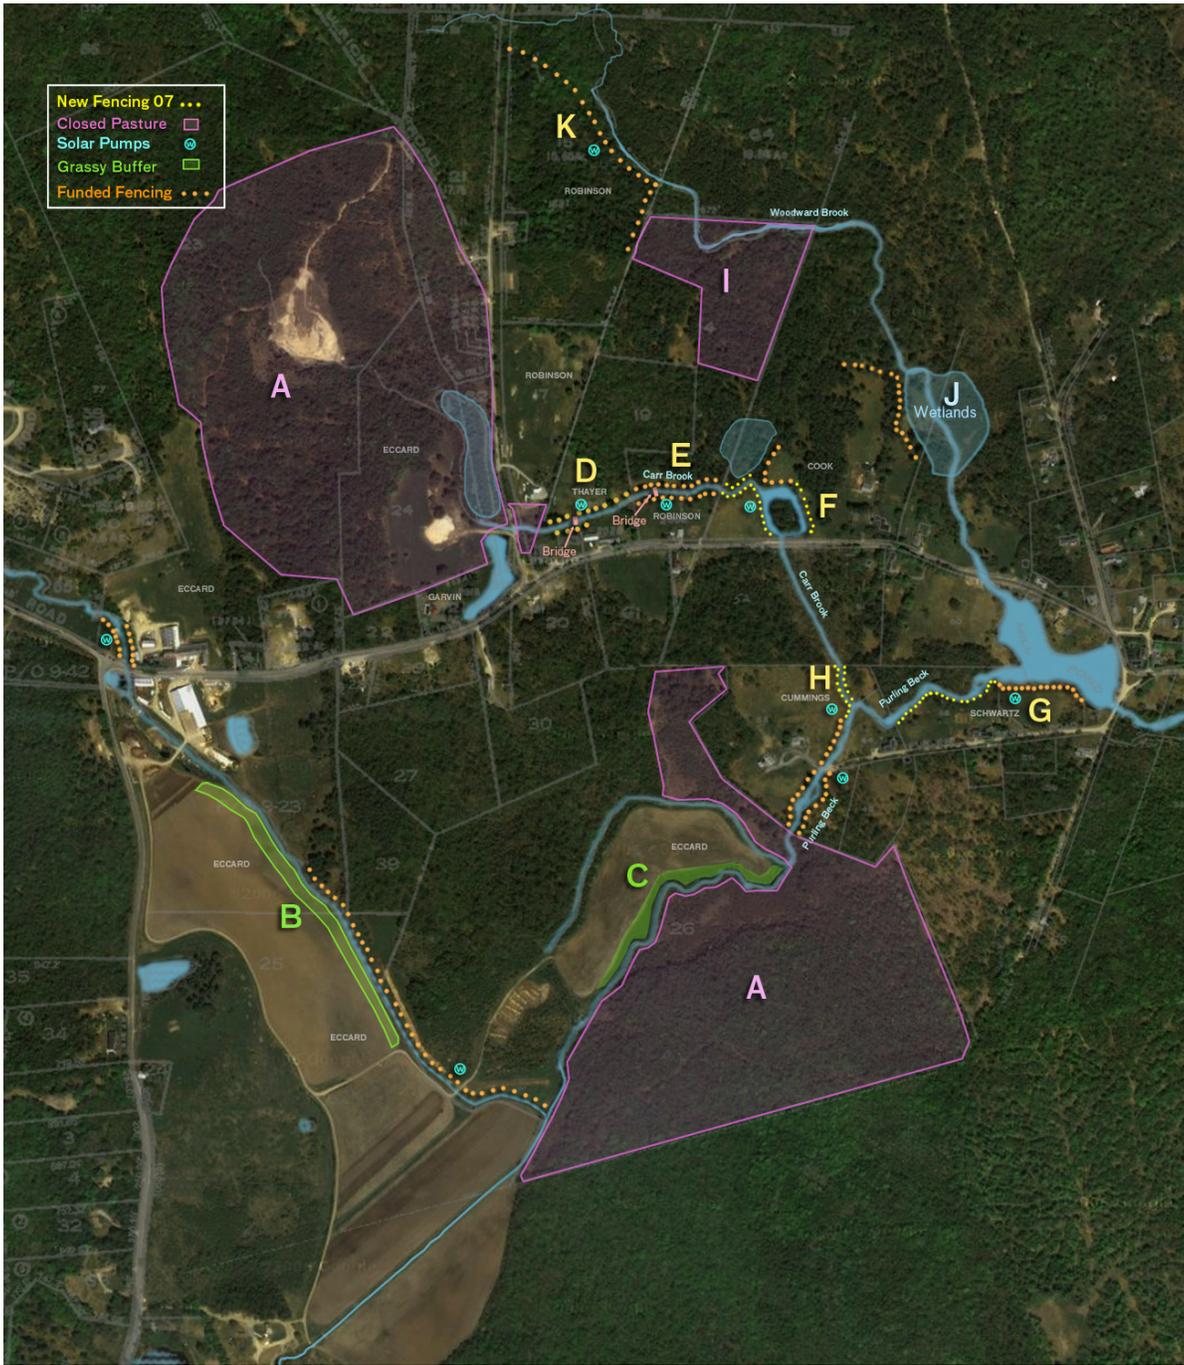
Figure 2 -- BMP Locations (see Table 1 for key)

Each livestock operation was surveyed and mapped as shown on Figure 2. Over 22,000 thousand feet of stream and pond frontage were fenced with solar powered water pumps installed to maintain water access for livestock. Two stream crossings were installed as shown in Figures 7 and 9.

The commercial dairy operation created approximately 45,000 square feet of grassy buffer strips to reduce waterfowl access to Purling Beck Brook, a tributary of Mill Pond. To address the waterfowl problem in Mill Pond, swan decoys were deployed during the unfrozen months, as shown on the top cover photo. A map of BMP locations is provided in Figure 2; a list of BMPs keyed to the letters on the map is provided in Table 1. BMP photos are provided in Figures 3-9.

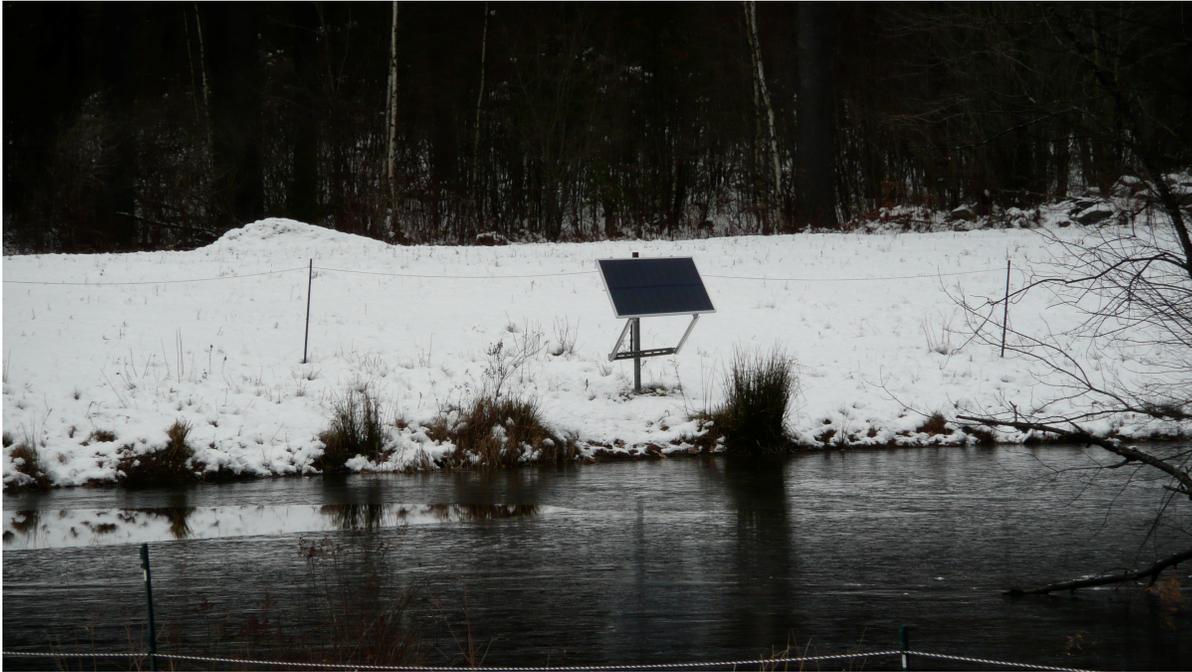
**Figure 3 -- Solar pump provides water for livestock; fencing keeps livestock out of farm pond at Cook farm.**

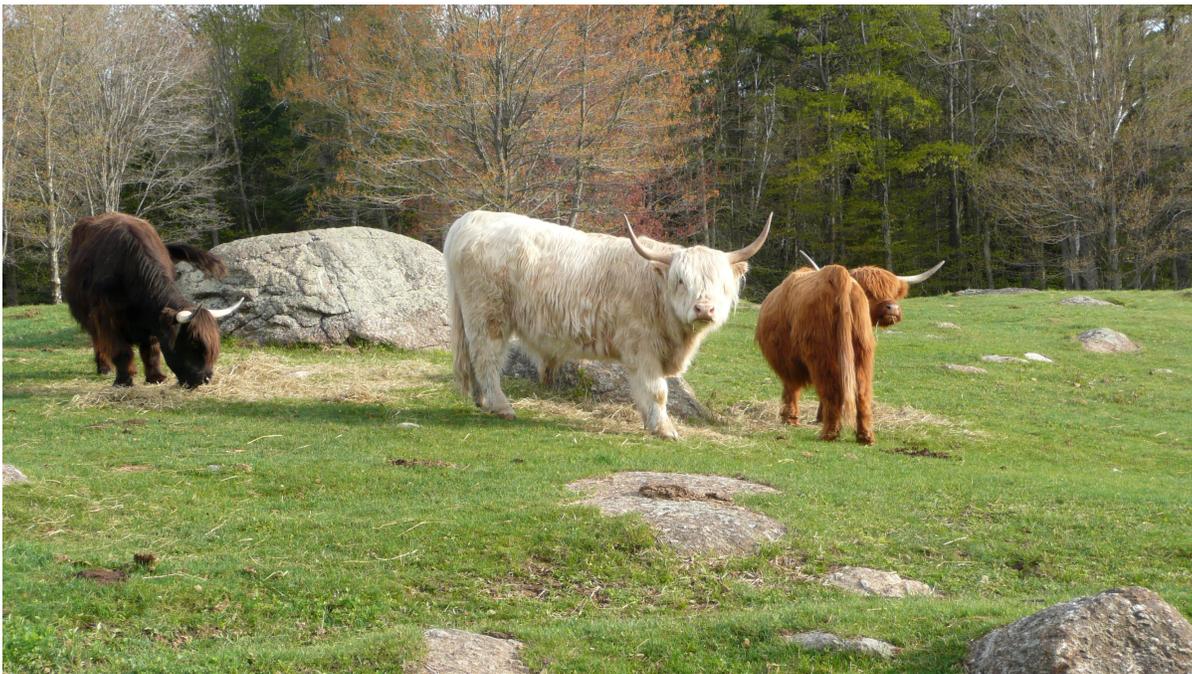
**Figure 4 -- Beef cattle grazing in fenced pasture at Cummings farm...(see Figure 5).**

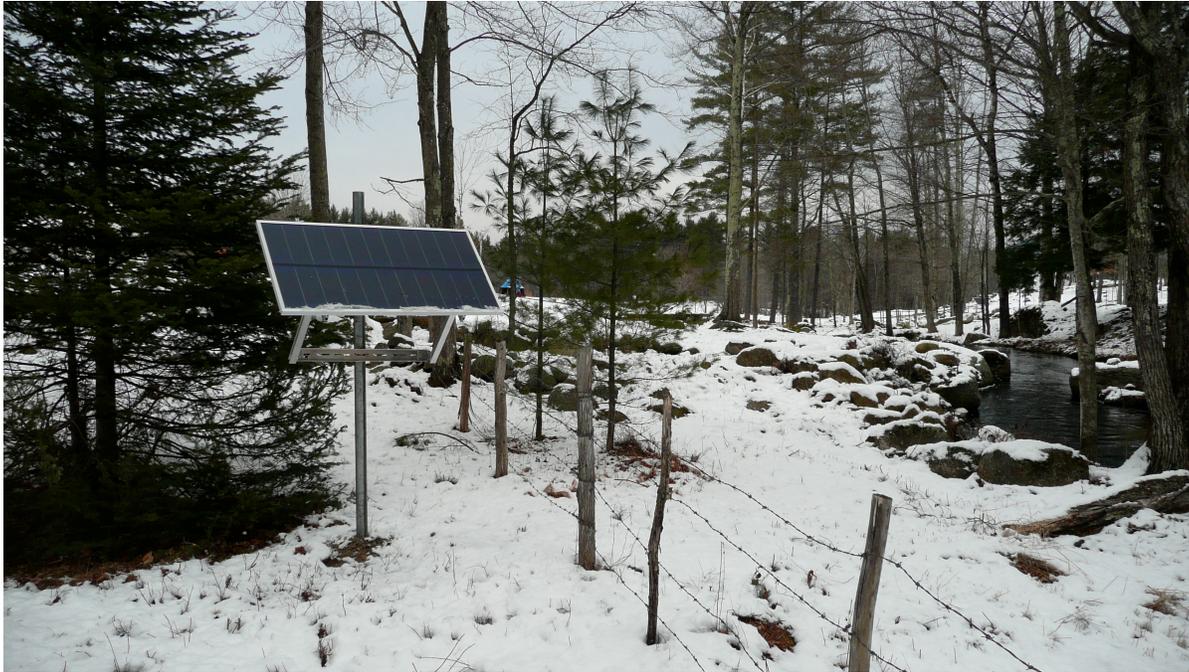
**Figure 5 -- Solar pump and livestock fencing at Cummings farm.**

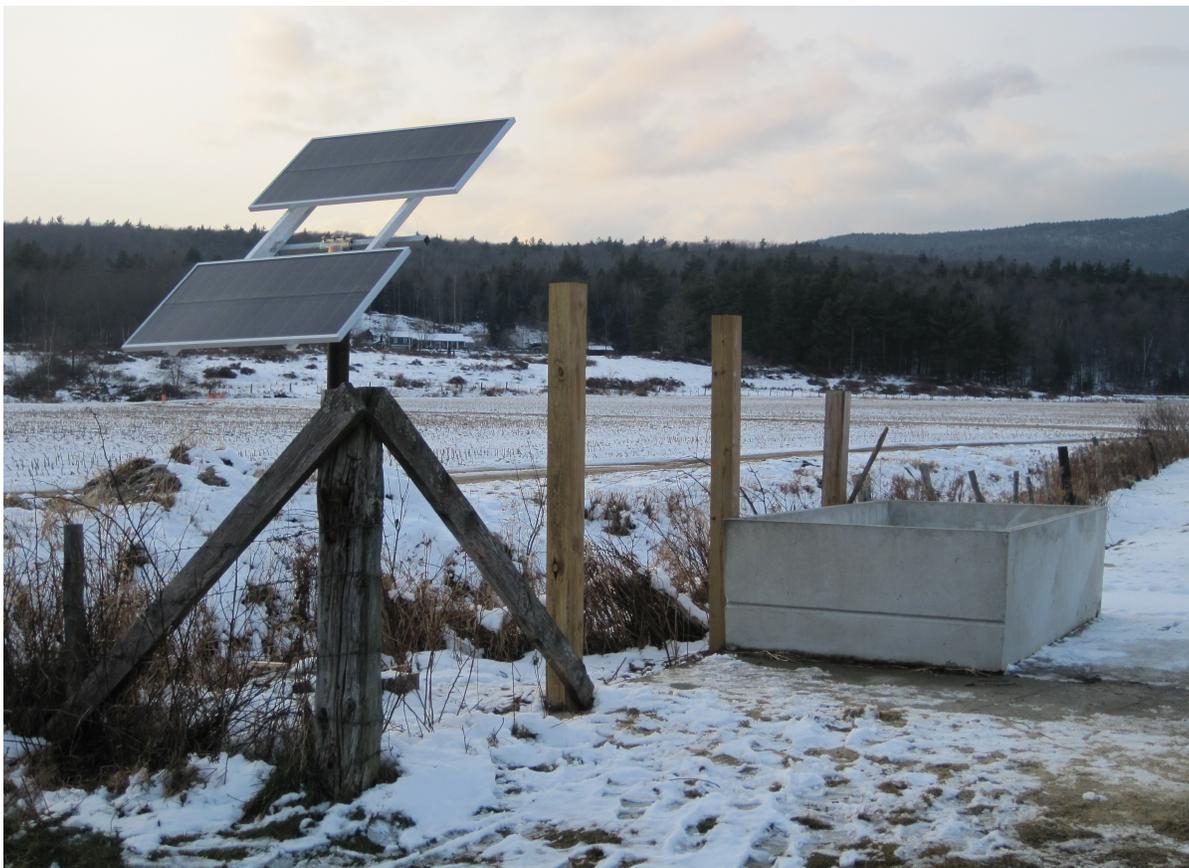
**Figure 6 -- Solar pump, fencing, and stock tank allow watering of livestock without direct access to the brook at Eccardt Farm.**

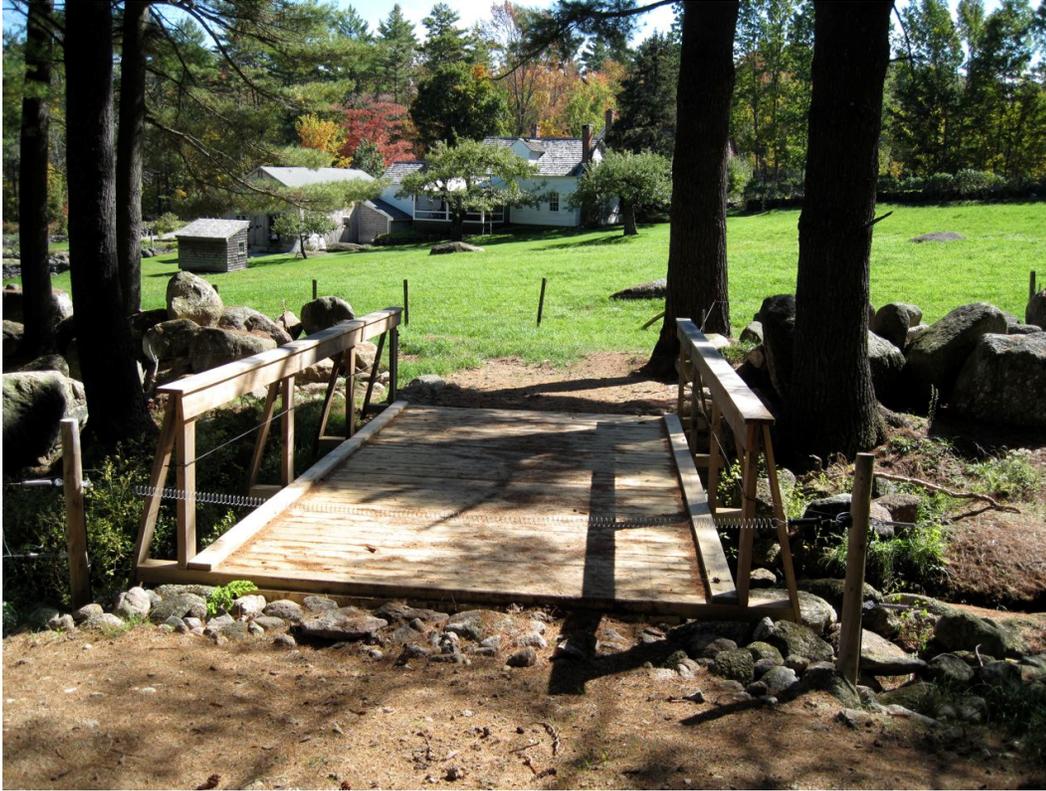
**Figure 7 -- Stream crossing and fencing keep livestock from the brook at Robinson/France farm.**

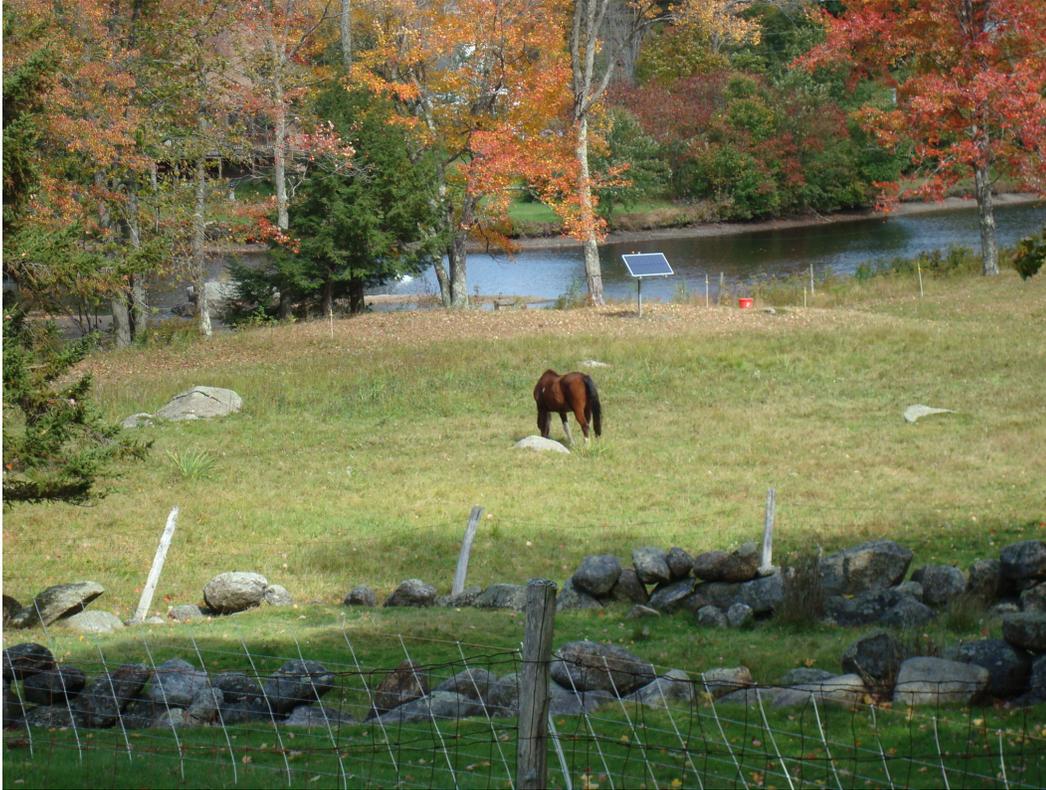
**Figure 8 -- Fencing and a solar pump at Schwartz farm.**

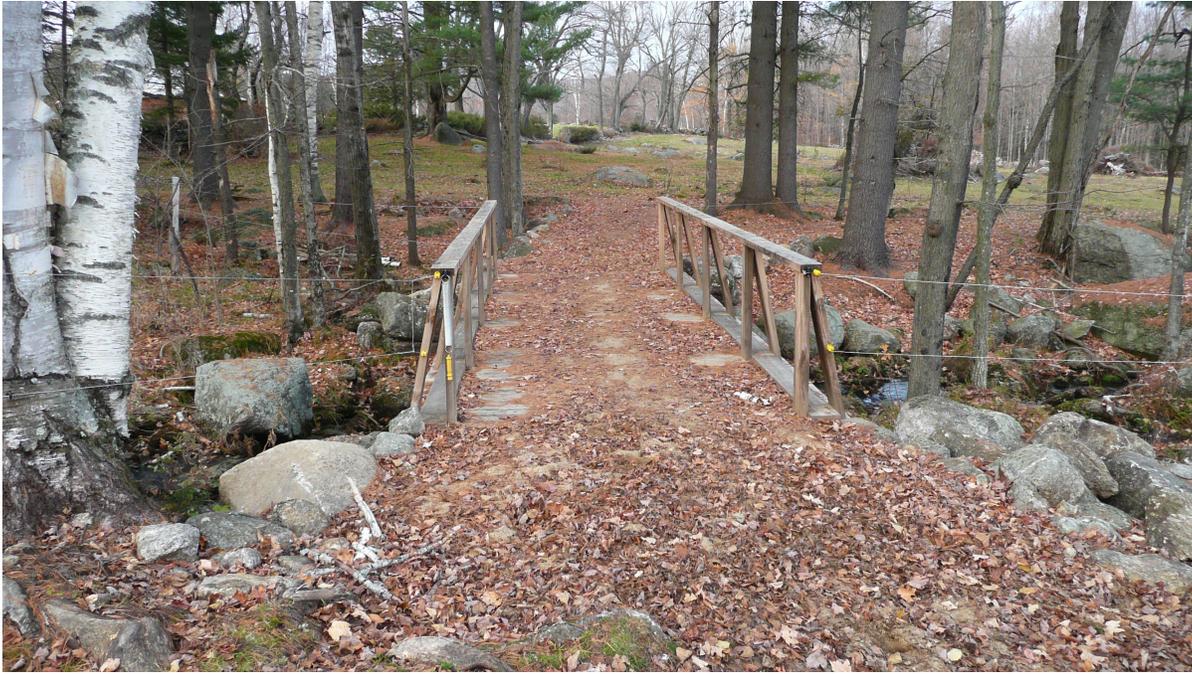
**Figure 9 -- Livestock crossing and fencing keep animals out of the brook at Thayer farm.**

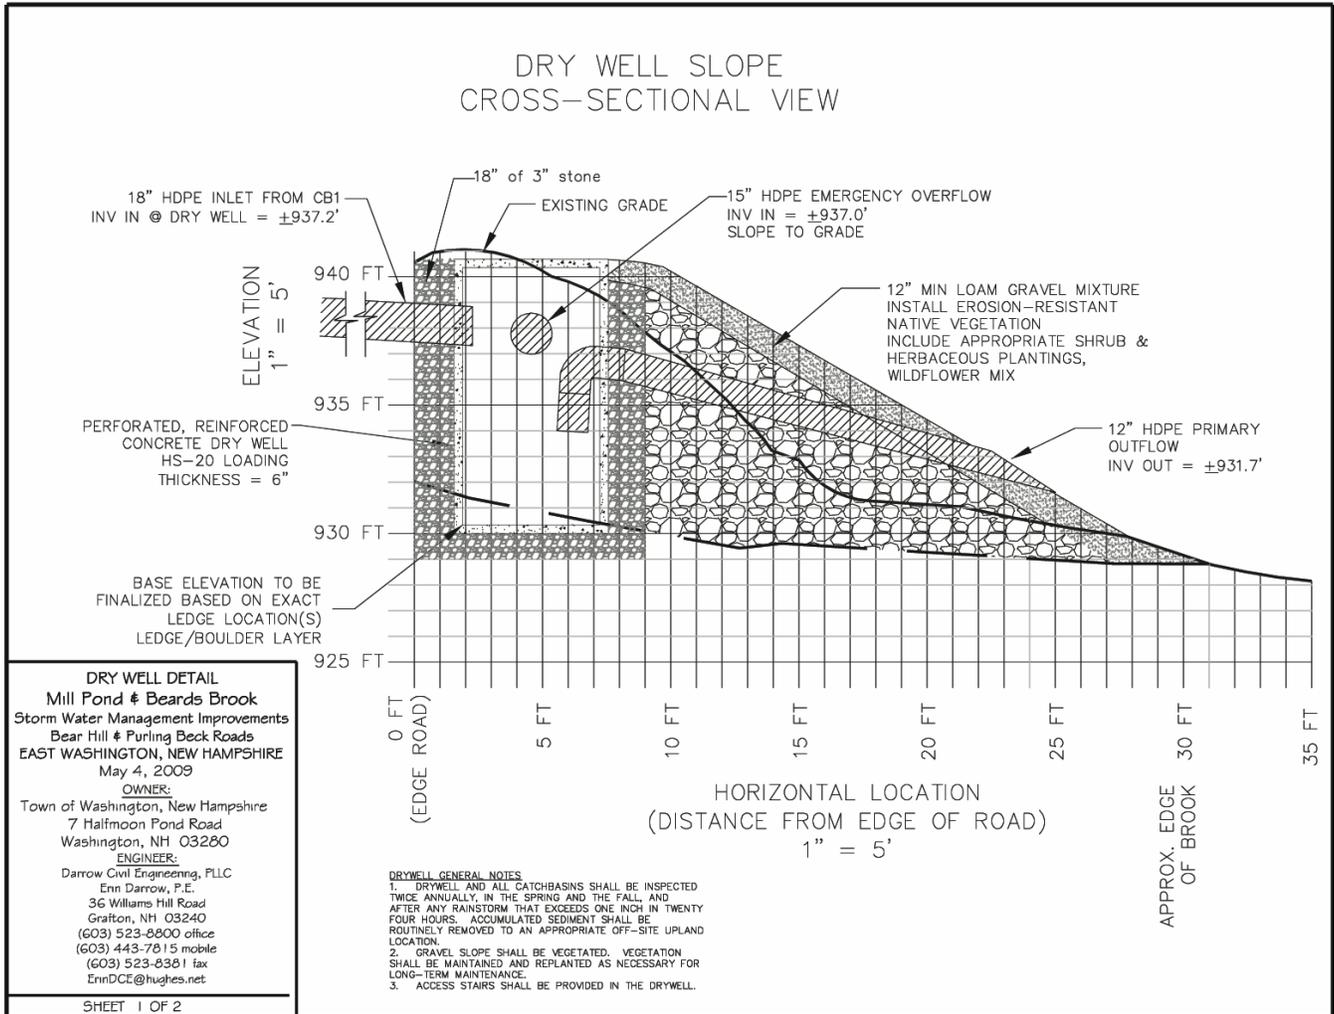
Darrow Civil Engineering of Grafton, NH designed the Purling Beck drainage system, which replaced the piped outlet to Mill Pond with a dry well on a small piece of town-owned land just downstream of the Mill Pond dam. Figure 10 shows the installed design of the BMP.

**Figure 10 -- Stormwater infiltration BMP design at Purling Beck Road**

The Town excavated 14 cubic yards of sediment from the pond and will track accumulated sediment in the dry well annually. The modeled rate of sediment reduction is 5 tons per year.
