# BABOOSIC LAKE WATERSHED BASED PLAN

MAY 2008

**New Hampshire Department of  
Environmental Services**

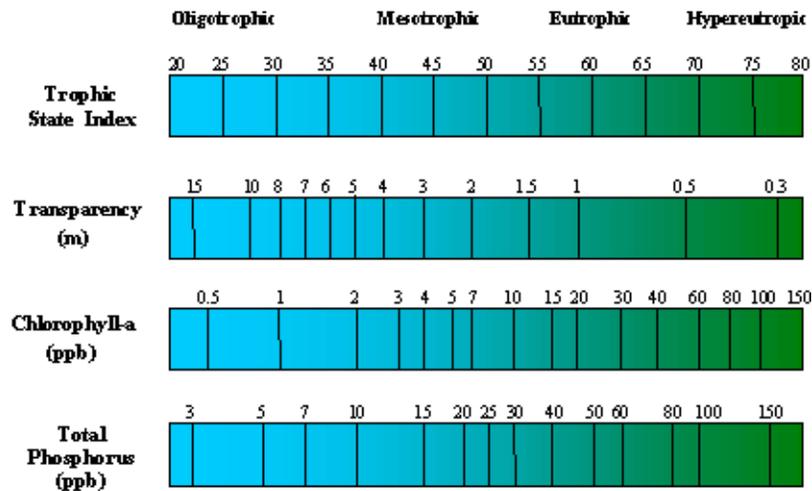
The Carlson Trophic State Index (TSI) is one of the most commonly used means of characterizing a lake's trophic state. As illustrated in the Figure 3 below, the TSI assigns values based upon formulas which describe the relationship between three parameters (total phosphorus, chlorophyll-a, and Secchi disk (clarity) and the lake's overall biological productivity. As shown in the figure below, TSI scores below 40 are considered oligotrophic, scores between 40 and 50 are mesotrophic, scores between 50 and 70 are eutrophic, and scores from 70 to 100 are hypereutrophic.

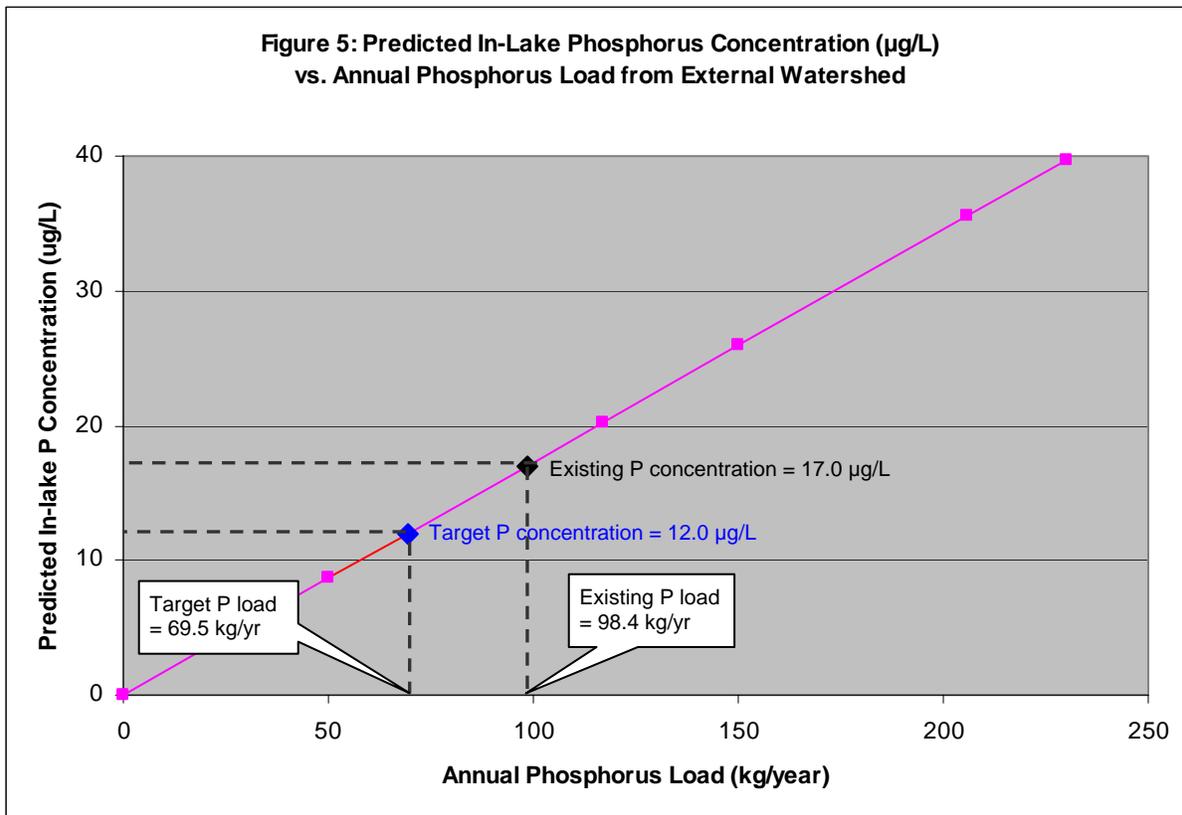
As shown in Figure 5, the Vollenweider equation predicts that the lake's phosphorus load would need to be reduced by 28.9 kg/year in order to achieve the recommended in-lake phosphorus concentration reduction of 5  $\mu\text{g/L}$ . It is important to note that the "existing" phosphorus load shown in Figure 5 has been estimated based on 1998 NHDES in-lake phosphorus measurements of 17  $\mu\text{g/L}$ . As previously discussed in Section 3.2, additional field investigations are required in order to refine the external phosphorus loading estimates from watershed land uses and septic systems. Section 4 provides a discussion of how the recommended phosphorus load reduction may be achieved.

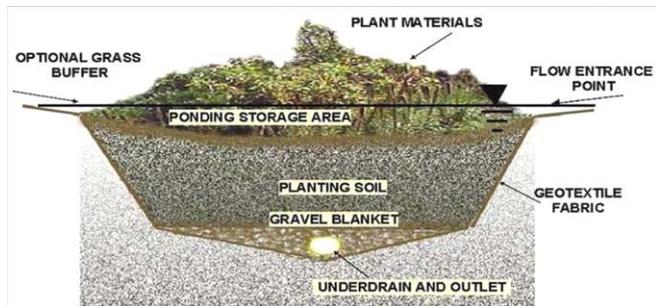
*A cross-section of a typical  
bioretention cell.*

Storm water that drains into a bioretention cell accumulates in a shallow depression and infiltrates the engineered soil mixture. Bioretention cells are typically designed to provide an infiltration rate approximately equal to the peak discharge rate associated with the 10-year, 24-hour storm event. Infiltration rates are enhanced during the growing season by uptake from vegetation (i.e., evapotranspiration) within the cell.

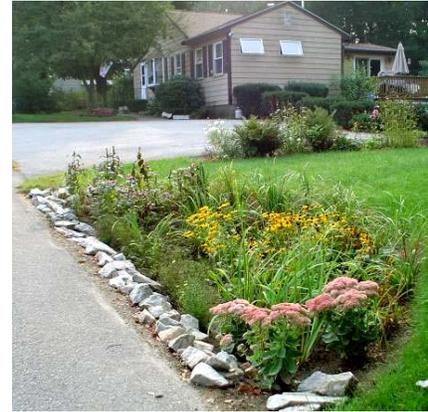
*A rain garden installed on a residential property.*

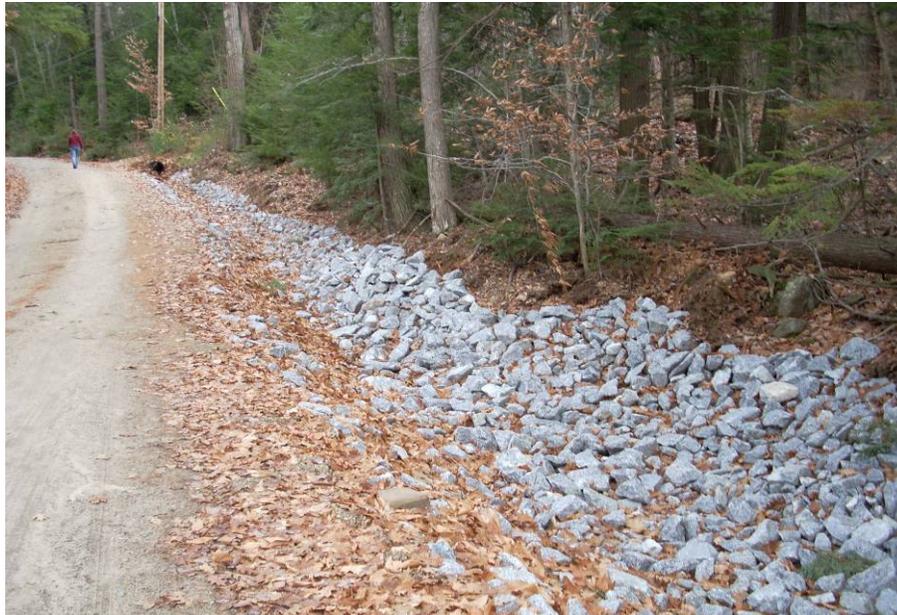
*A stone-filled infiltration trench constructed to intercept runoff from the adjacent unpaved road in the Silver Lake watershed (Harrisville, NH).*

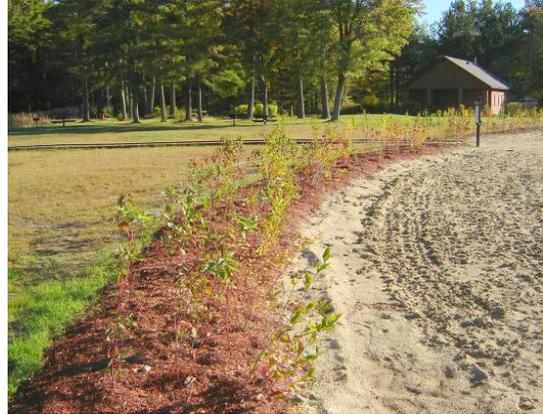
*A newly planted shrub buffer installed adjacent to the Lake Wyola State Park beach in Shutesbury, MA.*

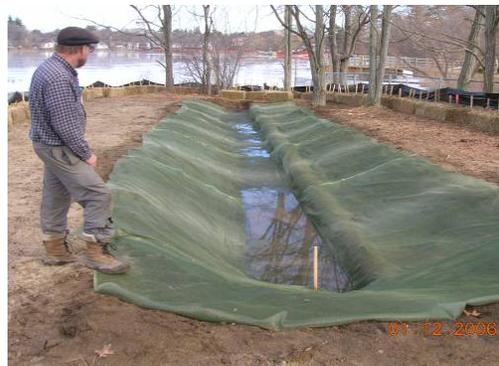
*Installation of turf reinforced mat (TRM) for a vegetated swale.*

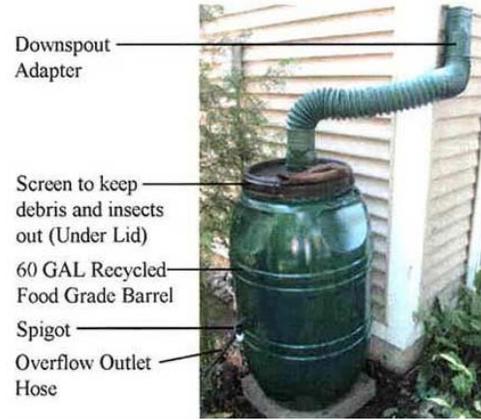
*A typical rain barrel application.*

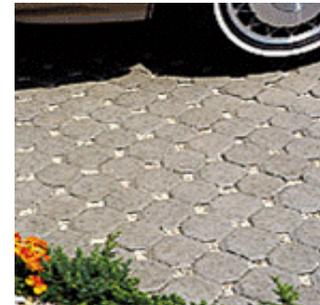
*Uni Eco-stone porous interlocking pavers*

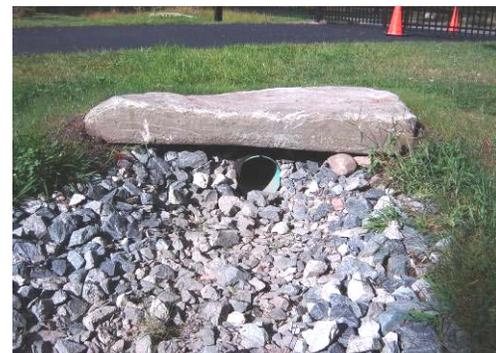
*Rip-rap used to protect and stabilize a culvert inlet.*

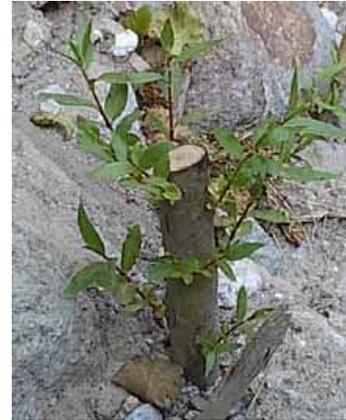
*Live stakes of quick-rooting tree and shrub species can be used to stabilize and establish vegetation on eroding slopes.*

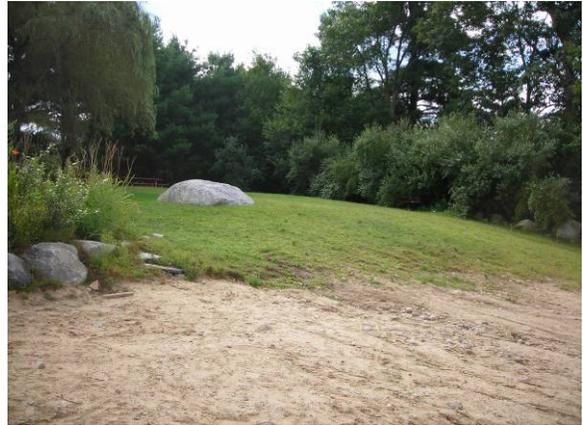
Photo # 1-1

The Four Seasons Community owns a private park area on the southeast corner of the Lake. Storm water runoff from vegetated portions of the site discharges overland onto the park's beach area (Photo 1-1). A portion of this vegetated area, between the boat ramp and the stairs, is vegetated with grass and slopes toward the Lake (Photo 1-2). Canada geese and goose feces were observed in this area during the field investigation. Erosion was observed immediately down gradient of this sloped area (Photo 1-3). The private beach area is used for swimming and boating by residents of the Four Seasons development.

Geosyntec recommends installation of a vegetated buffer strip along the slope, between the stairs and the boat ramp. The buffer strip would deter geese from accessing the area. The buffer would also filter storm water runoff from the upgradient areas prior to draining onto the beach and into the lake. The buffer strip would include:

- Soil amendments to ensure an adequate growth media for planted shrubs.
- A mixture of herbaceous and shrub plantings to create a visual and physical barrier to deter geese from accessing the grassed area. This would help reduce the amount of goose droppings and associated pollutants introduced to the beach area.
- In addition, improvements may include beach nourishment along the toe of the slope to reduce the erosion that has been caused by storm water runoff.

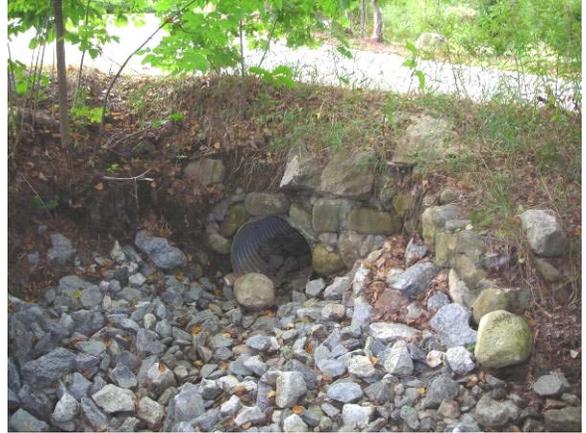
Photo # 2-1

Storm water runoff from Four Seasons Lane in the area of the park entrance drains into a road side ditch that discharges through a culvert under Sheridan Way (Photo 2-1) The culvert discharges into an unnamed tributary located southwest of the intersection of Sheridan Way and Four Seasons Lane. Erosion and scour was observed at the culvert outfall (Photo 2-2). However, evidence of erosion and sedimentation was not observed in the stream channel down gradient of the outfall (Photo 2-3).

Geosyntec recommends that energy dissipation and a level spreader device be installed at the culvert outfall. Recommended improvements include:

- Install energy dissipation consisting of a rip-rap lined plunge pool to reduce erosion and provide protection at the outfall.
- Install a level spreader device to reduce flow velocities discharging from the culvert. The level spreader would convert channelized flows to non-erosive shallow concentrated flows.

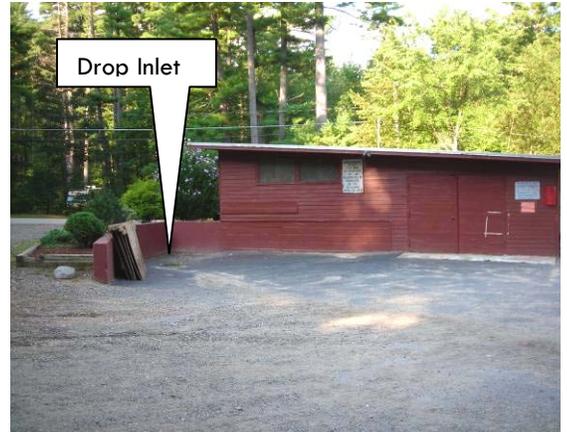
Photo # 3-1

The Amherst town beach is located in the southwest portion of the lake. Storm water runoff from the gravel town beach parking area is collected in a drop inlet structure located at the southeast corner of the bath house (Photo 3-1). The drop inlet structure discharges via a 12-inch diameter culvert to a drainage ditch along the north side of Broadway. The ditch also collects storm water runoff from Broadway and conveys these flows to an outfall located to the west of the town beach area (Photo 3-2). The outfall did not appear to be stabilized and erosion was observed at this location.

- Install a pre-fabricated bioretention cell (i.e., Filterra) at the drop inlet adjacent to the bath house. The cell would infiltrate storm water or discharge during large storms via the exiting culvert. An educational kiosk could be installed to provide an educational component.

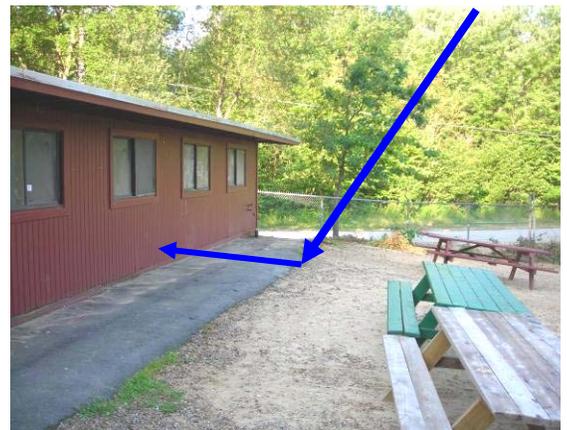
Photo # 3-3

Storm water runoff from the bath house roof discharges from the north side of the roof to the picnic area (Photo 3-3). Erosion was observed in the sand immediately down-gradient of the bath house.

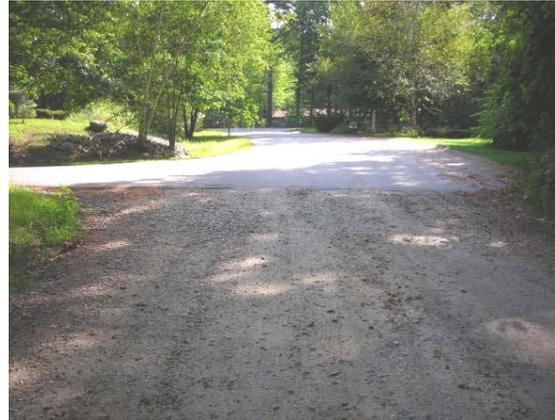
Photo # 5-1

Storm water runoff from the paved portions of Lakeview Drive (near the intersection of Surrey Lane) drains onto unpaved portion of Lakeview Drive (Photo 5-1). The runoff is collected in several drop inlet structures located along the edge of the unpaved road (Photo 5-2). At least two of these structures, in the area of Surrey Lane, discharge to an unnamed tributary that drains south toward the Lake. Sediment was observed in the unnamed tributary (Photo 5-3). Several other inlet structures appeared to be blocked with leaf litter and accumulated sediment.

- Additional BMPs to improve storm water quality include a maintenance program to clear drop inlet grates and clean accumulated sediment from the structure sumps.

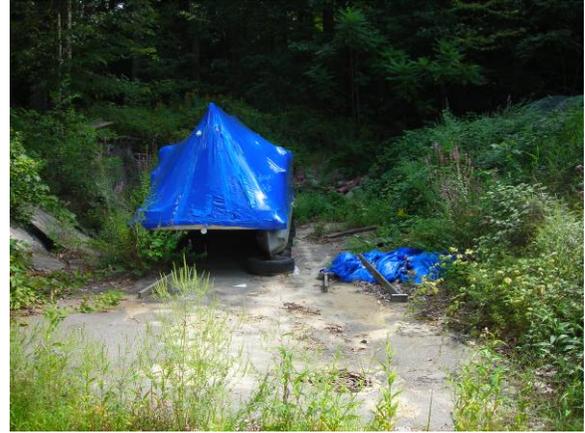
Photo # 6-1

Storm water runoff from the forested area to the north of Lakeside Drive drains onto an existing paved parking area (Photo 6-1). These flows are primarily collected in a drop inlet structure located in the paved area (Photo 6-2). The structure apparently drains into a second drop inlet structure located on the north side of Lakeside Drive (Photo 6-3). This structure also receives storm water runoff from a portion of the unpaved Lakeside Drive. The structure discharges via a culvert directly to the lake.

- Replace the existing impervious asphalt parking area with pervious porous-pavers. This would promote infiltration and reduce the volume of storm water runoff that is collected in the drop inlet structure and discharged to the lake.
- Install a pre-fabricated bioretention cell (i.e., Filtterra) to replace the existing drop inlet structure on the north side of Lakeside Drive. The bioretention cell would overflow during large runoff events via the existing culvert that drains into the lake.

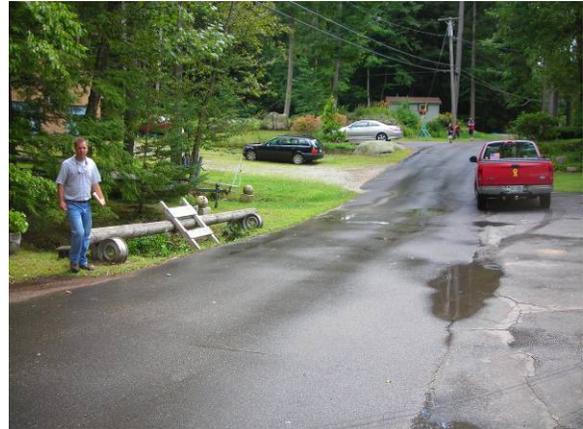
Photo # 7-1

Storm water runoff from Jebb Road in the area of house #17 drains via overland flow to a low-point in the road (Photo 7-1). The runoff then drains into a small depression located along the east side of Jebb Road (Photo 7-2). The small depression also receives flows from two culverts that apparently drain other portions of Jebb Road. The depression drains via a small diameter culvert to the west, directly to the lake (Photo 7-3).

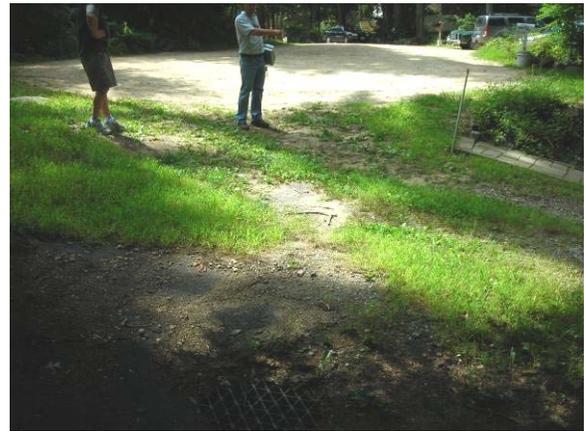
Photo # 8-1

Storm water runoff from the northern end of Lakeside Drive (in the area of house #30) drains via overland flow to the north (Photo 8-1). The runoff is collected in a drop inlet structure located to the north of Lakeside Drive adjacent to the driveway to house #30 (Photo 8-2). The drop inlet appears to discharge via the Lakeside storm drain system directly to the lake (Photo 8-3).

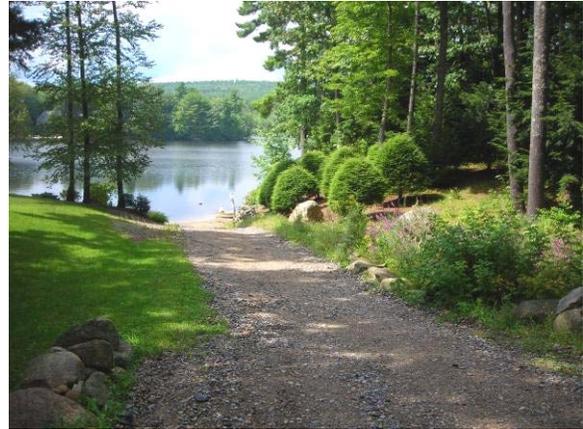
Photo # 9-1

Paul's boat ramp is a private boat ramp located on along the east shore of the lake near 310 Baboosic Lake Road (Photo 9-1). Storm water runoff from the unpaved road leading to the boat ramp drains via overland flow toward the lake (Photo 9-2). Erosion was observed in the ramp area. Accumulated sediment from erosion of the up-gradient portions of the unpaved road was also observed (Photo 9-3).

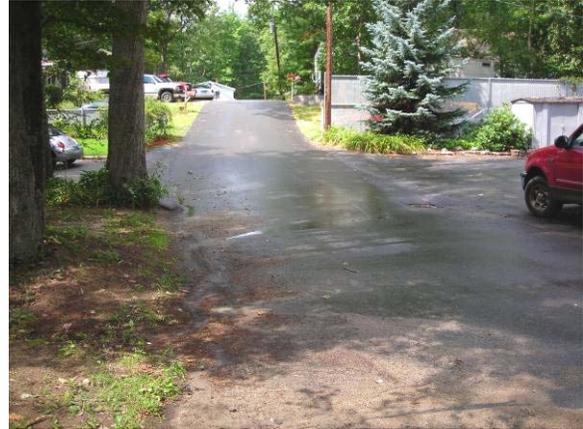
Photo # 10-1

Storm water runoff from portions of North Jebb Road near the intersection with Jebb Road is collected in drop inlet devices (Photo 10-1). The drop inlet device along the east side of North Jebb Road discharges via a culvert to a drop inlet along the west side of the road (Photo 10-2). This drop inlet discharges to the lake via the Jebb Road storm water system. The westernmost drop inlet structure was buried in accumulated sediment and leaf debris (Photo 10-3).

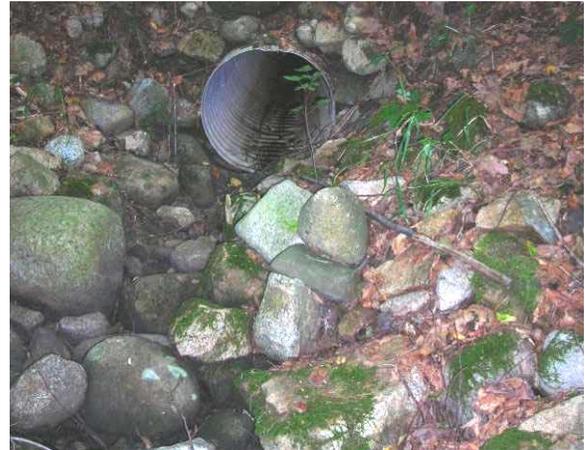
Photo # 13-1

Storm water management associated with Autumn Lane generally consists of a series of vegetated swales that drain to a culvert under Autumn Lane. The culvert discharges these flows into an undefined channel that drains into a wetland area prior to discharging to the lake (Photo 13-1). Severe erosion was observed in the unstabilized channel immediately down gradient of the culvert outfall (Photo 13-2). Sediment was observed in the lower reach of the channel in the location of the wetland (Photo 13-3). However, the wetland was densely vegetated and there did not appear to be evidence of erosion within the wetland area.

- Install energy dissipation and a level spreader device at the culvert outfall to reduce flow velocities.
- Construct a stepped rock-lined down chute between the culvert outfall and the down stream wetland system. Install a level spreader device at the outfall of the down chute at the wetlands. The down chute should be constructed using existing boulders as well as imported rock to create cascading plunge pools.

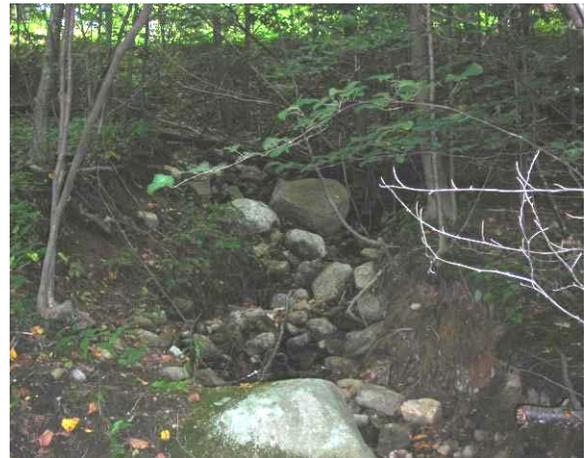
Photo # 13-2

In general, flows from the contributing watershed into the channel immediately down gradient of the Autumn Lane culvert can be characterized by high peak discharge rates. Storm water improvements made to the channel are end-of-pipe improvements that are not necessarily a long term solution. The long-term solution is to improve storm water management by increasing storm water storage volume within the watershed. The design should mimic pre-development flow conditions to reduce the peak discharge rates. These long term solutions may include LID techniques (as described in Section 2.0) distributed throughout the contributing watershed. However, immediate improvements are recommended to include:

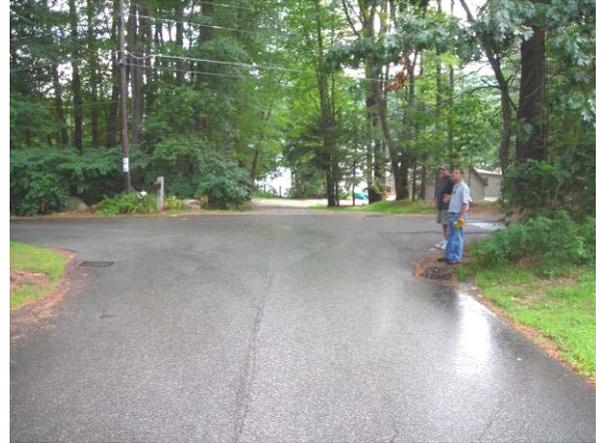
Photo # 14-1

Storm water runoff from portions of Carter Road (in the area of the intersection with Arnold Road) drain via overland flow toward the lake (Photo 14-1). The runoff is either captured in drop inlet structures or continues to flow overland onto the unpaved extension of Carter Road (Photo 14-2). These flows ultimately drain or discharge via a culvert to a rock-lined area adjacent to the lake (Photo 14-3). Some of the rock had been eroded and rills were observed in portions of this area.

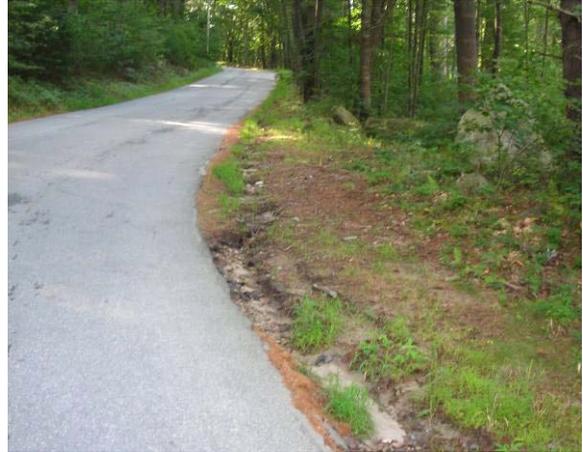
Photo # 15-1

Storm water runoff from the paved portions of Clark Road drain overland into an unlined channel along the south side the road (Photo 15-1). The channel was not stabilized and erosion was observed in portions of the channel, especially at the lower end of the channel (Photo 15-2). The channel drains into a beaver impoundment located on the south side of Clark Island Road. Accumulated sediment was observed at the channel outlet (Photo 15-3).

- Constructing a rock-lined storm water channel along the south side of Clark Island Road. The channel could be up to 3-feet wide and would consist of rock underlain by geotextile. The channel should be constructed with a proper outfall structure.
- Install energy dissipation at the channel outfall at the beaver impoundment.

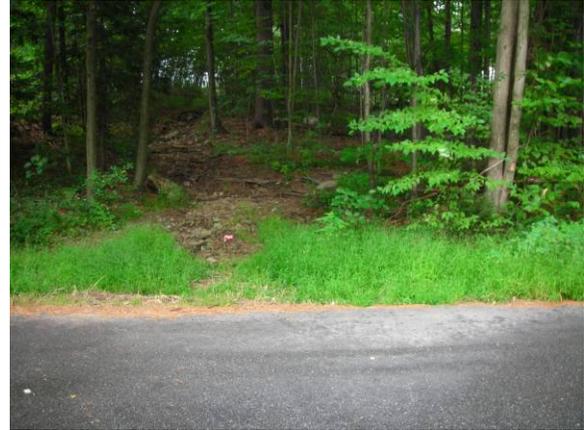
Photo # 16-1

A forested area located to the north of Shore Road drains west via an unstabilized intermittent channel (Photo 16-1). The channel discharges into a drainage ditch along the north side of Shore Road. The channel, which also receives road runoff, drains through a culvert to a drop inlet structure located in the southeast corner of house #20 (Photo 16-2). The drop inlet structure discharges via a culvert to an undefined drainage ditch along the paved driveway to house #20 (Photo 16-3).

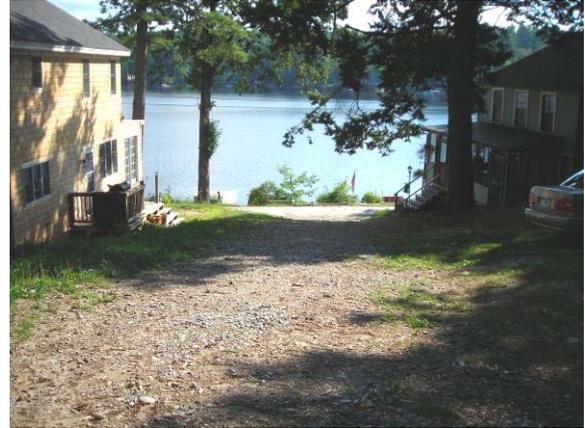
Photo # 17-1

Storm water runoff from unpaved portions of Hillside Road drain east via overland flow toward the lake (Photo 17-1). The runoff drains over the paved portion of Broad Street at the intersection (Photo 17-2). These flows discharge over a stone wall and through a vegetated buffer prior to entering the lake (Photo 17-3). The stone wall had been washed-out and repaired prior to the field investigation. Accumulated sediment was observed on the paved portion of Broad Street.

Recommended storm water improvements in the area of the intersection of unpaved Hillside Road and paved Broad street include:

**Estimated Cost:** \$14,000 to \$18,000

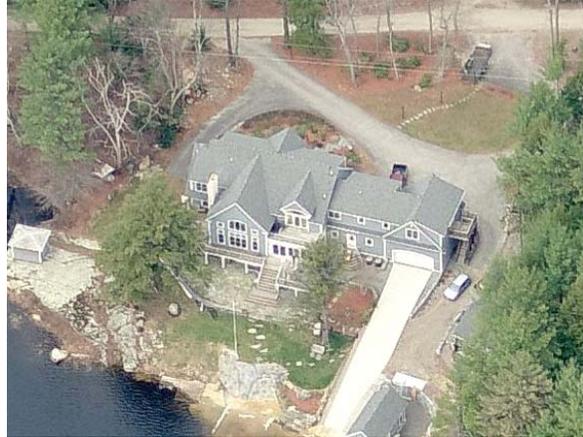
*Landscaping fertilizers from grassed lawns, such as this property adjacent to Baboosic Lake, can be a significant source of phosphorus to water bodies.*

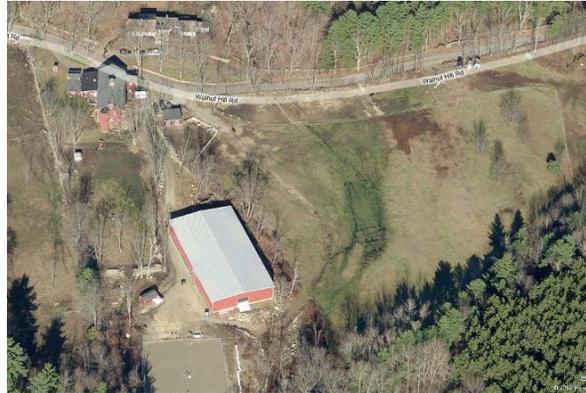
Farms, such as the Walnut Hill Road property shown above, may qualify for additional assistance for the installation of stormwater management features.

Install additional fencing and buffer plantings at priority locations such as farms located on tributaries and wetlands draining to Baboosic Lake.

- Conduct a detailed nutrient management assessment related to all agricultural activities in the Baboosic Lake watershed. This assessment could involve a development of more accurate nutrient runoff estimates, based on field sampling and a site-by-site assessment of ongoing practices related to nutrient management, manure/fertilizer application, the number of livestock on site, etc.
