# Cobbett's Pond Watershed Restoration Plan

Final Draft: July 6, 2010

### **Cobbett's Pond Improvement Association**

**Geosyntec**  
consultants

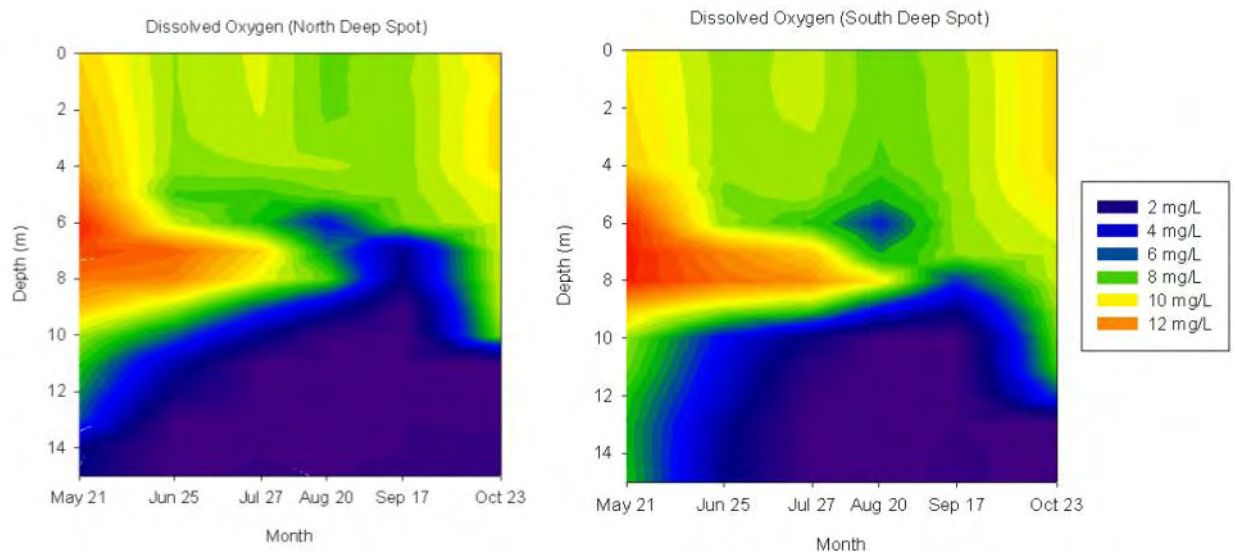
**Figure 5.** 2009 Dissolved Oxygen profiles for the North and South Deep Spot sampling locations.

As shown in Figures 5 and 6, Cobbett's Pond undergoes a typical summer thermal stratification. As the summer progresses, DO within the hypolimnion becomes progressively depleted due to decomposition of organic material in the sediment. By October, cooler temperatures eliminate the density barrier that exists during summer stratification, allowing DO to once again mix into the hypolimnion. A distinct increase in DO concentrations was observed in the metalimnion during the late spring/early summer months of 2009, possibly caused by abundant phytoplankton settling and collecting above the denser waters of the hypolimnion and releasing oxygen through photosynthesis.

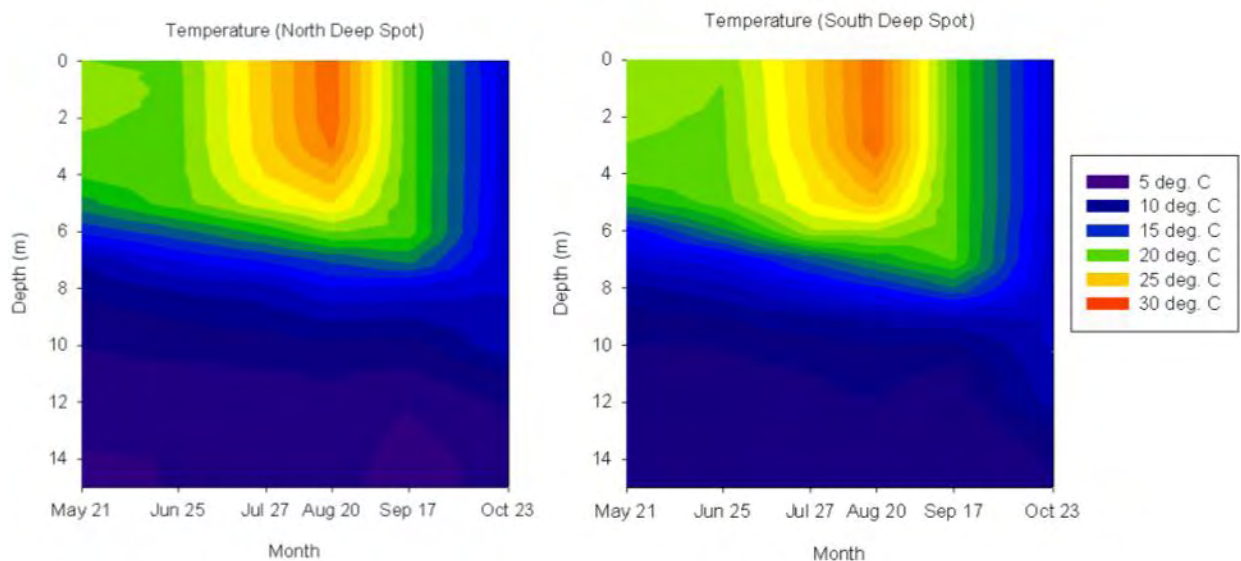
**Figure 6.** 2009 temperature profiles at North and South Deep Spot sampling locations.

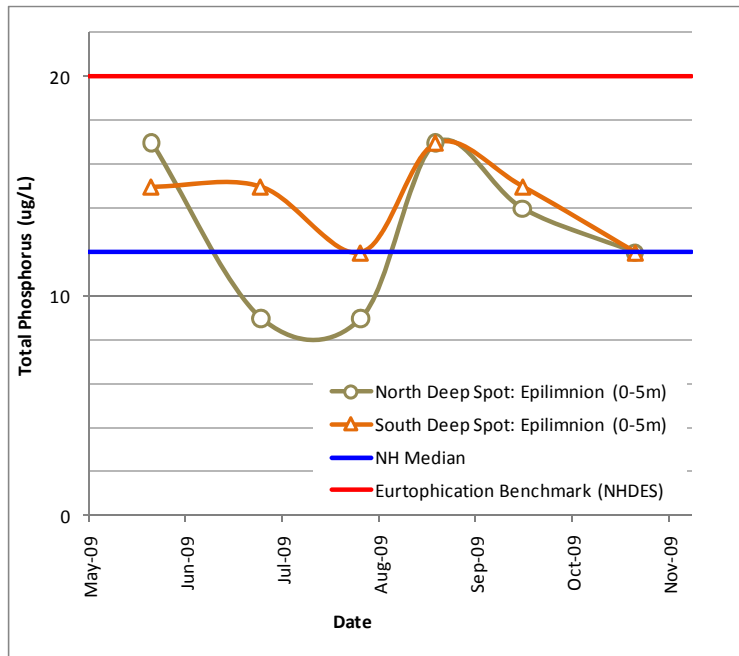
As shown below in Figure 7, TP concentrations in the South Deep Spot epilimnion (surface waters, 0-5m) were at or above the state median on all six sampling dates. The North Deep Spot epilimnion was at or above the state median on four dates and below the median on two dates.

Figure 7. Epilimnion total phosphorus concentrations at the deep spot sampling locations.

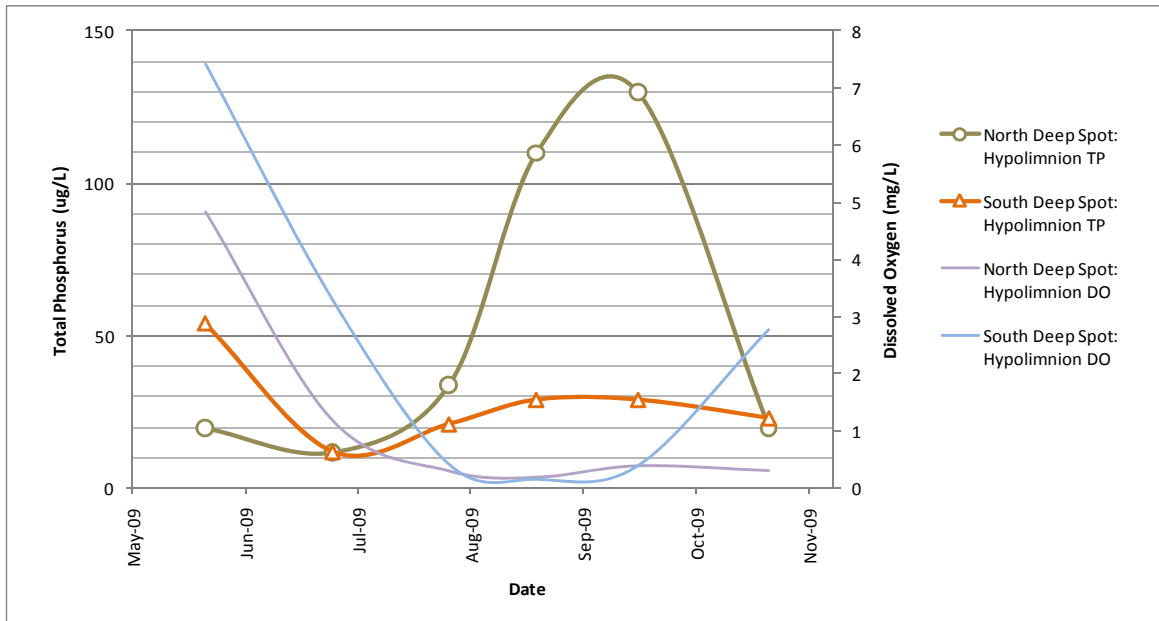
Elevated TP concentrations at the North Deep Spot hypolimnion indicate that anoxic (oxygen depleted) conditions are causing phosphorus normally bound to lake sediments to be released into the water where it can fuel algae growth. This process is known as internal phosphorus loading. Figure 8 shows a dramatic pulse of phosphorus being released at the North Deep Spot hypolimnion as the summer progresses. Although similar anoxic conditions existed at the South Deep Spot during August and September 2009, hypolimnetic phosphorus concentrations were elevated rather modestly in comparison to the North Deep Spot.

Figure 8. Hypolimnion total phosphorus and dissolved oxygen at the deep spot sampling locations.

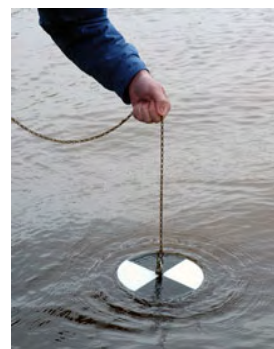
The **Secchi disk** is a weighted black and white disk that is lowered into the water by a calibrated chain until it is no longer visible. This method provides a measure of water clarity (light penetration), which is primarily a function of algal productivity, water color, and turbidity caused by suspended particulate matter. Water clarity influences the growth of rooted aquatic plants by determining the depth to which sunlight can penetrate to the lake sediments.

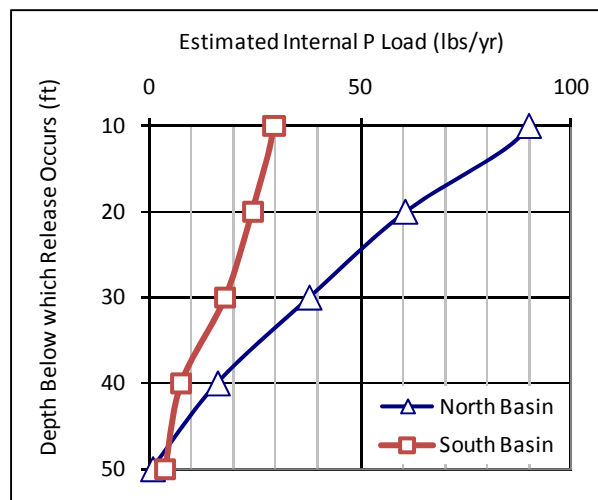
Figure 17. Estimated Internal Phosphorus Load from the Cobbett's Pond North and South Basins

For this study, Geosyntec only measured dissolved oxygen at two deep spot locations within the lake. As such, the extent to which the pond's sediments are exposed to anoxia could not be accurately defined. Geosyntec calculated an internal load for scenarios where differing areas of sediment contribute to the internal phosphorus release. Figure 17 below shows the internal load in each basin for varying depths below which sediment P is released. As a low estimate, assuming that sediments at depths greater than 40 feet release phosphorus under anoxic conditions, approximately 24 lbs P/yr could be released. At the other extreme, assuming that all sediments at depths greater than 10 feet release phosphorus under anoxic conditions, approximately 120 lbs P/yr could be released. The actual annual internal load is most likely somewhere between these two estimates, possibly in the range of 60 to 80 lbs P/yr. A more refined estimate could be determined through additional future sampling and monitoring, including mapping the spatial extent and duration of anoxia during the stratified months.

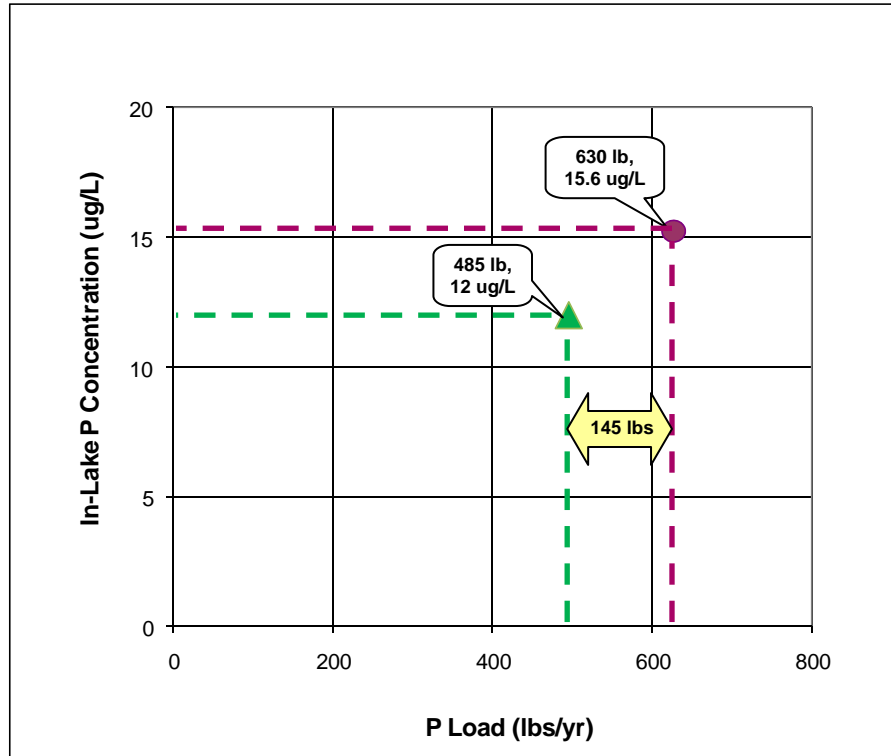
Figure 20. Vollenweider Plot for Cobbett's Pond

As shown in Figure 8, the Vollenweider equation predicts that the lake's phosphorus load must be reduced by 145 lb P/yr in order to achieve the recommended target in-lake phosphorus concentration of 12 µg/L. The recommended P load reduction represents approximately 20% of the estimated annual phosphorus load for the pond. Section 5 provides a discussion of how the recommended phosphorus load reduction may be achieved.

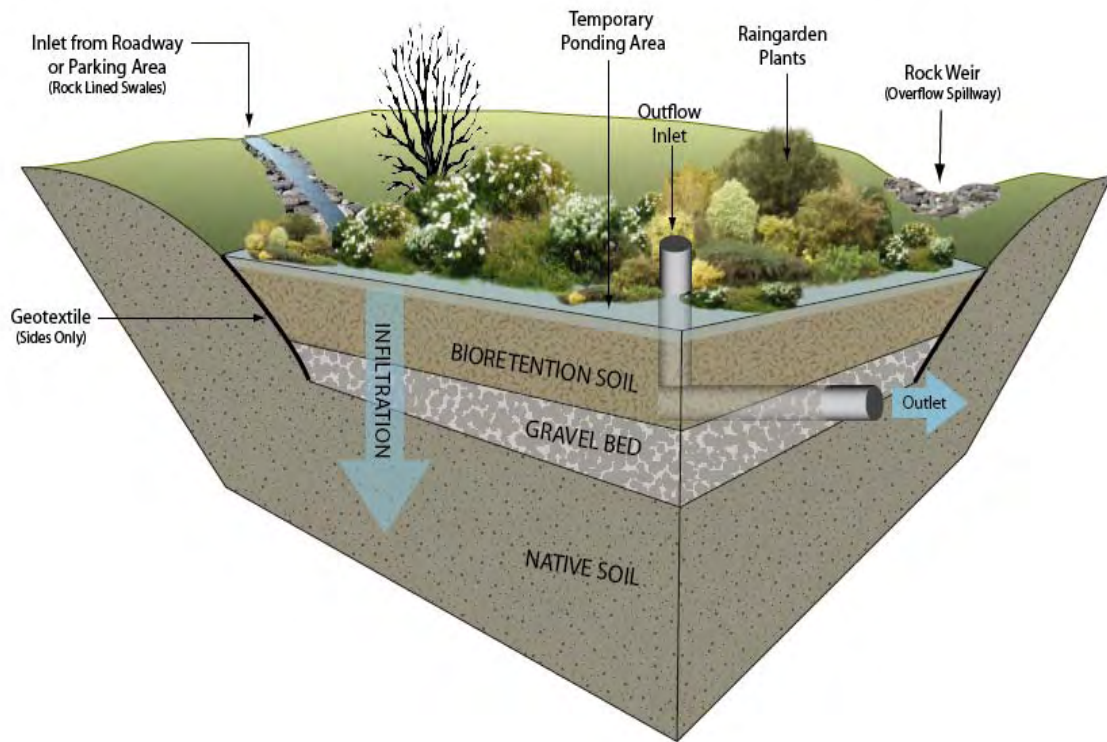
Figure 21. Cross-section of a typical bioretention cell with a riser pipe and outlet connection.

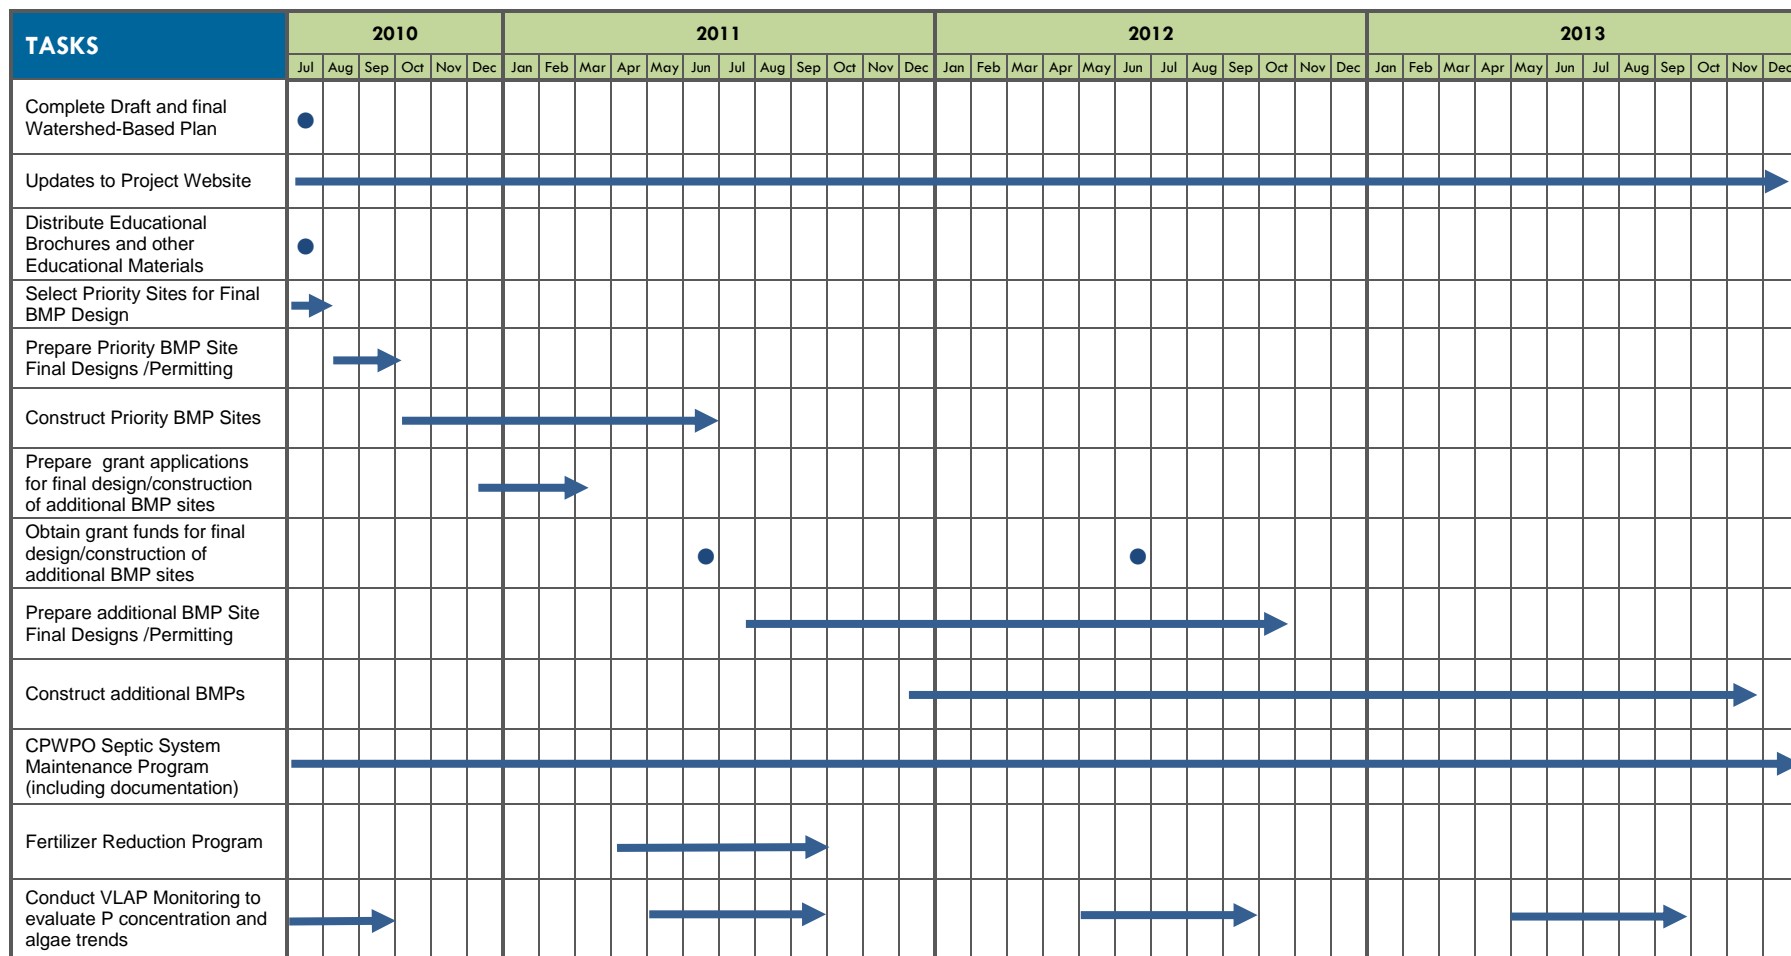
**Figure 23. Cobbett's Pond Watershed Restoration Plan - Implementation Schedule and Interim Milestones**

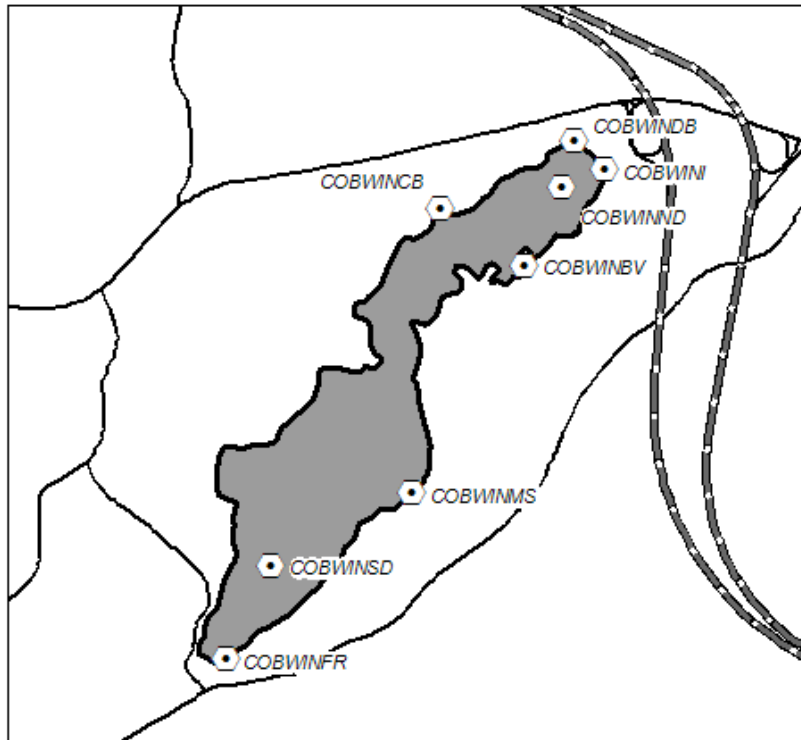
Figure 1. Sampling Location map with NHVLAP IDs.

Figure 1 and Table 1 below show the monitoring locations and their identification codes. Figure 2 shows the results of water quantity monitoring at the tributary locations, along with a plot of precipitation intensity. Figure 3 presents the results of in-situ water quality profiles at the in-lake deep spot monitoring locations, and Tables 3 and 4 provide further water quality monitoring results. A brief description of the various parameters measured in this study is provided at the end of this document.

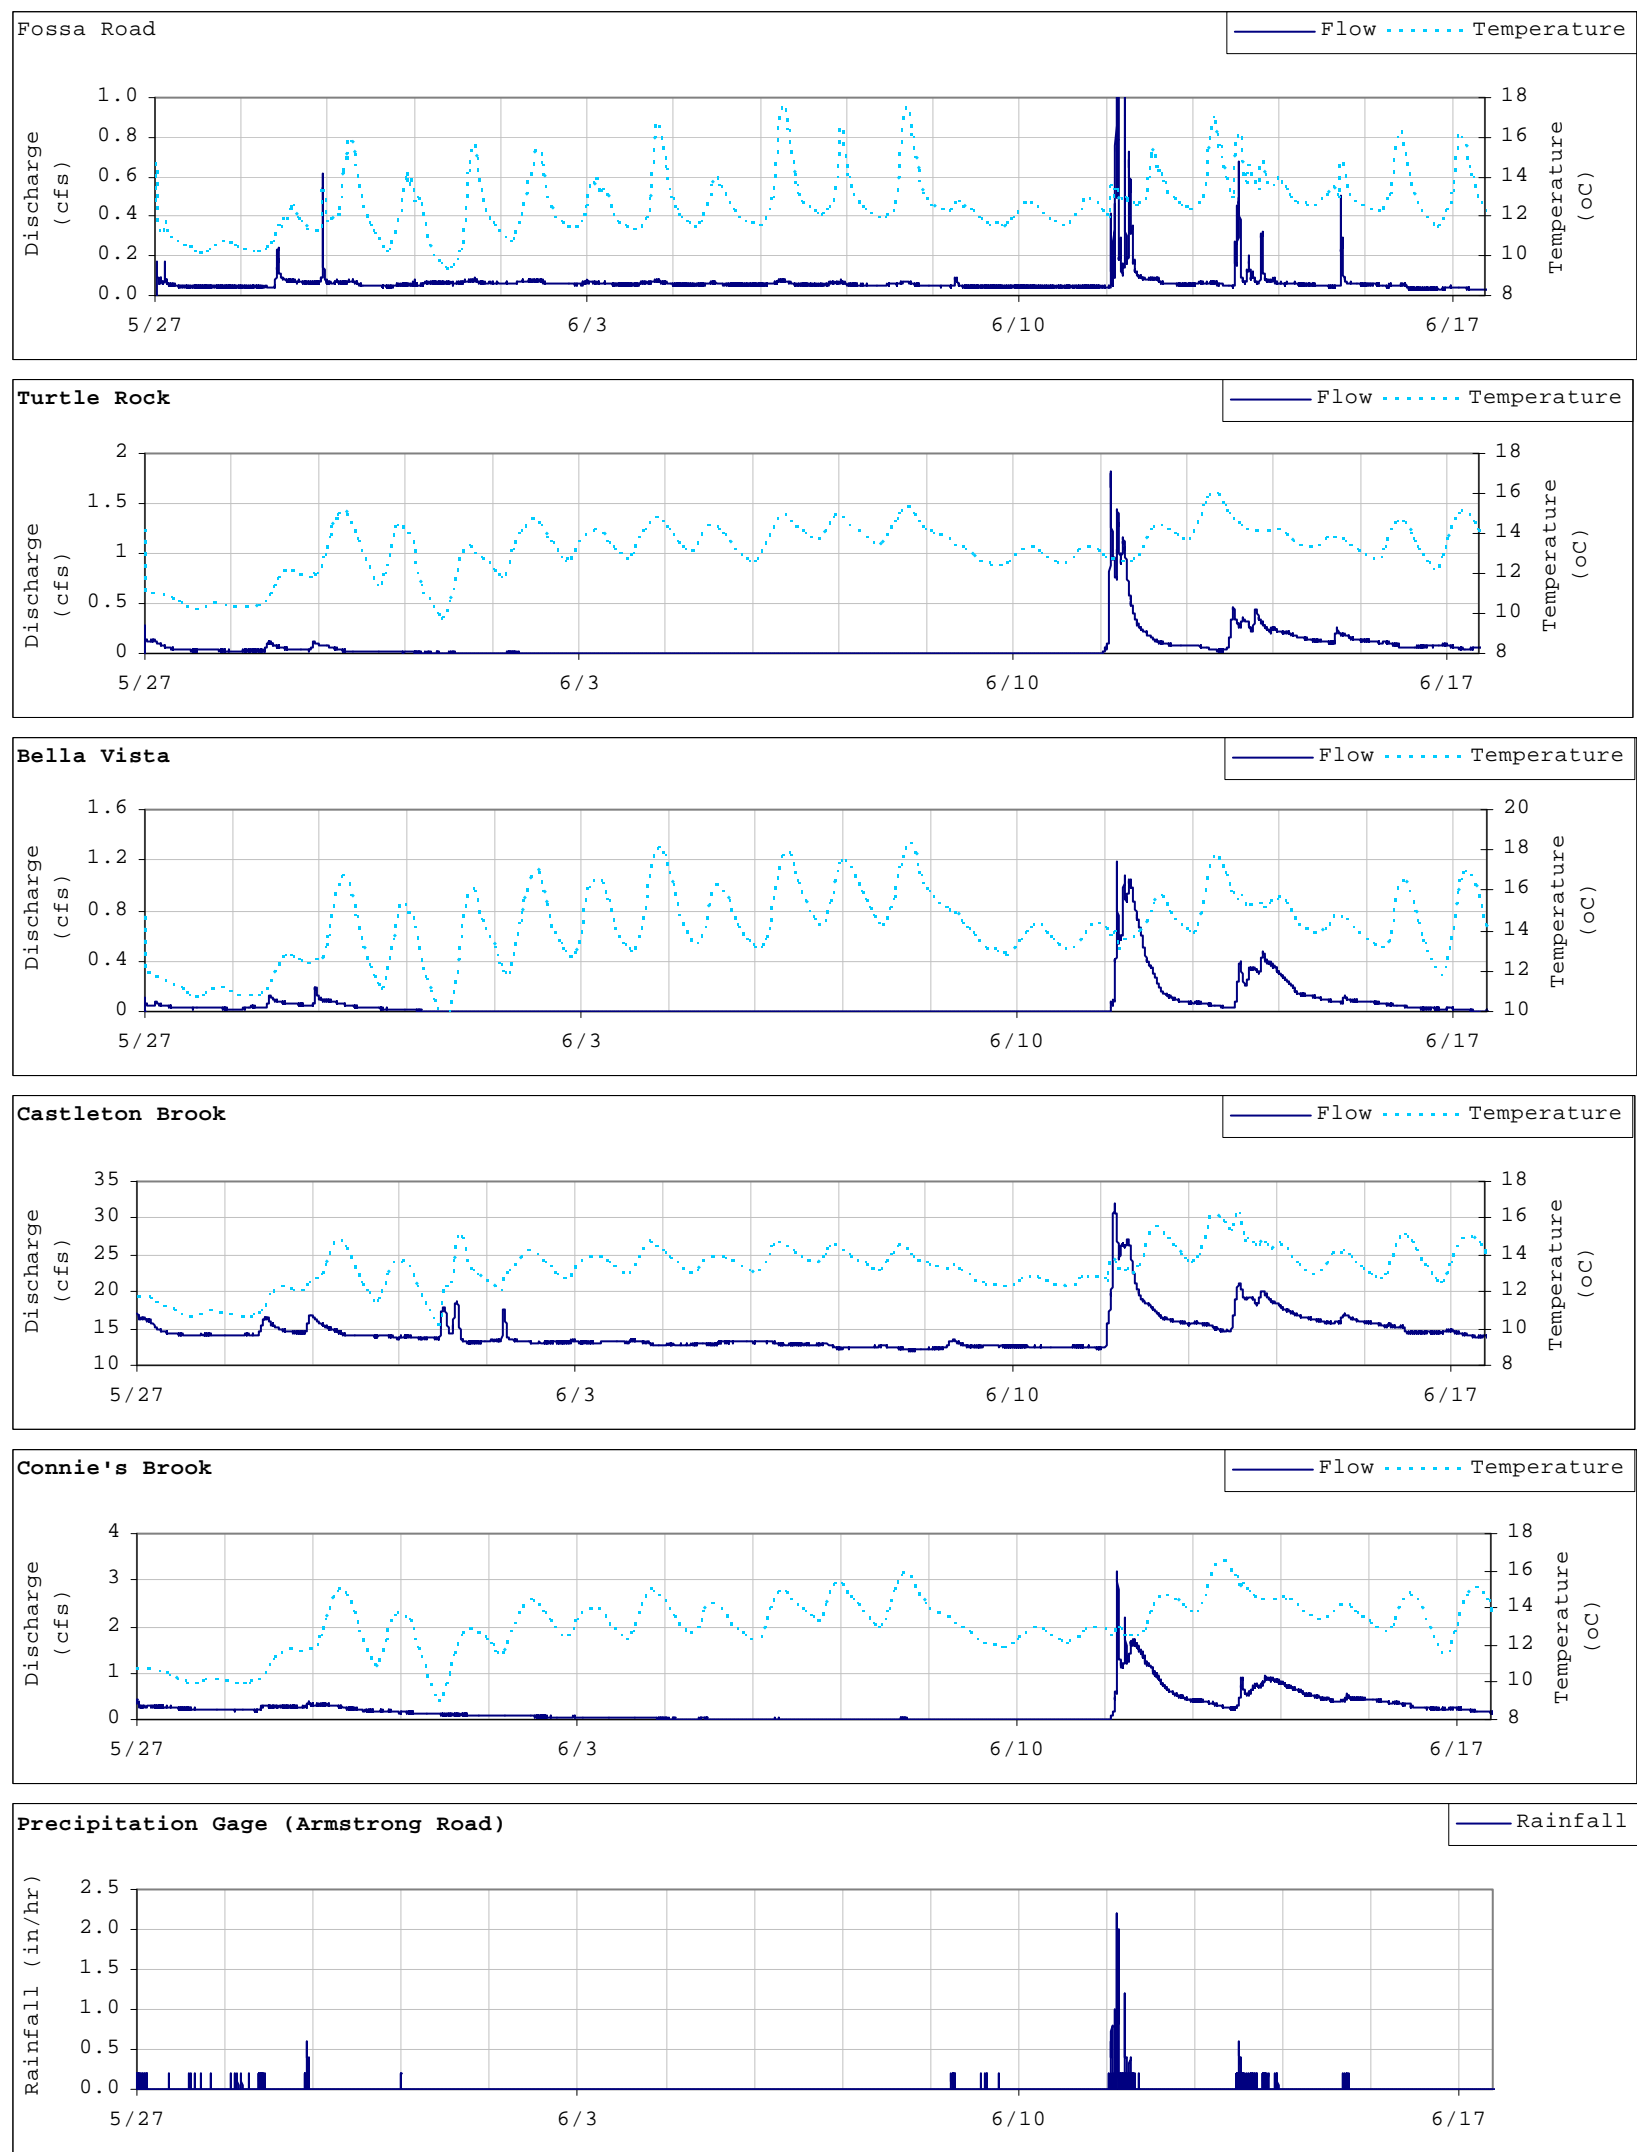
Figure 2. Discharge and Temperature monitoring for Cobbett’s Pond Tributaries (5/27/2009-6/18/2009)

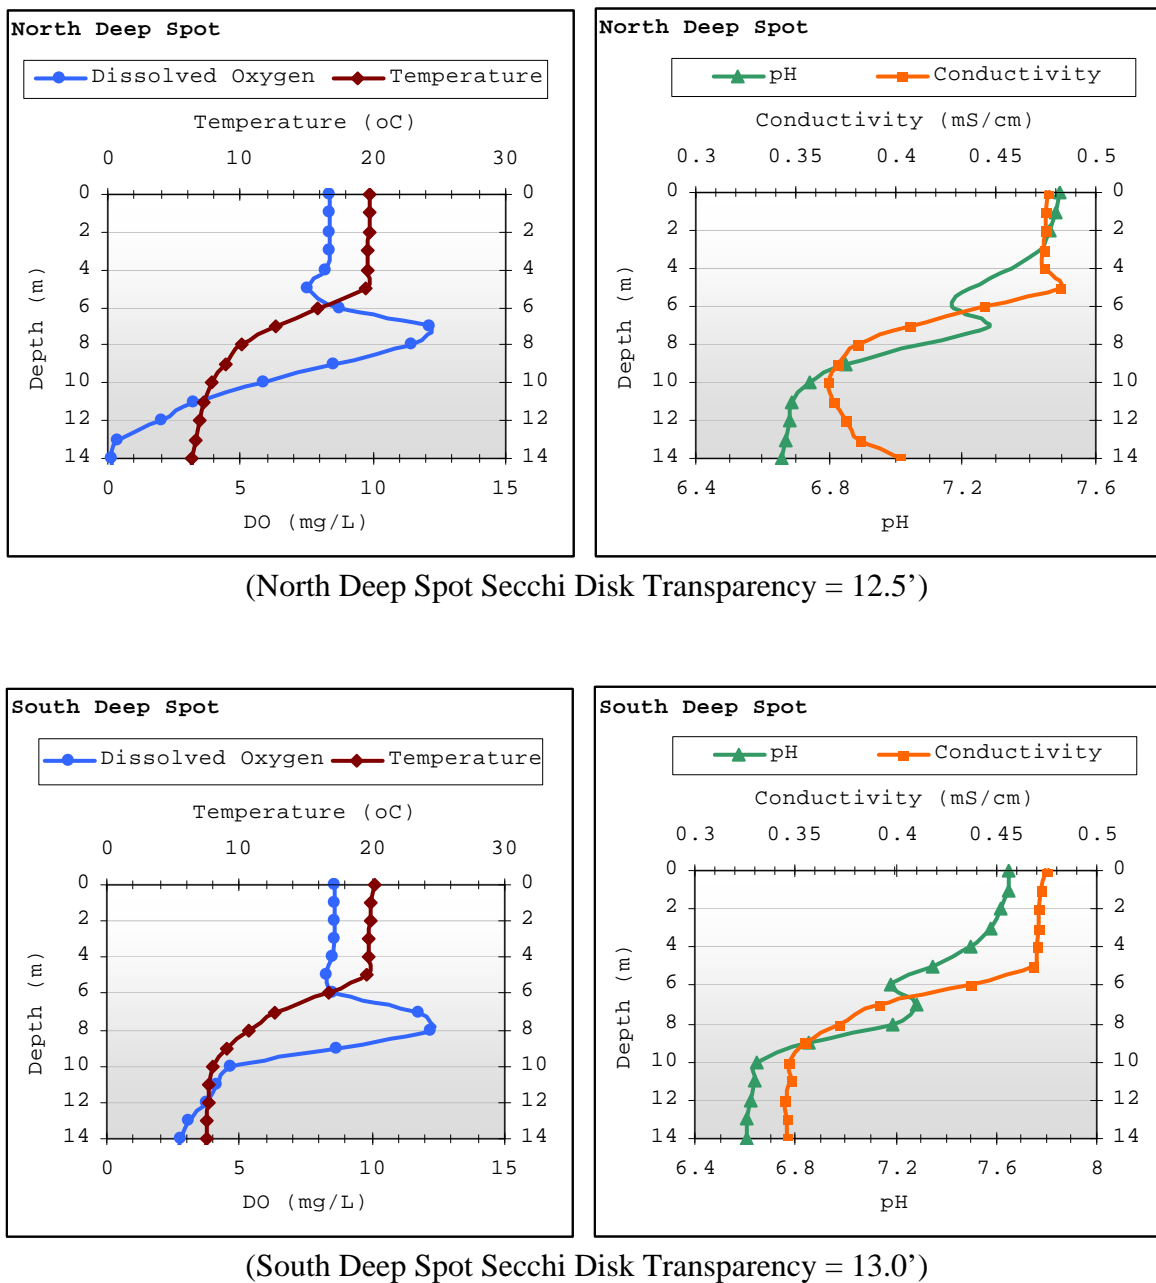
Figure 3. Deep Spot location water quality profiles (6/25/2009)

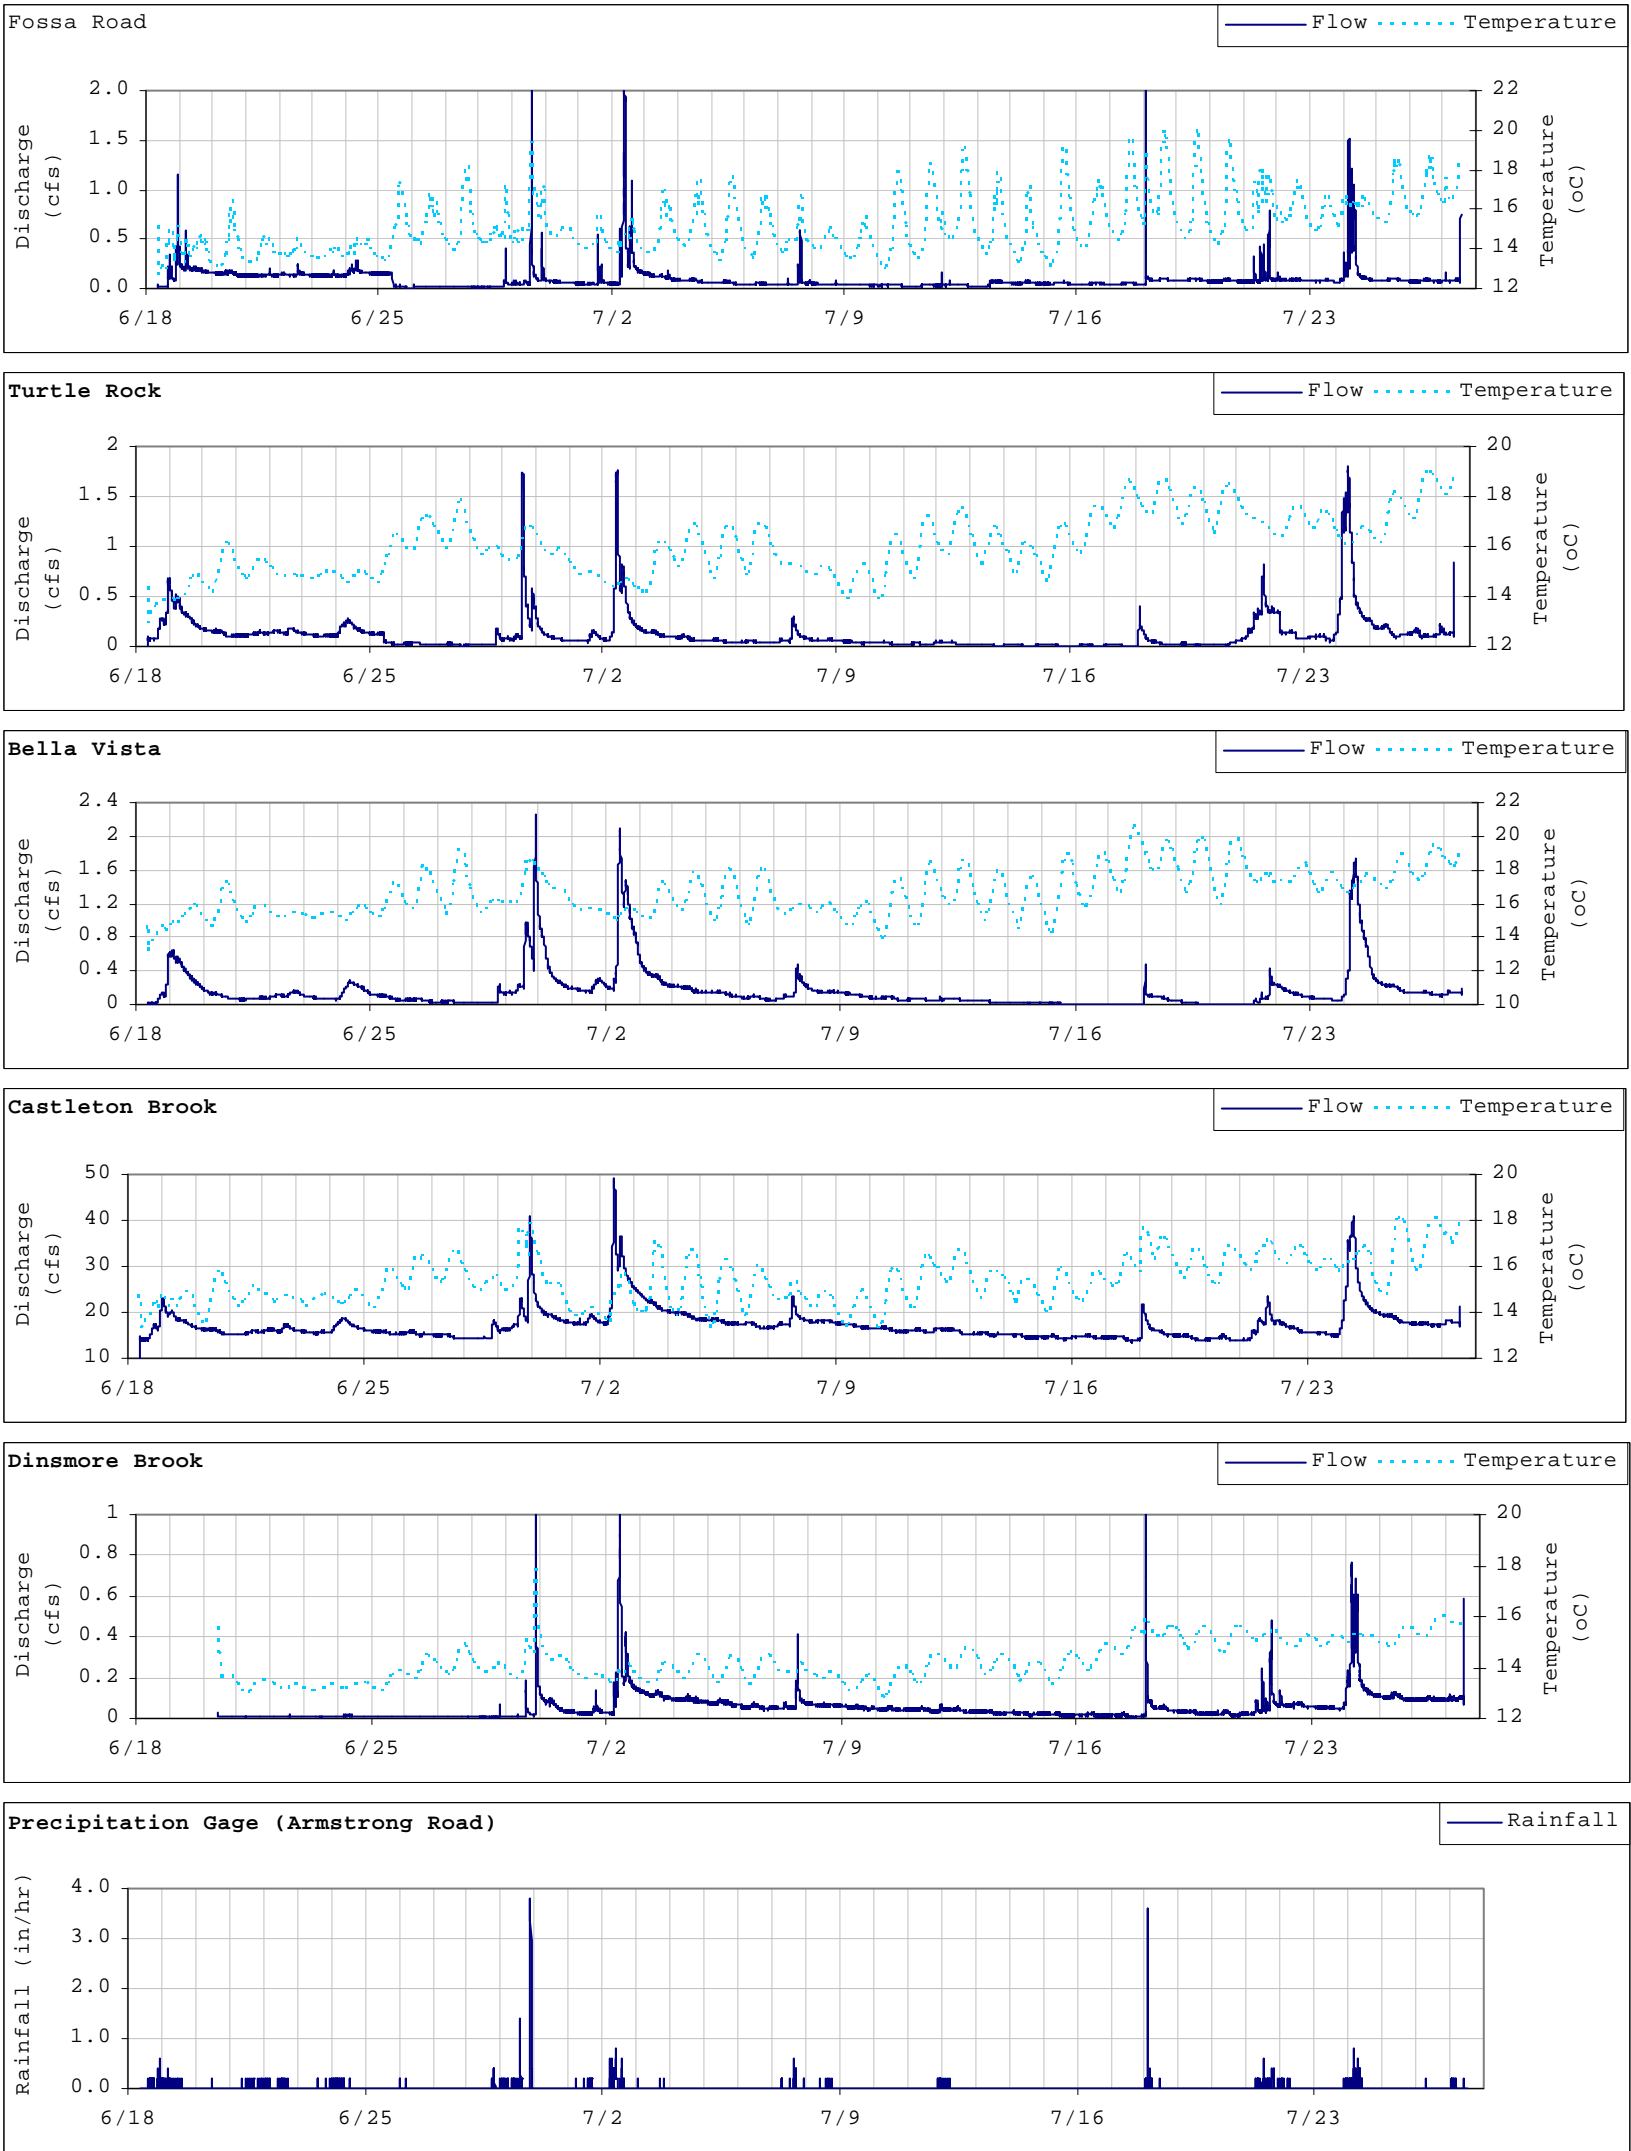
Figure 2. Discharge and Temperature monitoring for Cobbett’s Pond Tributaries (6/18/2009-7/27/2009)

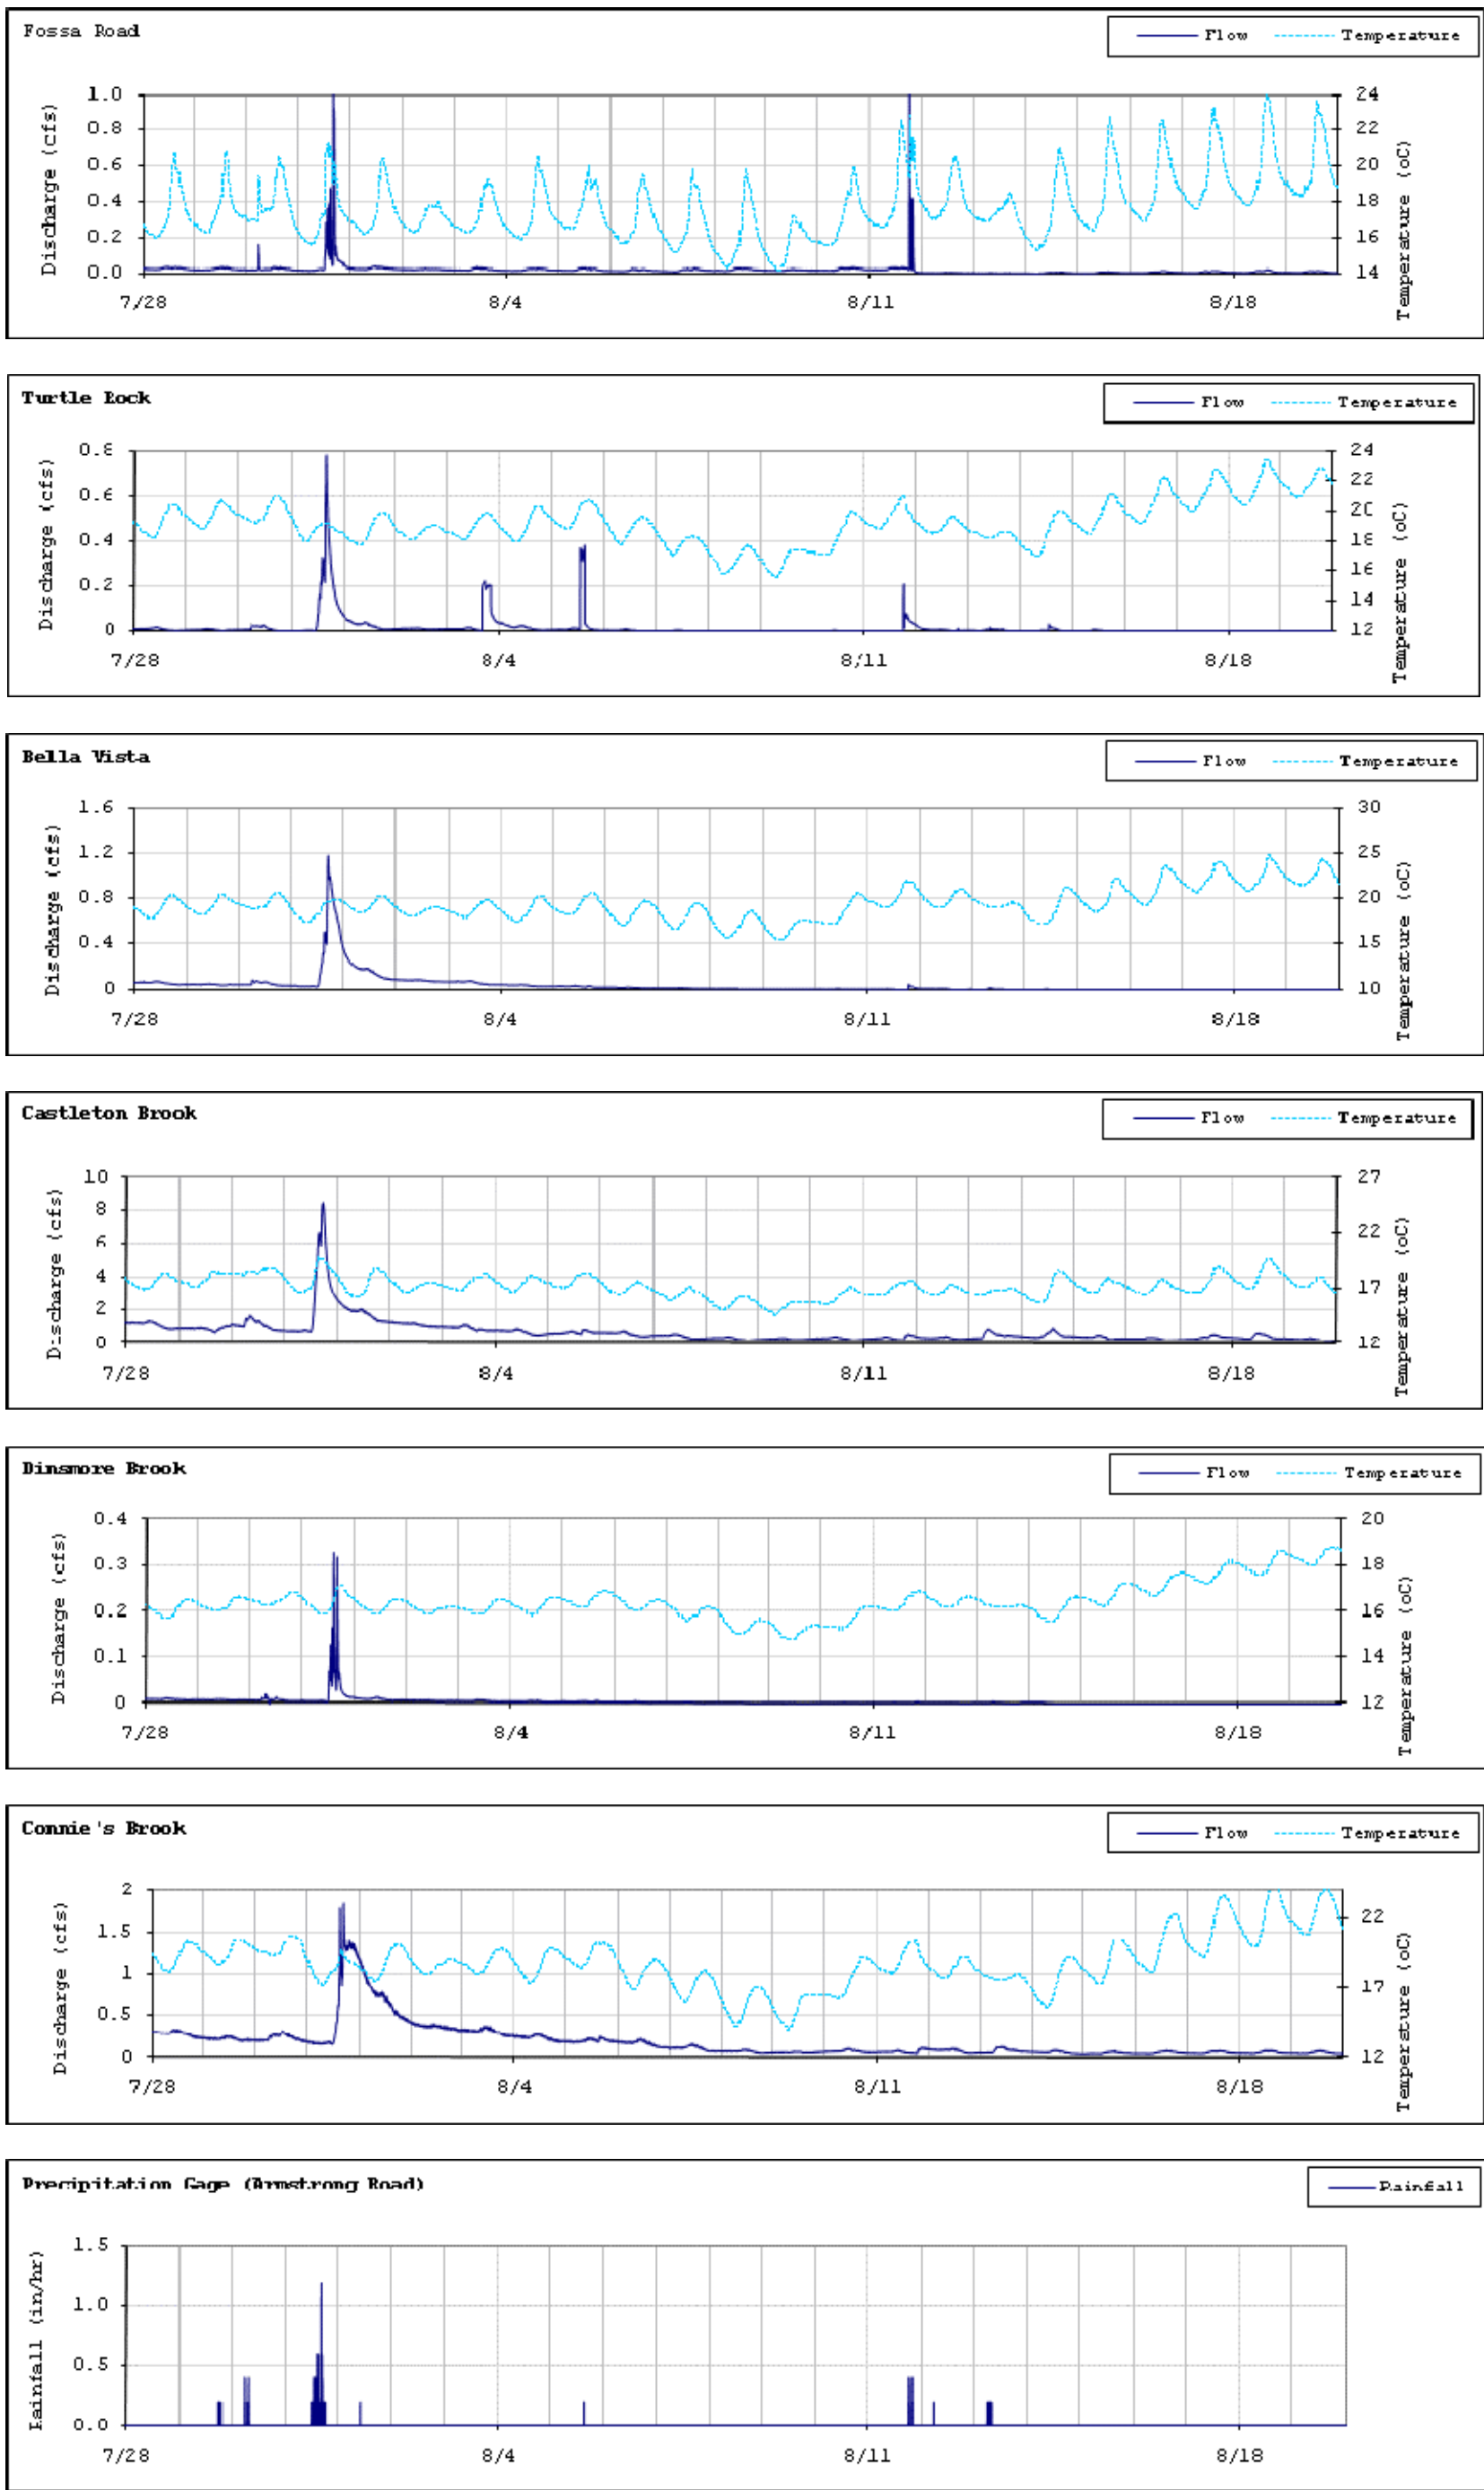
Figure 2. Discharge and Temperature monitoring for Cobbett’s Pond Tributaries (7/27/2009-8/20/2009)

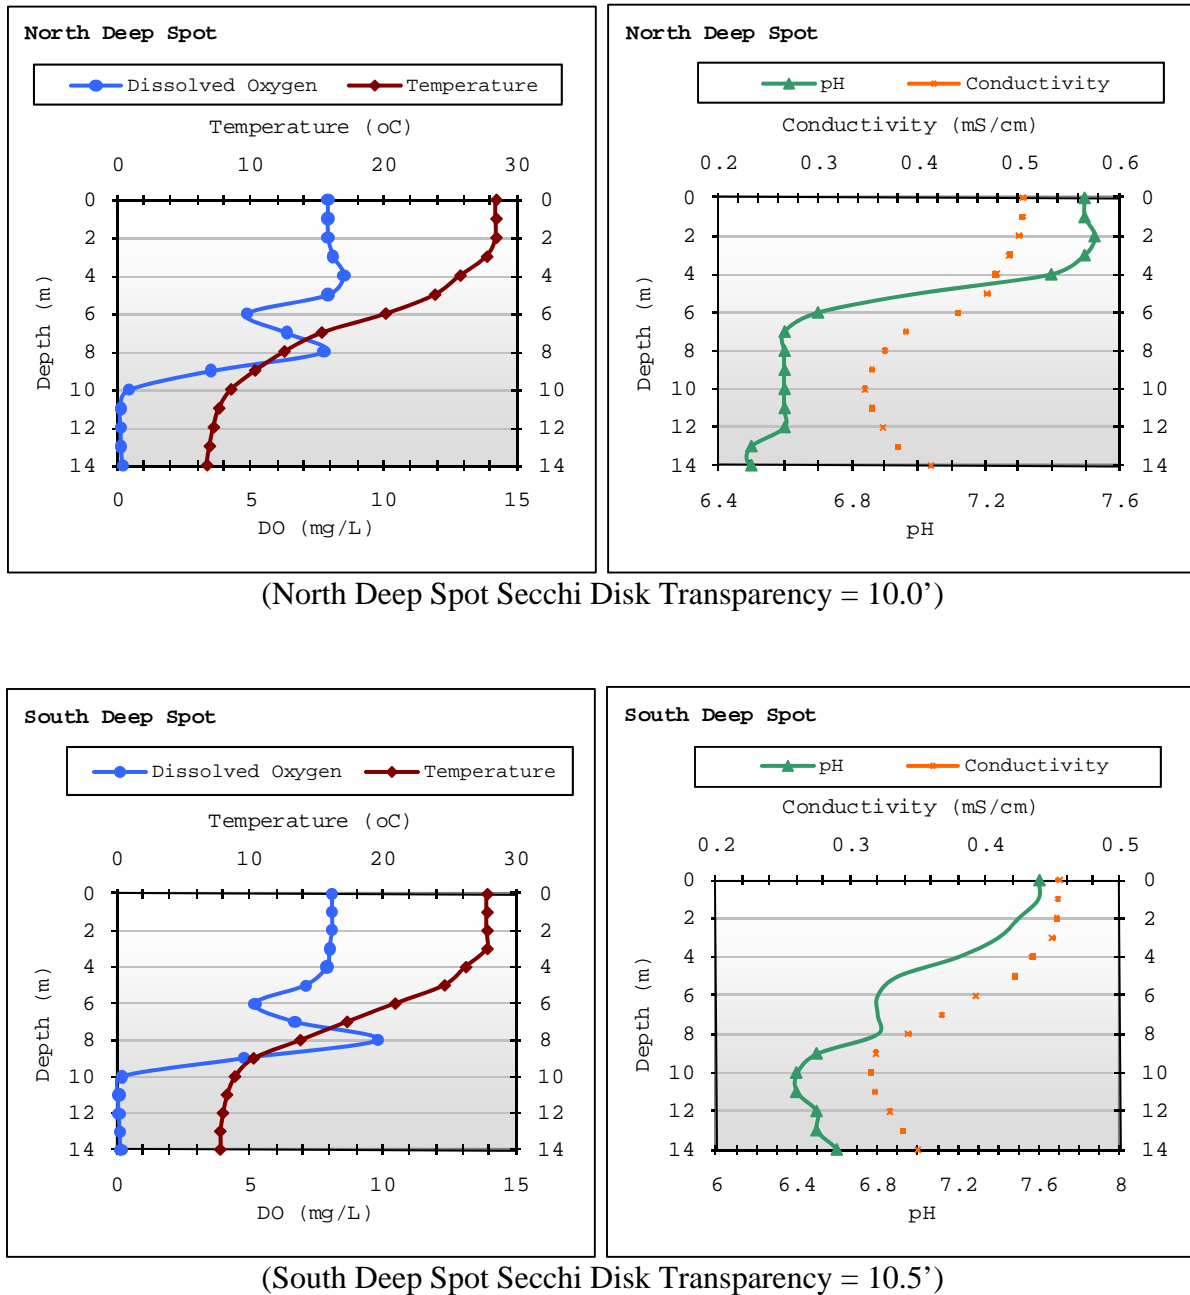
Figure 3. Deep Spot location water quality profiles (8/20/2009)
