# Cobbett's Pond Watershed Restoration Plan

Final Draft: July 6, 2010

### **Cobbett's Pond Improvement Association**

**Geosyntec**  
consultants

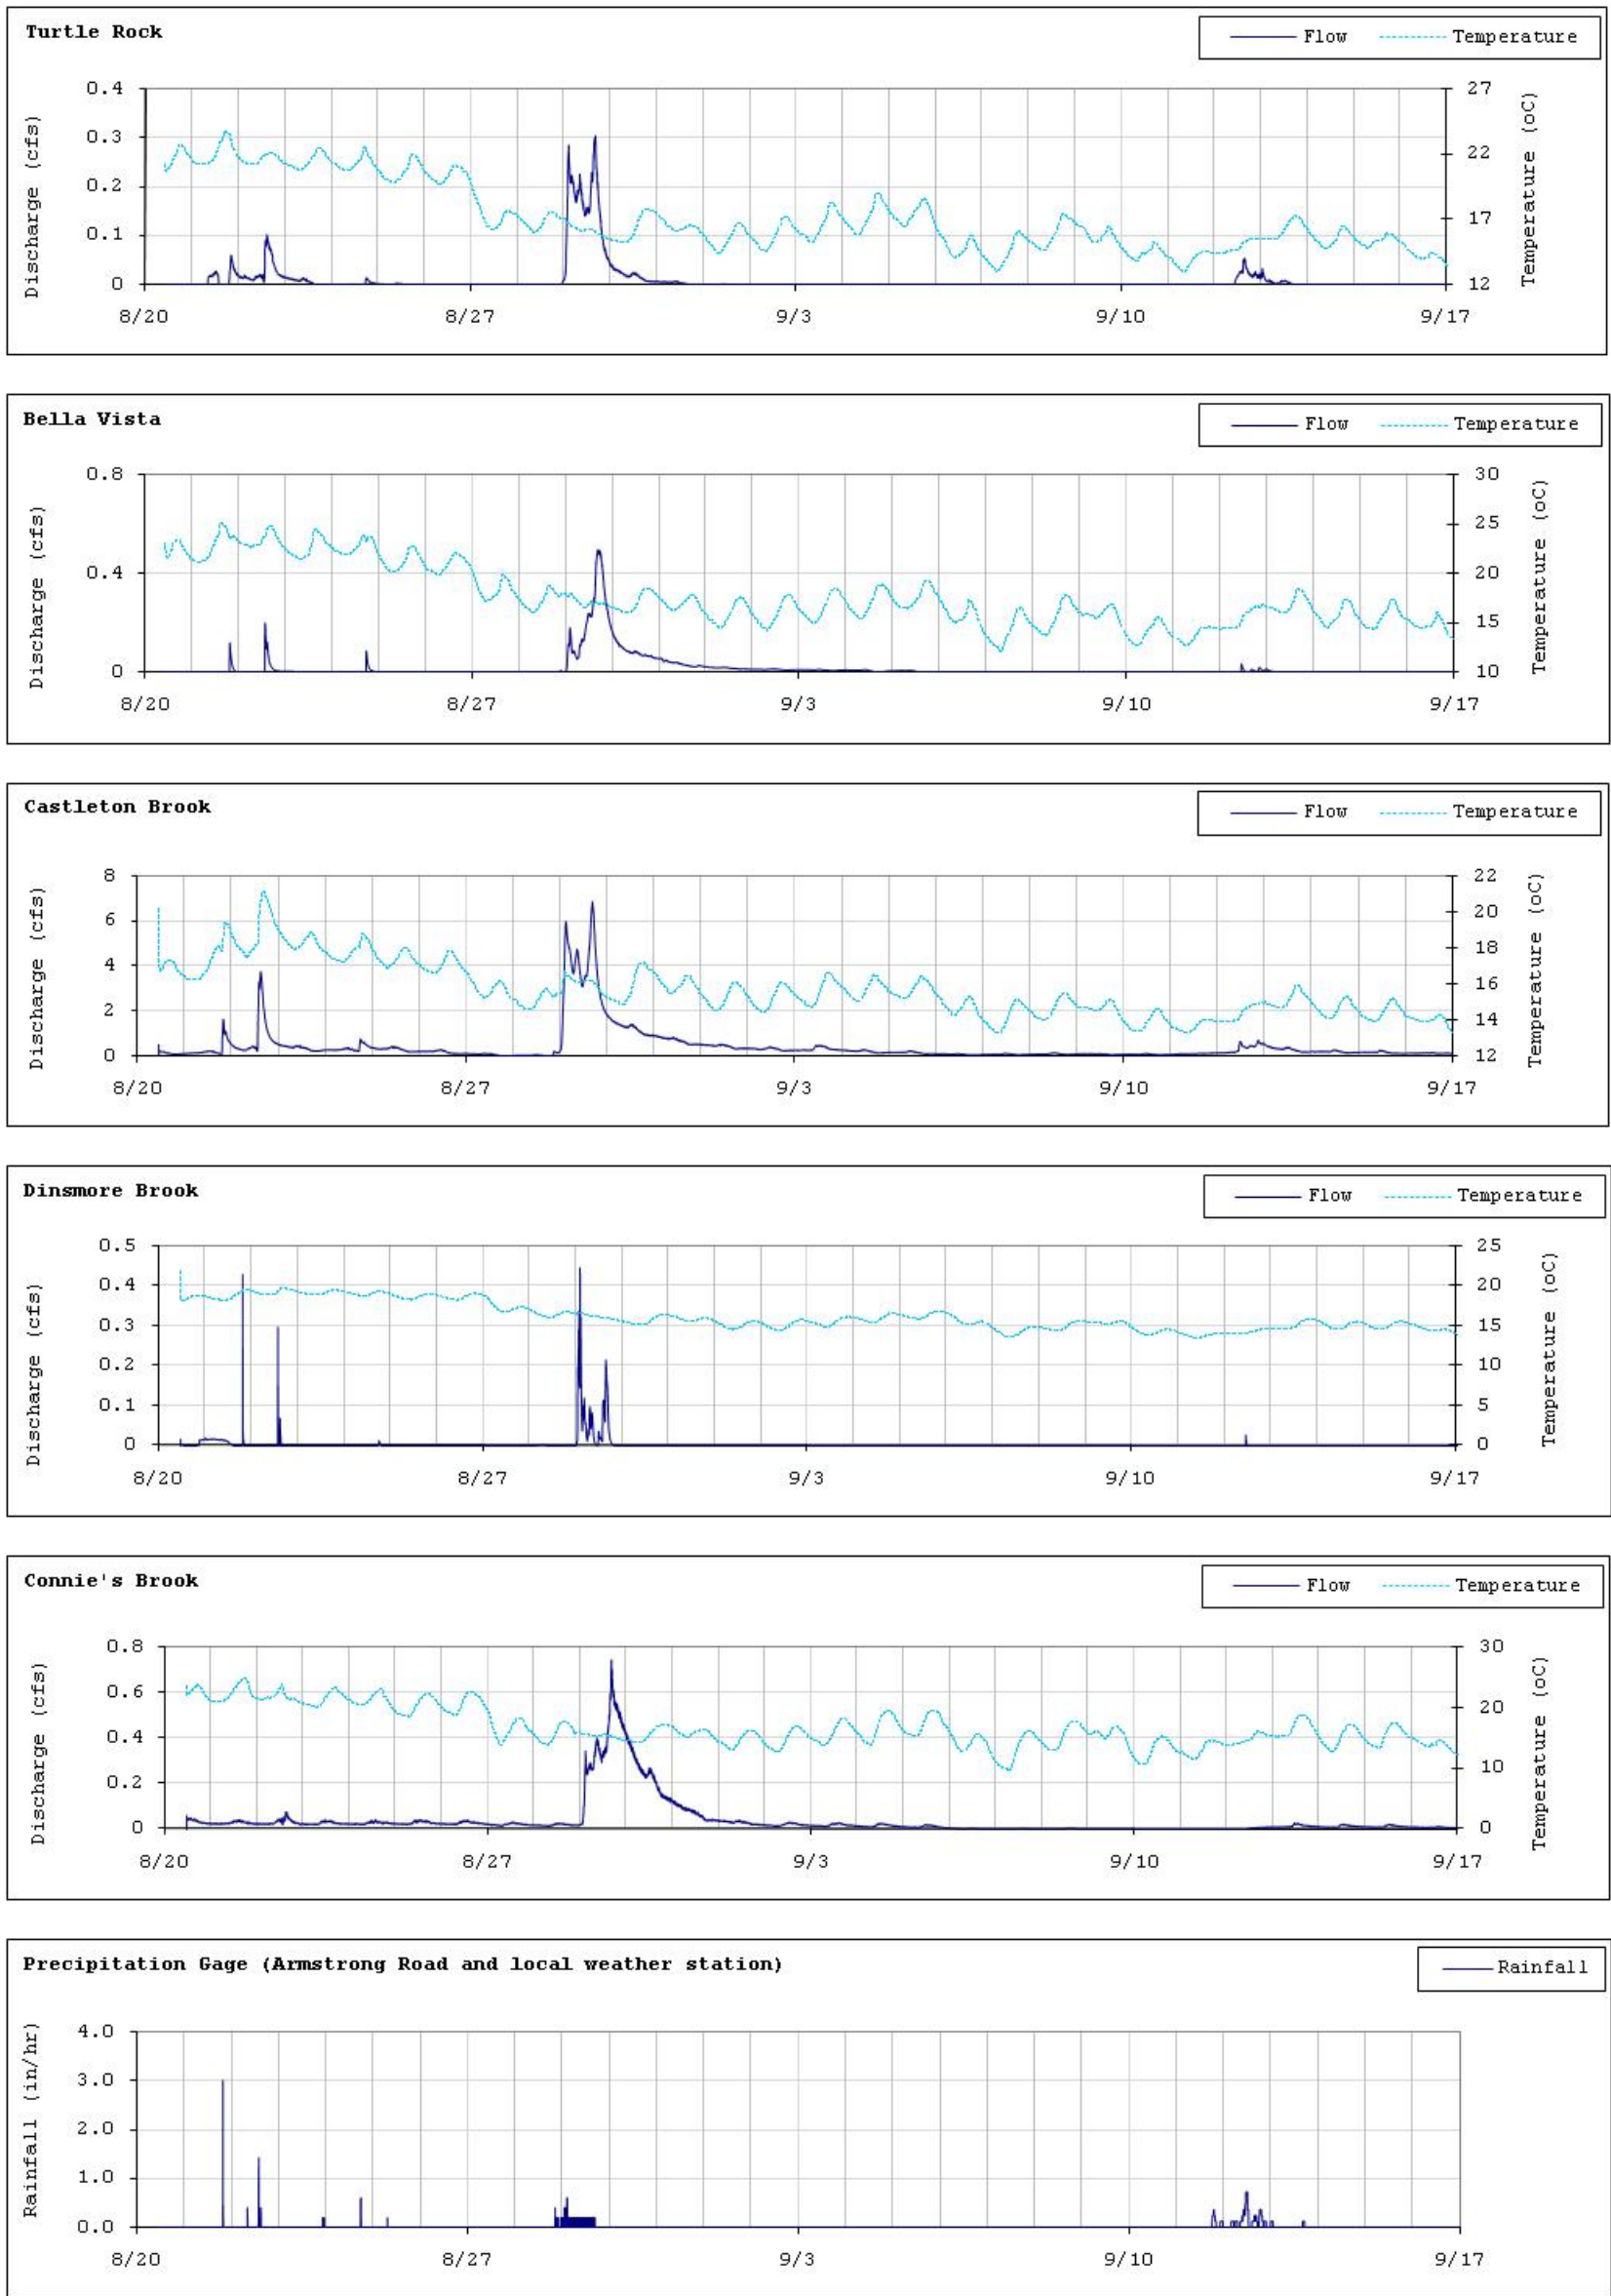
Figure 2. Discharge and Temperature monitoring for Cobbett’s Pond Tributaries (8/20/2009-9/17/2009)

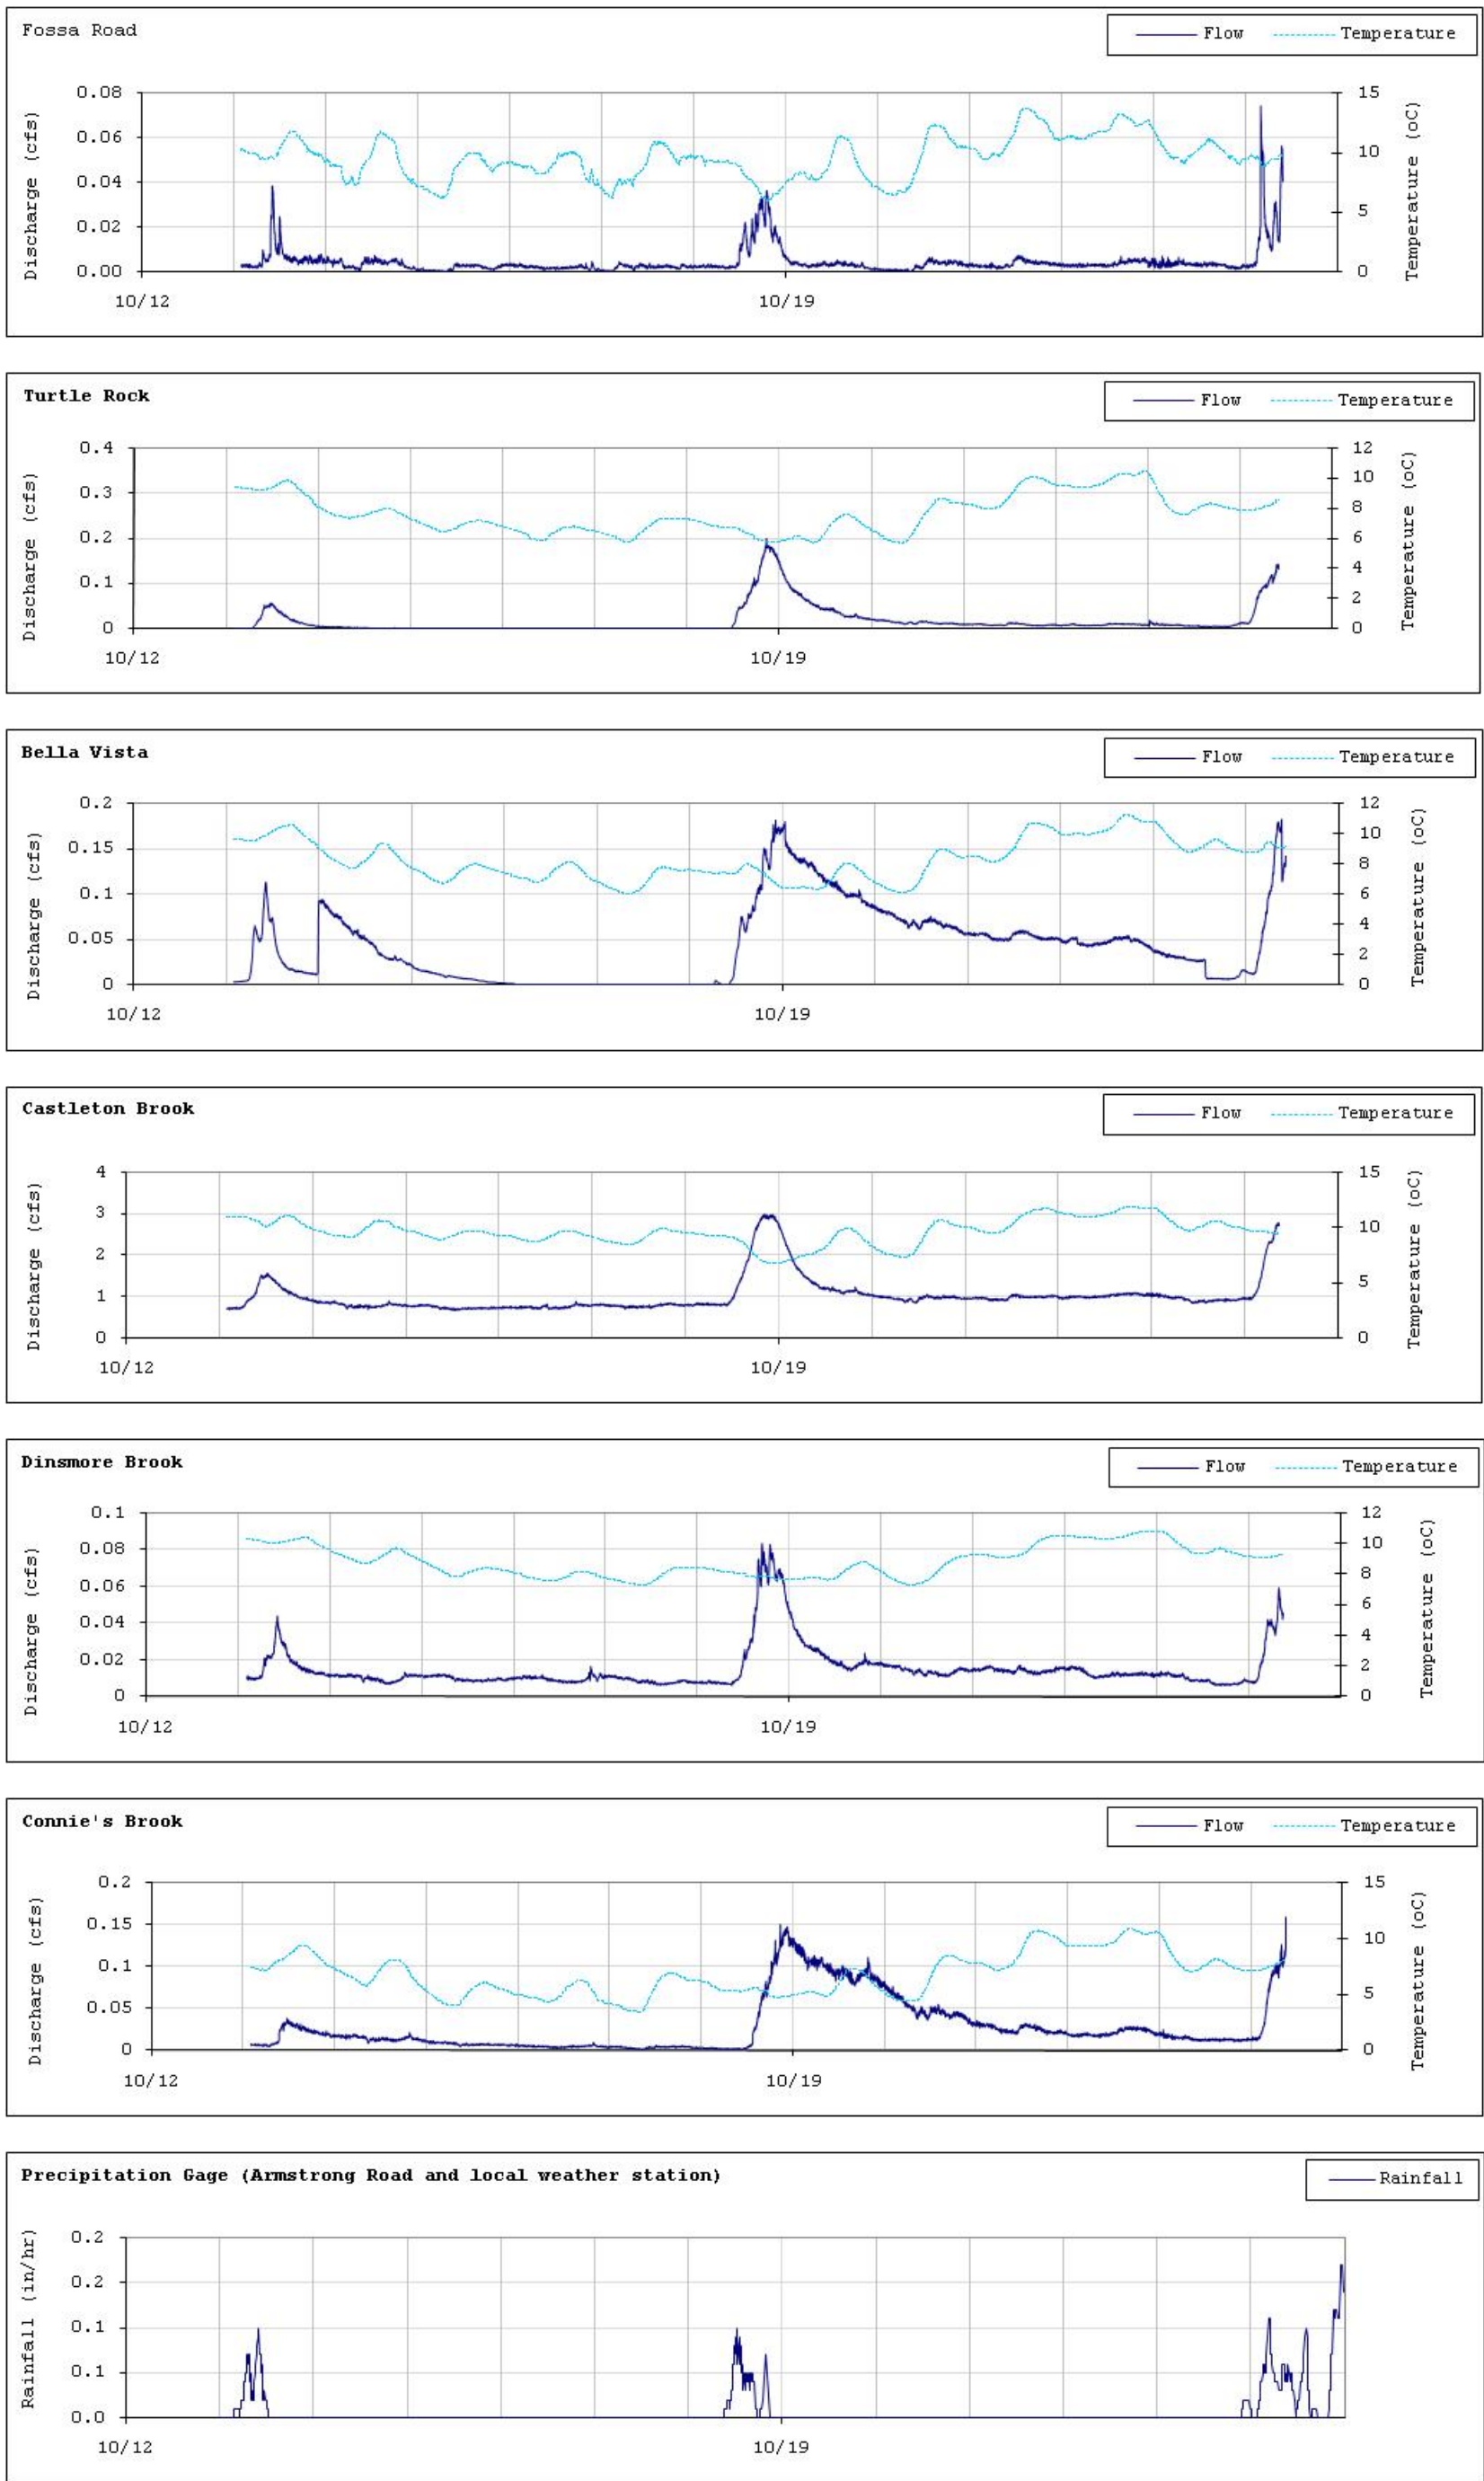
Figure 2. Discharge and Temperature monitoring for Cobbett’s Pond Tributaries (10/13/2009-10/24/2009)

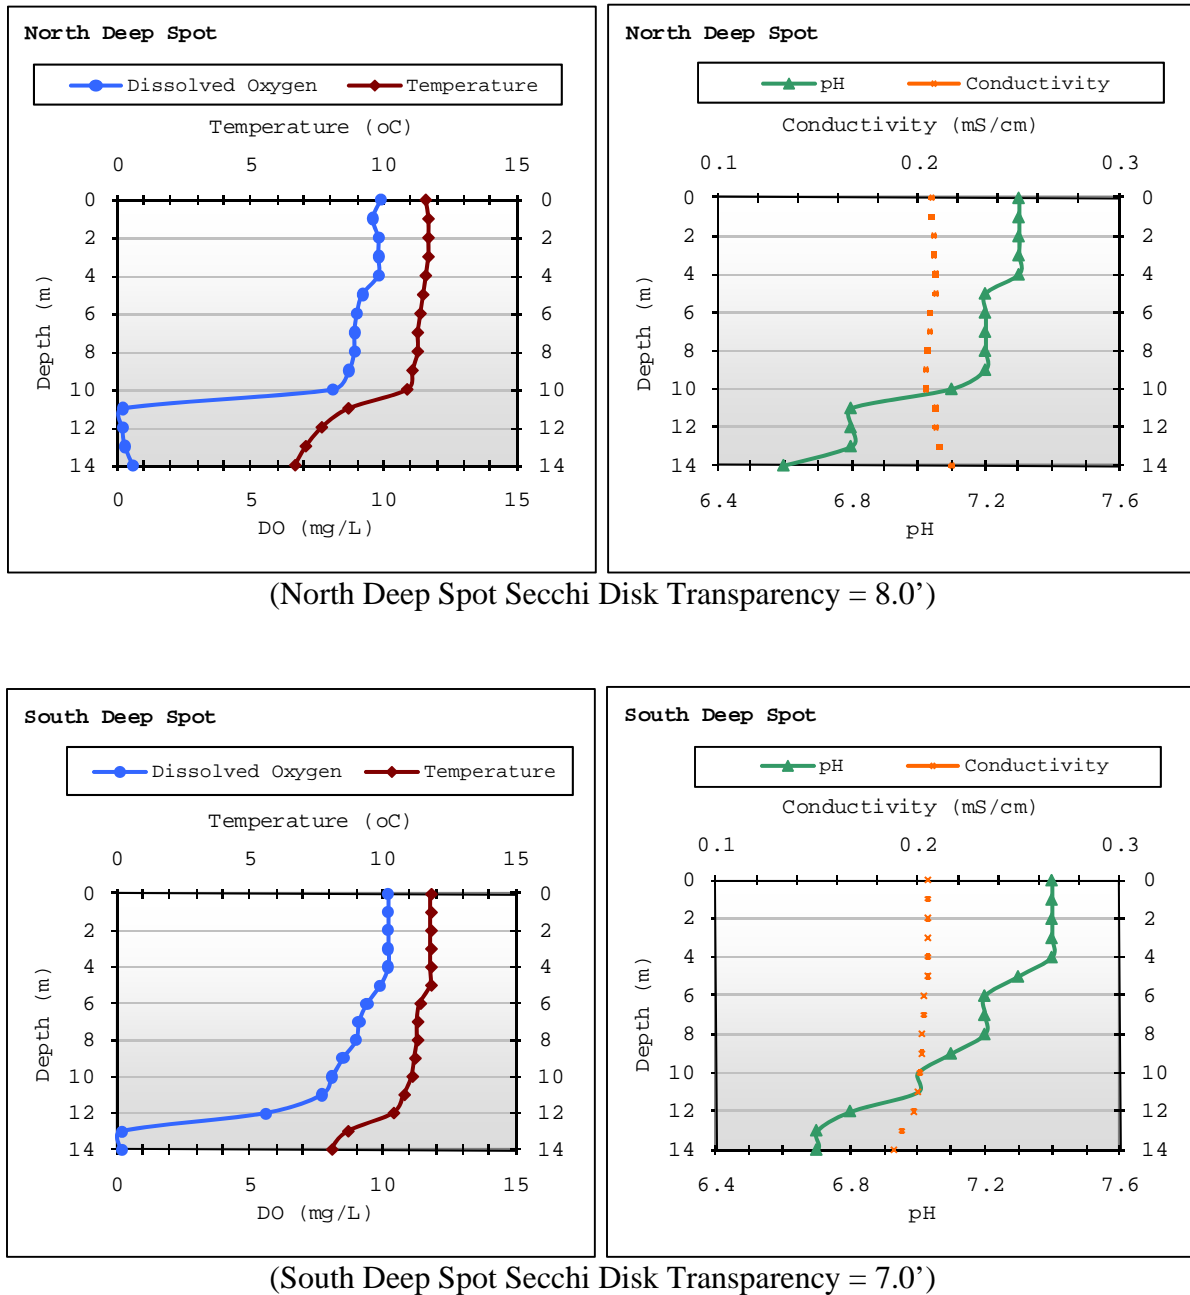
Figure 3. Deep Spot location water quality profiles (8/20/2009)
