# ENVIRONMENTAL Fact Sheet

GEO-10

## Flood and Geologic Hazards

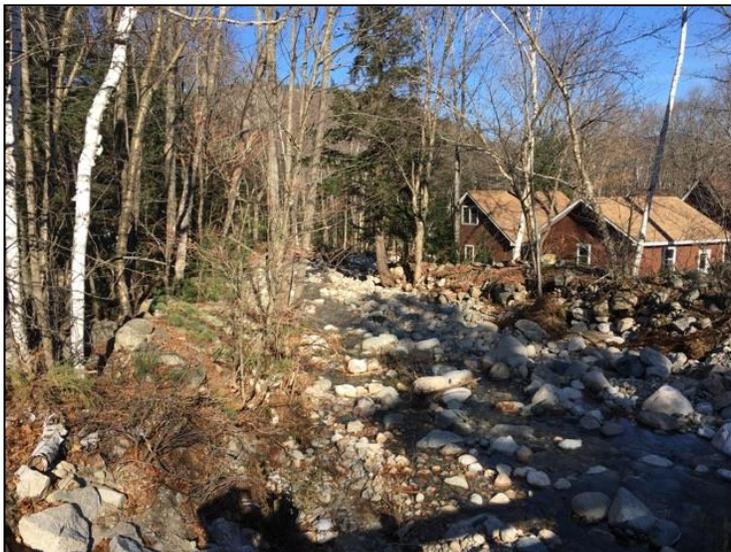
storm, including the Shelburne area (photo of effects at left).

New Hampshire has experienced continual reminders that brooks in small watersheds can flood and cause clogged culverts and erosion damage if the right ingredients come together. In 2018, a succession of three thunderstorms produced 4 inches of rain in 90 minutes in the Dublin and Harrisville areas. A year earlier (2017), multiple culverts failed in Grafton County when they could not convey the flows created by a summer thunderstorm complex. Later in 2017, program staff responded to concerns from the October

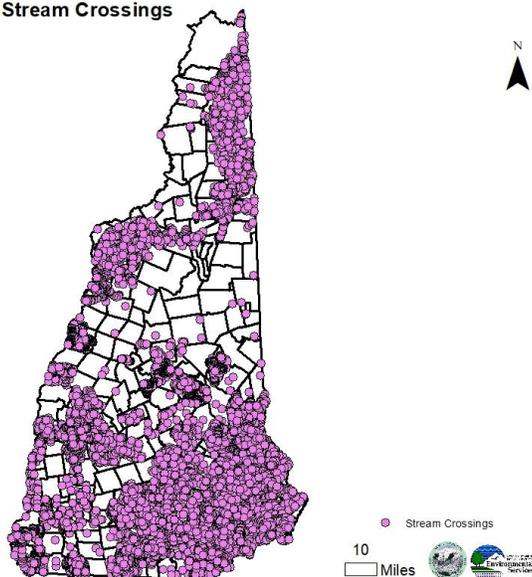
Locations of Completed Stream Crossings  
February 2019

To address these concerns, four state agencies, including NHDES, the New Hampshire Department of Transportation, Fish & Game, and the Department of Safety, Division of Homeland Security and Emergency Management, have partnered to manage New Hampshire stream crossing assessments. The State of New Hampshire has modified a stream crossing assessment protocol, initially developed in Vermont, for its own use. Since 2009, a total of 7,680 crossings (about 45% of the known total) that have been assessed statewide using this protocol, are present

in the statewide stream crossing database (figure left). Of this number, 2,547 have been assessed by NHGS staff and interns. NHGS also provides training to all data collectors statewide and performs
