MESSER POND WATERSHED-BASED IMPLEMENTATION PLAN

Prepared by

Base Flow, LLC
3 Brimstone Hill Road
Amherst, NH 03031

April 4, 2016

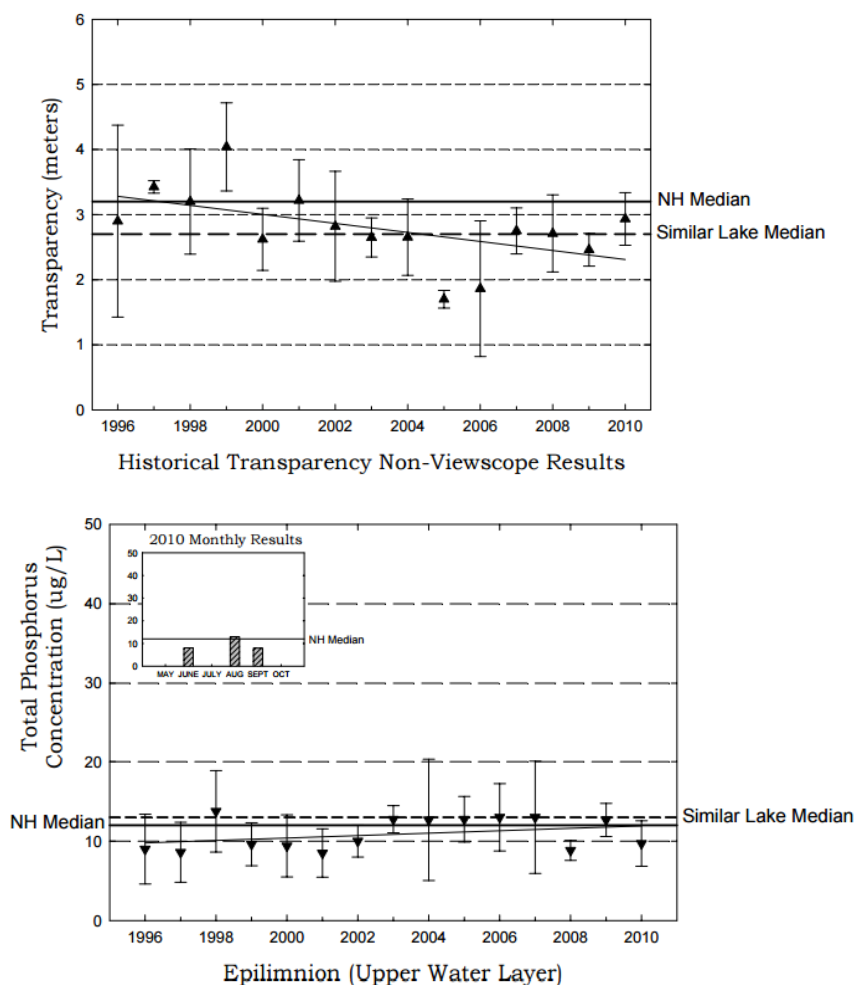
Figure 4. Historical Transparency and Epilimnion Total Phosphorus from the 2010 NHDES Annual Report for Messer Pond, New London, NH (NHDES 2010(b))

Figure 4 offers a slightly different view of the data and includes trend lines. Provided as part of the older NHDES VLAP annual reports, Figure 4 provides graphs of historical transparency and epilimnion total phosphorus from the 2010 NHDES Annual Report (NHDES 2010(b)). These graphs indicate a similar low to moderate increase in phosphorus concentrations over the sampling period, and worsening transparency trends. Further review of the data collected under the VLAP program indicates the following negative trends in water quality:

- Pond transparency has steadily decreased (worsened) since sampling began in 1996
- Conductivity measurements have continued to remain much greater than the state median for similar lakes in the pond and tributaries
- Elevated phosphorus concentrations have been observed in tributaries under various weather conditions
- Measurements of dissolved oxygen in the hypolimnion (lower water layer of the pond) indicate potential for hypoxic or anoxic (low to no dissolved oxygen in saturation) conditions
- pH in the lake and tributaries are slightly acidic and oftentimes these waterbodies do not meet the state water quality standard

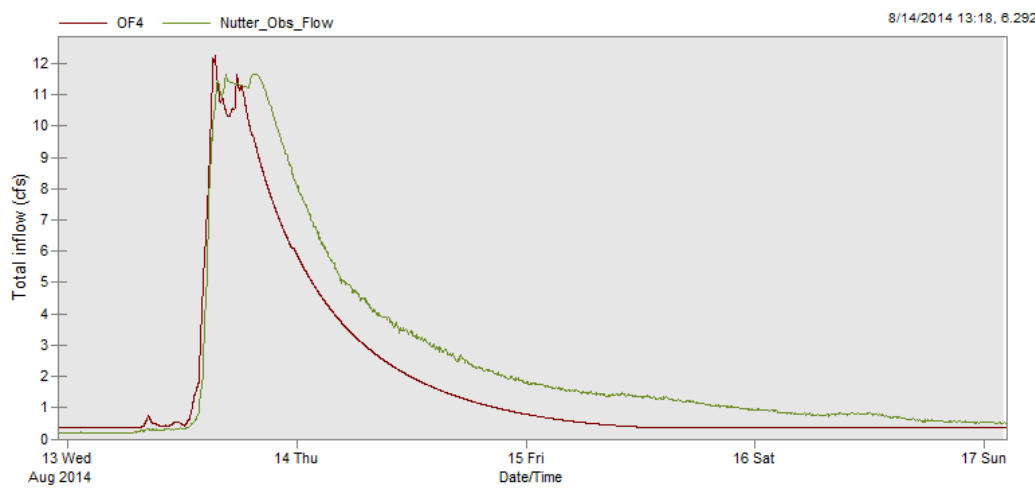
Figure 13. Hydrologic Model Calibration at Nutter Brook, During Storm Event 2

Calibration of the model consisted of two components – 1) hydrologic calibration, and 2) water quality calibration. Hydrologic calibration included the adjustment of up to five hydrologic-related parameters (watershed width, % impervious, maximum and minimum infiltration rate and slope, in that order) to optimize the best fit between model vs. field data for storm sampling events. An example of this best fit is provided as Figure 13. Water quality calibration was performed in a similar manner, adjusting the buildup and washoff coefficient factors using a best fit approach relative to model vs. field data. A similar example for water quality is provided as Figure 14.

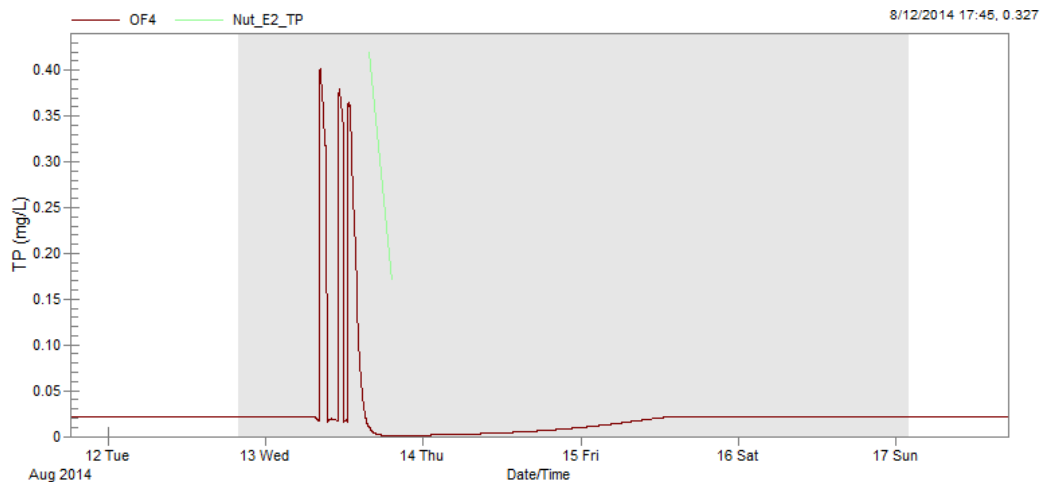
Figure 14. Water Quality Calibration at Nutter Brook, During Storm Event 2

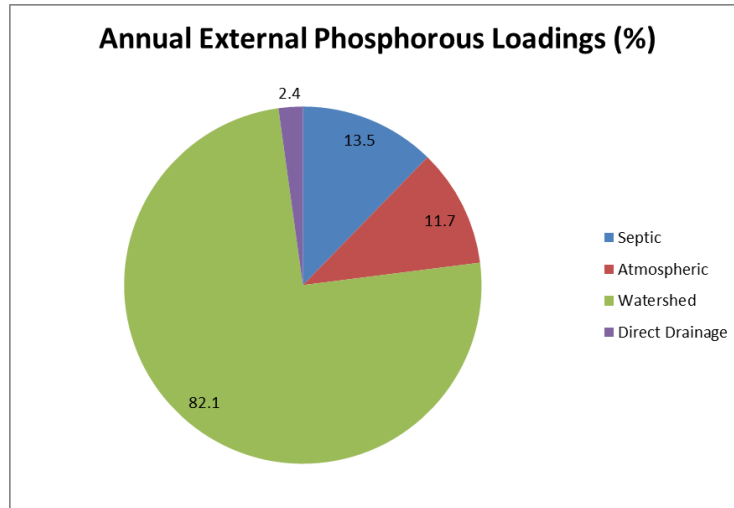
Figure 16. External Sources of Phosphorus to Messer Pond, Totaling 113 lb/year

- The phosphorus load generated from watershed modeling (i.e. surface water runoff conveyed over land uses in the 11 sub-watersheds of Messer Pond, plus seasonal baseflow from streams) accounts for 74.8% (84.5 lb) of the annual external phosphorus load to the lake

- Phosphorus loading from septic systems is estimated to account for 13.5% (15.3 lb) of the annual external phosphorus load
- Atmospheric deposition, including wet and dry deposition, is estimated to account for 11.7% (13.3 lb) of the annual external phosphorus load to the lake

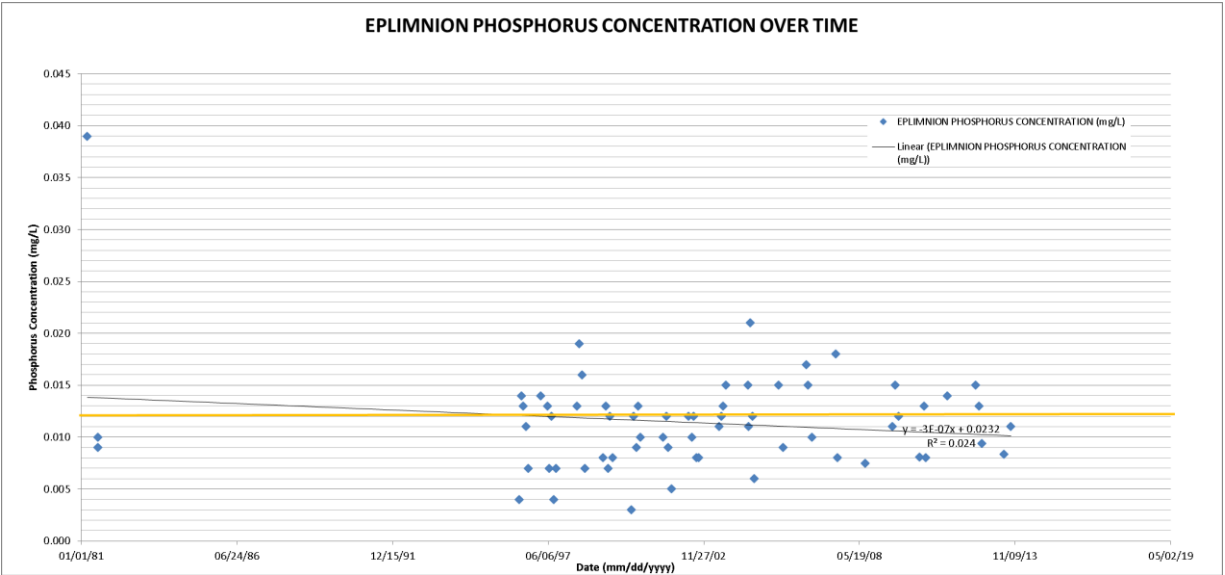
Figure 17. Epilimnion Phosphorus Concentration Over Time for Messer Pond, New London, NH

Based on the estimated annual phosphorus load of 113 lb/yr (51.3 kg/yr), the Vollenweider equation (with settling velocity coefficient adjustment) predicts an in-lake phosphorus concentration of 12.4 $\mu\text{g/L}$. This prediction matches well with the calculated average epilimnion P concentration equal to approximately 12 $\mu\text{g/L}$, as illustrated in Figure 17 below.

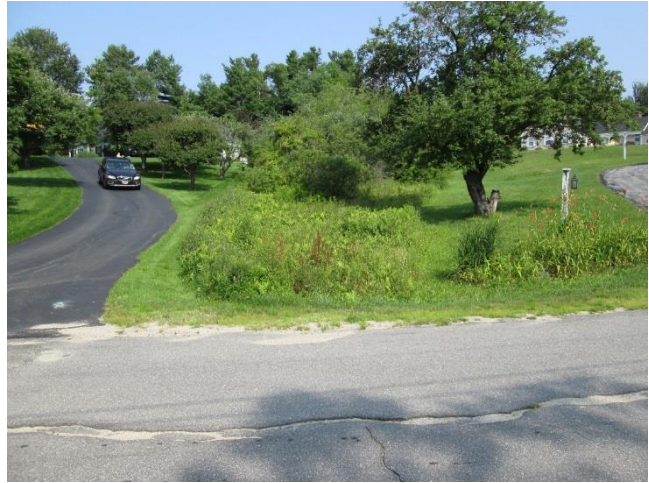
Photo 1-1

Upper County Road Brook runs through the residential areas located along roads Gay Farm Road and Carter Road. Some excellent examples of stream buffers exist in this area of the watershed (Photo 1-1), however there are some properties that lack or have minimal buffers to prevent NPS pollution from directly entering streams and resources (Photo 1-2).

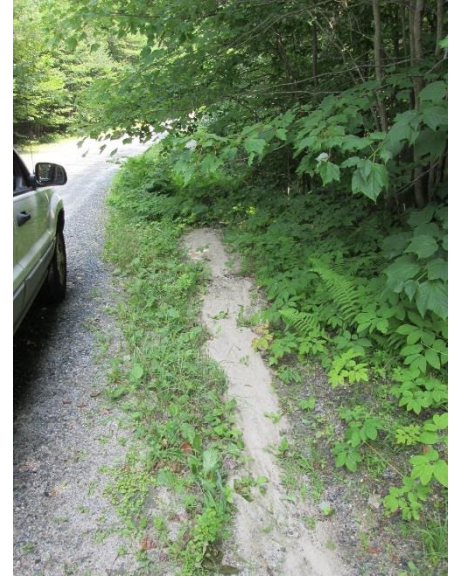
Photo 2-1

Forest Acres Road runs adjacent to residential homes located along the southern shoreline of the pond. It is a dirt road that is subject to sediment erosion following storm events, typical of dirt roads. Browns Brook, Nutter Brook, Haas Brook and an unnamed tributary all receive flow from I-89 and their watersheds and pass under Forest Acres Road via culverts. In order to prevent eroded road sediments and road sands/salts applied during the winter from entering the streams, the town has dug holes in the road shoulder on the up gradient sides of each stream essentially creating small 'settling basins', observed at Browns, Nutter and Haas Brooks in the recent past. Watershed survey observations indicated that these basins were very effective, however had reached their capacity and most likely weren't capturing any sediment once full.

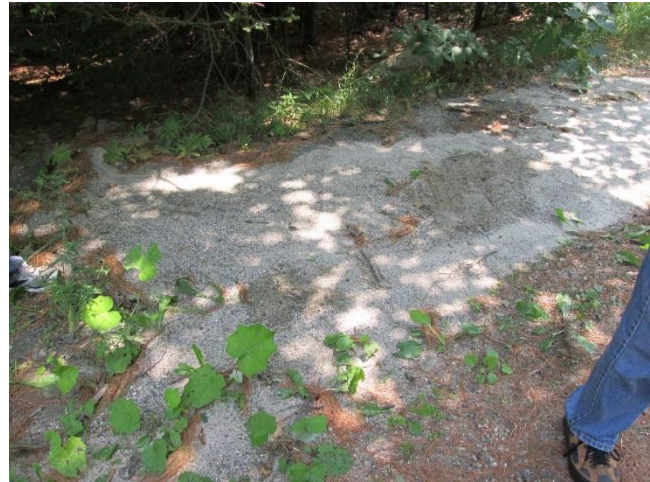
Photo 2-2

In addition to these settling basins a series of catch basins exist along the southern shoulder of Forest Acres Road. Slightly different from typical catch basins, these basins are constructed of solid concrete with a closed top but allow flow to enter the basins from the side of the basin, from the adjacent road swales. Although not opened during the watershed survey, it's suspected that these basins have a sump at the bottom (i.e. depth from the bottom of the structure to the bottom of the lowest invert out) which allows for some accumulation of sediment. The discharge location and sediment loading of these systems is currently unknown, however the town Department of Public Works (DPW) will be contacted prior to efforts regarding this BMP get underway.

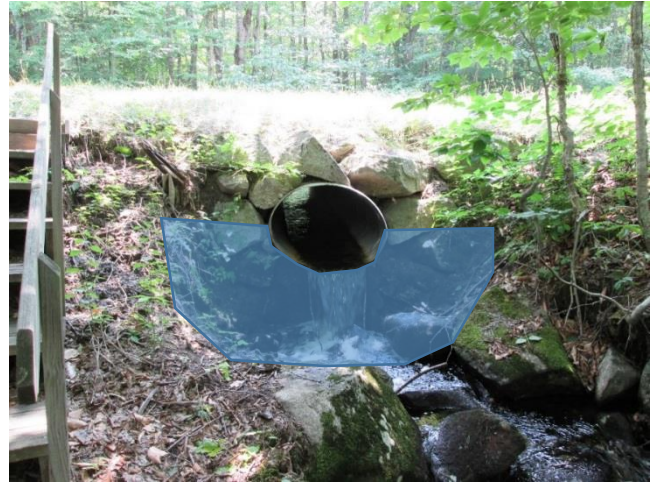
Photo 3-1

The culverts that convey flow under Forest Acres Road at Browns Brook and Nutter Brook are undersized and have resulted in bank erosion and historical sediment inputs to the Pond. A common problem throughout the country, many of our road-stream crossings installed decades ago were sized for the 25 year storm event and cannot adequately convey larger storms and increasing flows due to climate change. The result is significant bank erosion at the downstream end of the pipe due to the 'firehose' effect during large storm events that over time results in large sediment inputs to downstream resources and potential threats to roadway infrastructure. The photos provided show erosion that has occurred over time at Nutter Brook above, below and to the sides of the pipe (shown as the blue shaded polygons), evident under dry weather conditions (photo 3-1) and a large storm event (photo 3-2).

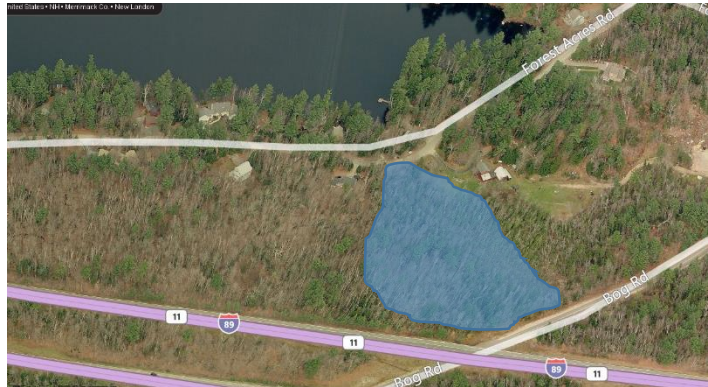
Photo 4-1

The Browns Brook wetland is located along Brown Brook and extends from the culvert at Forest Acres Road south to the intersection of I-89 and Bog Road (photo 4-1). Initial assessments of conditions at the wetland led the project team to believe that this wetland was not natural and that its origin was anthropogenically influenced; certain species of trees indicative of uplands were destabilized and present within the wetland; and water quality was poor and not typical of a stream and wetland complex (photo 4-2). Further research pointed to this wetland potentially being created during the construction of I-89 as an area for storage of runoff from the new impervious area associated with the highway.

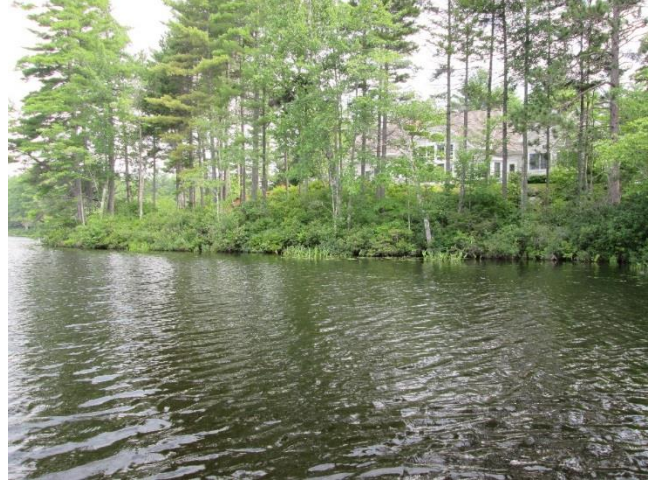
Photo 5-1

Messer Pond is a great example of natural shorelines – along with undeveloped properties, most shorefront homes have significant buffers that consist of native vegetation and features that provided for excellent filtering capacity of stormwater runoff (photo 5-1). However, during the Shoreline Survey a small number (2-3) of properties were observed either not to have buffers or to have property configurations that allow stormwater to runoff directly to the pond (photo 5-2).

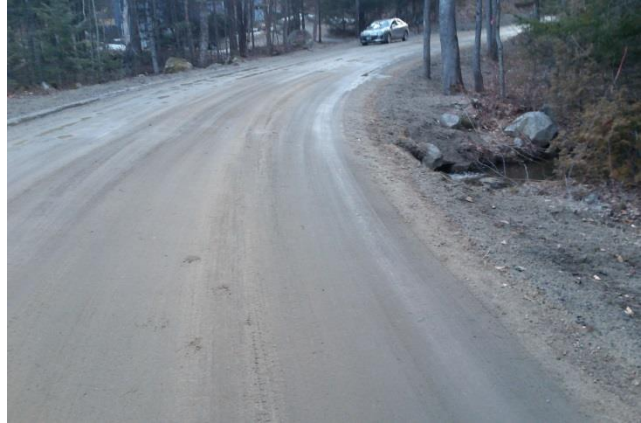
Photo 7-1

The proximity of Forest Acres Road to Browns Brook, particularly on the downstream side of the brook is close (*i.e.* within 3-5 feet); when visiting the site it is quite evident that there is a direct input of sediment, road salts and NPS from the road into the brook adjacent to the downstream end of the culverts (*i.e.* the edge of traffic travels less than 5-10 feet from the bank of the brook).

Install buffers or rain gardens within the right-of-way along both banks of the stream on the downstream side, using native vegetation. Target buffers that are at minimum 10 feet wide or rain gardens that will accommodate stormwater runoff and retention of sediment.

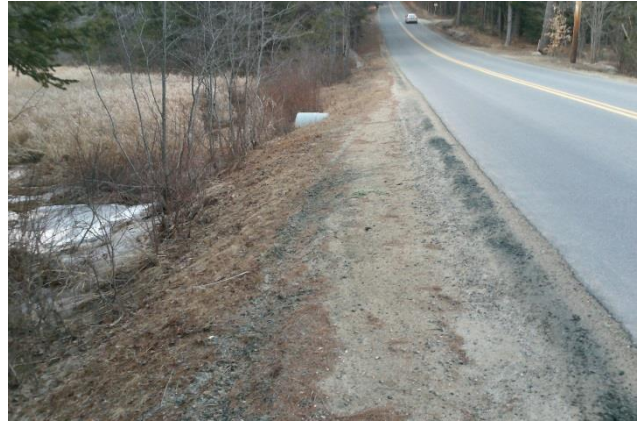
Photo 8-1

The proximity of County Road to County Road Brook on both sides of the road is close (*i.e.* approximately 8-10 feet); when visiting the site it is evident that there is a direct input of sediment, road salts and NPS from the road into the brook most likely on the upstream and downstream sides. This portion of County Road is the low point adjacent to a steep hill and it is suspected that some degree of runoff and NPS is entering the brook and likewise the associated wetland.

Install buffers within the right-of-way along each side of the road, using native vegetation. Since buffer width will be limited, plant selection and density should receive adequate attention for this BMP to be effective. Consideration of vegetation height and maintenance should also be considered with respect to maintenance and safety concerns.

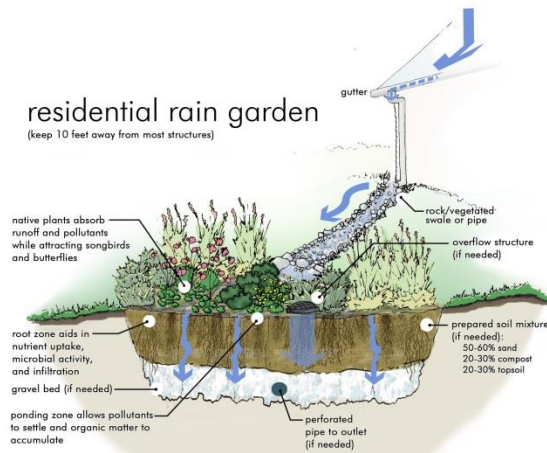
Photo 10-1 (Source: City of Vienna)

Installation of BMPs such as rain gardens is becoming more popular due to their relative ease of install and aesthetic value, both of which are attractive to watershed residents that want to take part in improving their watershed, the environment and property values. Programs such as 'Soak Up the Rain NH' sponsored by NHDES and EPA Region 1 (<http://soaknh.org/>) provide a wealth of information on such projects, including step-by-step instructions on these 'do-it-yourself' projects. It is expected that these projects will take place watershed-wide and will increase in number as word gets out about the plan and public outreach continues. It is expected that the MPPA will sponsor these efforts and encourage residents and stakeholders to become involved in these programs. A tool that estimates pollutant load reductions on private properties, called the NH Residential Loading Model is an excellent tool for such projects. It is located at: <http://winnepesaukeegateway.org/resources/phosphorus-calculator/>.
