APPENDIX H

- H-1 Historic NHDES presentation – History and current goals of lake level management at Newfound lake

History and Current Goals of Lake Level Management at Newfound Lake

Steve N. Doyon, PE
Water Resources & Public Safety

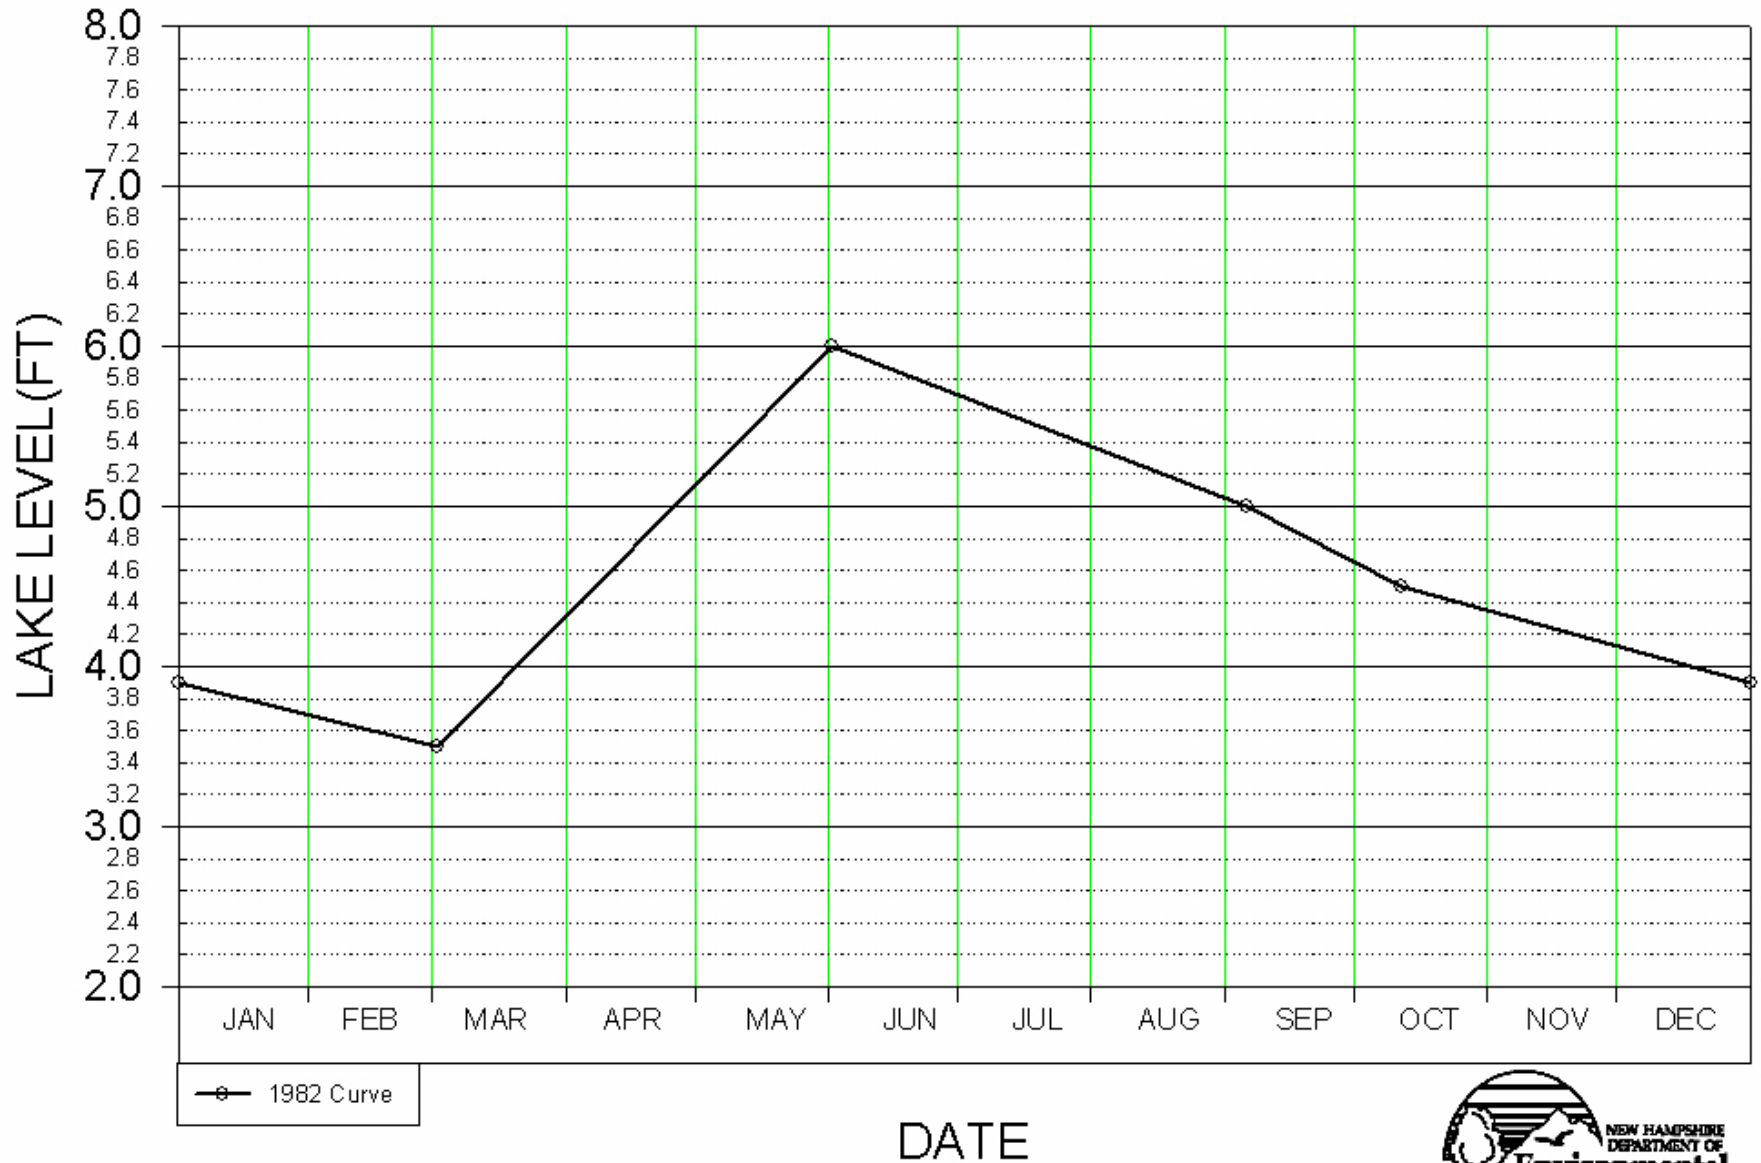
NEWFOUND LAKE

- In 1982, the management guidance was amended again to:
 - June 1st – 6.0' on the gage
 - Columbus Day – 4.5'
 - Columbus Day to spring refill – gradually drop the lake to 3.5' on hold it there.
 - Spring levels held below 7.2', if possible.

ELEV. 0.0' ON GAGE = 581.88' NGVD ELEV.

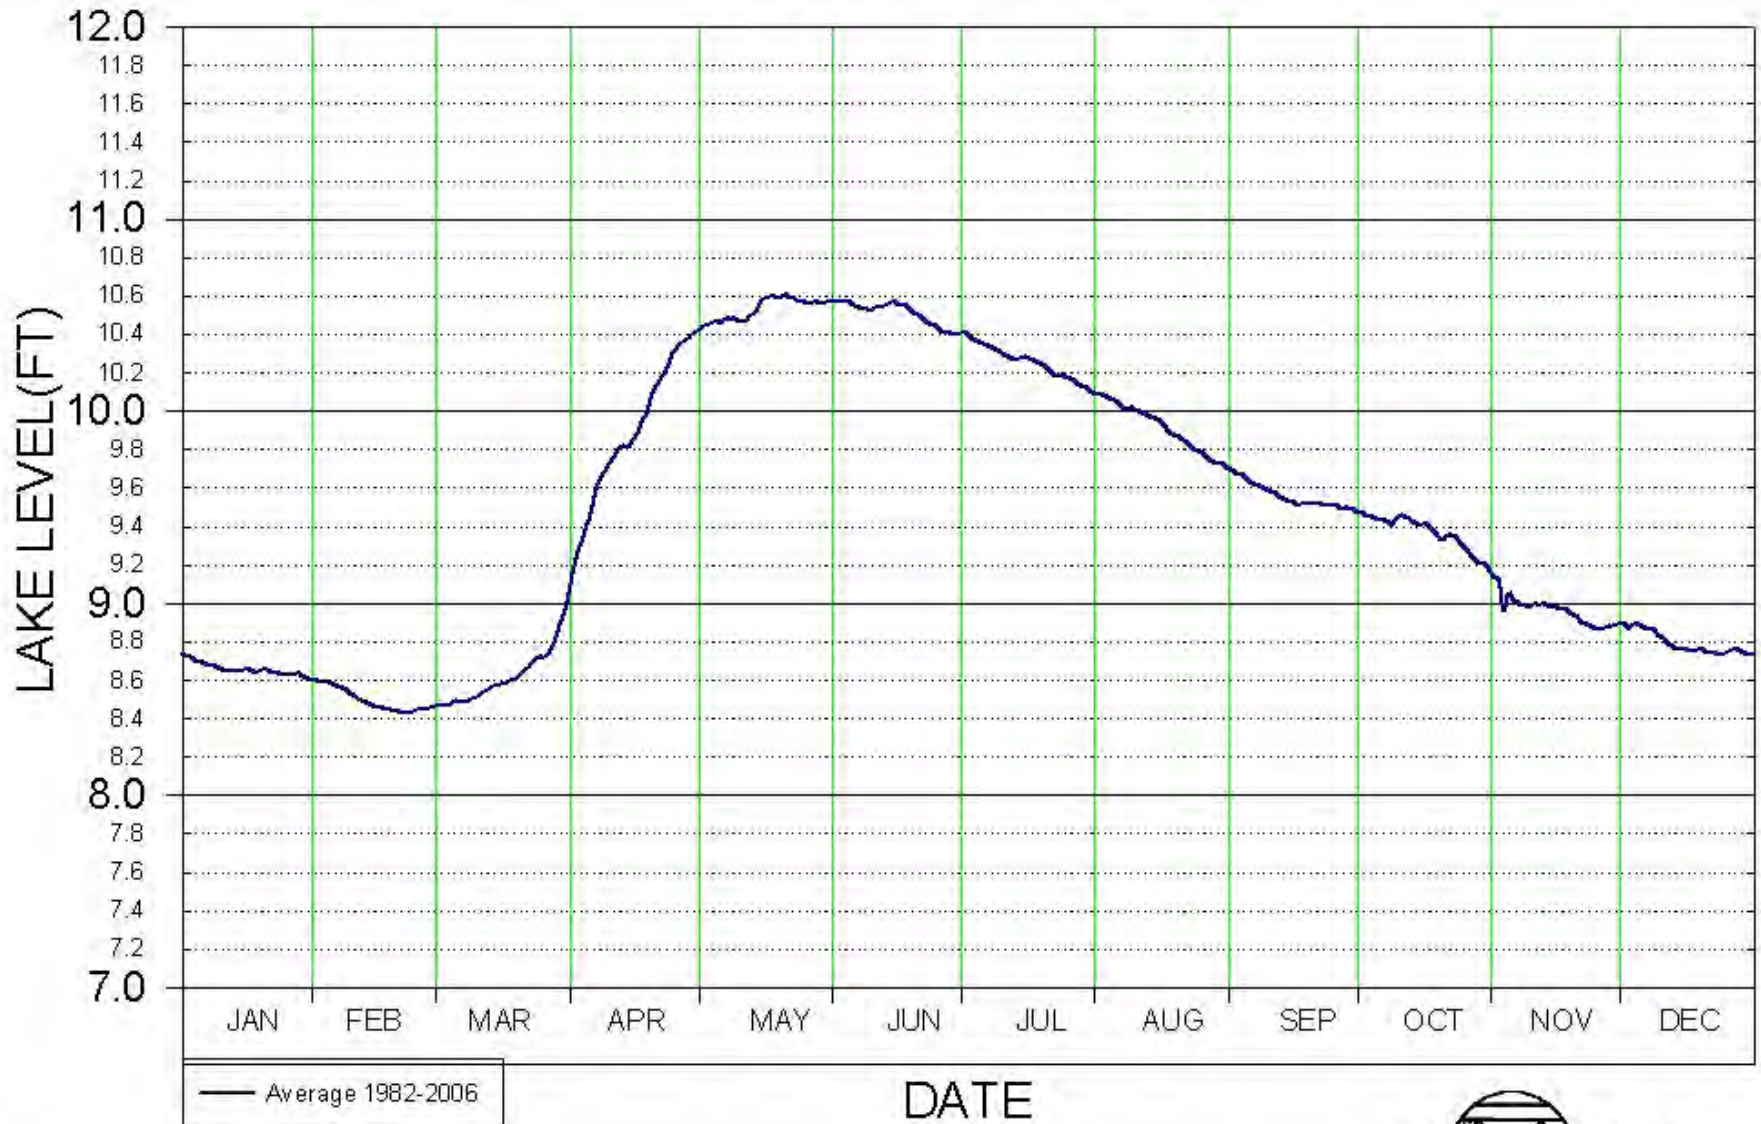
LAKE SUNAPEE

ELEV. 0.0' ON GAGE = 1082.65' USGS ELEV.

- Squam, Sunapee, Mascoma and Milton lakes show similar trends.
- Each watershed has variable land characteristics which affect runoff, such as average slope, type of soil, # of ponds, etc.
- “Flashy” basins produce runoff quickly but do not provide sustainable inflow.
- Basin characteristics affect management.

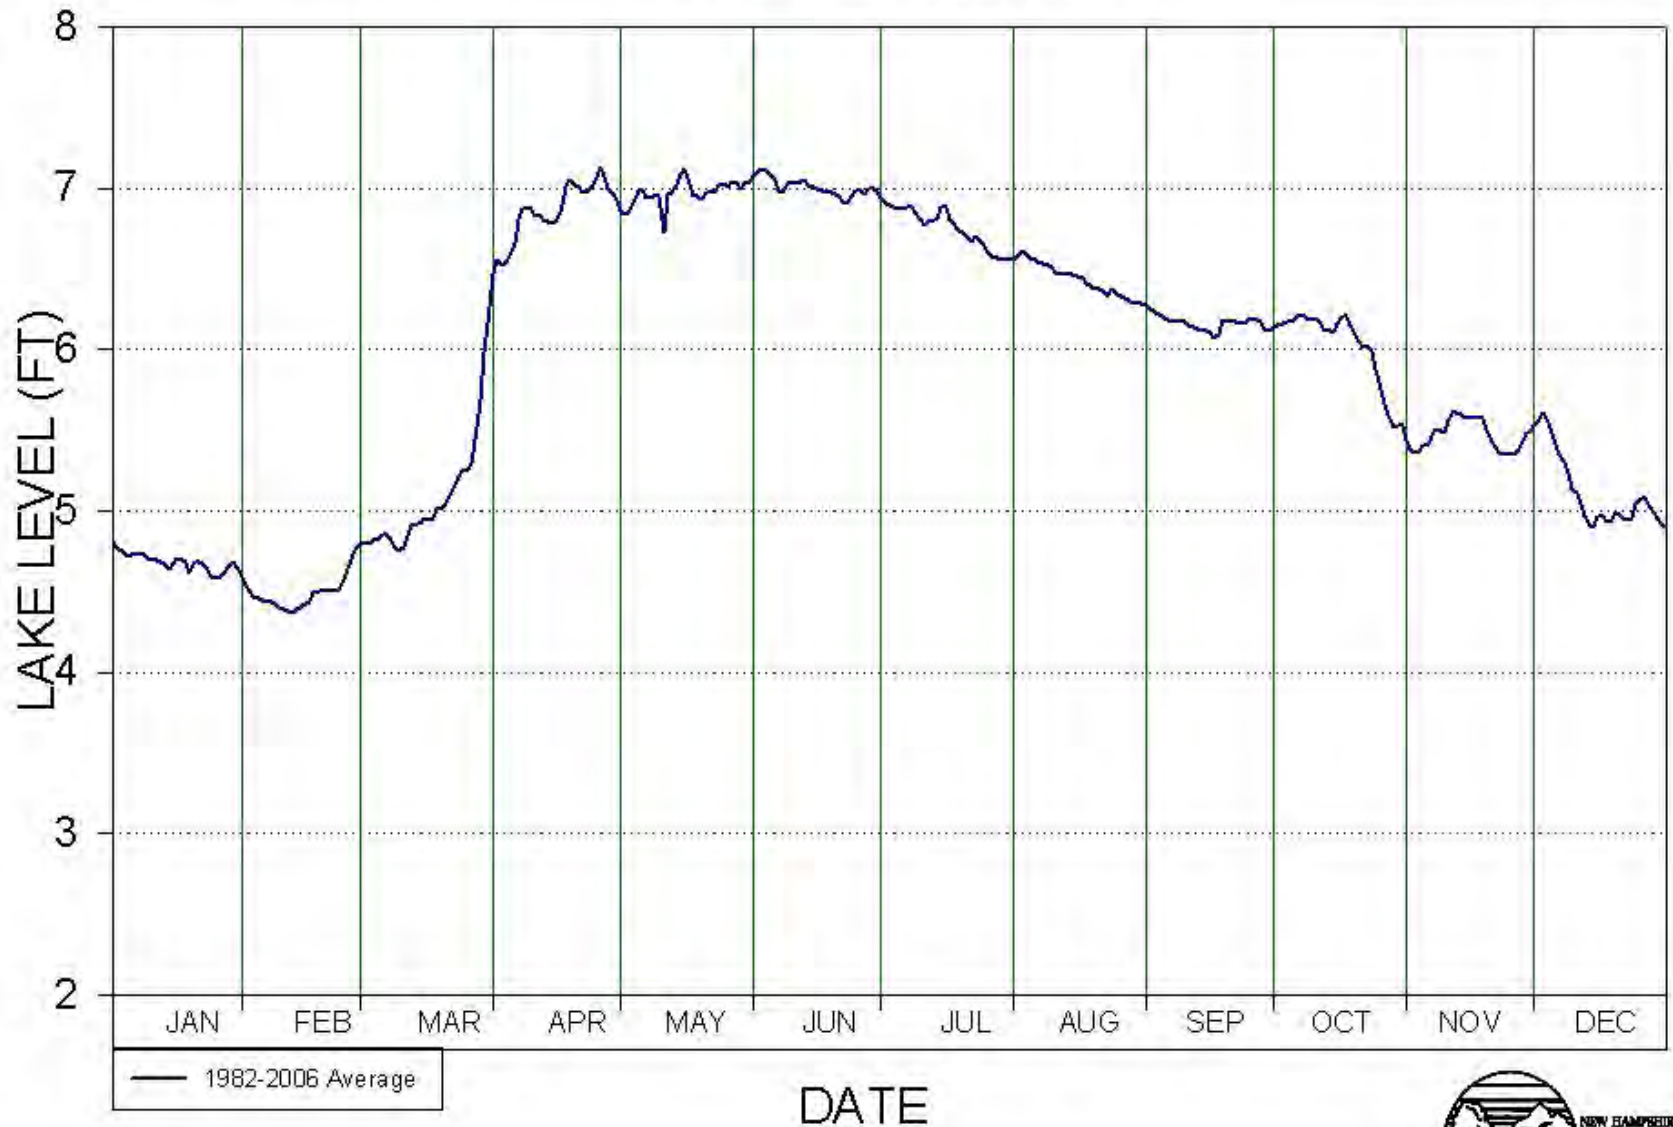
MASCOMA LAKE

ELEV. 0.0' ON GAGE = 743.00' USGS ELEV.

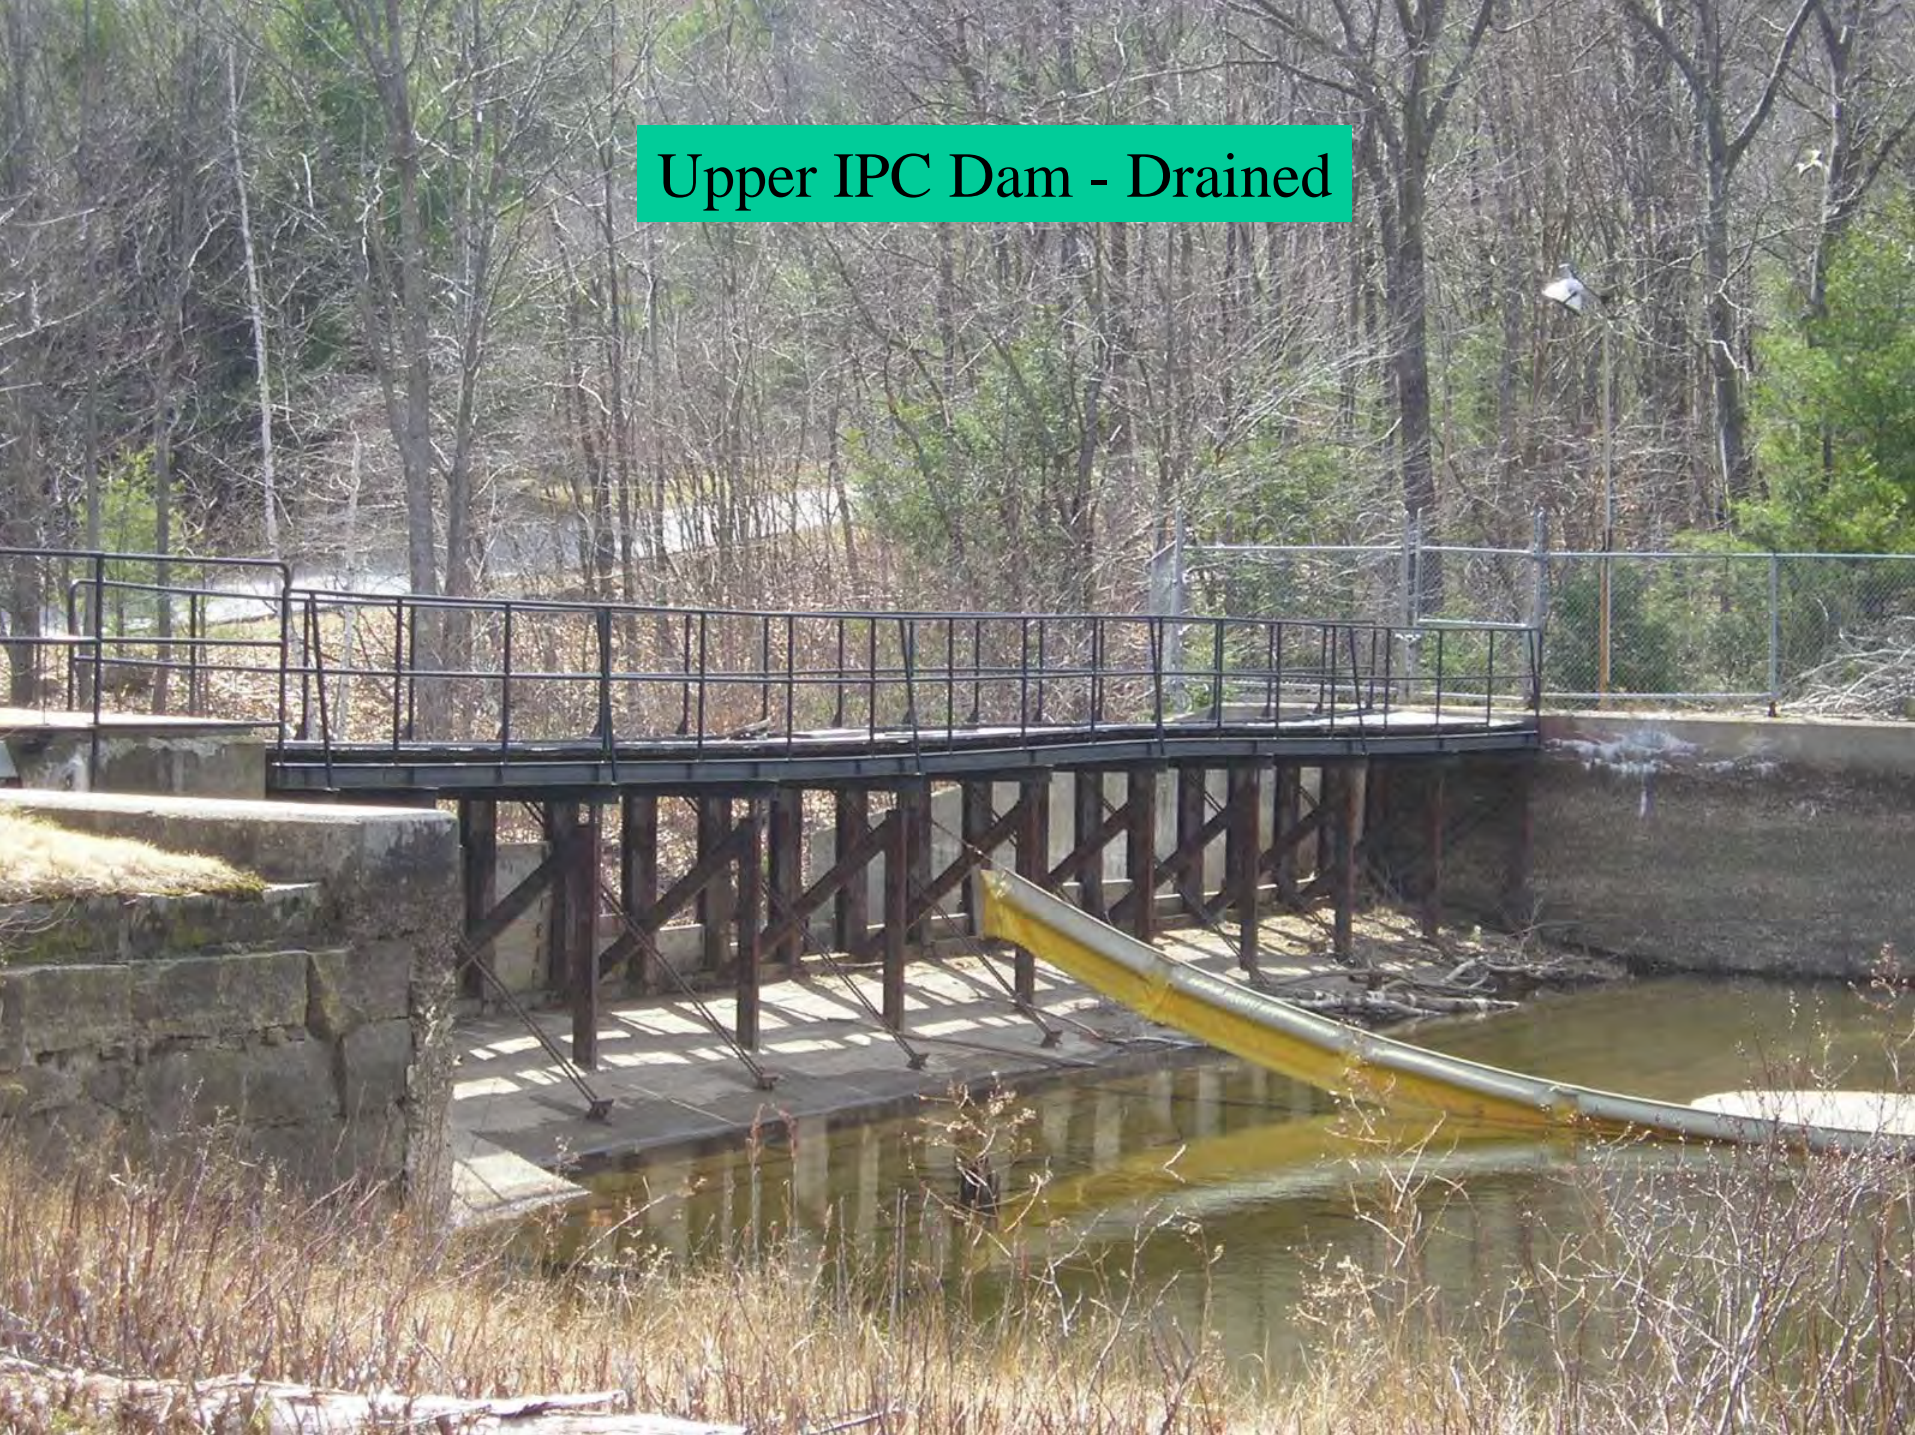
Upper IPC Dam - Drained

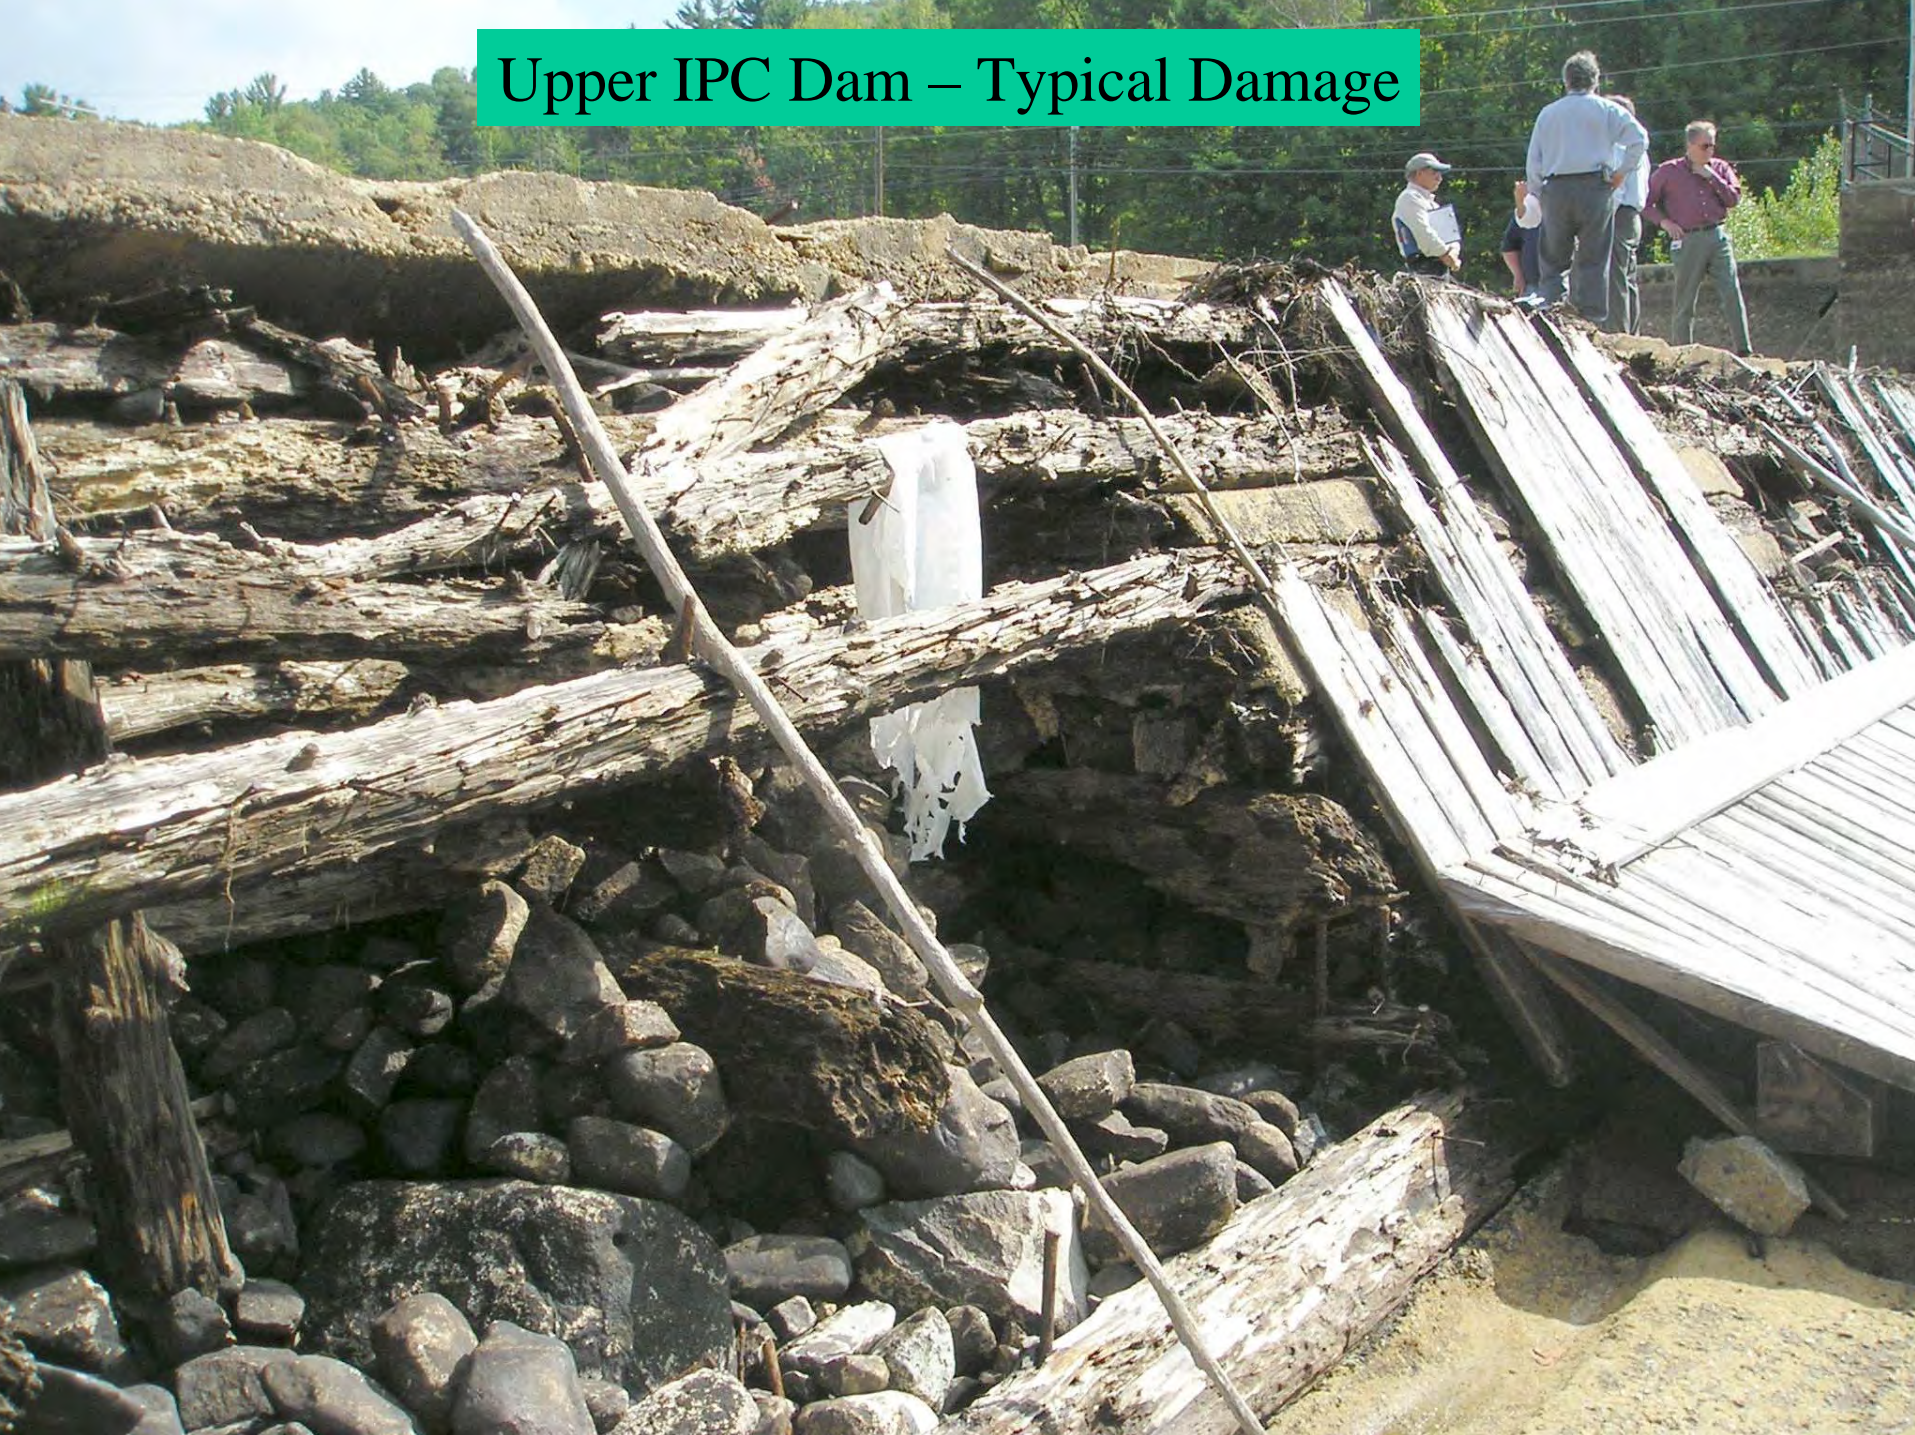
Upper IPC Dam – Typical Damage

- Near failures of two downstream dams owned by Freudenburg NOK.
- Lower dam was overtopped causing significant damage to adjacent property.
- Significant damage to Newfound Hydro dam.
- Town implemented evacuation of affected area for several days until failure danger had been addressed.
