SUBJECT: NHDES File No. 2020-02959

Application Amendment

City of Portsmouth Little Bay Water Line Replacement

RE: Wagon Hill Farm

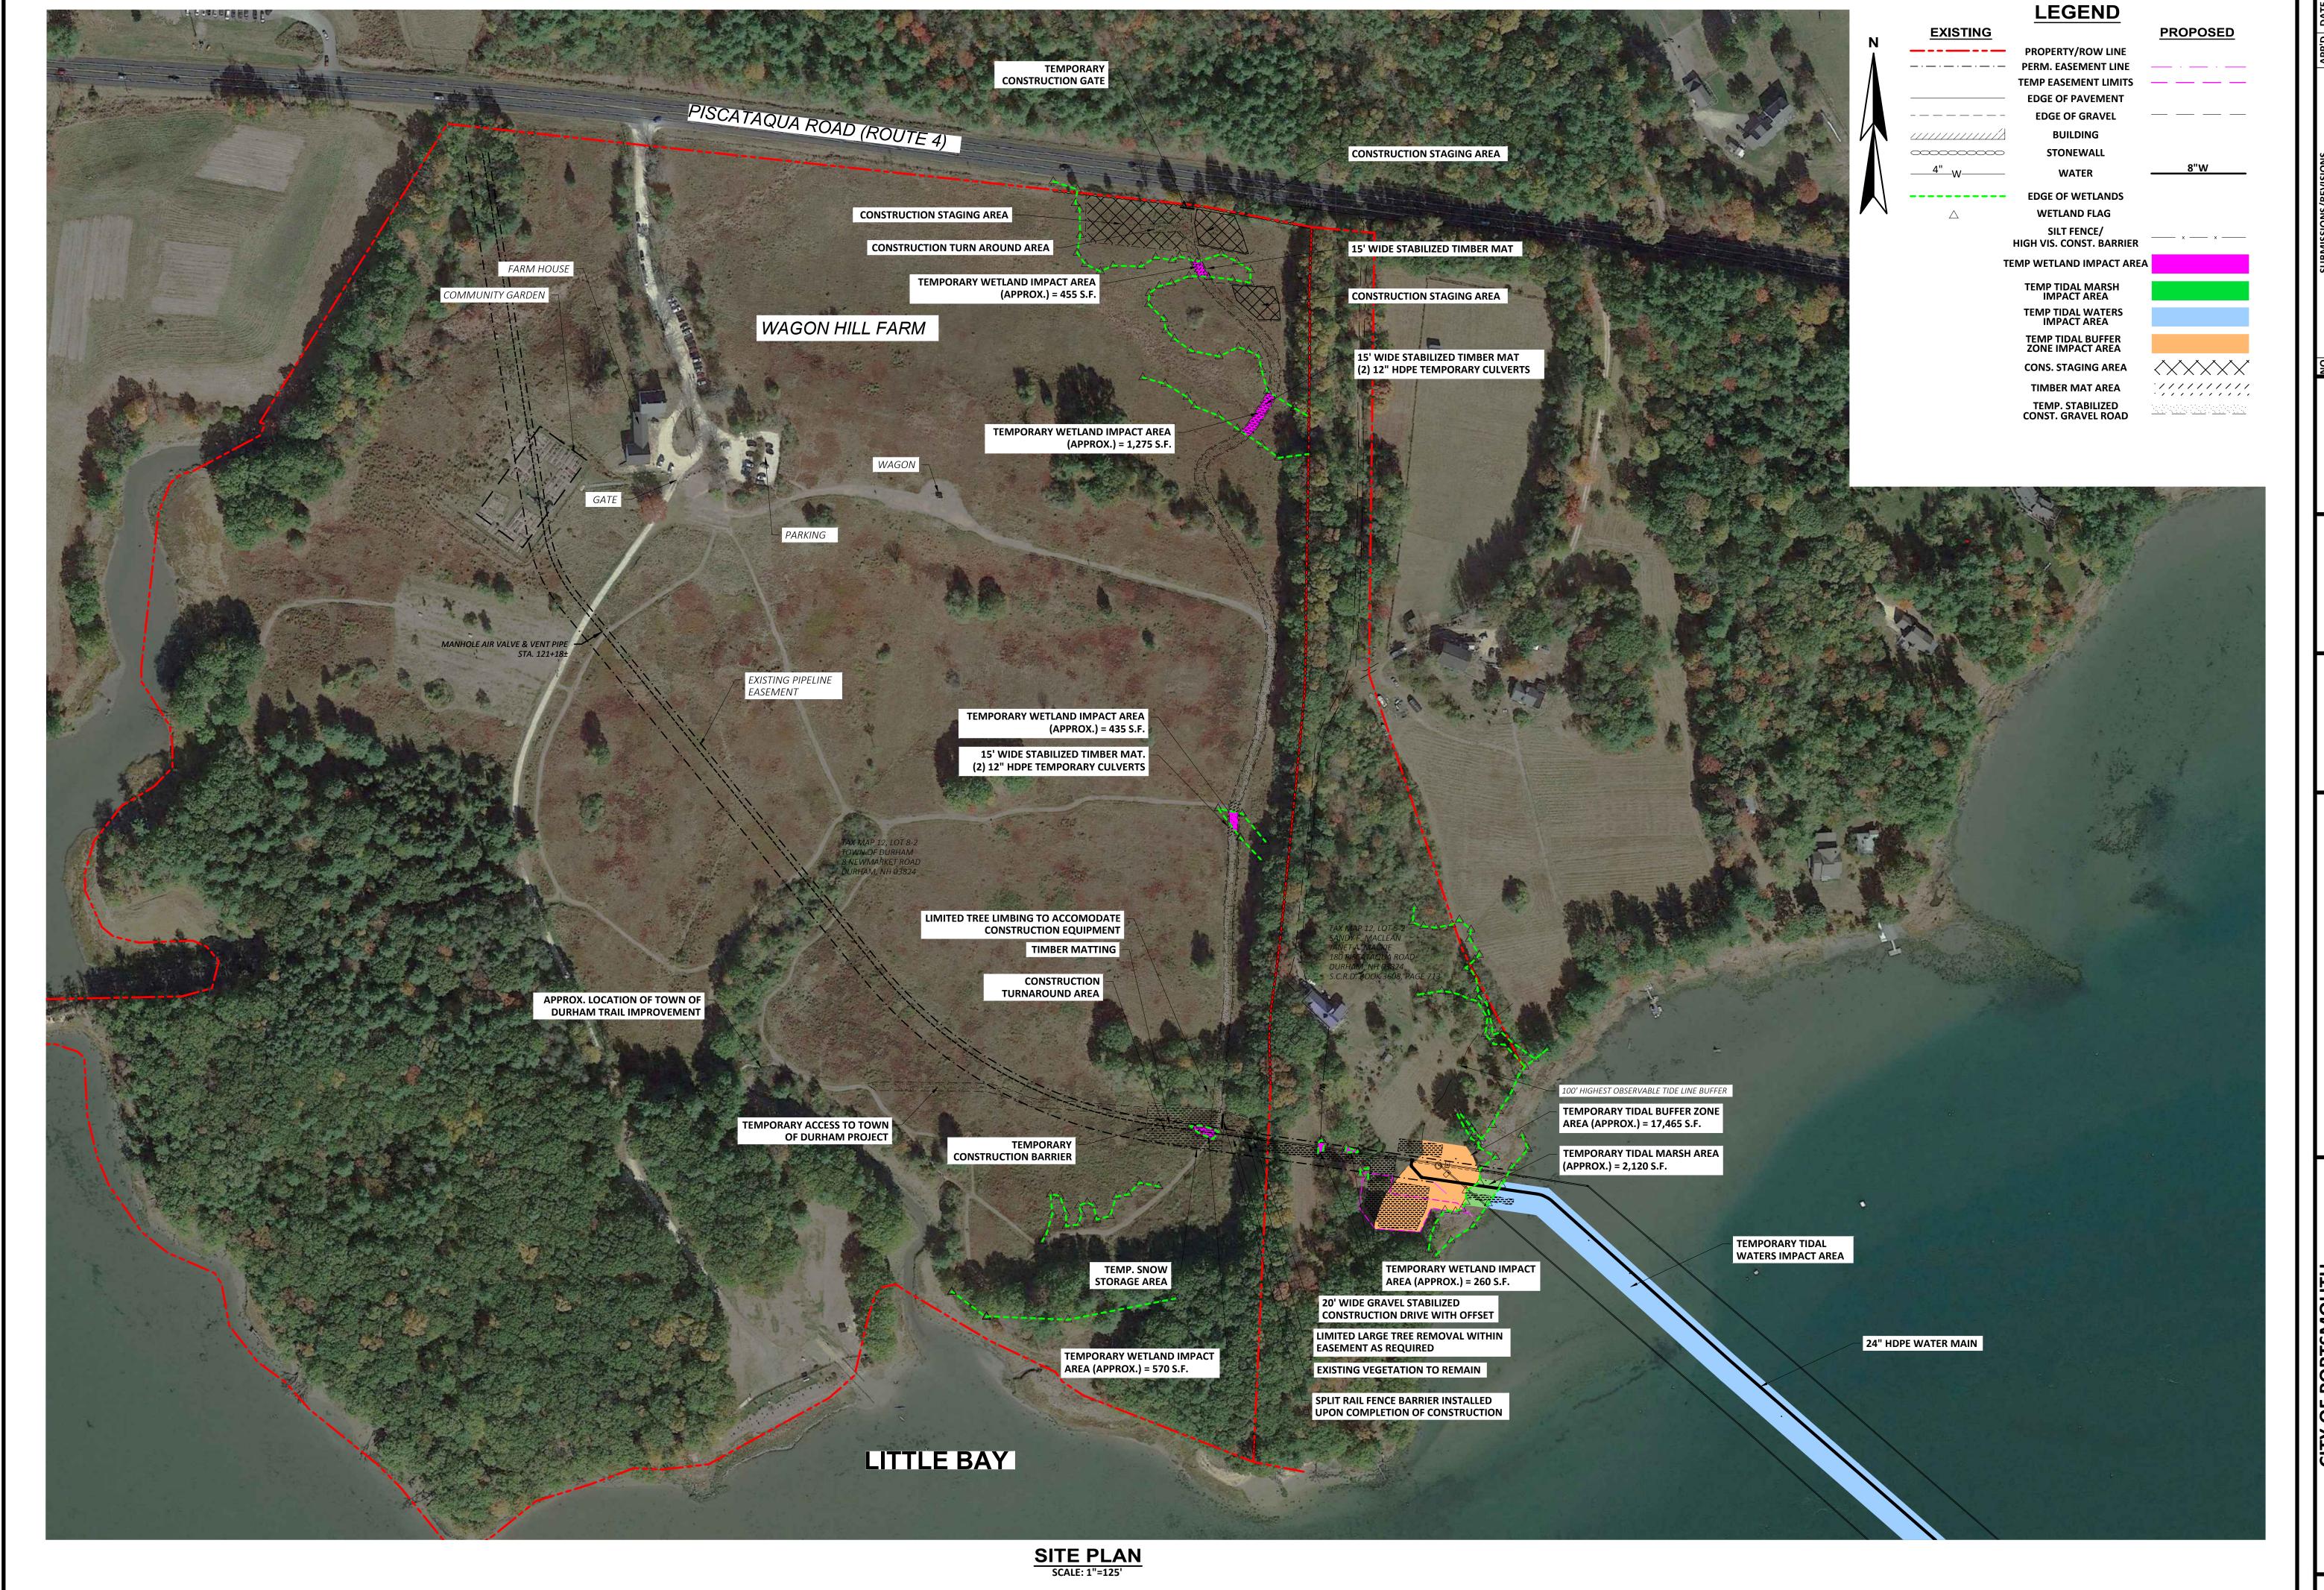
FIGURE 1

Refer to attached Wetland Impact Plan that show the revised proposed wetland impacts.

The revised route will require temporary impacts to freshwater wetlands. Certified wetland scientist Marc Jacobs delineated wetlands along the proposed access route in February 2023. The wetlands were classified as palustrine emergent. Please refer to attached wetland classification report. The proposed access route was selected to minimize impacts to wetlands and existing topography. Timber mats are proposed where the access drive crosses wetlands. The southern crossing will also have two 12-inch temporary culverts installed to allow for the flow of surface water. Please refer to attached Wetland Impact Plan.

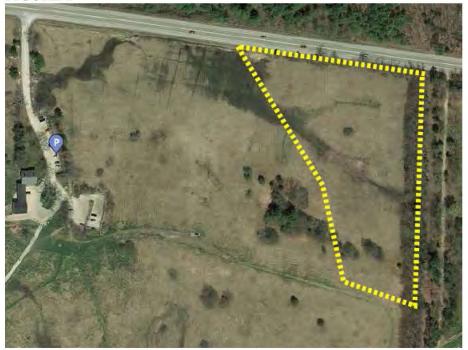
FIGURE 1

The AOI that is the subject of this report is identified with a dashed yellow poly line in Figure 1 below, which utilizes a May 2018 Google Earth© aerial image as a base. The jurisdictional resources which were delineated are depicted on the undated existing conditions drawing prepared by your office, which is appended to the back of this report. Various portions of the adjacent Maclean/Mackie property at 180 Piscataqua Road were delineated on two previous occasions. The initial delineation of the Maclean/Mackie property is described in our report dated September 19, 2019. A subsequent site visit was conducted to delineate a third AOI on the Maclean/Mackie property as well as a limited AOI at Wagon Hill Farm on July 8, 2022 and a report dated October 28, 2022 describes those investigations. This report is intended to supplement but not replace those reports.

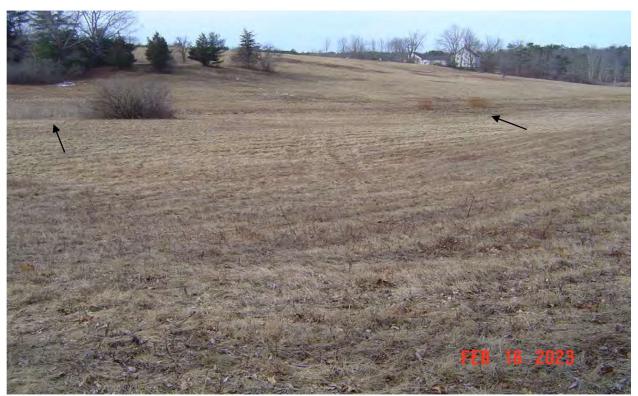
Image 1 – Looking southwest from near Route 4. Wagon Hill Farmhouse in the background. Note cat-tails on the left and willow 'whips' on the right. Wetland identified by flags MJ7-8± to MJ7-24± on plan in foreground.

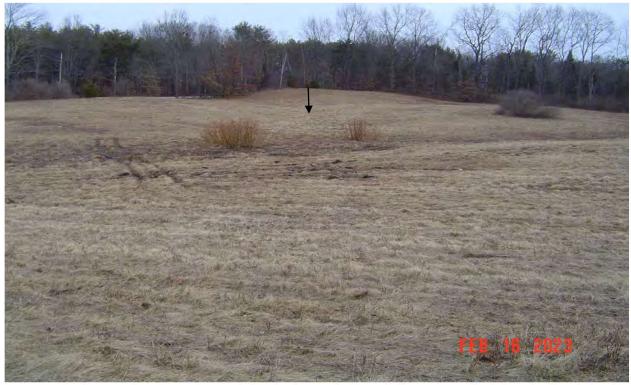
Image 2 – Looking northeast. Route 4 on left in background. Note shallow ruts on the left and willow 'whips' in the center. Arrow points to approximate location of wetland identified by flags MJ7-8± to MJ7-24± on attached plan. (Images captured before flags were placed.) See Figure 2 below.
