Furnace Brook

Watershed-Based Restoration Plan

March 2010

FB Environmental Associates, Inc.

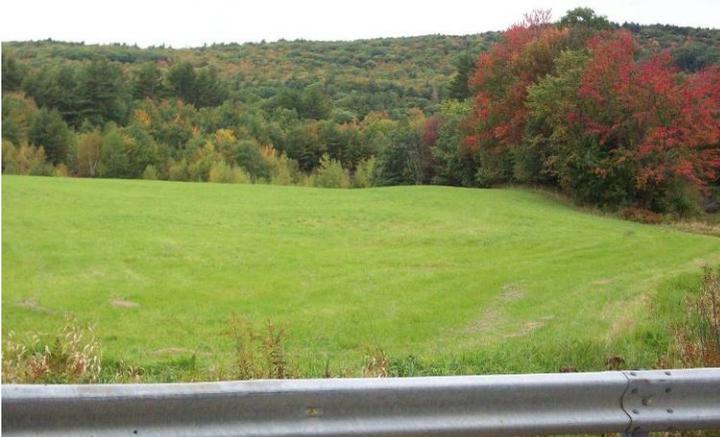
Figure 2-4: Photos of Furnace Brook above and below Appleton Road.

Upper Furnace Brook is defined as the headwaters to the outlet of the impoundment and represents roughly ½ (2.0 of 3.9 square miles) of the Furnace Brook watershed (Figure 2-3). At its headwaters, Furnace Brook drains the eastern slope of Kidder Mountain (elevation 1,805 feet) and two smaller hills. The Brook forms two braids as it flows across agricultural fields and under Appleton Road towards the impoundment. At this point, the Brook is typically 2 to 5 feet wide and 1 to 2 feet deep. Photographs of Furnace Brook above and below Appleton Road are provided in Figure 2-4 (below).

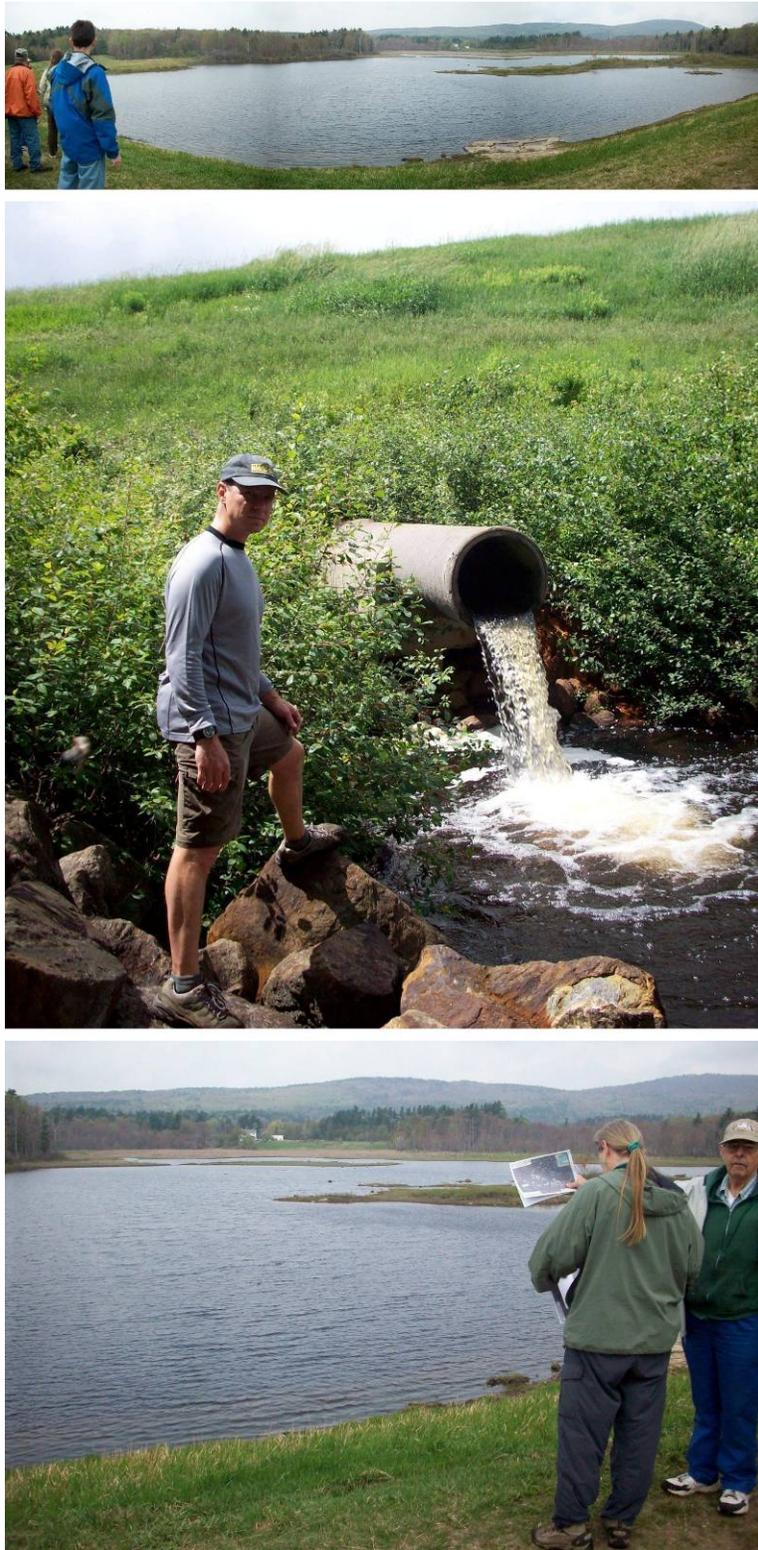
Figure 2-5: Photos of Furnace Brook facing west across the impoundment.

From the Appleton Road crossing (elevation approximately 1,100 feet), Furnace Brook flows through a low gradient reach and into the impoundment. Another unnamed brook enters the impoundment from the southeast after crossing Appleton Road near the Appleton Gates Apartment Building. Figure 2-5 (next page) provides photographs taken facing west across the impoundment and show Kidder Mountain on the right and the small ridges to the left. The two white buildings visible in the distance are situated near Furnace Brook at Appleton Road. Furnace Brook exits the impoundment via a pipe, shown in Figure 2-5.

- CM 1 – Furnace Brook Impoundment Outlet. Furnace Brook flows into a large flood control impoundment above Thayer Road. The outlet of the impoundment is a large pipe elevated more than 3 feet above the streambed (Figure 2-5). This impoundment outlet is a barrier to fish passage and introduces excessive hydrologic force resulting in erosion of downstream stream banks.
- CM 2, 3, 4, 5 – Undersized Roadway Culverts. As it flows downstream, Furnace Brook flows under Appleton Road, Thayer Road, Temple Road, and Tricnit Road. Each of these road

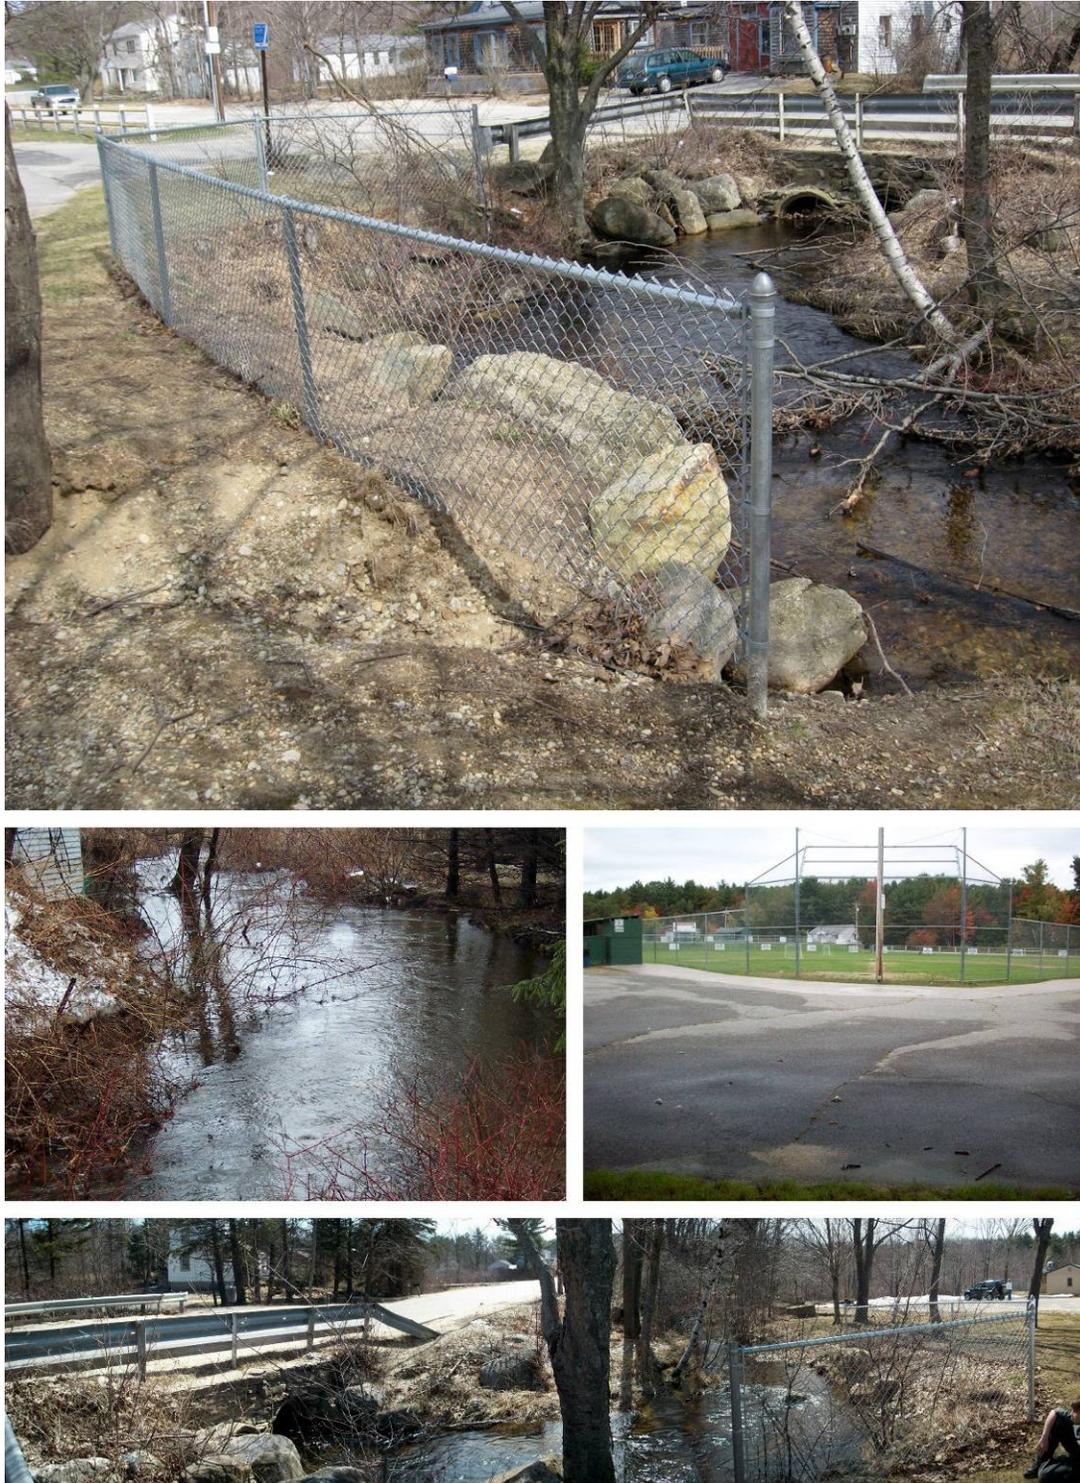
Figure 2-7: Photos of Furnace Brook at the Temple Road crossing.

At the outlet of the impoundment, Furnace Brook flows steeply downhill, crossing Thayer Road and into Temple Road and the downtown area. Furnace Brook drops roughly 100 feet, from approximately 1,070 at the impoundment outlet to approximately 970 at Temple Road in the downtown area. The downtown area is relatively flat and development has impacted Furnace Brook in this area. Figure 2-7 provides

photographs of Furnace Brook at the Temple Road crossing and illustrates the proximity of the park and nearby residences to the Brook.

Areas of DCIC in Furnace Brook include the town park adjacent to the Temple Road crossing (Figure 2-7). DCIC is present along Willow Brook from Route 124 to the confluence with Furnace Brook at Temple Road. During rain events, sheet flow of stormwater across the ballfield parking lot into Furnace Brook and from Temple Road into Willow Brook has been observed. This DCIC is likely to be causing adverse impacts on the Brooks. Furnace Brook and Willow Brook have been physically modified and adversely impacted by development activities in the downtown area.

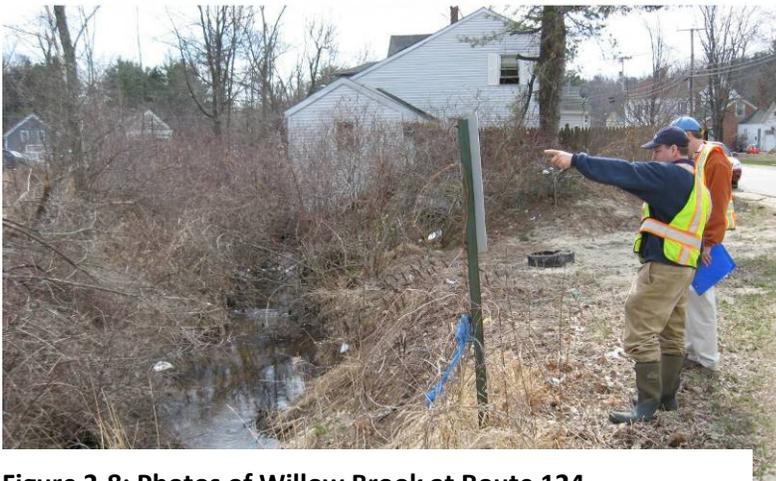
Figure 2-8: Photos of Willow Brook at Route 124.

Immediately south of Temple Road (within 10 feet), Willow Brook enters Furnace Brook along its southern bank. Willow Brook is a tributary to Furnace Brook that flows northward along Temple Road and joins Furnace Brook in the downtown area. Willow Brook is a roadway swale in the reach from Route 124 to Furnace Brook confluence (Figures 2-8 and 2-9). Upstream (and south) of Route 124, Willow Brook flows around a parking lot and becomes a wetland stream.

Directly-connected impervious cover (DCIC) was observed throughout the Middle Watershed area. Impervious cover (IC) is land covered with materials that do not allow rainwater to soak in. IC areas are impervious to rainwater and the water runs off of these areas. Examples of IC include parking lots, roadways, and roofs. At numerous locations along Furnace Brook and Willow Brook, IC areas are directly connected to the stream, such that rainwater flows directly across the IC area and into the Brook. DCIC can have an acutely adverse impact on small streams because rainwater runoff delivers excessive solids loads and a variety of pollutants to the stream. DCIC runoff also brings excessive hydrologic energy that tends to damage the stream channel (e.g., flash floods).

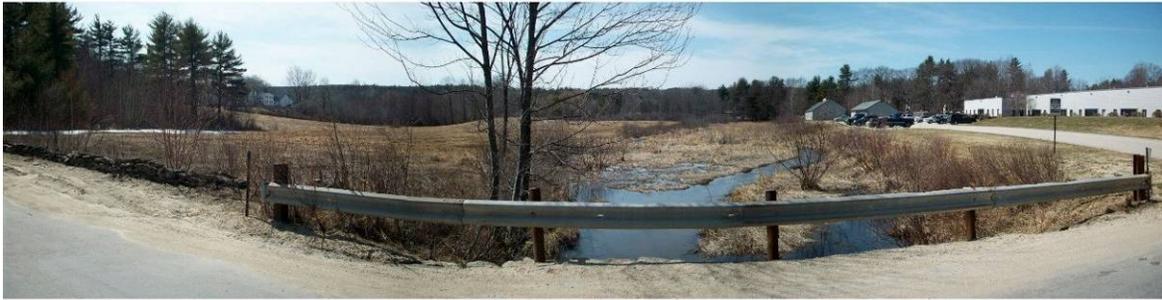
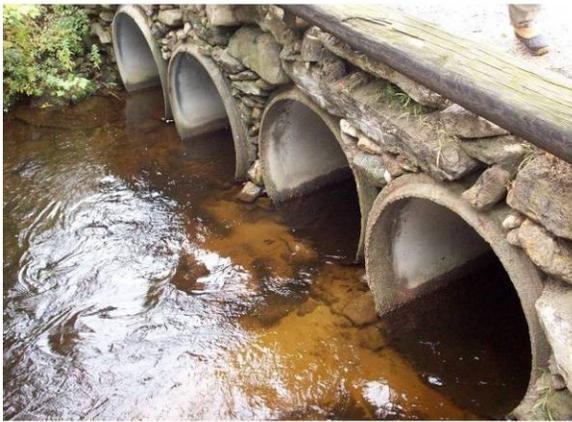
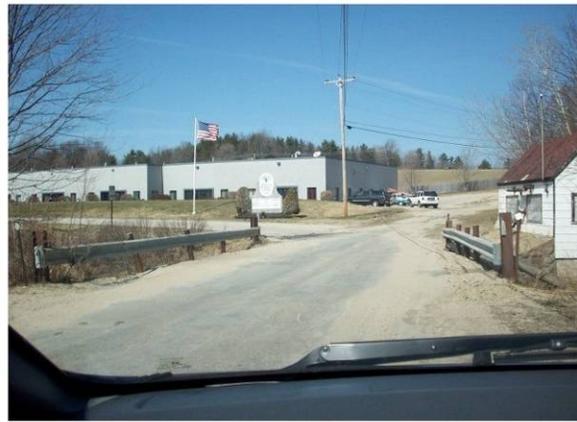
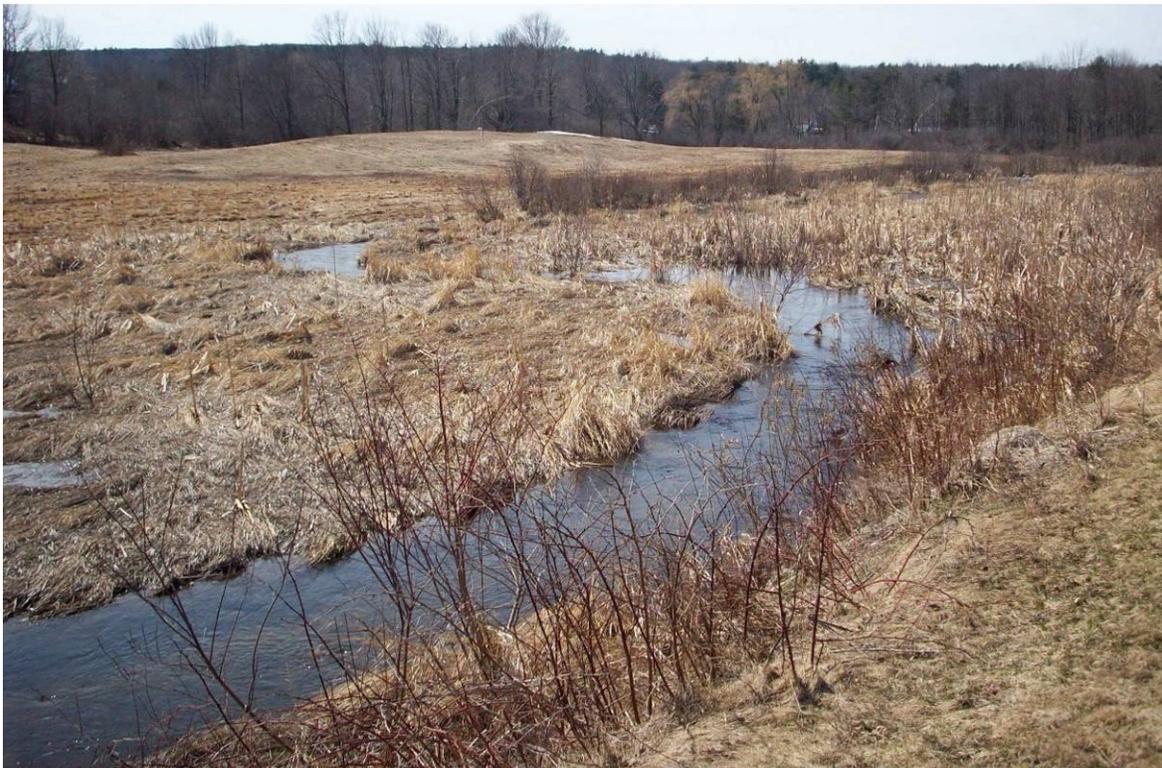
Figure 2-10: Photos of middle Furnace Brook at Tricnit Road.

Downstream of the Temple Road crossing, Furnace Brook flows into a wetland area and then crosses Tricnit Road (Figure 2-10). The wetland reach of Furnace Brook at Tricnit Road is bordered by a commercial building to the north and several residences to the south. The stream forms two braids as it flows through the wetland. There is a small historic dam just below the Tricnit Road crossing. Below the dam, the stream is straight and widens as it flows over cobbles.

- CM 6 and 7 – Abandoned Dams. At Tricnit Road and just below Old Tenney Road, Furnace Brook flows over abandoned dams. These dams adversely impact aquatic habitat and may increase flooding impacts.

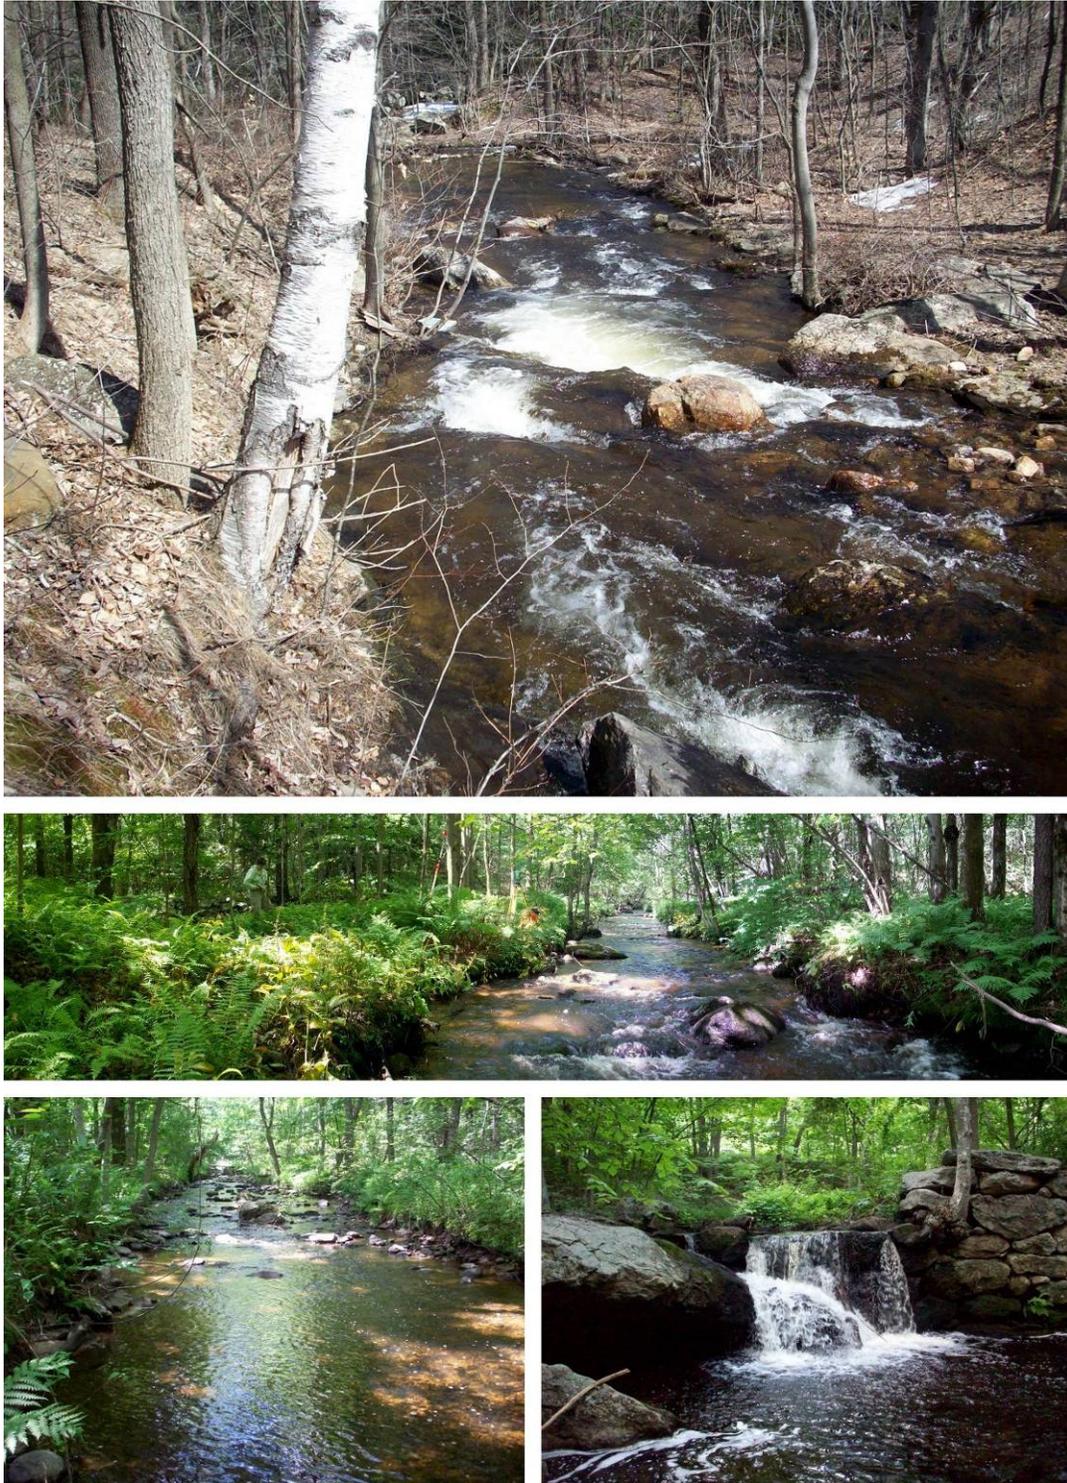
Figure 2-12: Photos of Lower Furnace Brook.

Lower Furnace Brook extends from the Tricnit Road crossing to the confluence with the Souhegan River (Figure 2-11). The lower reach is approximately 1.4 miles long and drains an area of approximately 0.7 square miles. This reach of Furnace Brook is relatively steep with a vertical drop of approximately 90 feet, from approximately 960 feet at the Tricnit Road crossing to approximately 850 feet at the Souhegan River confluence. The Lower Furnace Brook watershed is less developed than the middle Furnace Brook area and is forested along its banks (Figure 2-12). A conservation easement and nature walk are present in the Lower Reach from Route 124 to the confluence.

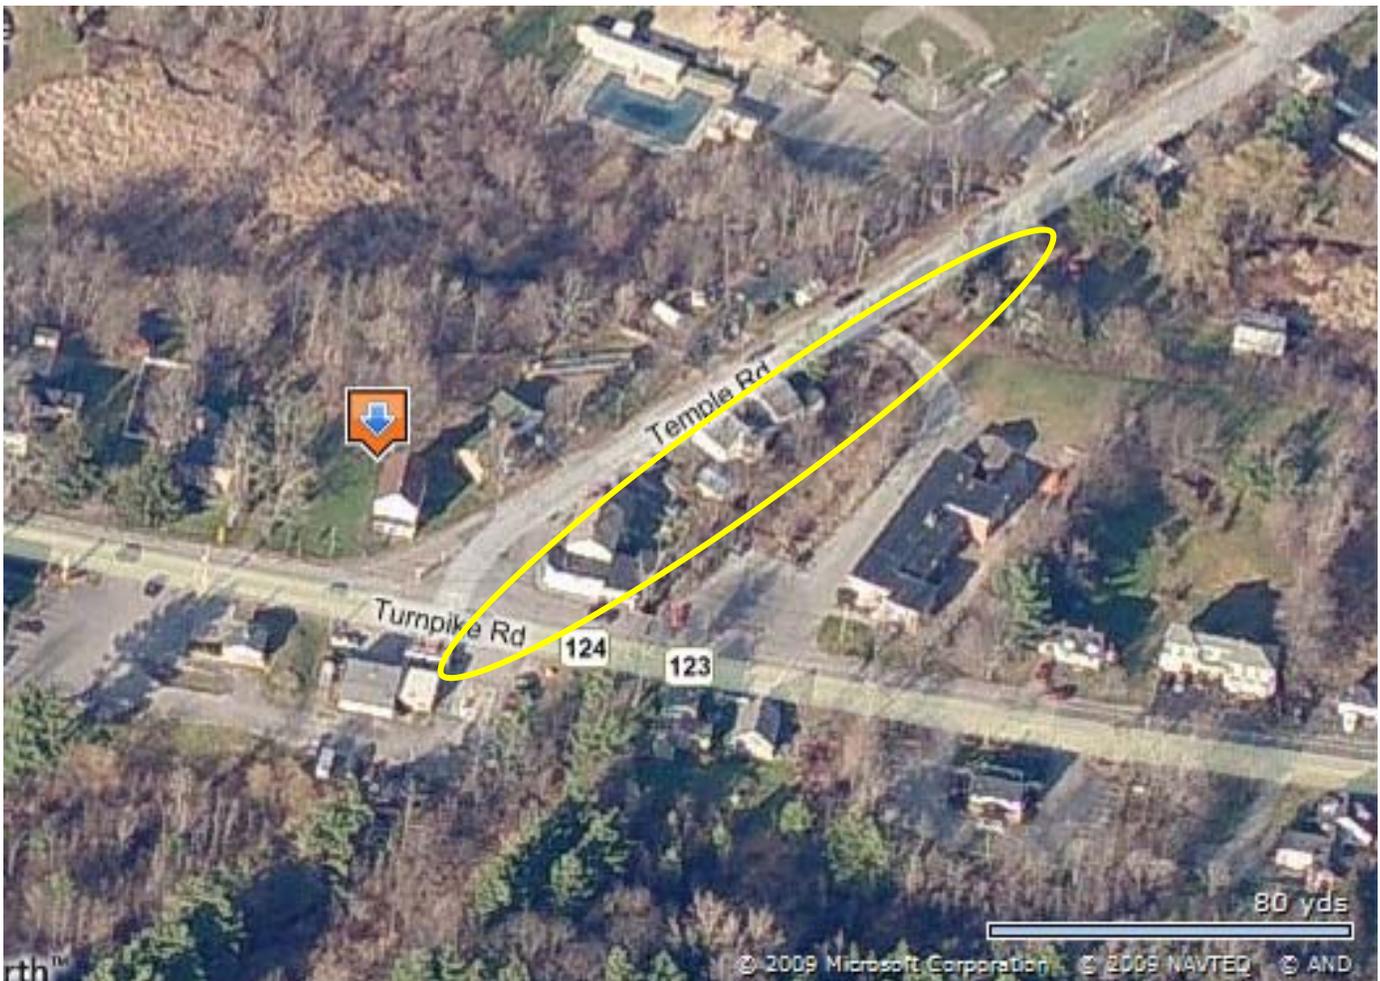
Background: Temple Road runs parallel to Willow Brook and bridges Furnace Brook. Roadway stormwater runoff appears to be routed in two ways along this stretch of road. Firstly, surface flow is routed to Willow Brook directly as the brook serves as a roadside swale. Secondly, roadway runoff is routed to a subsurface stormwater catch basin system.

The highlighted area indicates the location along Temple Road in which a multitude of runoff problems exist.

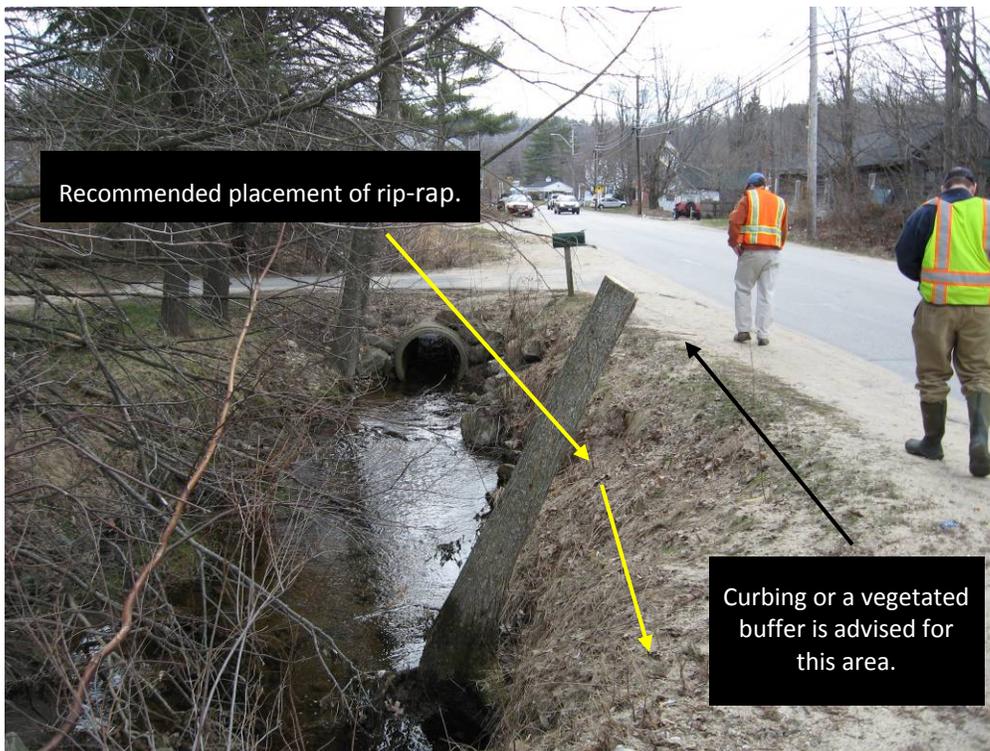
SITE RW1 (B): TEMPLE RD.

Problems: Runoff from Temple Rd. is entering Willow Brook due to a lack of an appropriate system to divert or absorb runoff. Brook also lacks a healthy buffer of vegetation.

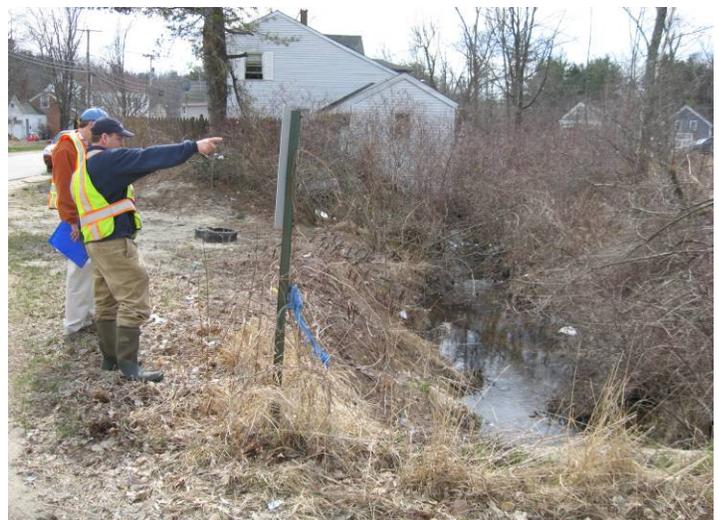
This image highlights the unprotected banks of Willow Creek. Install native riparian vegetation to increase bank stability and increase absorption.

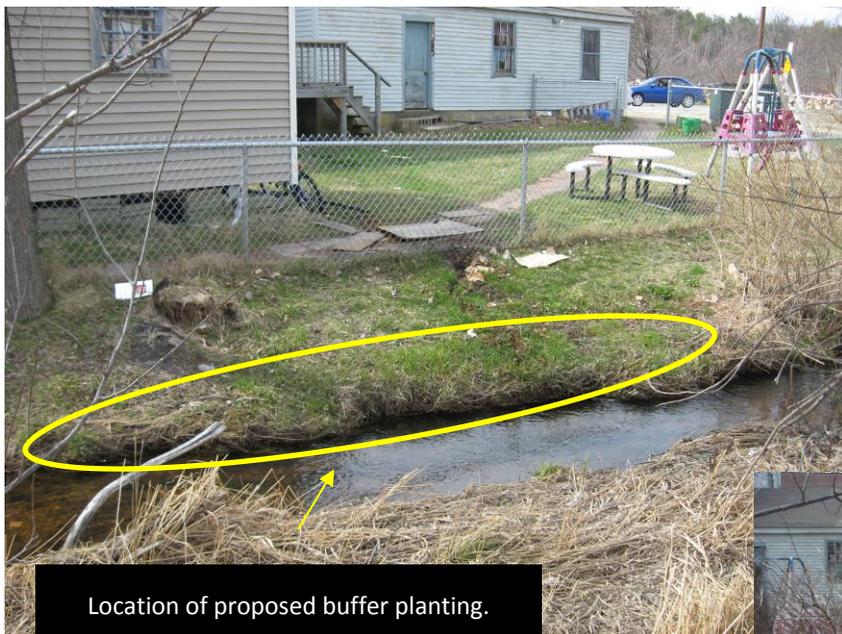
Location of proposed buffer planting.

Recommended Solutions: Install buffer plantings that extend from the road overpass back 50-75'. Have grocery store owners develop a Stormwater Pollution Prevention Plan (SWPPP) that addresses garbage disposal and dumpster maintenance. Outdoor storage of store supplies also needs to be addressed.

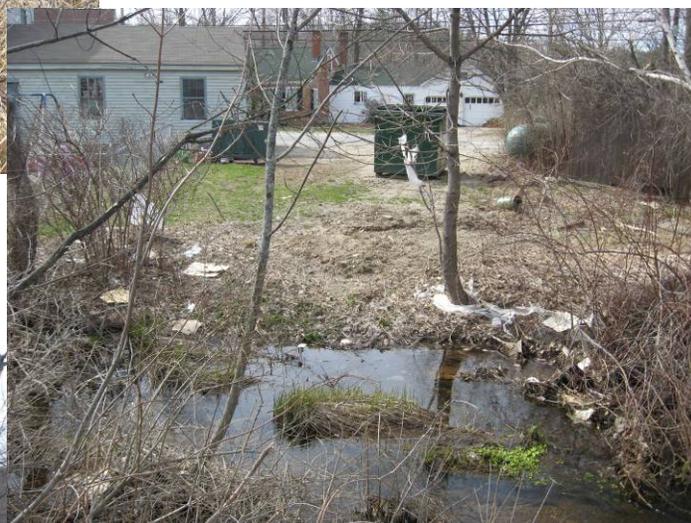
Poorly maintained dumpster area results in trash entering brook.

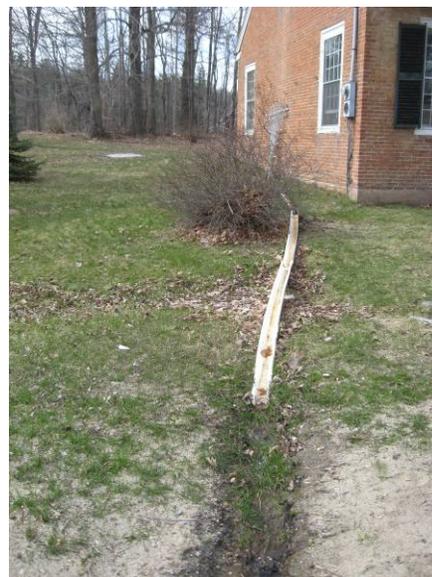
Roof runoff from house across the street runs directly into the brook.

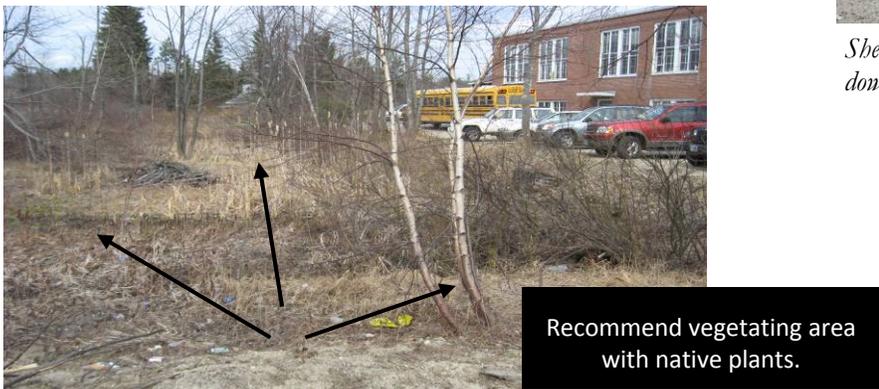
Lack of appropriate buffer between parking lot and brook results in runoff traveling unobstructed towards the water.

Sheet flow across parking area moves sediment down slope and towards brook.

Recommended Solutions: Remove some parking spaces in order to create more of a buffer between the brook and the lot. This will also reduce the amount of impervious surface of the lot. Another option is to repave lot with permeable pavement. Recommend installing an infiltration strip along edge of parking lot closest to brook to catch runoff from the lot. A snow plowing maintenance plan is also needed for this parking lot. Fill in unvegetated land between the lot and the brook with native plantings. This will help improve infiltration of water that travels off the lot. Curbing or vegetated swales are an option in this case as well.

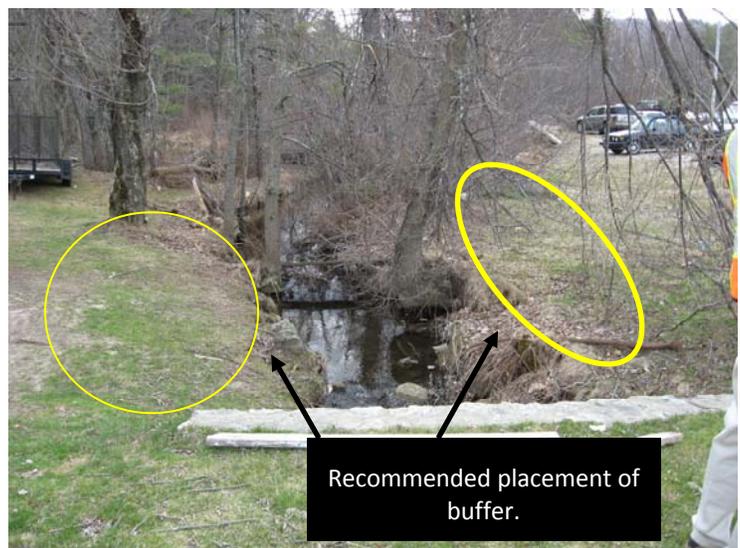
Problems: The parking lot of the Mobil Station is very close to Willow Brook and delivers contaminated runoff from the parking lot to the brook due to a lack of any type of buffer.

View of Mobil Gas Station parking area, next to Willow Brook. Installing a vegetated buffer will reduce the ability of stormwater to enter the brook.

Recommended Solutions: Install a vegetated buffer.

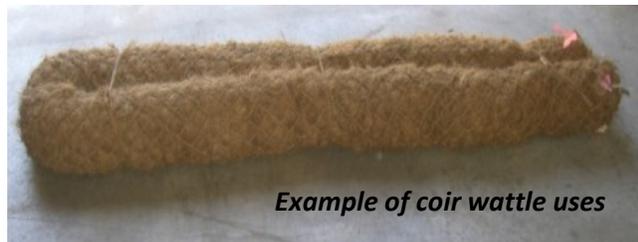
Design of culvert needs to be re-assessed for fish passage.

- 1) Install coir wattles or mulch rolls along Old Tenney Rd., extending from the intersection and leading north along the road for approximately 60'. This would provide a natural, low cost and effective way of controlling sediment runoff. Lightly packed fibers allow water to travel through freely while filtering sediment from stormwater.
- 2) Enhance and maintain existing turnout on Old Tenney Rd. Apply crushed stone to the area to cut down on sediment transport and reinforce the existing berm by applying erosion control mulch to armor the structure.
- 3) Further study is recommended to find out if this culvert design limits fish passage.

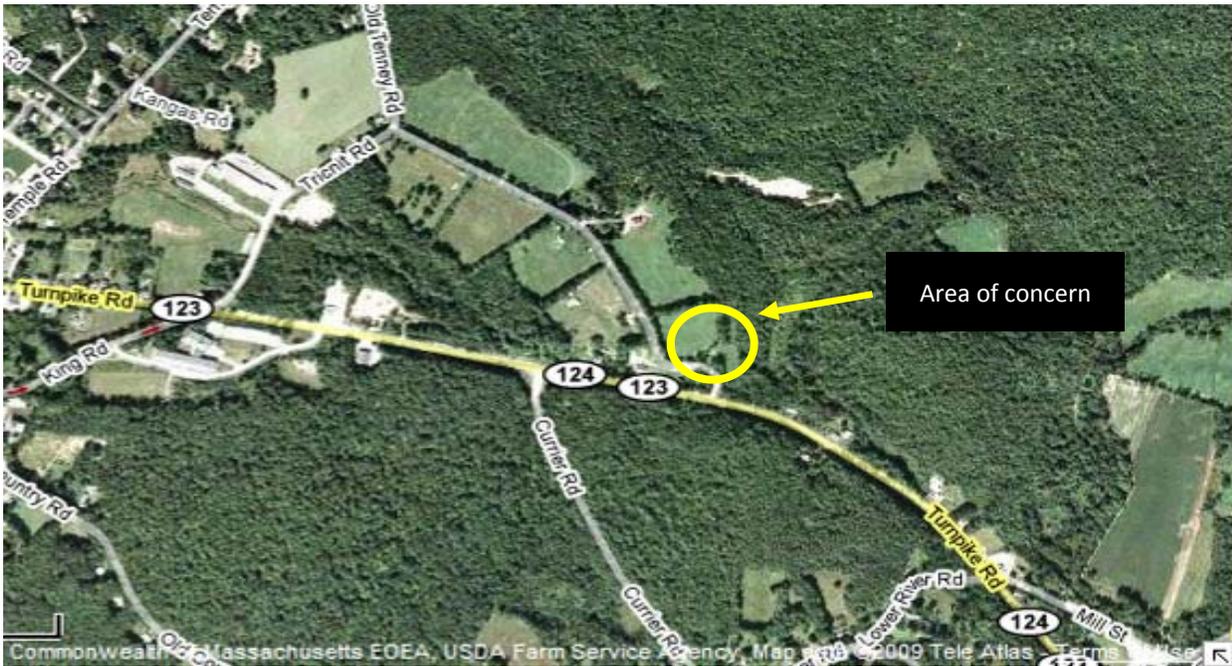
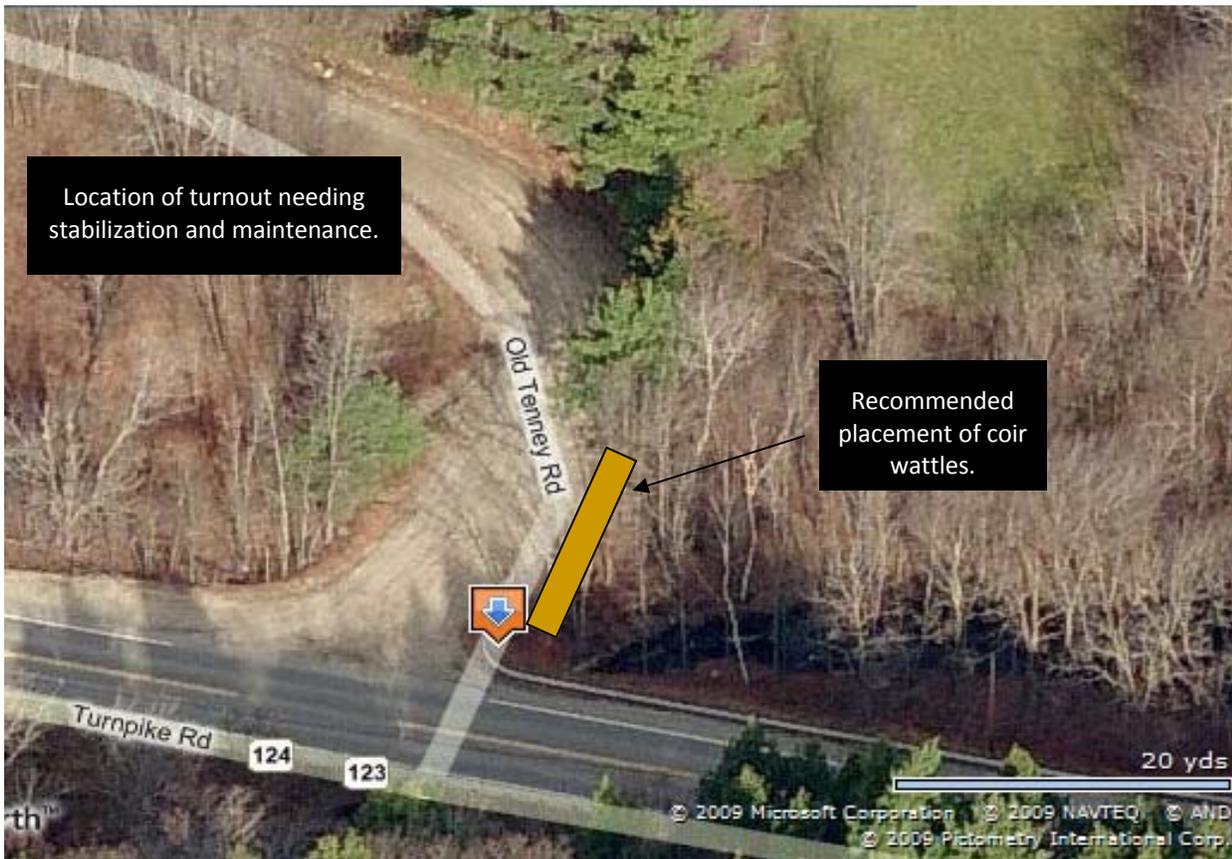
SITE RW4: OLD TENNEY RD. - RTE. 124

Background: This dirt road was re-graded in 2008 and large quantities of sand were observed to be transported from the roadway to Furnace Brook below, near the Rte. 124-Old Tenney Road intersection.

Recommended Solutions: Control sediment entering the stream from the road. Several different BMPs can be installed at this site to accomplish this. The suggestions are as follows:

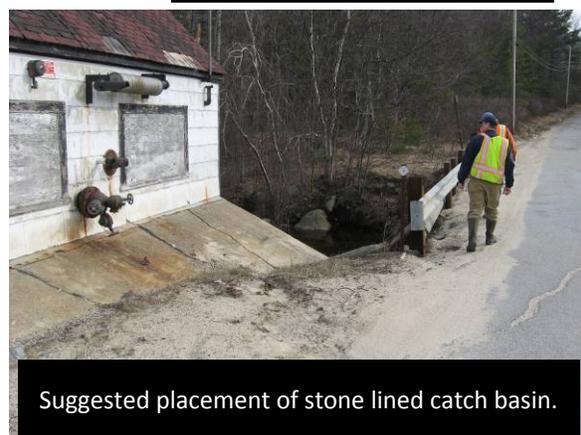
This image provides visual evidence that brook is susceptible to runoff from both sides of overpass.

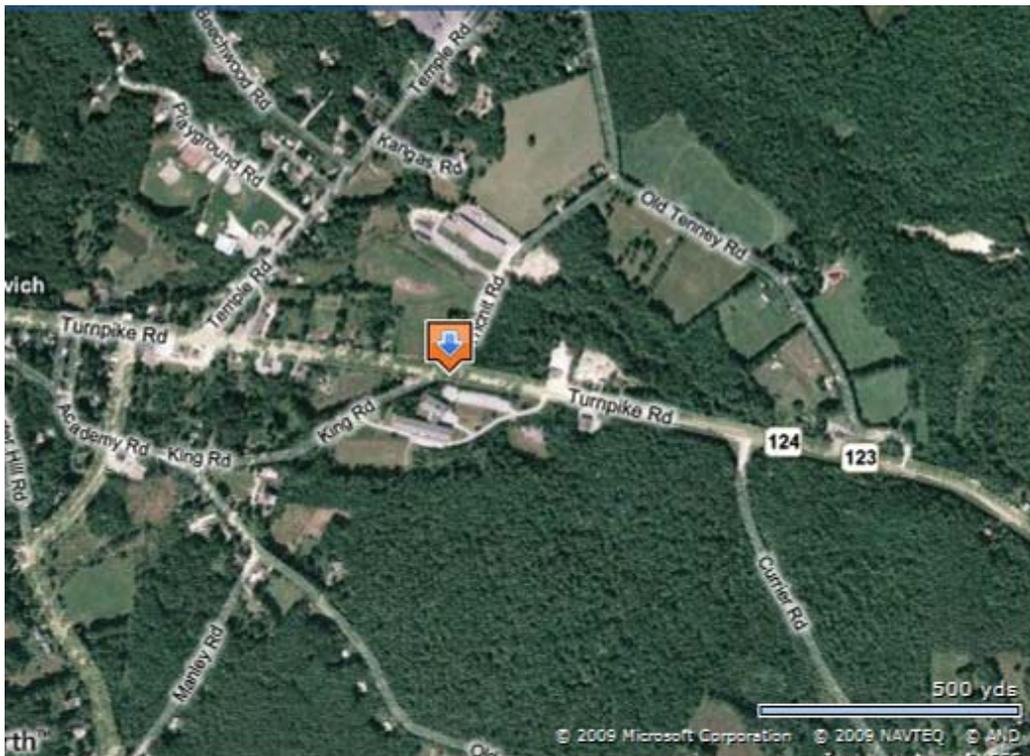
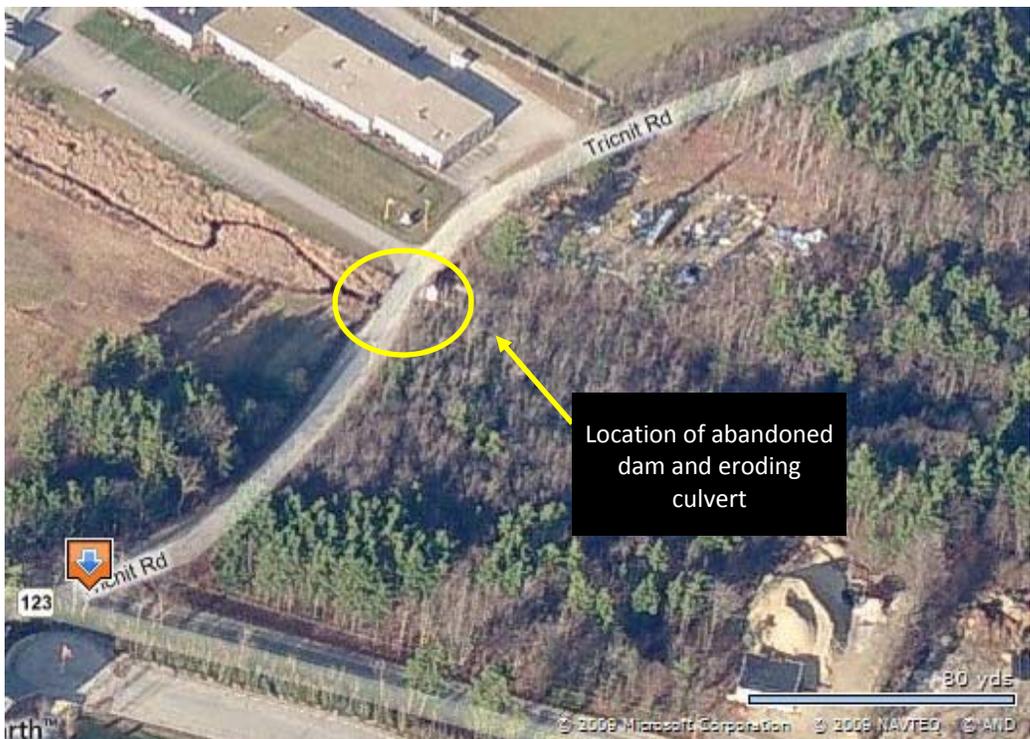
SITE RW8: TRICNIT RD.

Problems: Severe erosion of ditch lining the roadway, resulting in sediment deposition into brook. The unprotected areas around the overpass and the slope down to the brook are prime areas for sediment transport into brook.

Recommended Solutions: The area adjacent to the abandoned dam needs to be stabilized to prevent the sediment from traveling over the edge of the slope and into the brook. This can be accomplished by either installing a stone lined catch basin or lining the area with crushed stone or rip rap. On the other side of the brook, near the edge of the guardrail is the additional area that needs to be stabilized. The same treatment can be applied to this area as the other side, but considering that the conditions are more severe on this side, a large and/or deeper basin needs to be constructed.

Consideration should be made to the length of road and volume of sediment that these structures are receiving. Also recommend assessing the slopes of the stream channel itself for the possibility of reinforcement.

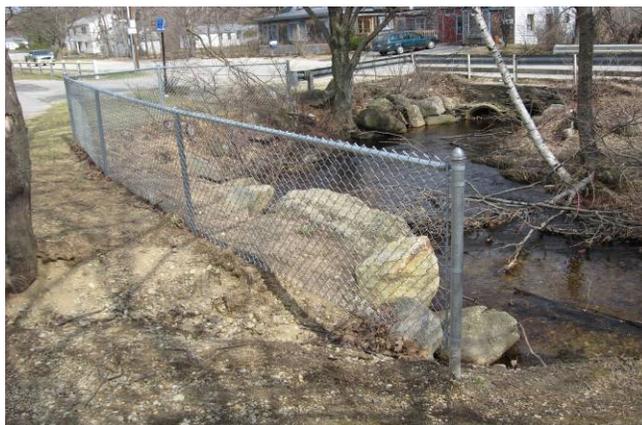
Severe erosion of this gully increases flow of runoff to the brook.

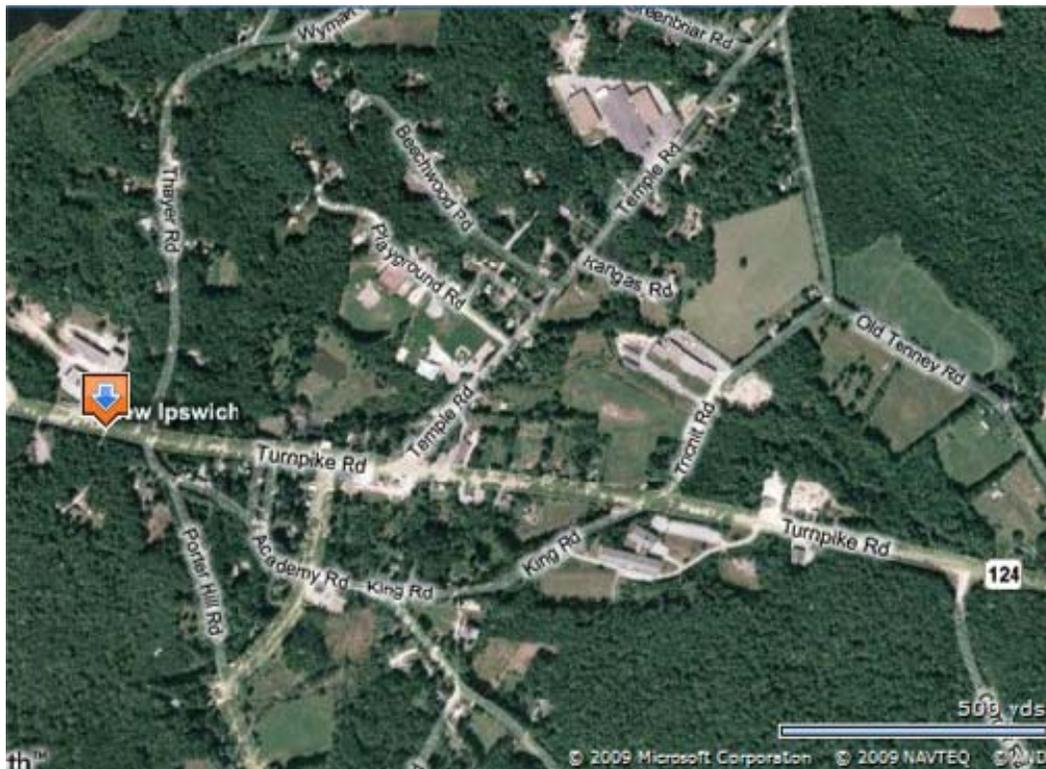
Image shows the location of the parking lot in respect to the brook. Installation of some type of permeable paving will assist in reducing the flow of runoff to the brook.

Recommended Solutions: There are several recommendations for improvements to this area to reduce sheet flow off of the parking lot. A recommendation is to install a type of permeable paving in the parking area—or for a portion of the parking area as a demonstration site. This is a LID (Low Impact Development) application that will result in increased absorption of water during a storm event which will help lessen the flow of sediment towards the brook. Second, a vegetated infiltration trench (120') is recommended for the area adjacent to the edge of the parking lot closest to the brook. Several other solutions are recommended including stabilizing a gully, posting signage that promotes good pet waste practices, and eliminating a pipe in the swimming pool area.

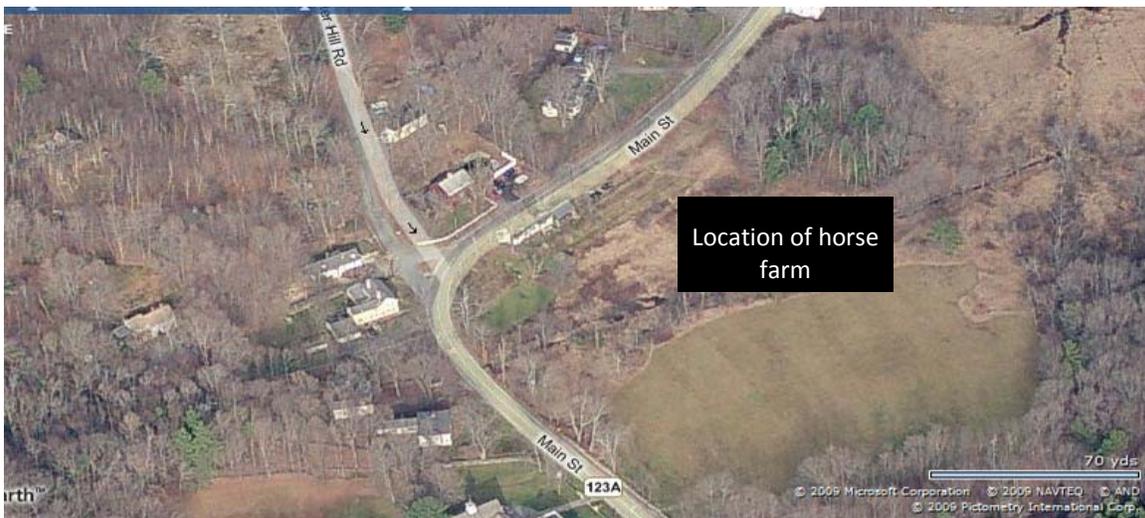
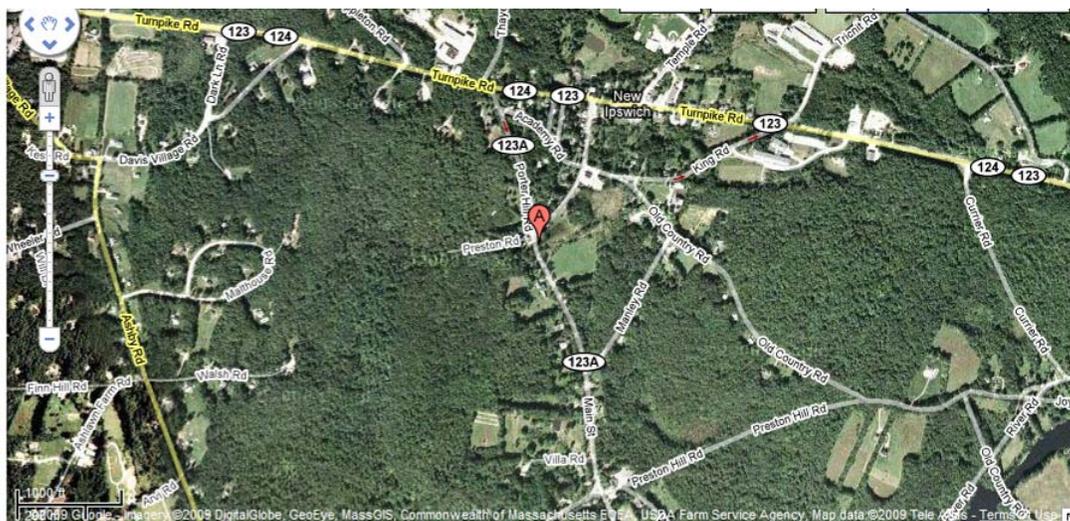
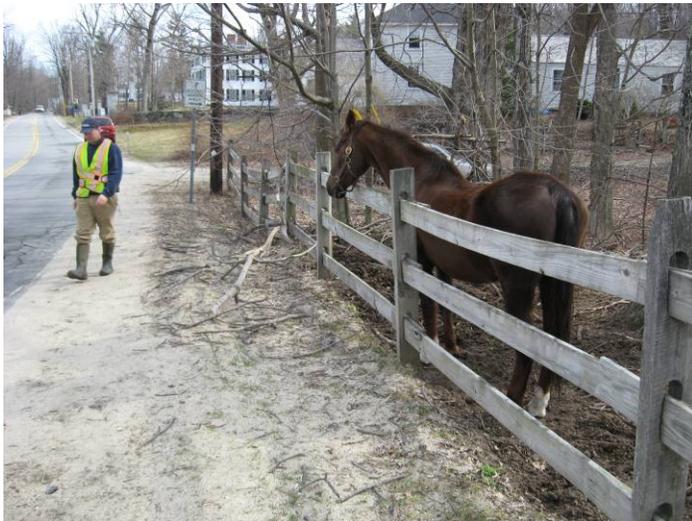
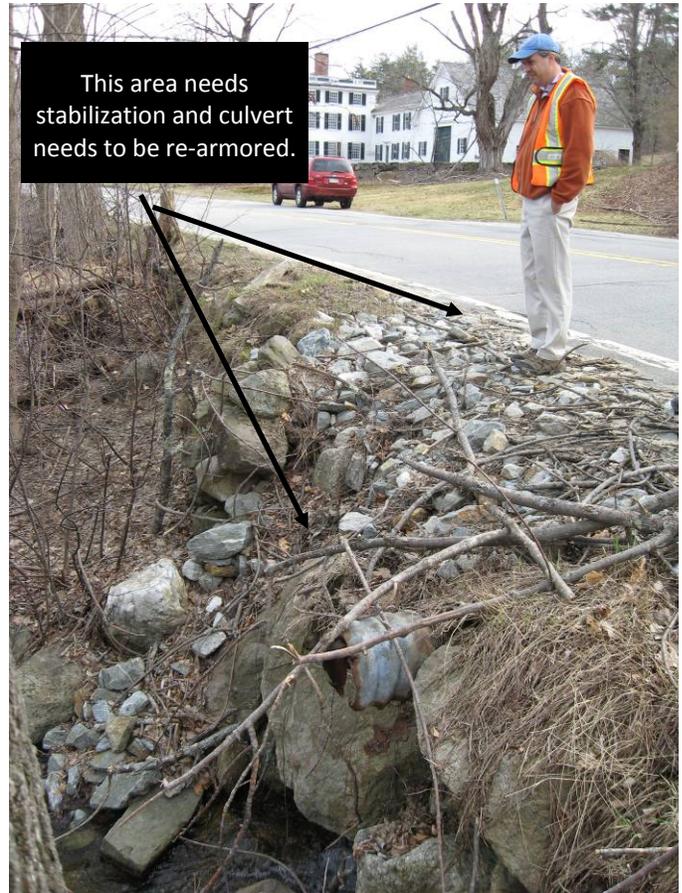
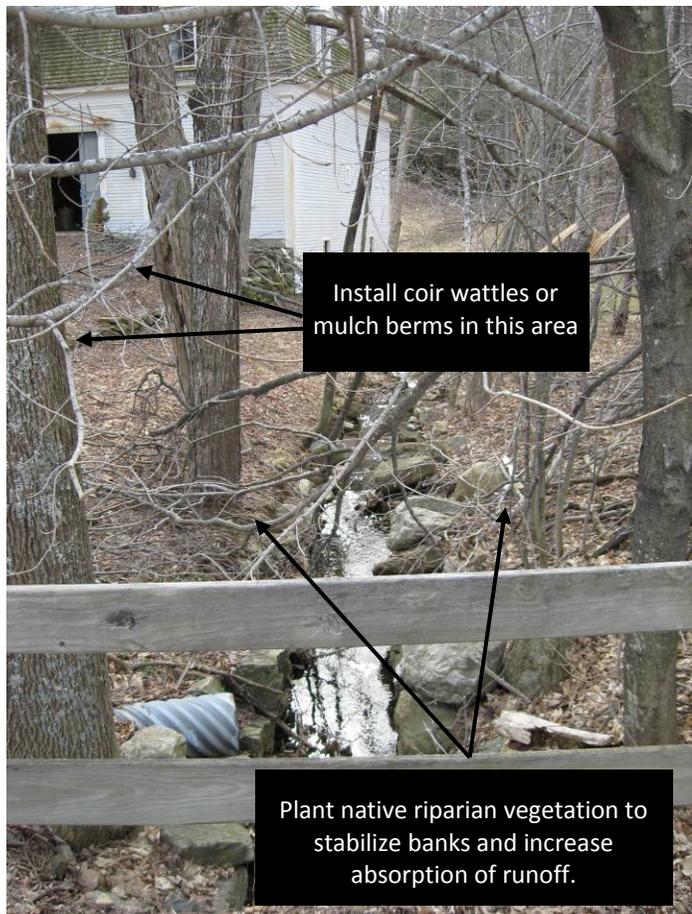
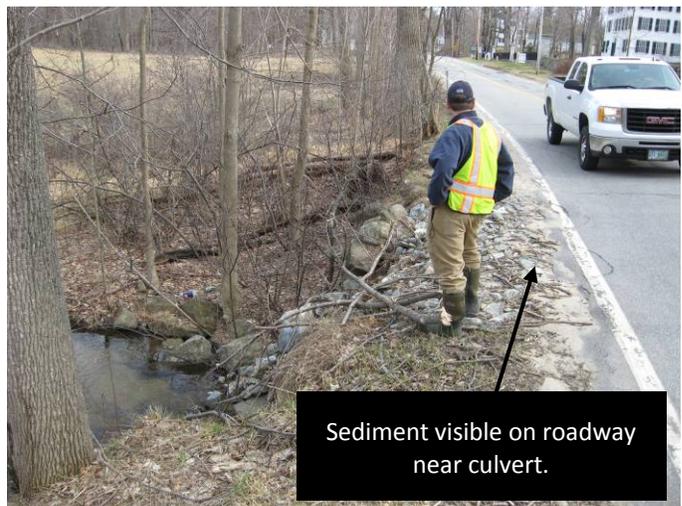
SITE HF4

Problems: This horse farm is located adjacent to Furnace Brook. With the horse farm being a potential source of pollutants, BMPs are recommended to prevent polluted runoff from entering the brook. Problem areas include the denuded bank of the brook close to the horse farm, and the culvert, which is not armored and has severe erosion occurring around it.

Recommended Solutions: Recommended BMPs for this site are as follows: 1) Line the perimeter of the horse pasture (abutting the brook) with coir wattles or a mulch berm 2) stabilize banks surrounding the culvert with rip-rap and armor the outlet 3) install buffer plantings along brook where there is barren and eroding soil. Owners are encouraged to work with the Hillsborough County Conservation District and NRCS District Engineer to develop a nutrient management plan for the property.
