Resilient Tidal Crossings

*An Assessment and Prioritization to Address New Hampshire's
Tidal Crossing Infrastructure for Coastal Resilience*

May 2019

Prepared in partnership with:
NHDES Coastal Program – Water Division
The Nature Conservancy
University of New Hampshire

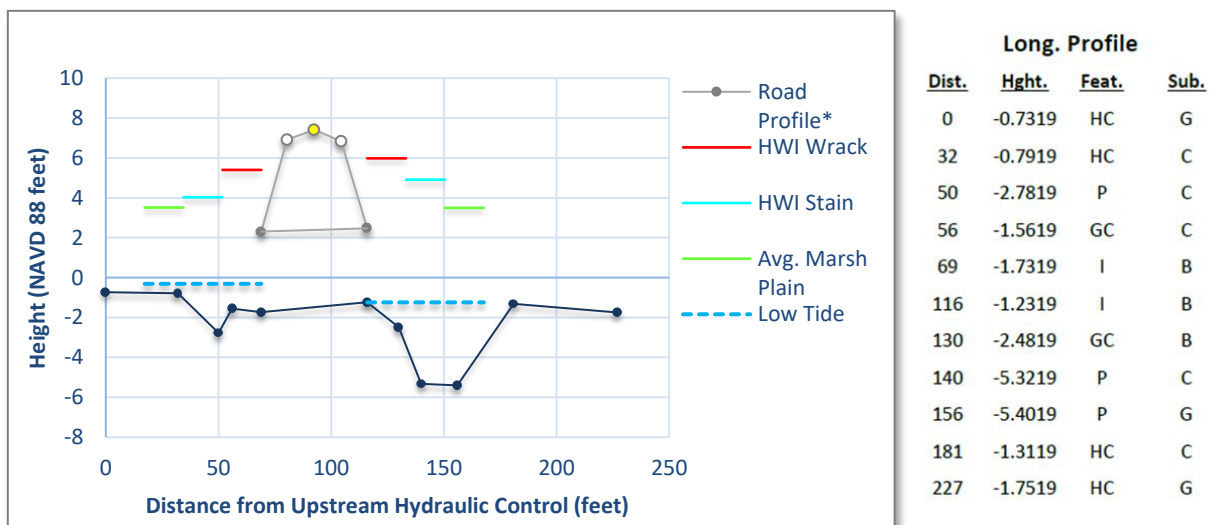
Another helpful aspect of the Crossing Cross Section and Stream Longitudinal Profile graphs are the high water indicators, which can inform the hydraulic performance of a tidal crossing structure. Assessed tidal crossing sites exhibit many configurations of high water indicators. Figure 23, for instance, shows that the high water indicators (wrack and stain) features are higher on the downstream side of the crossing, indicating slight buildup of water on the incoming tide. Other sites

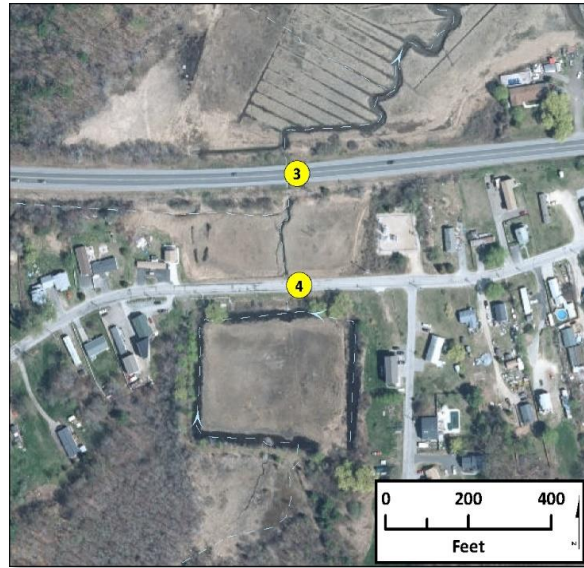
A pipe running under South Main Street in Seabrook conducts very limited tides to a small square marsh surrounded by a moat dredged at its edge which in turn is surrounded by a berm. The marsh was used to pasture horses without need for any fencing (moat) according to Sue Foote, long-time resident. The undersized crossing shows erosion, poor opportunity for organism passage and poses some risk to flooding the roadway, with an overall combined score of 5: highest priority for restoration.

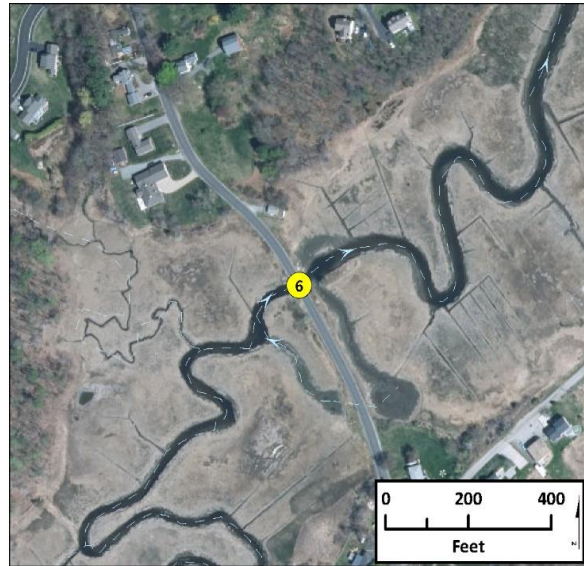
Cains Brook has two tidally influenced road crossings (crossing ID #6 and #7). The lower one is a bridge at Causeway Street where a dredged channel under the current bridge replaced a sinuous tidal creek to the south. The overall restriction score is 3, moderate priority. A combination of soil disturbance, restrictions and freshwater sources allowed common reed (*Phragmites australis*, an invasive weedy grass) to colonize the marsh on both sides of the crossing and the upstream marsh was the site of a long-term *Phragmites* control project that did not use herbicide.

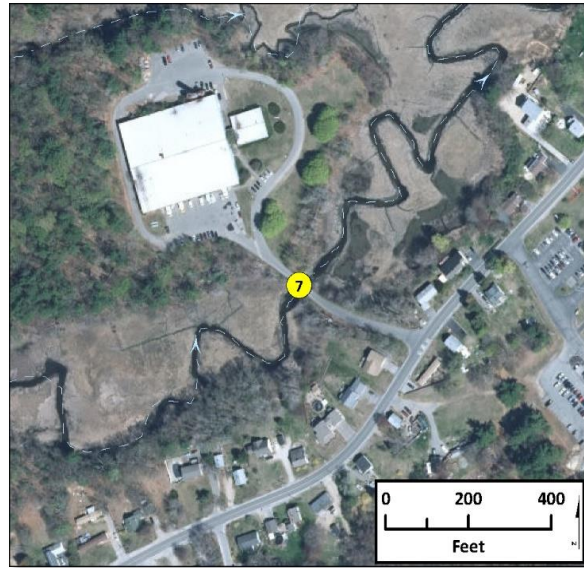
The upper tidal crossing at Cains Brook was restored in the mid 1990s by adding a concrete box culvert alongside the existing perched pipe, which still exists. The overall combined score is 3, moderate priority, because tides and organism passage appear to be partially restricted, there are signs of erosion and inundation risk to the structure is moderate. Above this crossing the marsh is brackish with cattail dominant and soon becomes fresh, but *Phragmites* has begun to invade this marsh (two colonies in 2016).

Crossing Condition:	Headwall Material	Headwall Condition	Wingwall Material	Wingwall Condition	Scour at Structure	Scour Severity
Upstream	Concrete	Good	Rip Rap	Fair	Wingwalls	Medium
Downstream	Concrete	Good	None	N/A	Armoring	Medium

Scour in Structure	Scour Severity in Structure	Road Surface Condition	Utilities at Crossing	Structure Condition Overall
None	None	Fair	Overhead electric. Smells of sewer.	Good

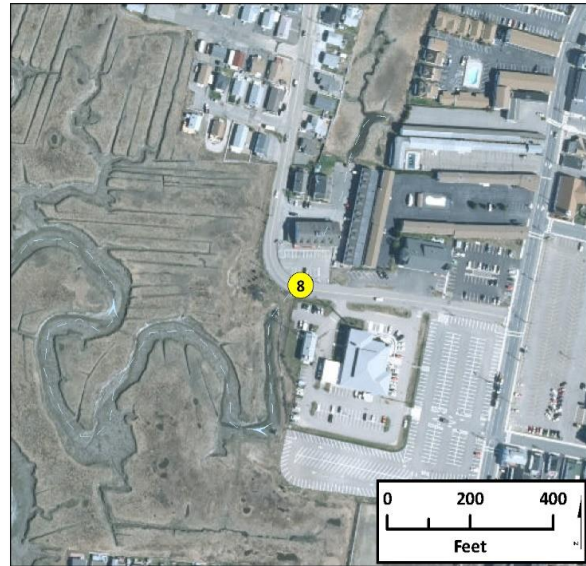
Brown Avenue crosses three tidal creeks (#8, 9, 10) providing tides to small marsh areas surrounded by development in Hampton. This crossing leads to the largest of the marsh areas where the upper portion has been filled for a parking lot. The tide is conducted by a 4-foot round culvert, which operates at a much lower capacity since the upstream side is crushed. The crossing condition is poor, and the culvert constricts the channel. The overall combined score is a 4, high priority for replacement.

Crossing Condition:	Headwall Material	Headwall Condition	Wingwall Material	Wingwall Condition	Scour at Structure	Scour Severity
Upstream	Concrete	Poor	None	N/A	Headwall	High
Downstream	Rip Rap	Fair	None	N/A	Headwall	Medium

Scour in Structure	Scour Severity in Structure	Road Surface Condition	Utilities at Crossing	Structure Condition Overall
None	None	Fair	Overhead electric	Poor

Structure Condition Comments:	Tide gate next to DS structure, see photo. US metal corrugated pipe.
--------------------------------------	--

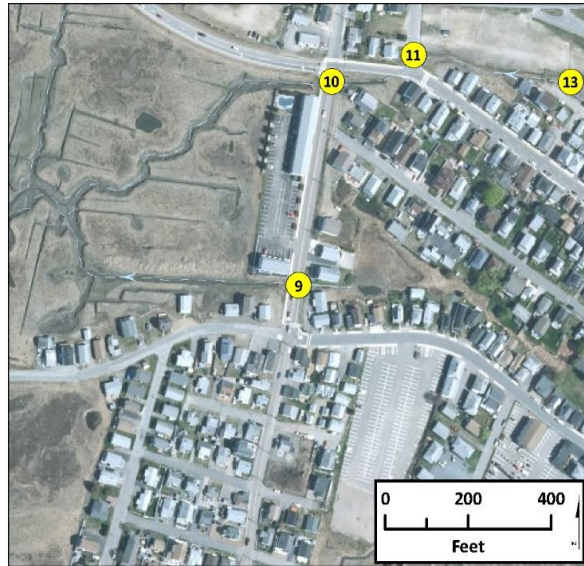
Brown Avenue crosses three tidal creeks (#8, 9, 10) providing tides to small marsh areas surrounded by development in Hampton. This crossing leads to the smallest of the marsh areas. The crossing condition is poor, the channel is severely restricted, and the 2-foot round culvert is largely buried by sediment, further restricting the tide. The upstream marsh plain appears to have subsided about 0.4 feet. The overall combined score is 4, high priority for replacement.

Crossing Condition:	Headwall Material	Headwall Condition	Wingwall Material	Wingwall Condition	Scour at Structure	Scour Severity
Upstream	Rip Rap	Poor	None	N/A	Headwall	Medium
Downstream	Rip Rap	Poor	None	N/A	Headwall	High

Scour in Structure	Scour Severity in Structure	Road Surface Condition	Utilities at Crossing	Structure Condition Overall
None	None	Fair	Overhead electric, telephone pole near bank	Poor

Structure Condition Comments:	Collapsed inlet and outlet, completely submerged
--------------------------------------	--

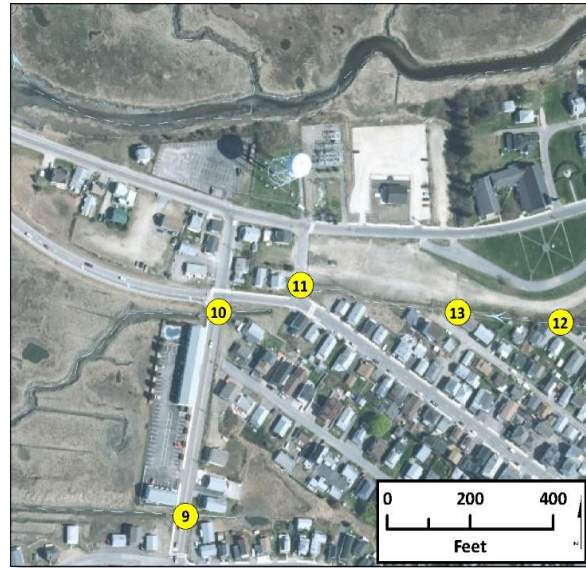
One of the small marshes in Hampton surrounded by development depends on the culvert under Highland Avenue in Hampton for its tides. The culvert is a round pipe about 3 feet in diameter, but its capacity is reduced by sediment. The crossing condition is poor, the channel is constrained with signs of erosion at the culvert. The original marsh is mostly filled by development. The overall combined score is 4, high priority for replacement.

Crossing Condition:	Headwall Material	Headwall Condition	Wingwall Material	Wingwall Condition	Scour at Structure	Scour Severity
Upstream	Masonry	Poor	None	N/A	Culvert	Low
Downstream	Masonry	Poor	None	N/A	Headwall	Medium

Scour in Structure	Scour Severity in Structure	Road Surface Condition	Utilities at Crossing	Structure Condition Overall
None	None	Good	OHE. Electric meter US RR	Poor

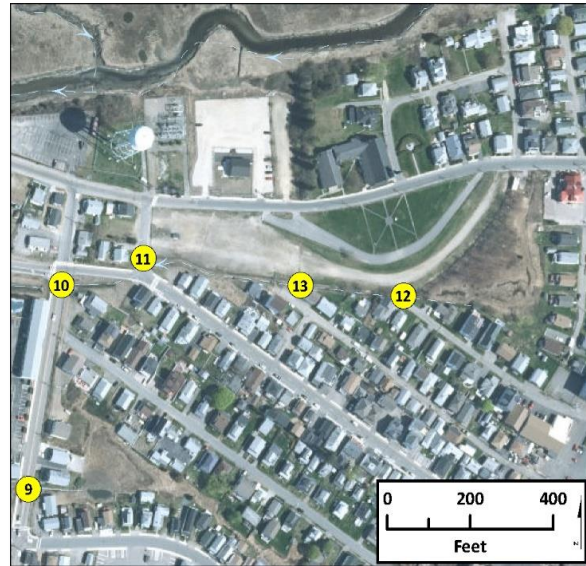
Church Street in Hampton crosses a tidal creek, providing tidal flow with a 2.5-foot round culvert. The crossing condition is fair and inundation risk to the road is high. Exotic Phragmites appears to increase above the crossing. The overall combined score is 4, high priority for replacement.

Crossing Condition:	Headwall Material	Headwall Condition	Wingwall Material	Wingwall Condition	Scour at Structure	Scour Severity
Upstream	None	N/A	Rip Rap	Poor	None	None
Downstream	None	N/A	None	N/A	None	None

Scour in Structure	Scour Severity in Structure	Road Surface Condition	Utilities at Crossing	Structure Condition Overall
None	None	N/A	US OHE	Poor

Structure Condition Comments:	Clay culvert
--------------------------------------	--------------

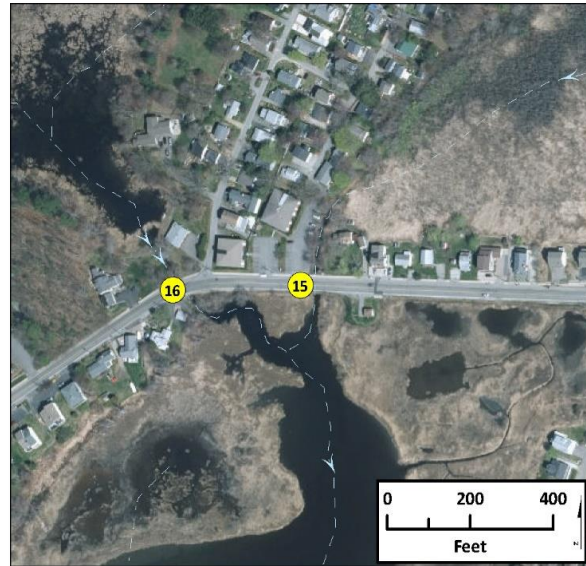
Fresh water from wetlands to the north drain into Meadow Pond under High Street in Hampton. The undersized culvert and low-lying roadway leave the crossing underwater at low tide and make it vulnerable to flooding. The crossing condition is poor and the potential for salt marsh expansion upstream is high, leading to an overall combined score of 5, highest priority for replacement.

Scour in Structure	Scour Severity in Structure	Road Surface Condition	Utilities at Crossing	Structure Condition Overall
None	None	Good	OHE US	Poor

Structure Condition Comments:	Totally submerged and partially clogged. Two twin pipes
--------------------------------------	---

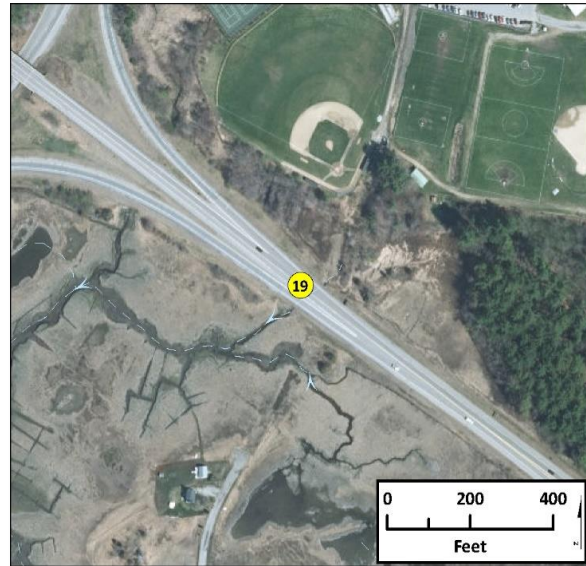
Route 101 was built at the edge of the Hampton Seabrook Estuary and a small marsh that was left upstream of the highway was provided with a 3.5-foot round concrete culvert to supply tidal flow and drainage. The crossing condition is poor, and the tidal range is muted, leading to fresher vegetation upstream of the crossing. The overall combined score is 4, a high priority for replacement of this crossing.

Crossing Condition:	Headwall Material	Headwall Condition	Wingwall Material	Wingwall Condition	Scour at Structure	Scour Severity
Upstream	Masonry	Poor	Masonry	Poor	Wingwalls	High
Downstream	Masonry	Poor	Rip Rap	Poor	Wingwalls	High

Scour in Structure	Scour Severity in Structure	Road Surface Condition	Utilities at Crossing	Structure Condition Overall
None	None	Good	None	Poor

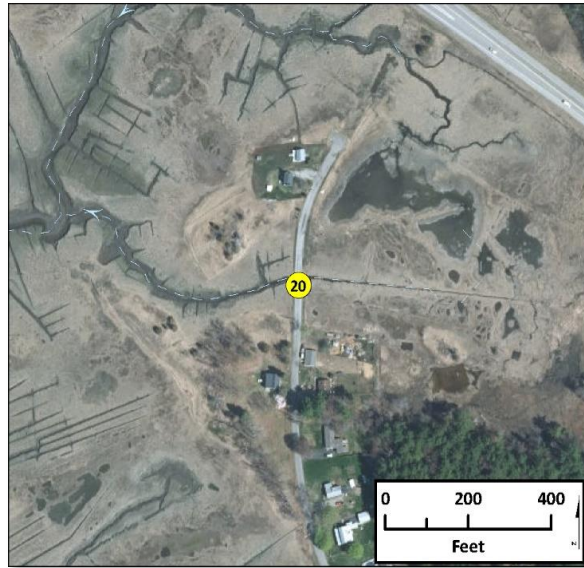
Landing Road in Hampton crosses an unnamed tidal creek with a 4 by 2-foot concrete box culvert that was installed as a tidal restoration in 2010. Tides regularly fill the undersized culvert and threaten to flood the road (and do flood the road during storms). The crossing condition is fair, inundation risk is very high and erosion is evident. In addition, the structure is perched. The overall combined score of 4 indicates this is a high priority for replacement.

Crossing Condition:	Headwall Material	Headwall Condition	Wingwall Material	Wingwall Condition	Scour at Structure	Scour Severity
Upstream	Rip Rap	Fair	Rip Rap	Fair	Wingwalls	Medium
Downstream	Rip Rap	Poor	Rip Rap	Poor	Headwall	Medium

Scour in Structure	Scour Severity in Structure	Road Surface Condition	Utilities at Crossing	Structure Condition Overall
Culvert	Low	Good	OHE DS and US in marsh	Fair

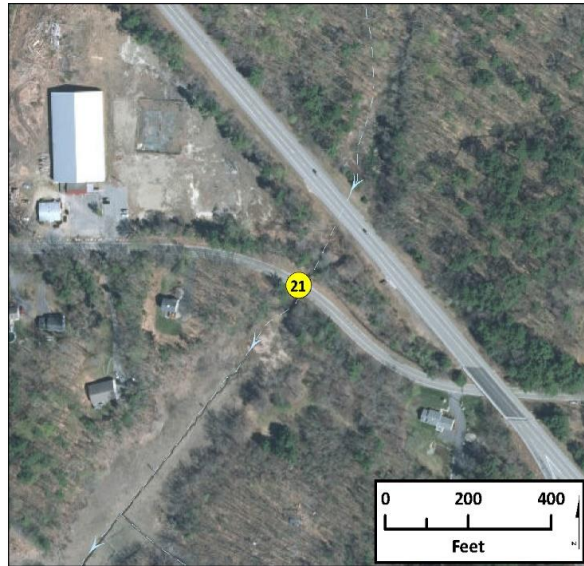
A 3.5-foot round concrete culvert under Drakeside Road drains a small wetland and its freshwater sources that were disrupted by the construction of Route 101. The longitudinal profile and water height indicators show the system is perched, impounding water upstream and preventing all but the highest tides from passing upstream, interfering with organism passage and influencing the upstream vegetation. The overall combined score is 4 for this culvert, indicating a high priority for replacement.

Crossing Condition:	Headwall Material	Headwall Condition	Wingwall Material	Wingwall Condition	Scour at Structure	Scour Severity
Upstream	Masonry	Fair	Masonry	Fair	Wingwalls	Low
Downstream	Masonry	Good	Masonry	Fair	Culvert	Low

Scour in Structure	Scour Severity in Structure	Road Surface Condition	Utilities at Crossing	Structure Condition Overall
None	None	Good	OHE US	Good

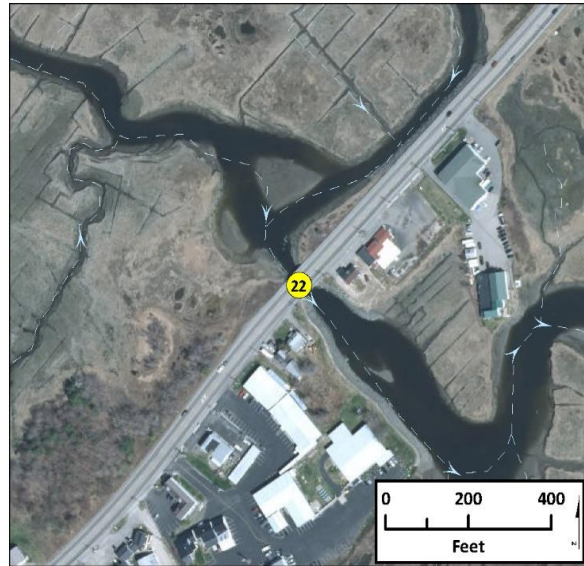
Crossing Condition:	Headwall Material	Headwall Condition	Wingwall Material	Wingwall Condition	Scour at Structure	Scour Severity
Upstream	None	N/A	Concrete	Fair	Wingwalls	Low
Downstream	None	N/A	Rip Rap	Good	Wingwalls	Low

Scour in Structure	Scour Severity in Structure	Road Surface Condition	Utilities at Crossing	Structure Condition Overall
Abutment	Medium	Good	DS OHE	Fair

Structure Condition Comments:	Some cracks inside structure RL
--------------------------------------	---------------------------------

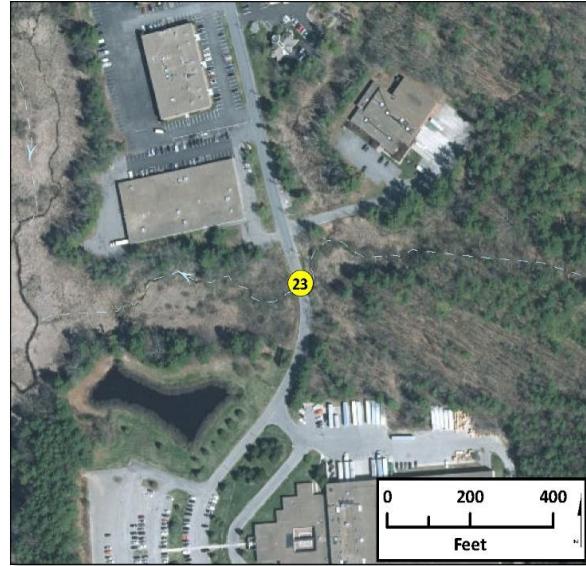
Crossing Condition:	Headwall Material	Headwall Condition	Wingwall Material	Wingwall Condition	Scour at Structure	Scour Severity
Upstream	Rip Rap	Poor	None	N/A	Culvert	Low
Downstream	None	N/A	None	N/A	Culvert	Low

Scour in Structure	Scour Severity in Structure	Road Surface Condition	Utilities at Crossing	Structure Condition Overall
Channel	Medium	Good		Good

Structure Condition Comments:	Two twin culverts, measured as one
--------------------------------------	------------------------------------

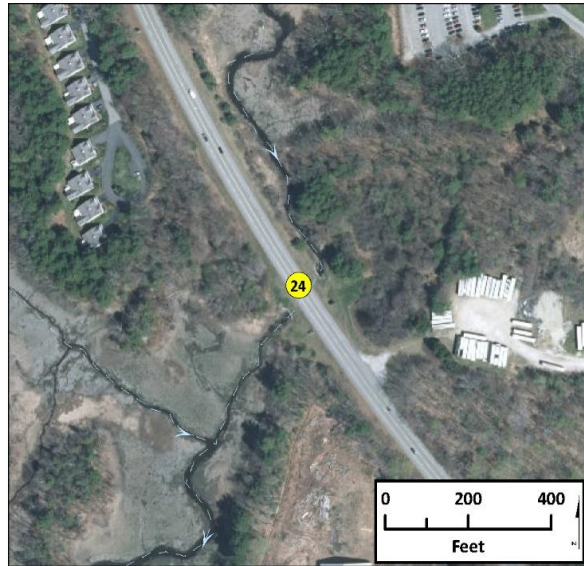
The upper crossing of Drakes River passes under Route 101 for over 100 feet and is a large concrete pipe alongside a rectangular culvert encased as a pair in concrete. The high water stain on the culvert structure indicates there is some tidal restriction and the culvert slope is about a foot and the low tide is more than 18 inches higher upstream, indicating impoundment. Along with high erosion, the perch (improperly high elevation of the culvert) leads to an overall combined score of 5: highest priority for replacement.

Crossing Condition:	Headwall Material	Headwall Condition	Wingwall Material	Wingwall Condition	Scour at Structure	Scour Severity
Upstream	Concrete	Good	Concrete	Good	None	None
Downstream	Concrete	Good	Concrete	Good	None	None

Structure Condition Comments:	Twin culverts surveyed as one structure. Box at inlet/outlet converts to round culvert
--------------------------------------	--

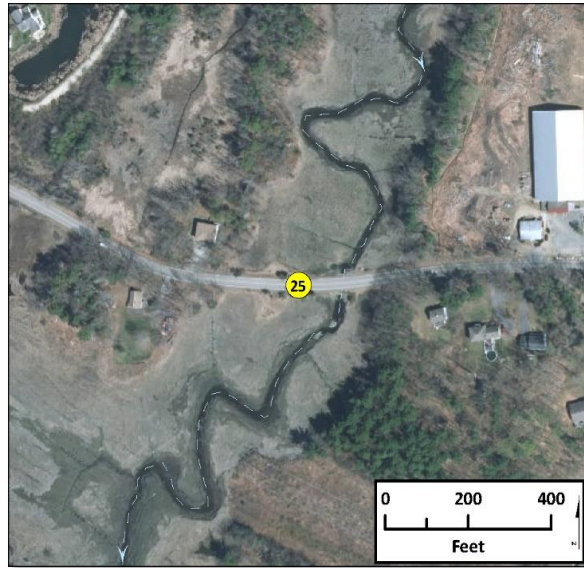
The lower tidal crossing of Drakes River passes under Drakeside Road through a 4 by 8 concrete culvert in Hampton. Despite restoration in 1996 tides are still restricted, with an overall combined score of 4 (high priority for replacement). This is due to reduced tidal range, interference with organism passage and poor crossing condition. *Phragmites*, which was overrunning the site in the mid-1990s, remains a visible feature in the marsh.

Crossing Condition:	Headwall Material	Headwall Condition	Wingwall Material	Wingwall Condition	Scour at Structure	Scour Severity
Upstream	Other	Poor	Rip Rap	Fair	Headwall	High
Downstream	Other	Fair	Rip Rap	Fair	Headwall	High

Scour in Structure	Scour Severity in Structure	Road Surface Condition	Utilities at Crossing	Structure Condition Overall
None	None	Poor	Telephone pole on US side	Fair

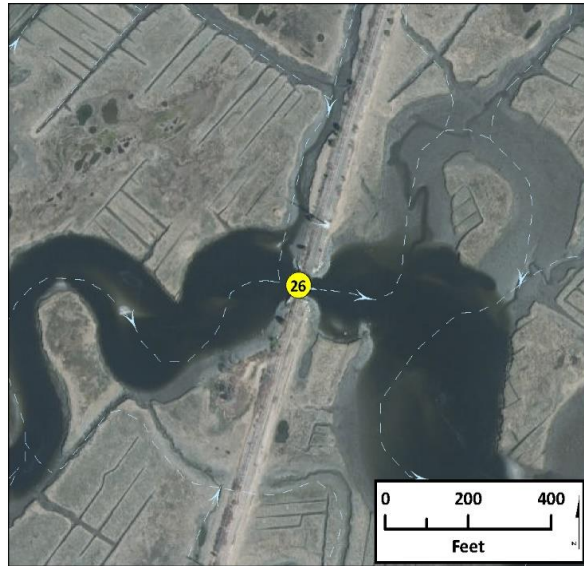
A railroad trestle crossing the Taylor River creates a constriction, approximately 60 by 16 feet in size, in the largest tributary to the Estuary. This is one of four tidal river crossings by the abandoned railroad bed that bisect Hampton Seabrook Estuary (the others are 28, 29 and 30) where tides are large (> 10 feet) and flows are huge. The crossing condition is rated poor and the potential for salt marsh migration in the upstream watershed is high. With an overall combined score of 4, this ranking indicates high priority for replacement or removal.

Crossing Condition:	Headwall Material	Headwall Condition	Wingwall Material	Wingwall Condition	Scour at Structure	Scour Severity
Upstream	None	N/A	Dry Fit Stone	Poor	Wingwalls	Medium
Downstream	None	N/A	Dry Fit Stone	Poor	Wingwalls	None

Scour in Structure	Scour Severity in Structure	Road Surface Condition	Utilities at Crossing	Structure Condition Overall
None	None	N/A	Overhead electric, tel poles in marsh	Poor

Structure Condition Comments:	Bridge is rusting out, rail logs rotted
--------------------------------------	---

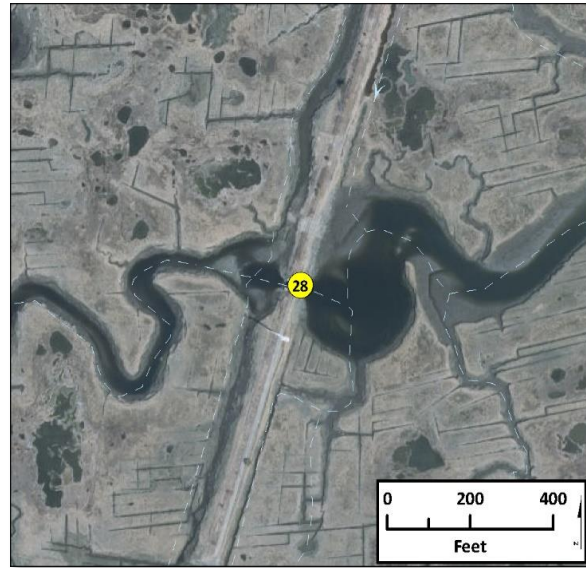
One of four tidal river crossings by the abandoned railroad bed that bisect Hampton Seabrook Estuary, this old granite bridge carries the flow of a major tidal creek. Despite its large size (16 feet by 10 feet), it constricts flow as shown by the very large plunge pools on either side of the crossing. The crossing condition is poor with high inundation risk and salt marsh migration potential in the upstream watershed, leading to an overall combined score of 5: highest priority for replacement (or removal).

Crossing Condition:	Headwall Material	Headwall Condition	Wingwall Material	Wingwall Condition	Scour at Structure	Scour Severity
Upstream	None	N/A	Dry Fit Stone	Poor	Wingwalls	High
Downstream	None	N/A	Dry Fit Stone	Fair	Abutment	High

Scour in Structure	Scour Severity in Structure	Road Surface Condition	Utilities at Crossing	Structure Condition Overall
Abutment	High	N/A	OHE wires from power plant.	Poor

Structure Condition Comments:	Rusting out I beams. Stones falling out of structure
--------------------------------------	--

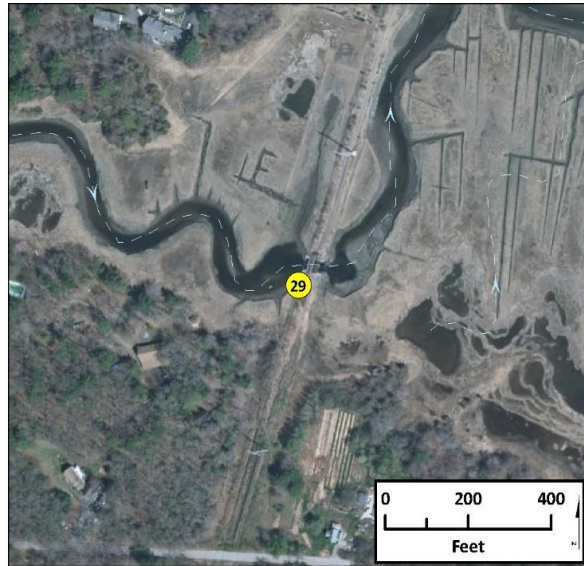
The granite structure conducts the Hampton Falls River, one of four tidal river crossings by the abandoned railroad bed that bisect Hampton Seabrook Estuary. The high water wrack line indicates tides in excess of 10 feet are not uncommon here and the large 27 foot by 11.5-foot structure is still shown to restrict tides by the 5 to 7-foot-deep plunge pools and over six inches of subsidence of the upstream marsh plain. The overall combined score of 4, high priority, is largely due to the poor structural condition of the crossing. Like crossings 26 and 28, this supports an abandoned railroad and could be removed.

Crossing Condition:	Headwall Material	Headwall Condition	Wingwall Material	Wingwall Condition	Scour at Structure	Scour Severity
Upstream	None	N/A	Masonry	Fair	Abutment	High
Downstream	None	N/A	Masonry	Poor	Culvert	High

Scour in Structure	Scour Severity in Structure	Road Surface Condition	Utilities at Crossing	Structure Condition Overall
Culvert	High	N/A	OHE	Poor

Structure Condition Comments:	Masonry missing mortar. Shifting stones. Support stumps exposed underneath structure
--------------------------------------	--

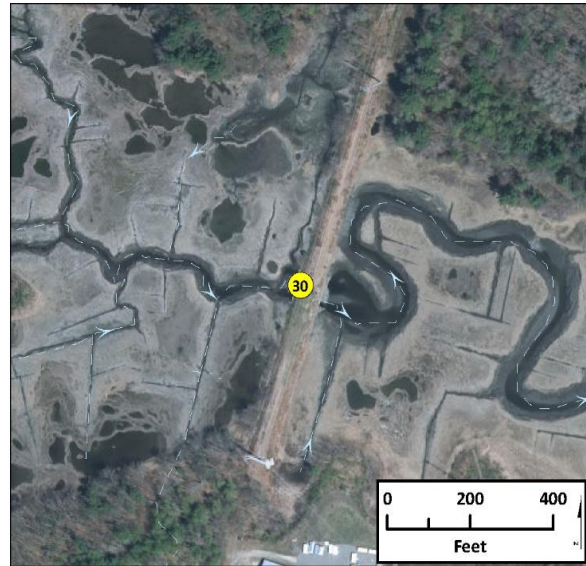
The crossing at Brown’s River was under an inactive rail line and the 48-inch diameter culvert was too small and perched too high, leading to tidal restriction and upstream marsh subsidence (about 5 inches) and invasion of exotic Phragmites. In addition, the ebb flow led to a greatly eroded channel, which is still evident (high crossing ratio score). In 2005, tidal flow was enhanced by the addition of a 4 by 6-foot culvert placed lower in the intertidal zone to support organism passage and reduce the tidal restriction. Although the marsh surface measurements were limited, the survey team found that the subsidence had decreased to only 1.5 inches in 2018. Despite the added benefits from the additional culvert, the crossing condition is poor, and the entire structure is regularly overfilled by tides, leading to an overall combined score of 4: high priority for replacement

Structure Condition Comments:	Cracking at headwall/wingwall DS
--------------------------------------	----------------------------------

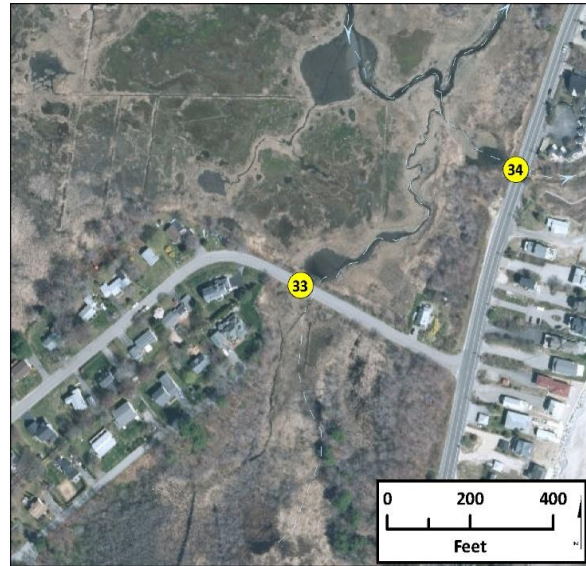
Huckleberry Lane crosses an unnamed tributary to the Little River and the tidal flow is supported by three small pipes that are underwater most of the time. The downstream area is eroded to a wider creek and erosion classification at the crossing is high for both upstream and downstream, leading to an overall combined score of 4, high priority for replacement.

Structure Condition Comments:	Tree culverts, surveyed as one, completely submerged
--------------------------------------	--

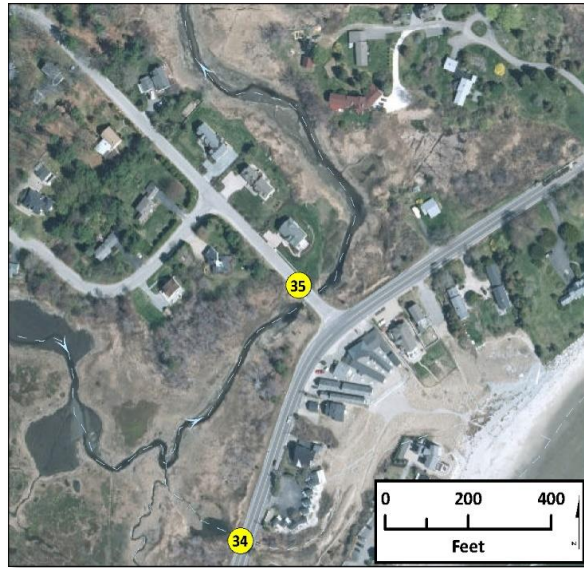
Appledore Avenue crosses creek running north to the Little River and the original structure was replaced in 1999 with a 4 by 8-foot box culvert to allow unrestricted tides to flow upstream. The overall combined score of 3 shows a moderate priority for replacement, largely based on crossing ratios and signs of erosion, some of which may remain from the previous structure. More information can be found for this and the Little River restoration in 2000 on the NRCS website:

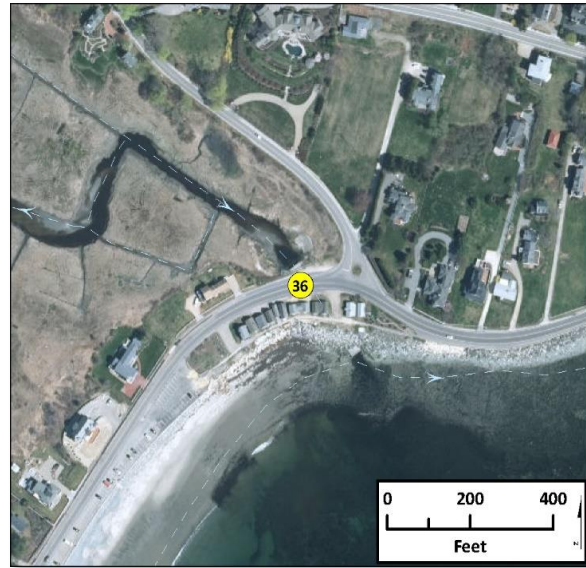
Little River once flowed into the ocean through an inlet south of Appledore Road, but with the construction of Route 1A and the ‘trunk’ that drained the marsh system (once measured at 193 acres) at its north end, the inlet variably closed which led to dynamic shifts in water levels and marsh degradation. The trunk was drained by a 4-foot round pipe and was woefully inadequate to support tidal flow into the marsh. It was replaced by two 6 by 12-foot culverts, side by side, in 2000. The disparity of the up and downstream highwater stains shows the top two feet of regular high tides are still prevented from flooding the marsh, signs of strong erosion are found upstream and the crossing is likely to be inundated by storms. The overall combined score is 5: highest priority. It should be stated the culvert size chosen in 2000 was recognized not to be able to conduct the full tidal flow but was selected as a more economical solution than a larger bridge. More information can be found for the Little River restoration on the NRCS website:

Structure Condition Comments:	Two twin box culverts, surveyed as one structure
--------------------------------------	--

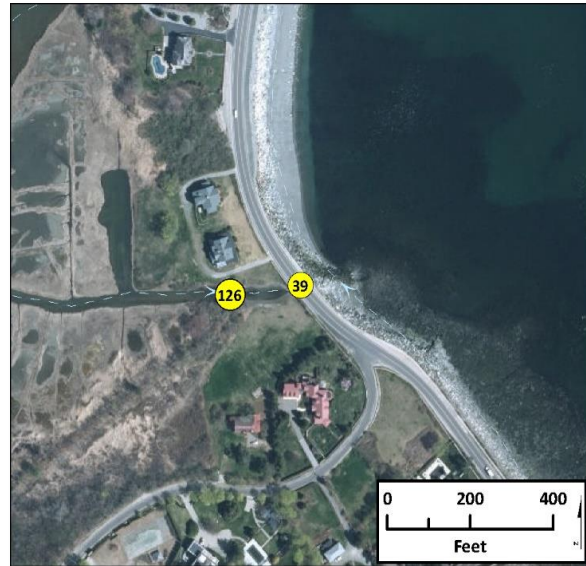
Tidal flow supporting the salt marsh at Philbrick’s Pond has been restricted by the trolley berm of the early 1900s as well as Route 1A (reported here). A recent investigation into the hydrodynamic flows and how they may be restored to rejuvenate the degraded salt marsh showed that the small clay pipe under the trolley berm was intact, but restricted tides, while the culvert under Route 1A was less restrictive (CMA Engineers 2018). The overall combined score of 4 indicates high priority for replacement.

Structure Condition Comments:	Converts to concrete pipe halfway downstream
--------------------------------------	--

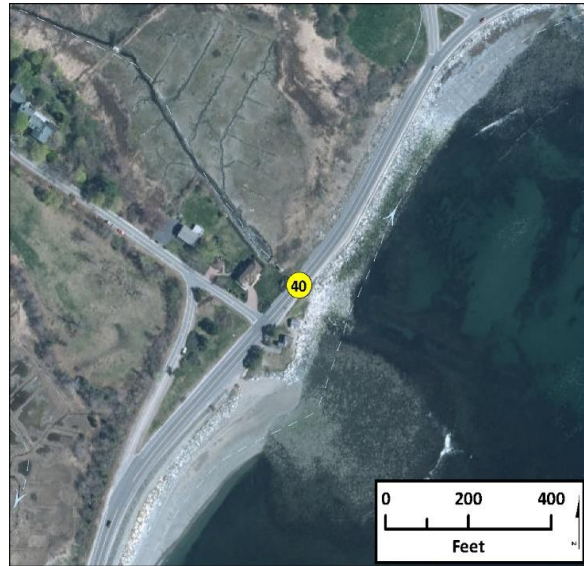
The inlet to Bass Beach Marsh is crossed by Route 1A (Ocean Boulevard) that uses a 2.4-foot circular culvert that is over 250 feet in length to conduct the tides. Although the marsh is perched about 5 feet above the downstream low tide, the culvert still restricts the upper portion of the tide as evidenced by the high crossing ratio. The marsh is being invaded by exotic common reed. The overall combined score of 5 indicates highest priority for replacement.

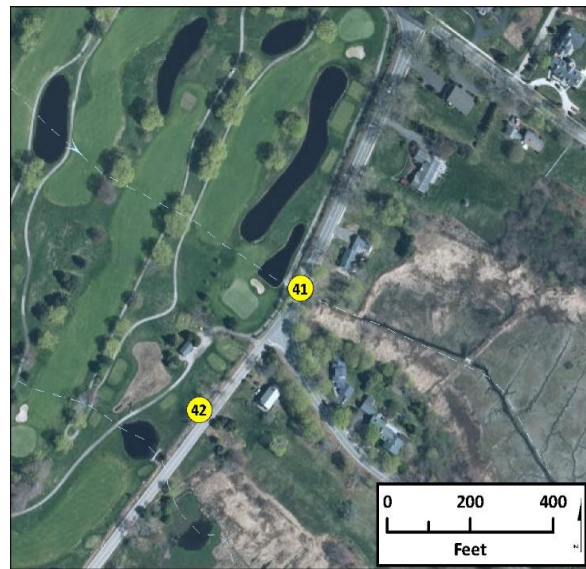
Crossing Condition:	Headwall Material	Headwall Condition	Wingwall Material	Wingwall Condition	Scour at Structure	Scour Severity
Upstream	Dry Fit Stone	Good	Dry Fit Stone	Good	None	None
Downstream	Masonry	Poor	None	N/A	Headwall	Medium

Scour in Structure	Scour Severity in Structure	Road Surface Condition	Utilities at Crossing	Structure Condition Overall
None	None	Good	OHE US	Fair

Structure Condition Comments:	US well taken care of. DS neglected and overrun with invasives. Minimal observed flow likely due to tide gate.
--------------------------------------	--

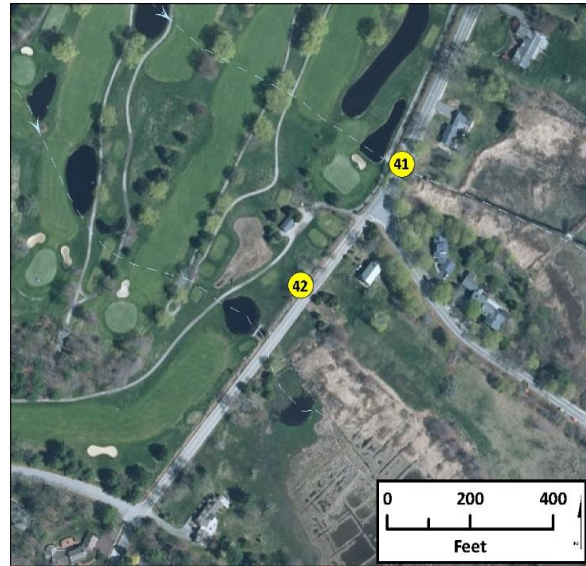
A small culvert (1-foot round pipe) runs from the golf course, under Old Locke Road and into the upper portion of Philbrick's Pond. The overall combined score for restriction is 4, high priority, because of erosion and inundation risk to road and the undersized culvert is submerged even at low tide.

Crossing Condition:	Headwall Material	Headwall Condition	Wingwall Material	Wingwall Condition	Scour at Structure	Scour Severity
Upstream	Dry Fit Stone	Fair	Dry Fit Stone	Fair	None	None
Downstream	Dry Fit Stone	Poor	None	N/A	None	None

Scour in Structure	Scour Severity in Structure	Road Surface Condition	Utilities at Crossing	Structure Condition Overall
None	None	Fair	Overhead electric	Poor

Structure Condition Comments:	Culvert flooded both sides, no culvert DS, open "box" where pipe should be
--------------------------------------	--

Site Identified in Hazard Mitigation Plan:	Yes
Emergency Access or Evacuation Route:	N/A
History of Flooding:	flood prone, culvert in need of repair or replace

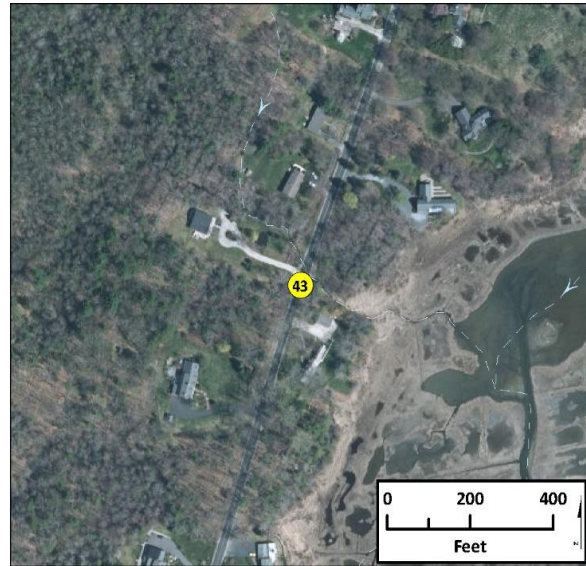
An unnamed creek under Old Locke Road conducts brackish tides to and from Philbrick’s Pond through a 2-foot round culvert, but it serves mostly as upland drainage to the Pond. It has an overall combined score of 3, moderate priority, because of signs of erosion, crossing condition and potential ecological impacts.

Crossing Condition:	Headwall Material	Headwall Condition	Wingwall Material	Wingwall Condition	Scour at Structure	Scour Severity
Upstream	Dry Fit Stone	Poor	None	N/A	None	None
Downstream	Dry Fit Stone	Poor	None	N/A	None	None

Scour in Structure	Scour Severity in Structure	Road Surface Condition	Utilities at Crossing	Structure Condition Overall
None	None	Good	US OHE	Fair

Structure Condition Comments:	Slightly squashed inlet. Loose granite on US Headwall
--------------------------------------	---

Site Identified in Hazard Mitigation Plan:	Yes
Emergency Access or Evacuation Route:	N/A
History of Flooding:	Past flooding reported. culvert damaged.

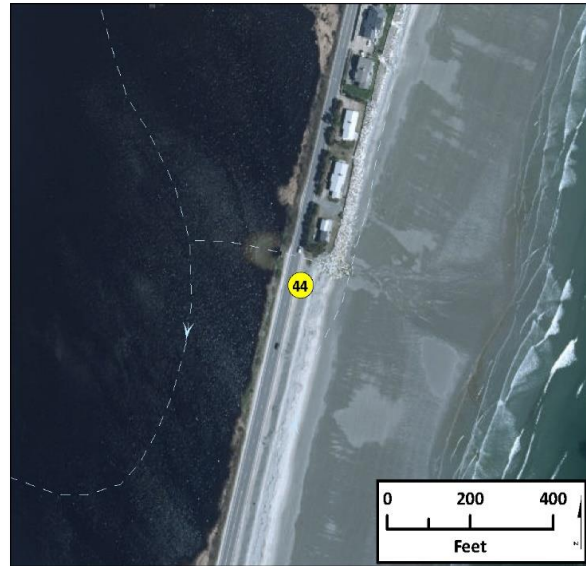
The inlet to Eel Pond is controlled by a double 4 by 4-foot cement culvert running under Route 1A in Rye. The tides are prevented from entering by two sets of stop logs at the downstream end, which is perched above a beach facing the Atlantic Ocean. Stoplogs are removed seasonally to release freshwater and a limited flow of salt water enters the pond. Recognizing the current policy of maintaining a low-salinity pond and surrounding marsh, the overall combined score for the crossing is 5, highest priority for consideration of replacement.

Crossing Condition:	Headwall Material	Headwall Condition	Wingwall Material	Wingwall Condition	Scour at Structure	Scour Severity
Upstream	Concrete	Good	Concrete	Good	None	None
Downstream	Concrete	Fair	Concrete	Fair	None	None

Scour in Structure	Scour Severity in Structure	Road Surface Condition	Utilities at Crossing	Structure Condition Overall
None	None	Good	N/A	Fair

Structure Condition Comments:	Twin 48" c pipes. DS blocked by stop logs. US one side blocked by sheet. One side grated.
--------------------------------------	---

Site Identified in Hazard Mitigation Plan:	Yes
Emergency Access or Evacuation Route:	Yes
History of Flooding:	floods regularly under high/king tide condntions

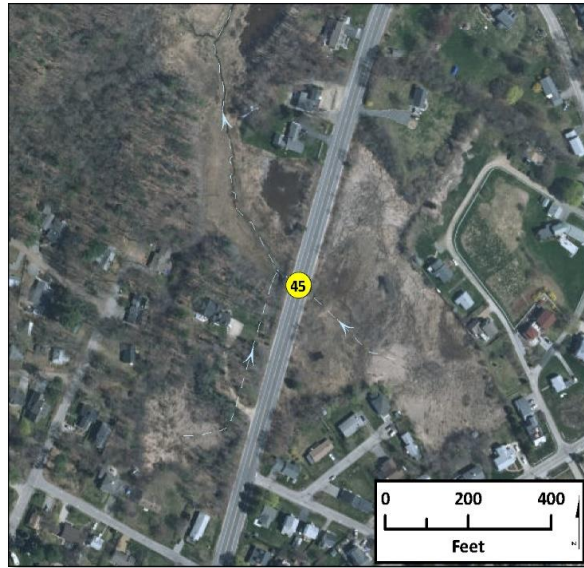
The southernmost upper reach of the salt marsh at Rye Harbor passes back under Route 1A into a brackish marsh surrounded by a residential neighborhood. A pair of 3-foot round culverts recently replaced or fortified conducts the tide. Although erosion is evident upstream and downstream of the culverts, restriction appears minor and the overall combined score is 2: low priority.

Crossing Condition:	Headwall Material	Headwall Condition	Wingwall Material	Wingwall Condition	Scour at Structure	Scour Severity
Upstream	Rip Rap	Good	Rip Rap	Good	None	None
Downstream	Rip Rap	Good	Rip Rap	Good	None	None

Scour in Structure	Scour Severity in Structure	Road Surface Condition	Utilities at Crossing	Structure Condition Overall
None	None	Good	Overhead electric	Good

Structure Condition Comments:	New culvert. Replaced 2018
--------------------------------------	----------------------------

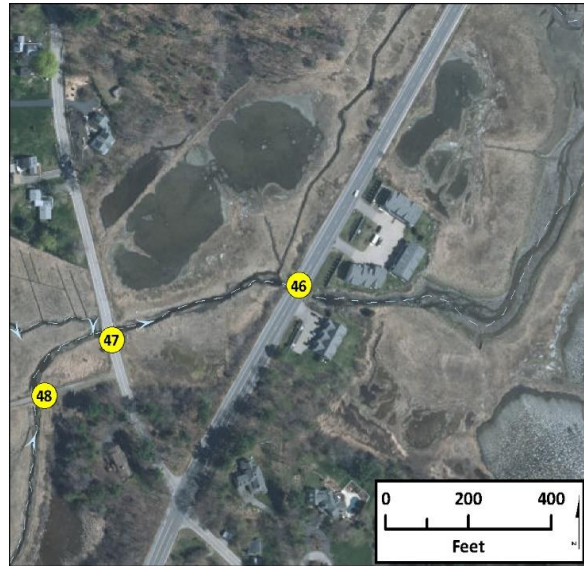
One of two crossings of Rye Harbor Marsh as it passes across Route 1A from east to west, this branch conducts the tide to the Locke Road area through an old granite structure capped by concrete. The unfavorable crossing ratio and high erosion indicators lead to a moderate priority for replacement, with an overall combined score of 3. Tidal restriction here influences three more crossings upstream that limit flow to a significant marsh area.

Crossing Condition:	Headwall Material	Headwall Condition	Wingwall Material	Wingwall Condition	Scour at Structure	Scour Severity
Upstream	Concrete	Good	Masonry	Good	Wingwalls	Medium
Downstream	Concrete	Good	Masonry	Poor	Wingwalls	Medium

Scour in Structure	Scour Severity in Structure	Road Surface Condition	Utilities at Crossing	Structure Condition Overall
None	None	Good	Ohe US	Poor

Structure Condition Comments:	20 inch section of masonry collapse in structure
--------------------------------------	--

Site Identified in Hazard Mitigation Plan:	Yes
Emergency Access or Evacuation Route:	Yes
History of Flooding:	higher tides flood US Marsh. 6" harbor rd 1/4/18

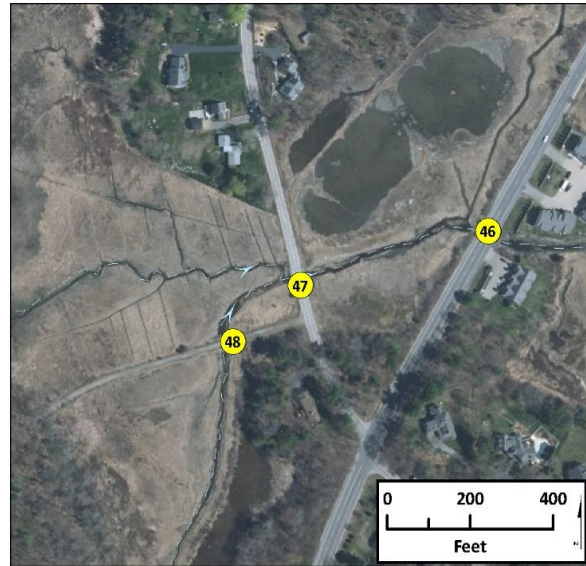
The main tidal creek that conducts the tides to all marsh areas west of Locke Road passes through a 5 by 9 foot box culvert. In 1996 the Town of Rye replaced a smaller culvert here and on the upstream drive (#48, private). however, the high water stain indicates the culvert capacity is regularly exceeded, signs of erosion were evident and the flooding risk to the structure and roadway is high. The overall score for this crossing is 3, indicating moderate priority for replacement.

Crossing Condition:	Headwall Material	Headwall Condition	Wingwall Material	Wingwall Condition	Scour at Structure	Scour Severity
Upstream	Concrete	Good	Rip Rap	Fair	None	None
Downstream	Concrete	Good	Rip Rap	Good	Wingwalls	Medium

Scour in Structure	Scour Severity in Structure	Road Surface Condition	Utilities at Crossing	Structure Condition Overall
None	None	Fair	Overhead electric	Fair

Site Identified in Hazard Mitigation Plan:	Yes
Emergency Access or Evacuation Route:	N/A
History of Flooding:	prone during very high tides when marsh floods.

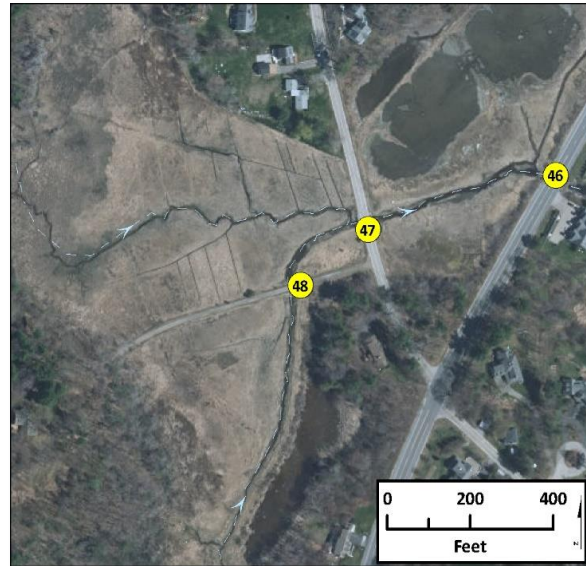
The culvert under this private drive was replaced circa 1996, with a round 4-foot culvert, but the effective cross-sectional area has been reduced by sediment fill or crushing. The observations of poor crossing condition, erosion, flood risk and high water stain all suggest this crossing severely restricts tidal flow and is in need of an upgrade. The overall combined score is 5, highest priority for replacement.

Crossing Condition:	Headwall Material	Headwall Condition	Wingwall Material	Wingwall Condition	Scour at Structure	Scour Severity
Upstream	Rip Rap	Poor	Rip Rap	Fair	Culvert	High
Downstream	Rip Rap	Poor	Rip Rap	Fair	Culvert	High

Scour in Structure	Scour Severity in Structure	Road Surface Condition	Utilities at Crossing	Structure Condition Overall
Culvert	High	Good	OHE	Poor

Structure Condition Comments:	US Severe wing wall scour, DS moderate wing wall scour
--------------------------------------	--

Site Identified in Hazard Mitigation Plan:	Yes
Emergency Access or Evacuation Route:	N/A
History of Flooding:	Prone during high tide events when DS marsh floods

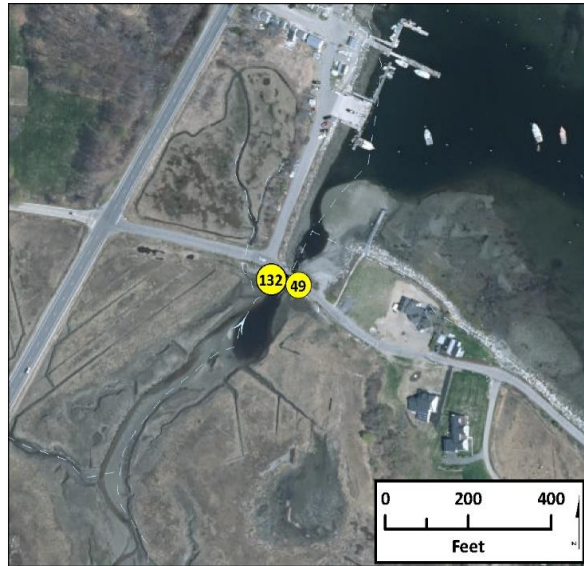
The bridge on Harbor Road conducts all the tidal waters into Rye Harbor Marsh, which is extensive. It is wide (19 feet) and tall (13 feet) and does not appear to restrict the tide, though there is a large erosional pool on the upstream side. It has an overall combined priority of 3 (moderate) for replacement.

Structure Condition Comments:	Underside of bridge deck spalling, road surface jo
--------------------------------------	--

Site Identified in Hazard Mitigation Plan:	Yes
Emergency Access or Evacuation Route:	N/A
History of Flooding:	6" over road on 1/4/18

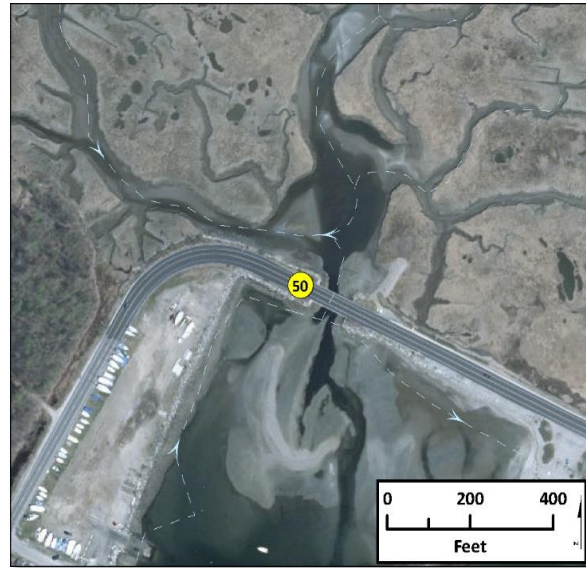
This crossing is a large bridge on Route 1A over a man-made inlet that supplies all of Awcomin Marsh with tides. The original inlet along with large portions of the marsh was filled in 1941 and 1962 when Rye Harbor was dredged. In the 1990s and 2000s several projects were undertaken to remove dredge spoil and restore hydrology to the marsh, which had been overrun with common reed. The overall combined score is 3, indicating moderate priority for replacement because of erosion on the upstream side. Information on the restoration actions can be found at: https://www.des.nh.gov/organization/divisions/water/wmb/coastal/restoration/saltmarsh_restoration.htm

Crossing Condition:	Headwall Material	Headwall Condition	Wingwall Material	Wingwall Condition	Scour at Structure	Scour Severity
Upstream	None	N/A	Concrete	Good	None	None
Downstream	None	N/A	Concrete	Good	None	None

Scour in Structure	Scour Severity in Structure	Road Surface Condition	Utilities at Crossing	Structure Condition Overall
None	None	Good	OHE US	Good

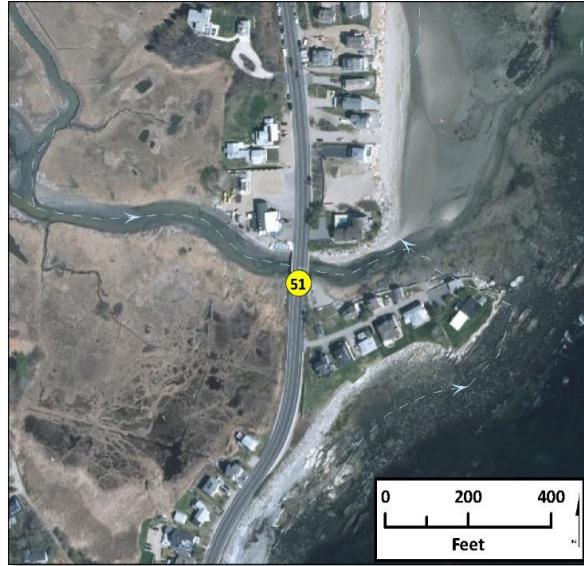
Crossing Condition:	Headwall Material	Headwall Condition	Wingwall Material	Wingwall Condition	Scour at Structure	Scour Severity
Upstream	None	N/A	None	N/A	None	None
Downstream	None	N/A	None	N/A	None	None

Scour in Structure	Scour Severity in Structure	Road Surface Condition	Utilities at Crossing	Structure Condition Overall
Abutment	Low	Good	OHE RR	Good

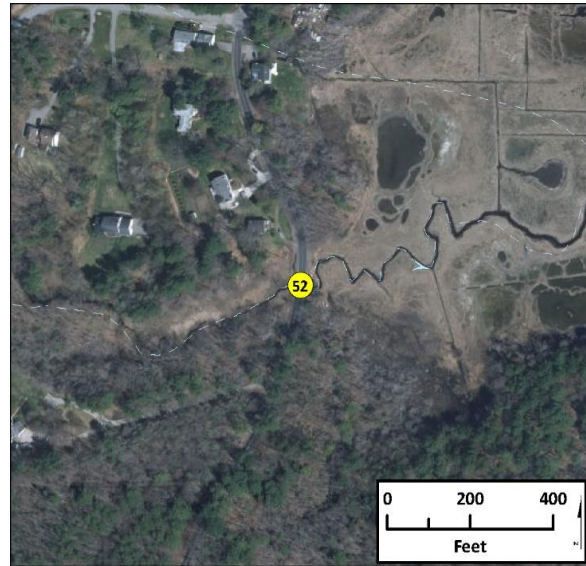
Crossing Condition:	Headwall Material	Headwall Condition	Wingwall Material	Wingwall Condition	Scour at Structure	Scour Severity
Upstream	Concrete	Good	Rip Rap	Good	Wingwalls	Low
Downstream	Concrete	Good	Rip Rap	Good	Wingwalls	Low

Scour in Structure	Scour Severity in Structure	Road Surface Condition	Utilities at Crossing	Structure Condition Overall
None	None	Good	Overhead electric	Good

Site Identified in Hazard Mitigation Plan:	Yes
Emergency Access or Evacuation Route:	N/A
History of Flooding:	Road sometimes flooded from tidal influence

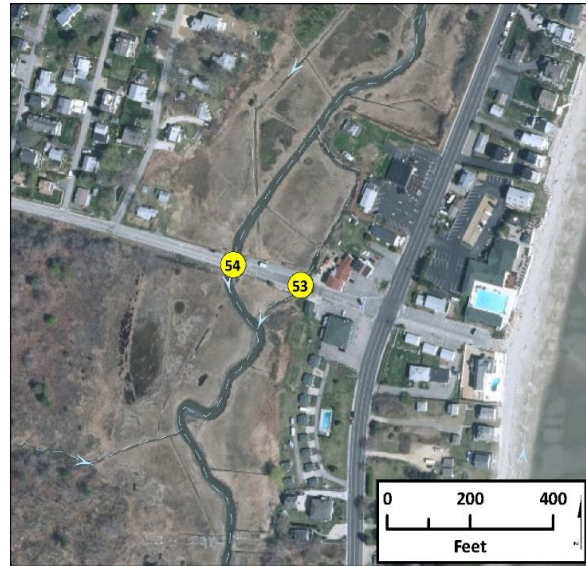
The Parsons Creek Marsh has an inlet under Route 1A and the north branch of the main tidal creek passes under Wallis Road where a 4 by 10-foot box culvert was installed by the Town of Rye in 1998 to relieve the previous tidal restriction. This eastern crossing (western crossing is #54) conducts minor amounts of tidal flow and is partially filled with sediment but becomes important for higher and storm tides. It has an overall combined score replacement priority of moderate: 3, mostly due to high flooding risk. Information on restoration can be found at:

Crossing Condition:	Headwall Material	Headwall Condition	Wingwall Material	Wingwall Condition	Scour at Structure	Scour Severity
Upstream	Concrete	Good	Rip Rap	Good	None	None
Downstream	Concrete	Good	Rip Rap	Good	None	None

Site Identified in Hazard Mitigation Plan:	Yes
Emergency Access or Evacuation Route:	Yes
History of Flooding:	king tide causes prolonged highwater. flood 1/4/18

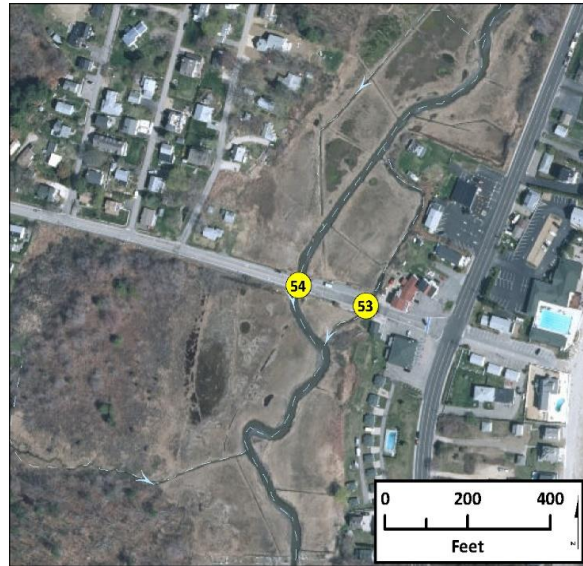
The Parsons Creek Marsh has an inlet under Route 1A and the north branch of the main tidal creek passes under Wallis Road where two 6 by 12-foot box culverts were installed by the Town of Rye in 1998 to relieve the previous tidal restriction. This is the western crossing (eastern crossing is #53) that conducts most of the tidal flow, but it shows little evidence of erosion. It has an overall combined score of 3, indicating moderate replacement priority, only because the road is vulnerable to inundation. Information on restoration can be found at:

Scour in Structure	Scour Severity in Structure	Road Surface Condition	Utilities at Crossing	Structure Condition Overall
None	None	Fair	OHE	Good

Structure Condition Comments:	Twin 12 ft box culverts assessed as one structure
--------------------------------------	---
