Resilient Tidal Crossings

*An Assessment and Prioritization to Address New Hampshire's
Tidal Crossing Infrastructure for Coastal Resilience*

May 2019

Prepared in partnership with:
NHDES Coastal Program – Water Division
The Nature Conservancy
University of New Hampshire

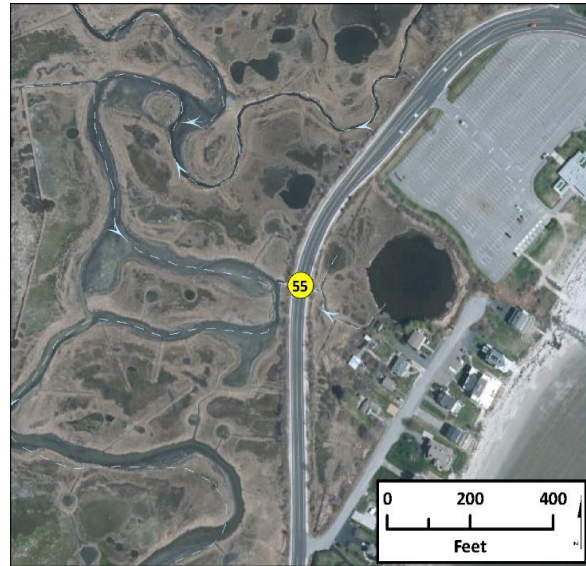
A small portion of the Parsons Creek Marsh is crossed again by Route 1A and extends eastward up to the private residences on the barrier beach. In 1999 a 3 foot round corrugated metal pipe was replaced with a 3 by 6-foot concrete box culvert by the Town of Rye. The current restriction, if any, appears to be minor and the overall combined score is 3, moderate priority for replacement. Information on the 1999 restoration can be found at:

Crossing Condition:	Headwall Material	Headwall Condition	Wingwall Material	Wingwall Condition	Scour at Structure	Scour Severity
Upstream	Concrete	Good	None	N/A	None	None
Downstream	Concrete	Good	Rip Rap	Good	None	None

Site Identified in Hazard Mitigation Plan:	No
Emergency Access or Evacuation Route:	Yes
History of Flooding:	Flooding along this portion of 1A

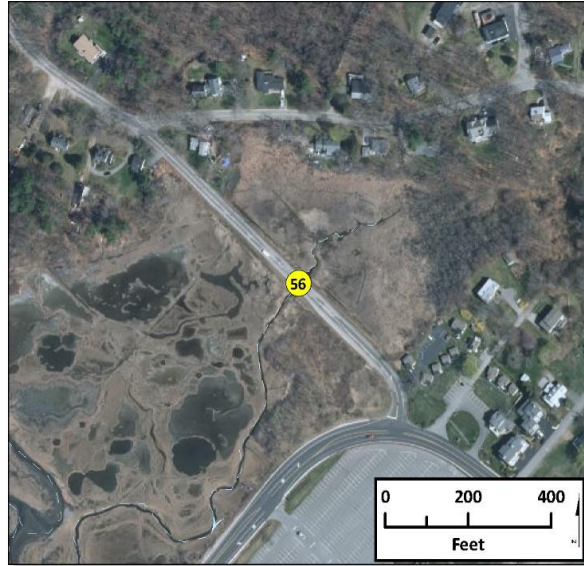
Crossing Condition:	Headwall Material	Headwall Condition	Wingwall Material	Wingwall Condition	Scour at Structure	Scour Severity
Upstream	Concrete	Good	Dry Fit Stone	Good	Wingwalls	Low
Downstream	Concrete	Good	Rip Rap	Good	None	None

Scour in Structure	Scour Severity in Structure	Road Surface Condition	Utilities at Crossing	Structure Condition Overall
None	None	Good	Overhead electric	Good

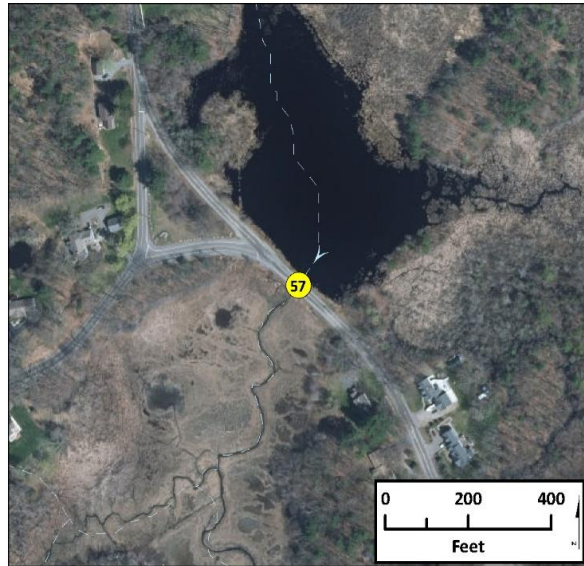
The upper section of Parsons Creek Marsh drains from a freshwater impoundment caused by an undersized crossing (1-foot diameter pipe) running under Parsons Road in Rye. Although the crossing condition is good, the undersized pipe results in a poor crossing ratio, restricted tidal range, poor organism passage and an impediment to salt marsh migration. The result is a fresh to brackish pond rather than a continuation of the salt marsh that is found below Parsons Road. The overall combined score is a 5, indicating highest priority for replacement.

Crossing Condition:	Headwall Material	Headwall Condition	Wingwall Material	Wingwall Condition	Scour at Structure	Scour Severity
Upstream	None	N/A	None	N/A	None	None
Downstream	None	N/A	Rip Rap	Fair	Culvert	Medium

Scour in Structure	Scour Severity in Structure	Road Surface Condition	Utilities at Crossing	Structure Condition Overall
None	None	Good	OHE, Utility box DS RR	Fair

Structure Condition Comments:	Scour at wingwalls
--------------------------------------	--------------------

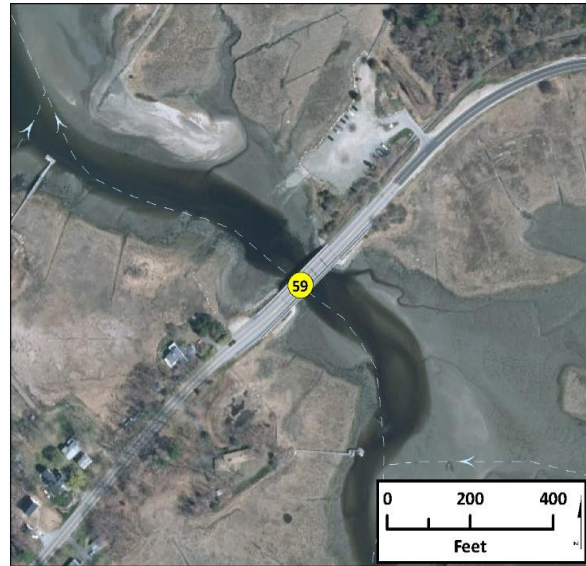
Crossing Condition:	Headwall Material	Headwall Condition	Wingwall Material	Wingwall Condition	Scour at Structure	Scour Severity
Upstream	None	N/A	None	N/A	None	None
Downstream	None	N/A	None	N/A	None	None

Scour in Structure	Scour Severity in Structure	Road Surface Condition	Utilities at Crossing	Structure Condition Overall
None	None	Good	OHE DS	Good

Structure Condition Comments:	Wood ceiling. Concrete abutments. Metal pillars.
--------------------------------------	--

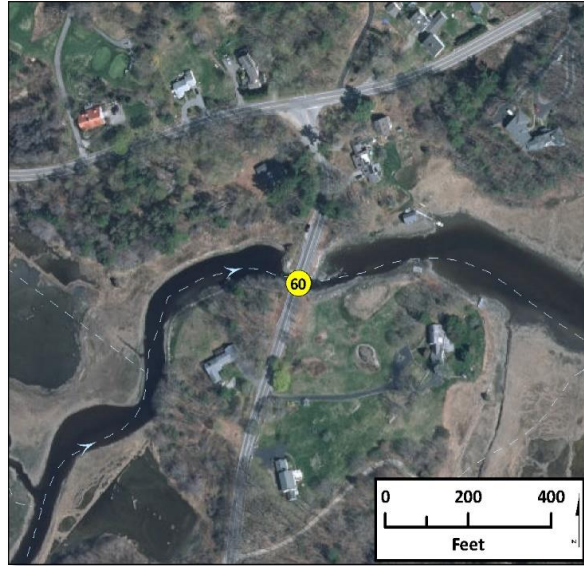
Crossing Condition:	Headwall Material	Headwall Condition	Wingwall Material	Wingwall Condition	Scour at Structure	Scour Severity
Upstream	None	N/A	Rip Rap	Good	None	None
Downstream	None	N/A	Rip Rap	Good	None	None

Scour in Structure	Scour Severity in Structure	Road Surface Condition	Utilities at Crossing	Structure Condition Overall
None	None	Good	Overhead electric	Good

Site Identified in Hazard Mitigation Plan:	Yes
Emergency Access or Evacuation Route:	Yes
History of Flooding:	Flooding on Brackett Rd and 1A

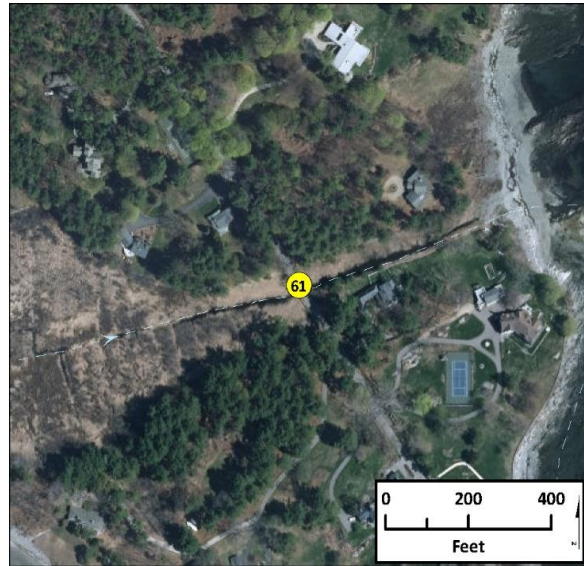
A small back-barrier wetland landward of Fort Stark has a central ditch that is crossed by Wild Rose Lane and has a 3-foot round culvert. The wetland appears fresh to brackish, with exotic common reed and cattail, and is cut off from tidal flooding by gravel barrier beaches to the east and south. The crossing is an undersized culvert that is continually and entirely under water. It has an overall combined score of 3, indicating moderate priority for replacement.

Structure Condition Comments:	Structure completely flooded. Difficult to get structure measurements
--------------------------------------	---

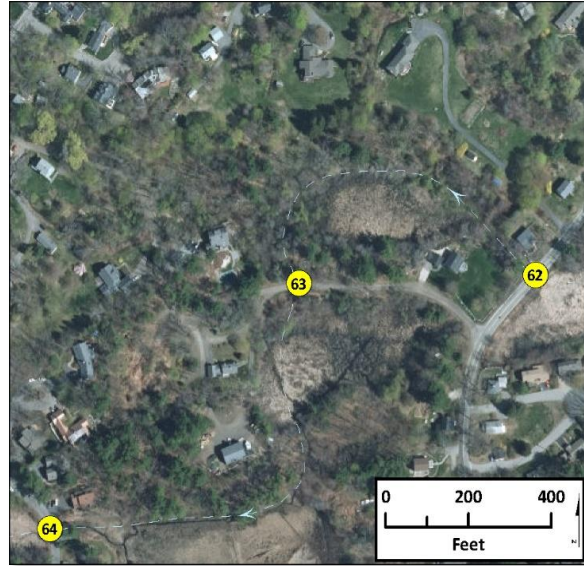
Structure Condition Comments:	Bottom of culvert rusted out. Water flow under culvert. No observed flow during assessment.
--------------------------------------	---

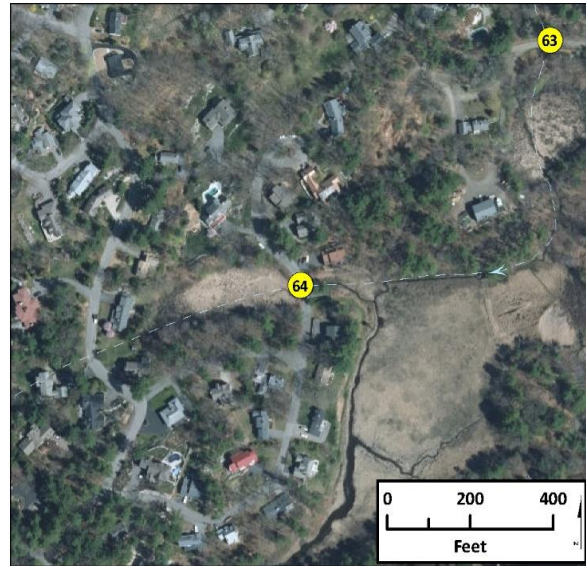
A small marsh extends west of Lavenger Creek in New Castle and its tidal creek runs under Quarterdeck Lane through a concrete box culvert 4 feet wide by 3 feet tall. This culvert replaced a 3-foot pipe in 2008 that was restricting flow and impounding water. Although the crossing condition is very good, erosion is evident, the tidal flow appear restricted and tides regularly overflow the culvert. The upstream marsh is cattail while the downstream marsh is dominated by salt marsh grasses. The overall combined score is 3, indicating moderate priority for replacement.

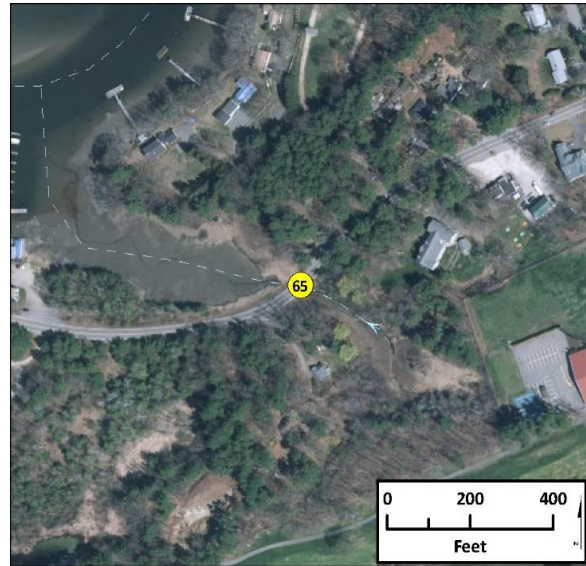
The tiny culvert that runs under Route 1B is a 1-foot diameter pipe that restricts tides from Sagamore Creek to a small upstream marsh. The tidal range is restricted and erosion occurs on the upstream side, but an intensive study found that mummichogs (salt marsh minnows) regularly navigated the culvert (Eberhardt et al. 2011). It has an overall combined score of 5, indicating highest priority for replacement. The high water stain suggests that an immediate expansion of salt marsh would be supported by a larger culvert. The link for cited text can be found below:

Structure Condition Comments:	Culvert chipped at invert both sides.
--------------------------------------	---------------------------------------

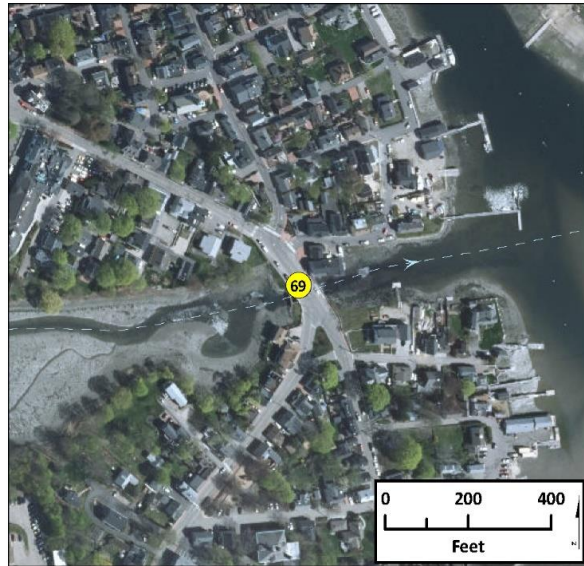
The crossing over the inlet to South Mill Pond at Marcy Street is a tide gate that was regularly closed before 2000 on occasions when combined sewer overflows (CSO) produced a stench. The closures resulted anoxia in the water and death of aquatic animals, but policy change with restoration of shellfish and salt marsh coupled with sewer upgrades and reductions in CSO events has allowed the gate to remain open (McDermott et al. 2005). This crossing has an overall combined score of 3, indicating moderate priority for replacement. The link for cited text can be found below:
<https://scholars.unh.edu/jel/33/>

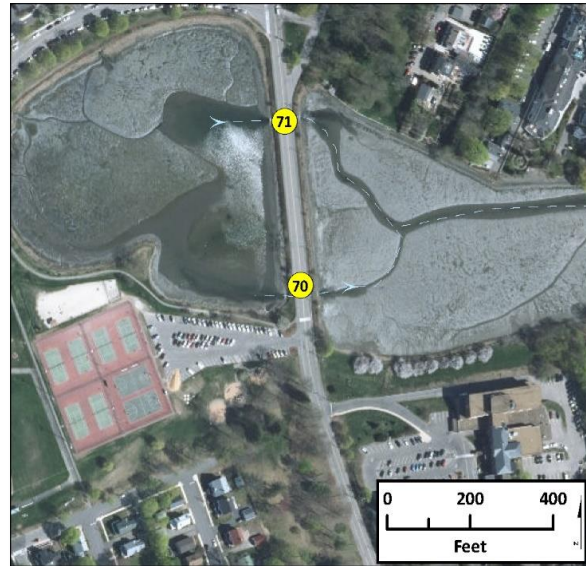
The crossing on Junkins Avenue provides tides to the inner portion of South Mill Pond through a pair of 3 by 8-foot concrete box culverts (#71 is the other culvert). Salt marsh and shellfish have been restored in parts of the pond following opening of the tide gate (see crossing #69), but erosion and tidal restriction indicate replacement is needed. The crossing has an overall combined score of 4, indicating high priority for replacement.

Structure Condition Comments:	Concrete falling off structure. Exposed rebar DS
--------------------------------------	--

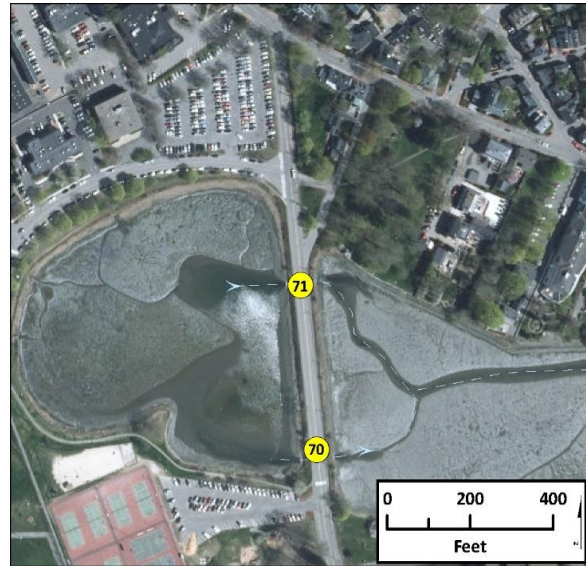
The crossing on Junkins Avenue provides tides to the inner portion of South Mill Pond through a pair of 3 by 8-foot concrete box culverts (#70 is the other culvert). This culvert appears to be partially filled with sediment (cobble sized). Salt marsh and shellfish have been restored in parts of the pond following opening of the tide gate (see crossing #69), but erosion and tidal restriction indicate replacement is needed. The crossing has an overall combined score of 5, indicating highest priority for replacement.

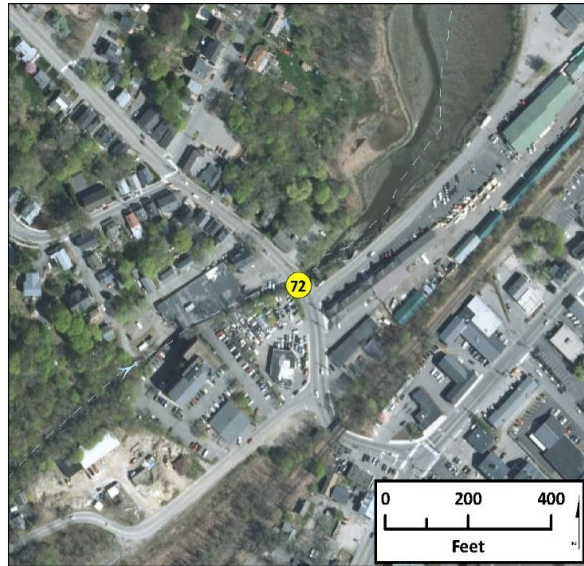
Bartlett Street and upstream development covers Hodgson Brook almost 500 linear feet: from an artificially straightened freshwater stream to the southern terminus of North Mill Pond, which is a salt water pond. Spring tides can push salt water into the stream, but the gradient rises more than three feet over the length of the structure and upstream tides are, for the most part, fresh. The overall combined score for replacement is 5, highest priority, due to restriction in tidal range, stream width and erosion.

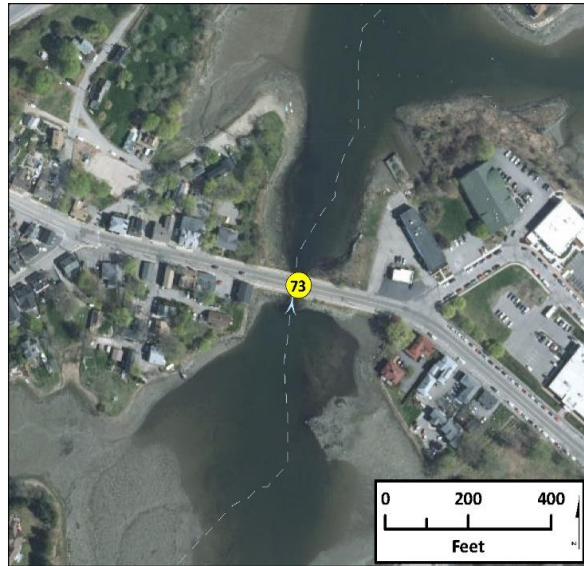
The bridge on Maplewood Avenue conducts all the tides to the North Mill Pond through a large arch (about 12 by 25 feet) supported by courses of granite blocks. A tide gate that resulted in a non-tidal fresh pond was destroyed in a truck accident on the road in the 1950s. The crossing is very old and is in need of repair; it restricts larger tides. Although almost all of the shoreline has been filled, little in the way of new structures or infrastructure has been built so inundation risk to development is small. The overall combined score is a 5: highest priority for replacement.

Crossing Condition:	Headwall Material	Headwall Condition	Wingwall Material	Wingwall Condition	Scour at Structure	Scour Severity
Upstream	None	N/A	Masonry	Fair	Wingwalls	Medium
Downstream	None	N/A	Masonry	Poor	Wingwalls	High

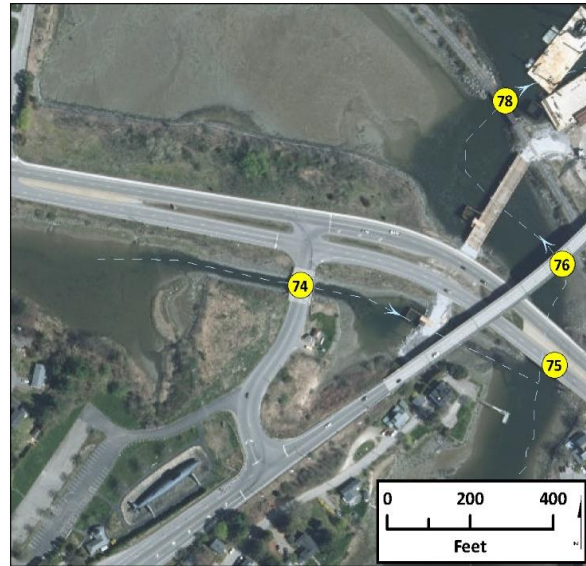
This crossing was built for access to the Albacore Sub Museum and conducts tides through a rip-rap canal into a small intertidal embayment formed by the construction of Market Street Extension. The canal had a sill that created a subtidal salt pond with the intention to reduce odors from undocumented sewage. In the 1990s the sill was removed and sewage sources were identified and corrected. The crossing does not impede flow and the structure is in good shape, leading to an overall combined score of 2, indicating low priority for replacement.

Structure Condition Comments:	Old retaining wall/dam coming into DS channel from banks
--------------------------------------	--

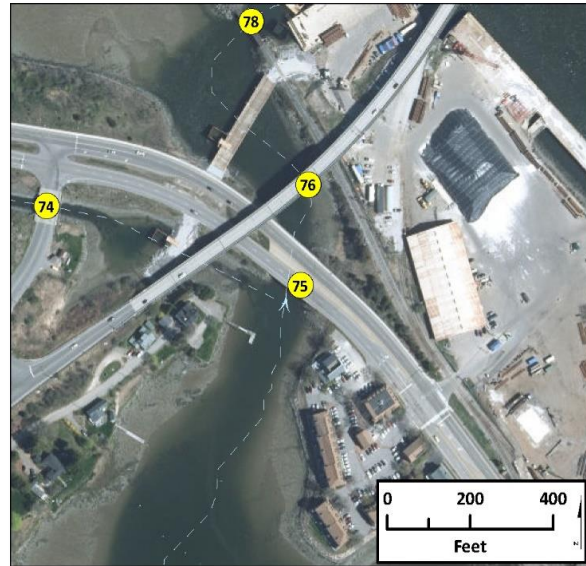
Market Street Extension is built over the inlet to the North Mill Pond system and the crossing is very large (23 by 130 feet) that carries the tides without restriction. The structure is in very good shape and the overall combined score is 2, low priority for replacement.

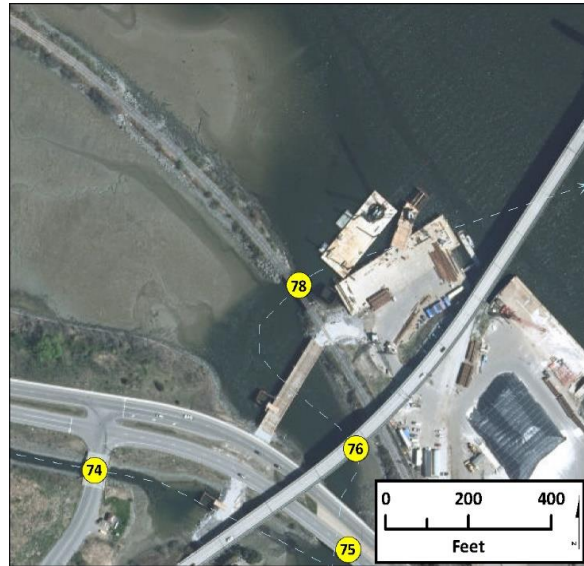
This is the railroad bridge for a spur line that was built out upon Cutts Cove to connect a gypsum plant that makes wallboard. The crossing is somewhat restrictive in that it increases current speed through the opening, but it likely doesn't affect high tides upstream of the 96-foot span. The overall combined score is 2, indicating low priority for replacement.

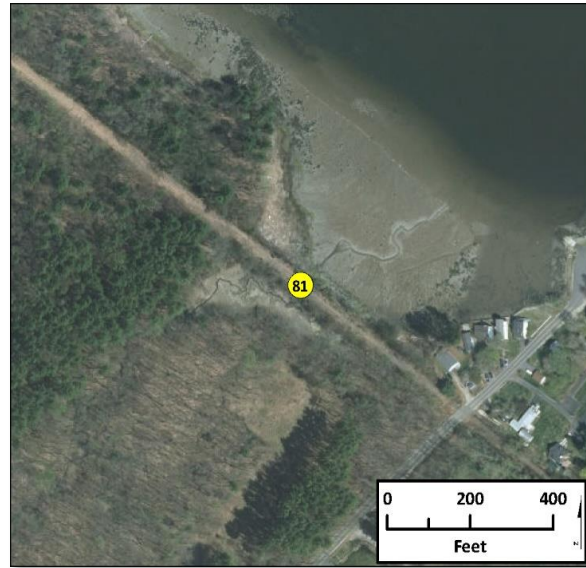
An unnamed tidal creek supplying a salt marsh with tidal flow is crossed by Boston and Maine Corporation rail line by a 3-foot-wide by 4-foot-tall granite culvert that connects the wetland to the Piscataqua River. The crossing condition is poor, erosion is evident, and the entire culvert is underwater on a daily basis. In addition, the culvert is perched and the upstream plant community is different. All these deficiencies and vulnerabilities make this a high priority for replacement with an overall combined score of 4.

Structure Condition Comments:	Highly scoured. DS structure destroyed
--------------------------------------	--

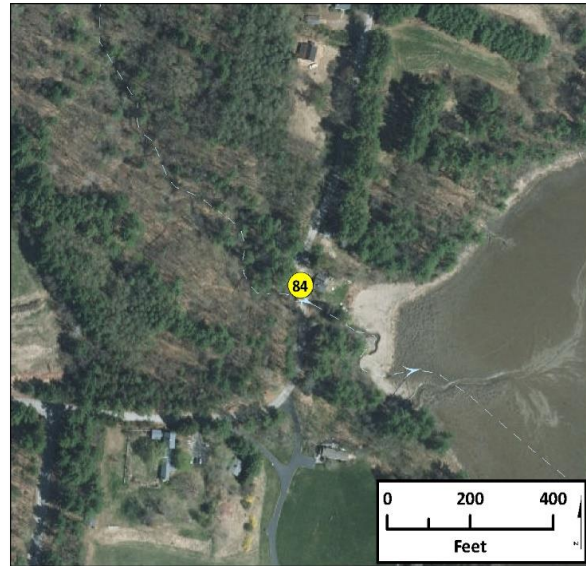
Sligo Road in Rollinsford crosses the Sligo Brook and provides drainage through a 6 by 6-foot stone culvert with a crossing condition rated as poor. The potential for tidal flow through a restored culvert is low until sea level rise occurs because the crossing is perched at the head of tide. The overall combined score is 4: high priority for replacement.

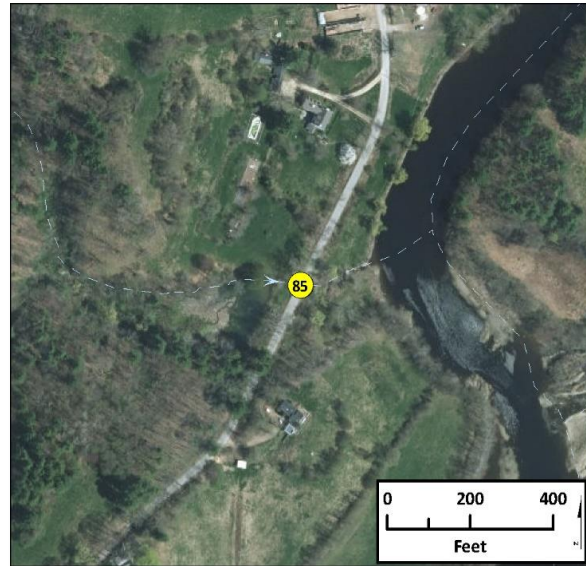
Sligo Road crosses an unnamed creek just north of crossing #84 through a 6 by 2-foot stone culvert. The crossing condition is poor with erosion and tidal restriction observed, including a plunge pool downstream and an impoundment upstream. The overall combined score is 4: high priority for replacement. The roadway was washed out in 2011 and a pipe was added above the failing culvert to prevent another washout, highlighting the need for replacement.

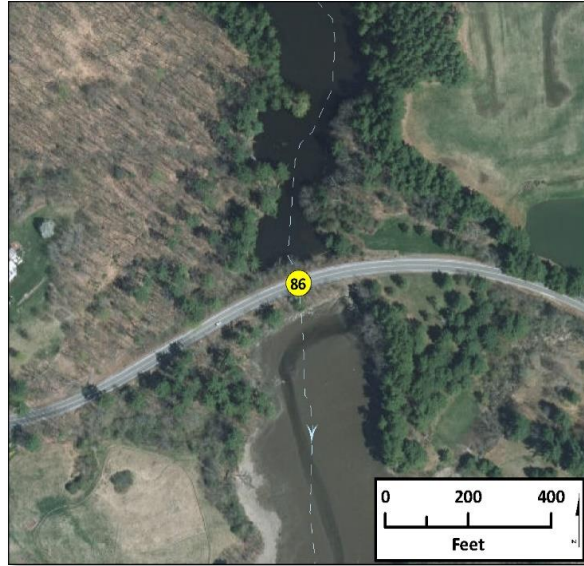
The crossing over Fresh Creek is a 6 by 20-foot culvert that is relatively new and in good shape, but it is perched just above the high water line. The overall combined score is a 5, highest priority for replacement because it cuts off the entire watershed from tidal waters and prevents organism passage, including anadromous fish. It has been considered as a possible restoration site.

Structure Condition Comments:	Good shape
--------------------------------------	------------

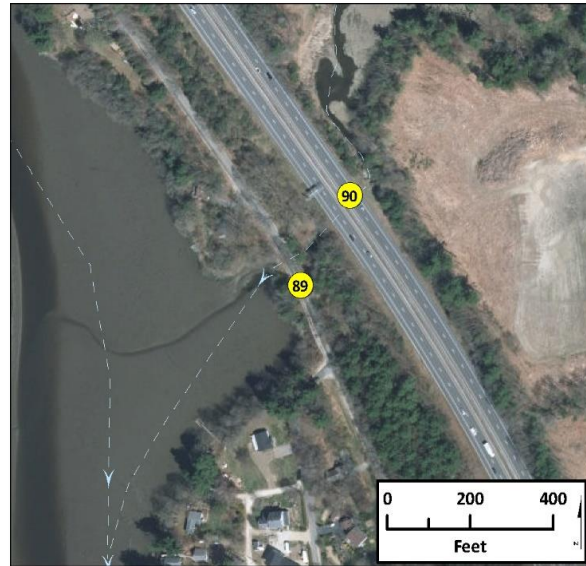
Spur road in Dover crosses Varney Brook with a 7 by 8-foot granite culvert. Just 80 feet upstream of this crossing Route 16 crosses the Brook (#90) with double 6-foot diameter round culverts. The upstream area is heavily shaded and is not likely to support tidal marsh plants. The overall combined score for this crossing is 5, highest priority for replacement based upon crossing conditions, erosion and tidal restriction.

Structure Condition Comments:	Overall not bad. Collapsing wing walls.
--------------------------------------	---

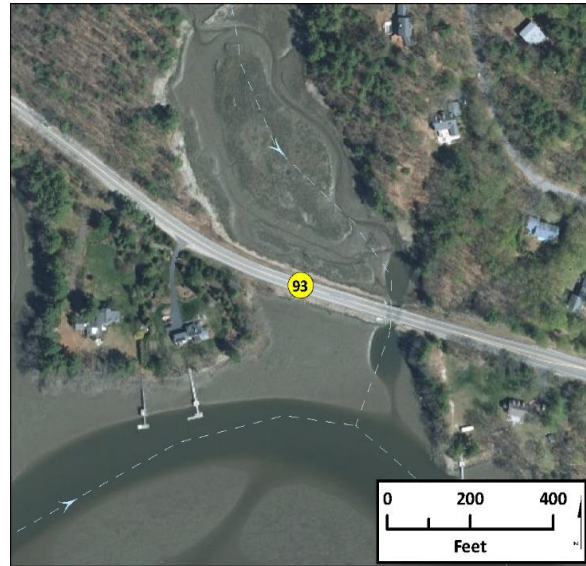
The crossing of Bunker Creek at Route 4 in Durham is a 10.5 by 13-foot concrete structure showing multiple signs of wear and erosion. It features plunge pools on either side and restricts tidal flow to an upstream marsh that is largely tall form cordgrass (in contrast, almost all marshes in the State are dominated by salt hay). The upstream marsh is managed by NH Fish and Game and is a sentinel site with long term monitoring for the Great Bay National Estuarine Research Reserve. The combined overall combined score is 4, a high priority for replacement.

Crossing Condition:	Headwall Material	Headwall Condition	Wingwall Material	Wingwall Condition	Scour at Structure	Scour Severity
Upstream	None	N/A	Concrete	Poor	Wingwalls	Medium
Downstream	None	N/A	Concrete	Poor	Wingwalls	Medium

Scour in Structure	Scour Severity in Structure	Road Surface Condition	Utilities at Crossing	Structure Condition Overall
Abutment	Medium	Fair	Overhead electric	Poor

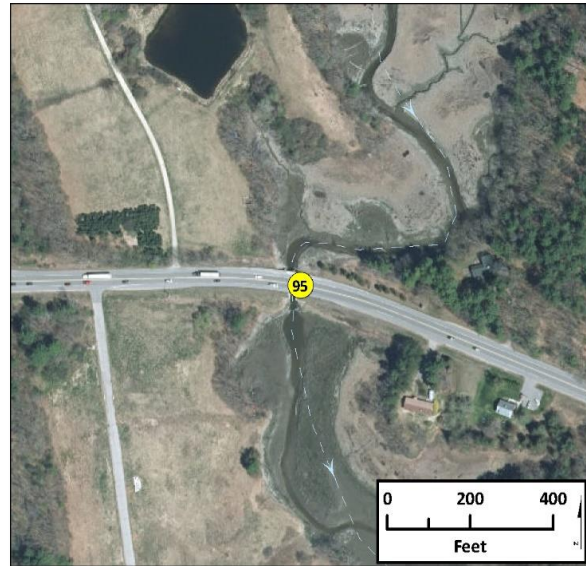
Crossing Condition:	Headwall Material	Headwall Condition	Wingwall Material	Wingwall Condition	Scour at Structure	Scour Severity
Upstream	None	N/A	Concrete	Good	None	None
Downstream	None	N/A	Concrete	Good	Abutment	Medium

Scour in Structure	Scour Severity in Structure	Road Surface Condition	Utilities at Crossing	Structure Condition Overall
Abutment	Low	Fair	Overhead electric	Good

Structure Condition Comments:	Good overall so spalling/scour inside exposing rebar
--------------------------------------	--

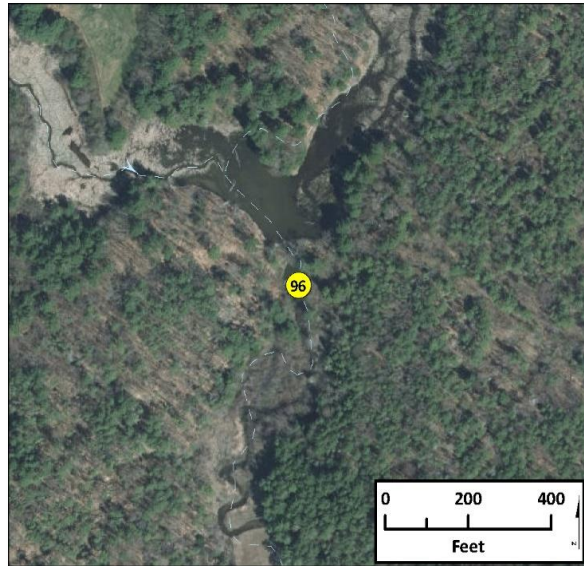
Johnson Creek is a long narrow tidal creek that reaches into Madbury as it becomes brackish and fresh. Creek Road crosses the waterway with a 9.3 feet wide by 6.8 feet tall stone bridge. The crossing condition is poor, crossing ratio is poor and erosion is evident. The overall combined score is 5, highest priority for replacement.

Crossing Condition:	Headwall Material	Headwall Condition	Wingwall Material	Wingwall Condition	Scour at Structure	Scour Severity
Upstream	None	N/A	None	N/A	Abutment	High
Downstream	None	N/A	None	N/A	Abutment	Medium

Scour in Structure	Scour Severity in Structure	Road Surface Condition	Utilities at Crossing	Structure Condition Overall
Culvert	High	N/A	None	Poor

Structure Condition Comments:	Stone abutments with 3 boards over it. Otherwise open
--------------------------------------	---

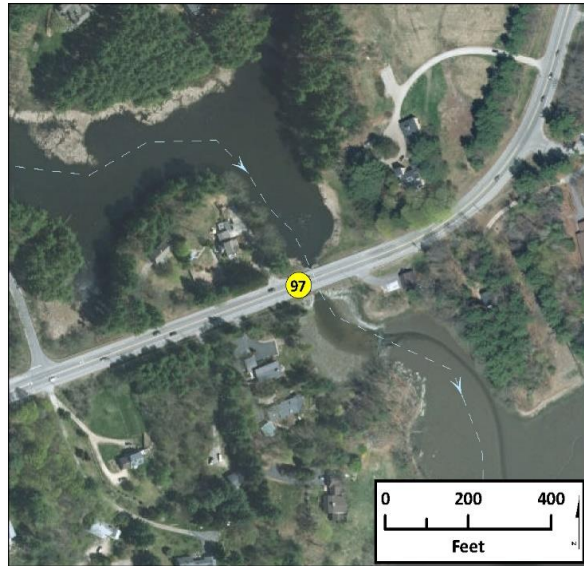
The entrance to the town center of Durham on Route 108 (Dover Road) passes over Beards Creek which drains through an 8.5 high by 7.5-foot-wide concrete box culvert. Stop logs had kept the upstream wetland an open freshwater pond with no tidal exchange. The crossing is in good shape but has severe ecological impacts to the upstream wetlands and will prevent future marsh migration. The overall combined score is a 5, highest priority for replacement due to the ecological impacts. The main sewage line leading to the treatment plant to the south crosses the mouth of the culvert, below the stop logs, so that tidal restoration would require reconfiguration of the sewer line.

Crossing Condition:	Headwall Material	Headwall Condition	Wingwall Material	Wingwall Condition	Scour at Structure	Scour Severity
Upstream	Concrete	Fair	Metal	Fair	None	None
Downstream	Concrete	Good	Metal	Good	None	None

Structure Condition Comments:	Dam condition is poor.
--------------------------------------	------------------------

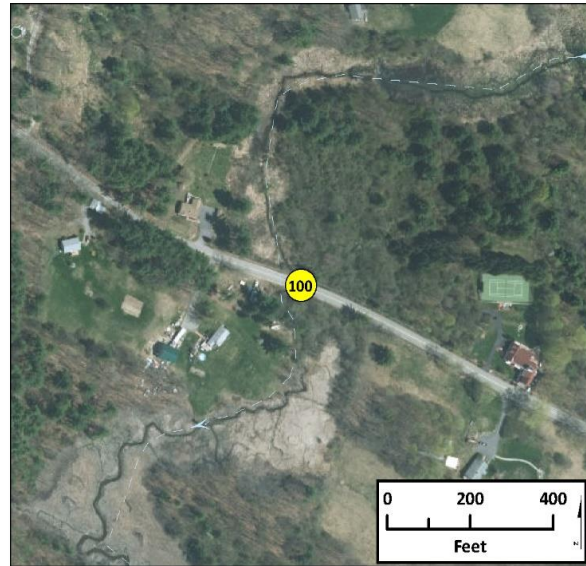
The crossing at Lubberland Creek, where it crosses Bay Road in Newmarket is effectively at the head of tide. The restrictive crossing is in poor condition; it contributes to the inundation risk from stormwater flooding, and is undersized, leading to severe scour, strongly restricting tides and prevention of organism passage. The overall combined score is 5 indicating highest priority for restoration. The culvert is slated to be restored in 2019 and the project champion and abutting landowner is The Nature Conservancy.

Crossing Condition:	Headwall Material	Headwall Condition	Wingwall Material	Wingwall Condition	Scour at Structure	Scour Severity
Upstream	Dry Fit Stone	Poor	Dry Fit Stone	Poor	Wingwalls	High
Downstream	Dry Fit Stone	Poor	Dry Fit Stone	Poor	Wingwalls	High

Scour in Structure	Scour Severity in Structure	Road Surface Condition	Utilities at Crossing	Structure Condition Overall
None	None	Fair	Overhead electric	Poor

Structure Condition Comments:	Upstream opening clogged with sediment and veg due to Beaver gate.
--------------------------------------	--

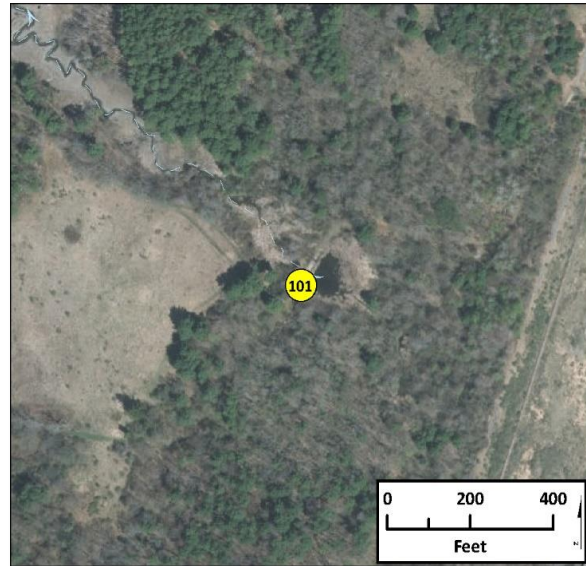
Structure Condition Comments:	Vertical structure covering inlet. Barrier to two directional flow. Water trickling in from US pond.
--------------------------------------	--

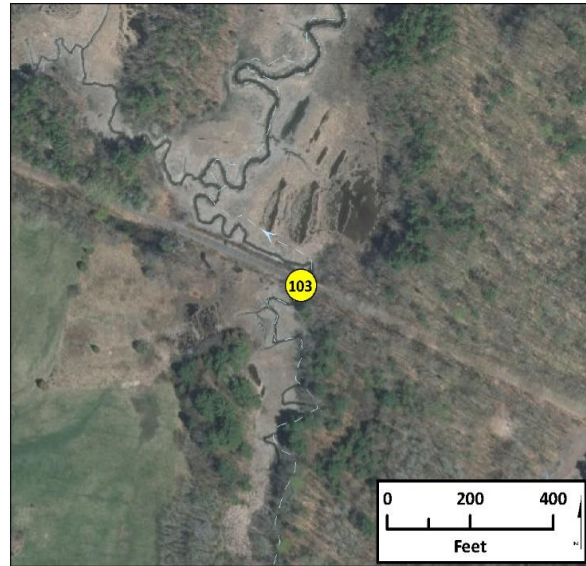
Crossing Condition:	Headwall Material	Headwall Condition	Wingwall Material	Wingwall Condition	Scour at Structure	Scour Severity
Upstream	None	N/A	Dry Fit Stone	Fair	Wingwalls	Low
Downstream	None	N/A	Dry Fit Stone	Poor	Wingwalls	High

Scour in Structure	Scour Severity in Structure	Road Surface Condition	Utilities at Crossing	Structure Condition Overall
Abutment	Low	Fair		Fair

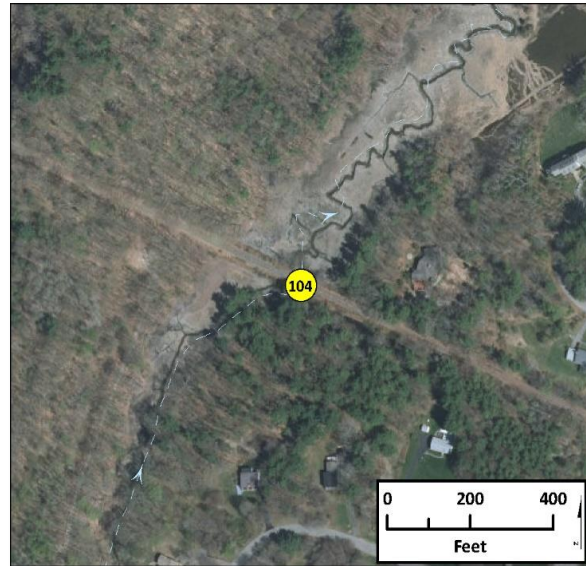
The railroad line that traverses the southeast corner of Great Bay crosses several small valleys of salt marsh (#103, 104, 106) and the Winnicut River (#105). This crossing is a granite culvert, about 1.5 feet wide and 5 feet tall, over a small tributary called Shaw Brook. With poor crossing condition, erosion and poor crossing ratio the overall combined score is 4, high priority for replacement.

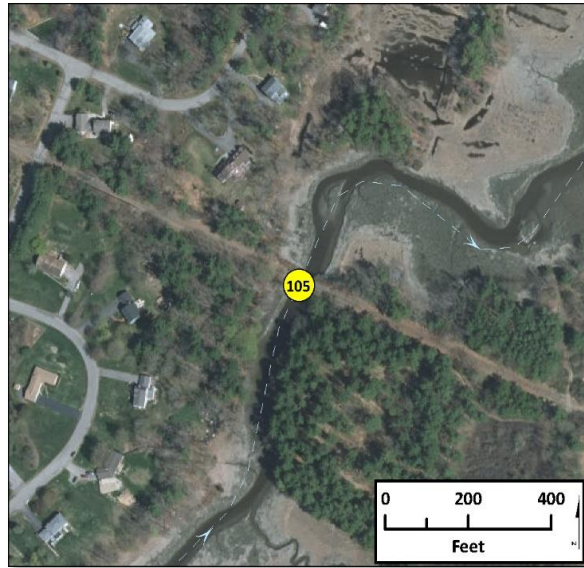
The railroad line that traverses the southeast corner of Great Bay crosses several small valleys of salt marsh (#103, 104, 106) and the Winnicut River (#105). The Winnicut River is bridged by the railroad (about 19 feet wide and 18 feet tall) with granite abutments. The crossing condition is poor and exhibits some erosion and minor tidal restriction. The vegetation upstream becomes brackish and is more shaded by large trees and the marsh plain was measured more than 0.5 foot lower, an indicator of peat subsidence. The overall combined score is 4, high priority for replacement.

Crossing Condition:	Headwall Material	Headwall Condition	Wingwall Material	Wingwall Condition	Scour at Structure	Scour Severity
Upstream	None	N/A	Masonry	Poor	Wingwalls	Medium
Downstream	None	N/A	Masonry	Poor	Wingwalls	Medium

Scour in Structure	Scour Severity in Structure	Road Surface Condition	Utilities at Crossing	Structure Condition Overall
Abutment	Medium	N/A		Poor

Structure Condition Comments:	Sink hole rail surface river left
--------------------------------------	-----------------------------------

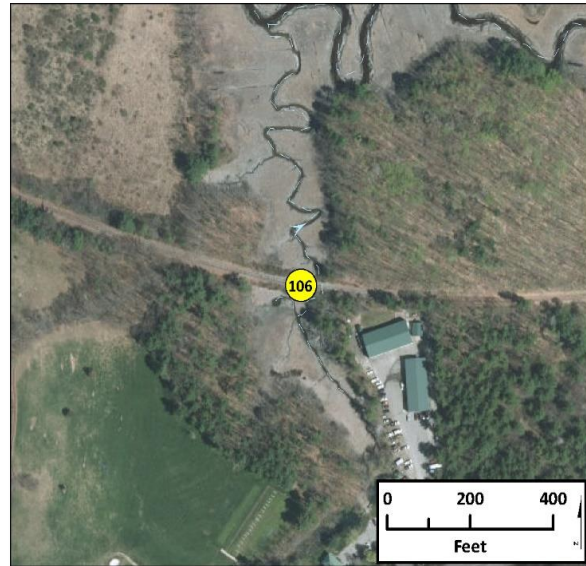
The railroad line that traverses the southeast corner of Great Bay crosses several small valleys of salt marsh (#103, 104, 106) and the Winnicut River (#105). This easternmost crossing is over a tributary to the Winnicut River, a 3 by 3 (approximately) granite culvert. The crossing condition is poor and moderate erosion was observed as well as a change in plant community. The culvert is slightly perched, and high tides often overtop the culvert. The overall combined score is 4, high priority for replacement.

Crossing Condition:	Headwall Material	Headwall Condition	Wingwall Material	Wingwall Condition	Scour at Structure	Scour Severity
Upstream	None	N/A	None	N/A	Culvert	Medium
Downstream	None	N/A	None	N/A	Culvert	None

Scour in Structure	Scour Severity in Structure	Road Surface Condition	Utilities at Crossing	Structure Condition Overall
Culvert	Medium	N/A	None	Poor

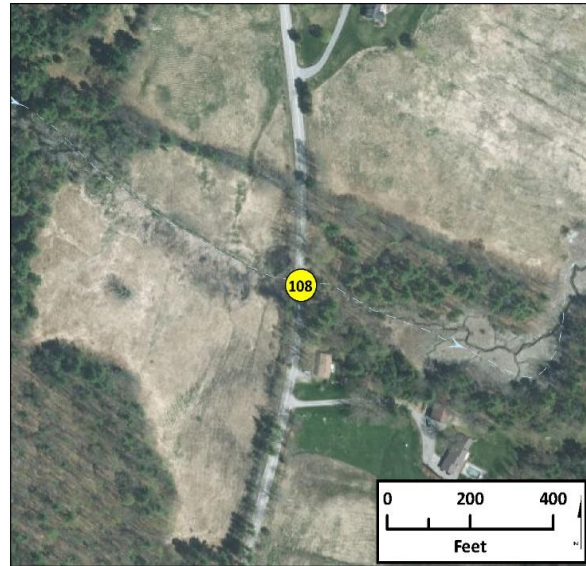
This crossing under New Road in Newmarket conducts water to a wetland high in the intertidal zone with little potential for migration. However, its crossing condition is poor, it is restrictive, and it exhibits high erosion. The overall combined score is 4, indicating high priority for replacement.

Crossing Condition:	Headwall Material	Headwall Condition	Wingwall Material	Wingwall Condition	Scour at Structure	Scour Severity
Upstream	Masonry	Poor	Masonry	Poor	Headwall	High
Downstream	Masonry	Poor	None	N/A	None	None

Scour in Structure	Scour Severity in Structure	Road Surface Condition	Utilities at Crossing	Structure Condition Overall
None	None	Good	Over head electric	Poor

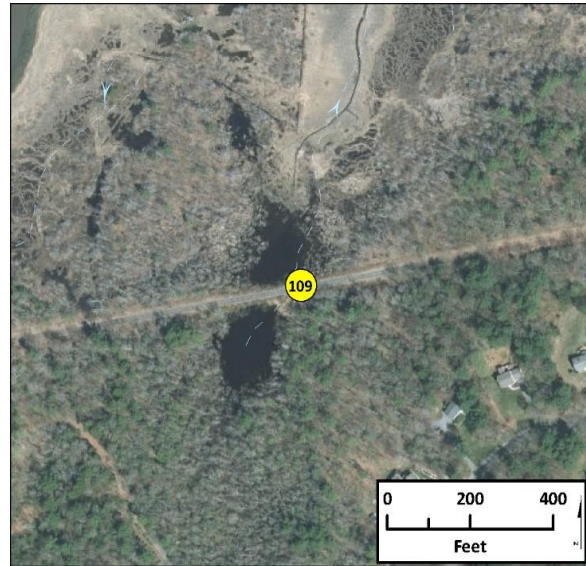
This is a railroad crossing of a small upper tidal reach with a 2 by 2-foot granite culvert. Ponding on either side of the structure suggests an artificial condition of the wetlands (perhaps a borrow site for fill for the railroad bed). The vegetation appears to be largely salt marsh downstream and fresh upstream. This crossing has an overall combined score of 3, indicating moderate priority for replacement, which may rank higher for marsh migration as sea levels rise.

Scour in Structure	Scour Severity in Structure	Road Surface Condition	Utilities at Crossing	Structure Condition Overall
Culvert	Low	N/A	None	Fair

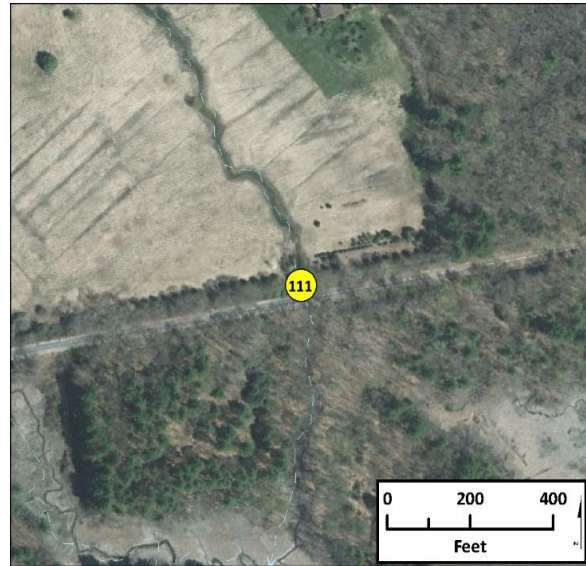
This crossing is over a branch of an unnamed brook and marsh and supports the rail line through Newington. It is terribly undersized (1.2 by 1.4 feet granite box culvert), has a poor crossing condition and exhibits high erosion. The crossing has an overall combined score of 4, indicating high priority for replacement.

Crossing Condition:	Headwall Material	Headwall Condition	Wingwall Material	Wingwall Condition	Scour at Structure	Scour Severity
Upstream	None	N/A	Rip Rap	Poor	Wingwalls	Medium
Downstream	None	N/A	Rip Rap	Poor	Wingwalls	Medium

Scour in Structure	Scour Severity in Structure	Road Surface Condition	Utilities at Crossing	Structure Condition Overall
Culvert	Medium	N/A	None	Poor

Structure Condition Comments:	Stones collapsing at structure.
--------------------------------------	---------------------------------

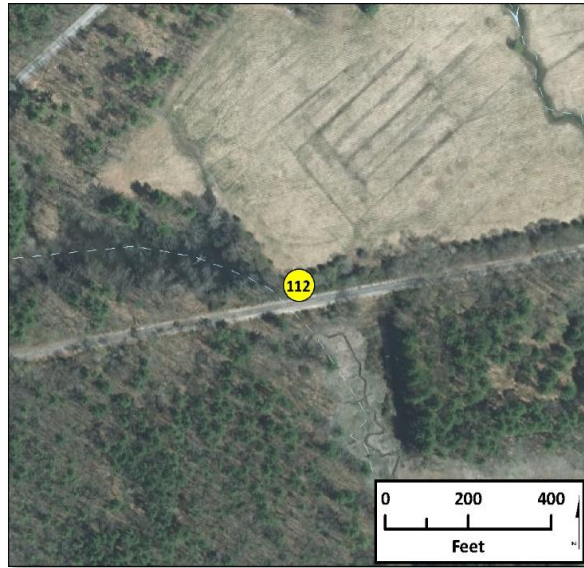
The crossing is a railroad line over the upper reaches of a small drainage to the Squamscott River. It is a stone box culvert about 2 feet wide and 3 feet tall that shows constriction of the channel, erosion and potential impacts to the plant community. The overall combined score is a 5, highest priority for replacement.

Crossing Condition:	Headwall Material	Headwall Condition	Wingwall Material	Wingwall Condition	Scour at Structure	Scour Severity
Upstream	Dry Fit Stone	Poor	Dry Fit Stone	Fair	Wingwalls	Low
Downstream	None	N/A	Dry Fit Stone	Fair	Wingwalls	Medium

Scour in Structure	Scour Severity in Structure	Road Surface Condition	Utilities at Crossing	Structure Condition Overall
Culvert	Low	Fair	None	Poor

Structure Condition Comments:	R clogged DS
--------------------------------------	--------------

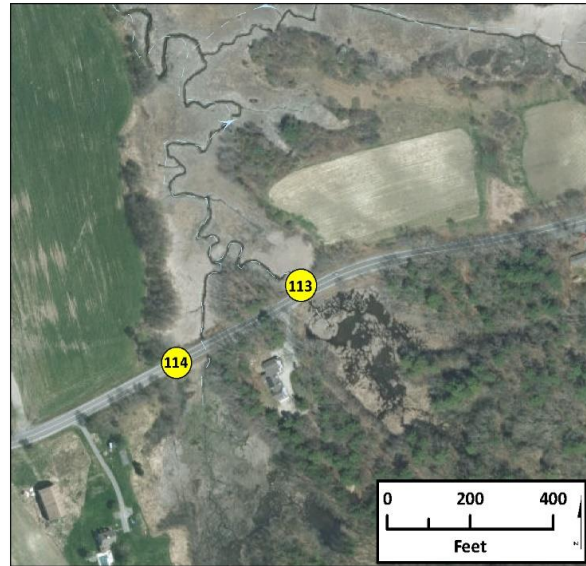
The crossing is on Squamscott Road over one of the unnamed upper marshes in Stratham and is rated an overall combined score of 4: high priority for replacement, due to tidal restriction and erosion associated with the 18-inch round culvert. The tidal creek fills the height of the culvert, even at low tide. Cattails are seen on both sides, but there is extensive marsh loss through ponding on the upstream side.

Crossing Condition:	Headwall Material	Headwall Condition	Wingwall Material	Wingwall Condition	Scour at Structure	Scour Severity
Upstream	Dry Fit Stone	Poor	None	N/A	Headwall	Low
Downstream	None	Poor	None	N/A	Wingwalls	Low

Scour in Structure	Scour Severity in Structure	Road Surface Condition	Utilities at Crossing	Structure Condition Overall
None	None	Good	None	Poor

Structure Condition Comments:	Structure submerged
--------------------------------------	---------------------

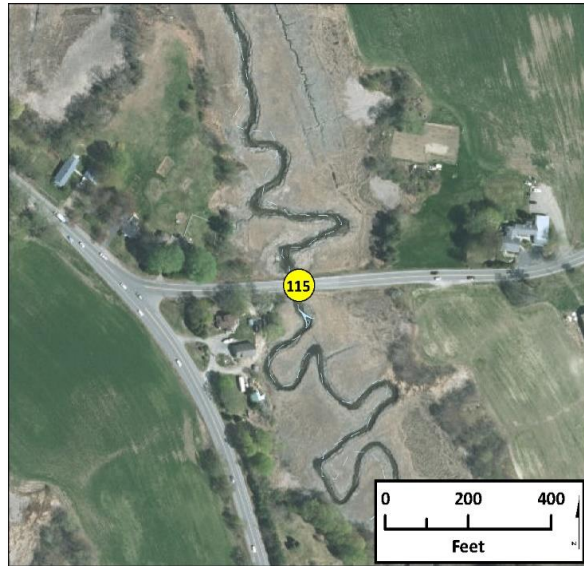
Jewel Hill Creek carries tides through a fairly significant salt marsh and is crossed by Squamscott Road through an arched culvert, 8 feet wide and about 7 feet high. Although it appears to have been recently replaced, the structure condition was poor. The culvert constricted the channel and may have a negative impact on the plant community upstream. The overall combined score is 4, high priority for replacement.

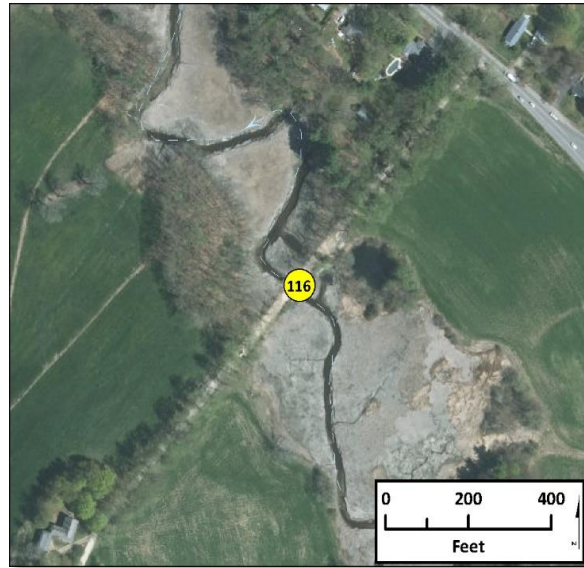
The tidal crossing at Mill Creek is on the drive to Stuart Farm. In 1993 a tide gate was removed and replaced by a large arched culvert. This was one of the first tidal restorations in the State. See link below for more information:

The upstream side had subsided by 1 foot and the vegetation included purple loosestrife and common reed (exotic variety). Purple loosestrife was almost all eliminated, but some common reed remains, and the elevation of the marsh was found to build rapidly (0.12 feet per year in the 1990s). Today the elevation difference of the marsh is only 0.08 feet lower upstream than downstream. The metal pipe corroded and had to be replaced by a 9.5-foot round culvert in 2010. The crossing has an overall combined score of 2, indicating low priority for replacement. See the link below for more information on habitat change after tidal restoration:

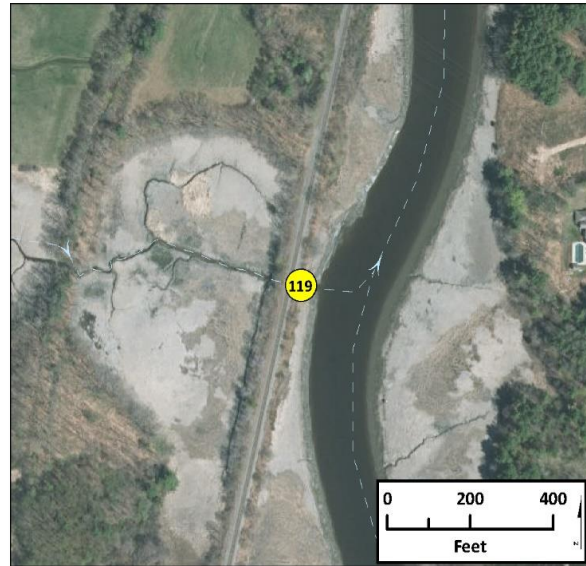
The railroad bed traveling north and south on the west side of Great Bay has several crossings of tidal marsh and creeks (117, 118, 119, 121). The granite culvert for this crossing is about 7 feet high by 4 feet wide and conducts water of an unnamed tidal creek to about 10 acres of tidal marsh. The crossing condition is poor, it constricts the channel width, restricts the tidal range and has a perch at low tide. The culvert fills during high tide on a regular basis. The overall combined score is 4, high priority for replacement.

Crossing Condition:	Headwall Material	Headwall Condition	Wingwall Material	Wingwall Condition	Scour at Structure	Scour Severity
Upstream	Dry Fit Stone	Poor	Dry Fit Stone	Poor	Wingwalls	Medium
Downstream	Dry Fit Stone	Fair	Dry Fit Stone	Fair	Headwall	Medium

Scour in Structure	Scour Severity in Structure	Road Surface Condition	Utilities at Crossing	Structure Condition Overall
Culvert	Low	N/A	None	Poor

Structure Condition Comments:	Water runs under wood bottom
--------------------------------------	------------------------------

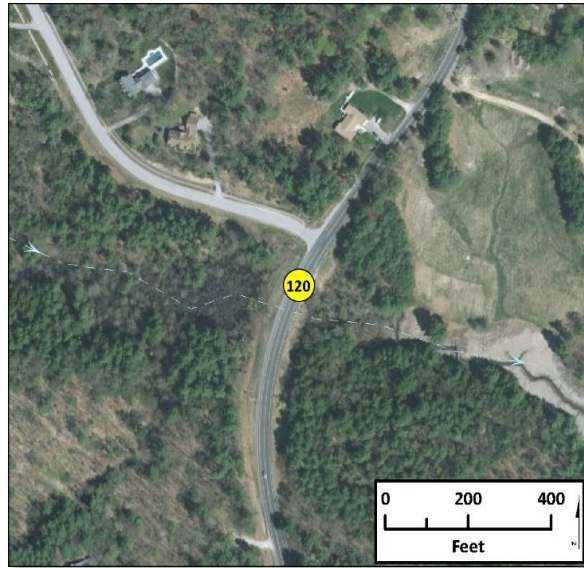
Newfield's Road crosses Rocky Hill Brook well above the railroad bed and the Brook runs through a 3.5-foot round metal pipe (although the upstream pipe exiting the road bed is partially crushed). The crossing condition is poor, with strong evidence of erosion and the culvert constricts the channel flow. The overall combined score is 4 for this culvert, indicating a high priority for replacement.

Crossing Condition:	Headwall Material	Headwall Condition	Wingwall Material	Wingwall Condition	Scour at Structure	Scour Severity
Upstream	Masonry	Poor	Masonry	Poor	Culvert	High
Downstream	Masonry	Good	Rip Rap	Poor	Culvert	High

Scour in Structure	Scour Severity in Structure	Road Surface Condition	Utilities at Crossing	Structure Condition Overall
Culvert	High	Good	OHE	Poor

Structure Condition Comments:	US grate fallen
--------------------------------------	-----------------

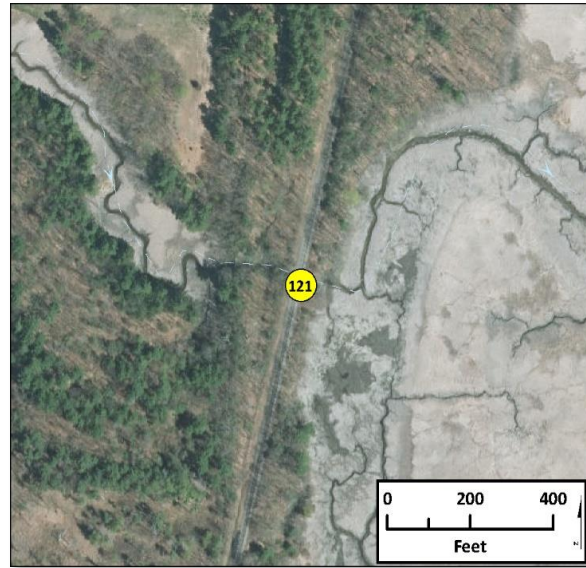
The railroad bed traveling north and south on the west side of Great Bay has several crossings of tidal marsh and creeks (117, 118, 119, 121). Rocky hill brook is tidal marsh where it crosses under the railroad through a 4-foot-wide and 5.5-foot-tall stone bridge. The crossing condition is poor showing channel constriction and severe erosion, with high tides overflowing the structure on a daily basis. The upstream marsh is more than 0.5 feet lower than the downstream marsh plain, indicating restriction has led to subsidence. The overall combined score is 4, high priority for replacement.

Crossing Condition:	Headwall Material	Headwall Condition	Wingwall Material	Wingwall Condition	Scour at Structure	Scour Severity
Upstream	Dry Fit Stone	Poor	None	N/A	Headwall	High
Downstream	Dry Fit Stone	Fair	None	N/A	Headwall	High

Scour in Structure	Scour Severity in Structure	Road Surface Condition	Utilities at Crossing	Structure Condition Overall
None	None	N/A	Tracks	Poor

Structure Condition Comments:	Scour from lack of wingwalls
--------------------------------------	------------------------------

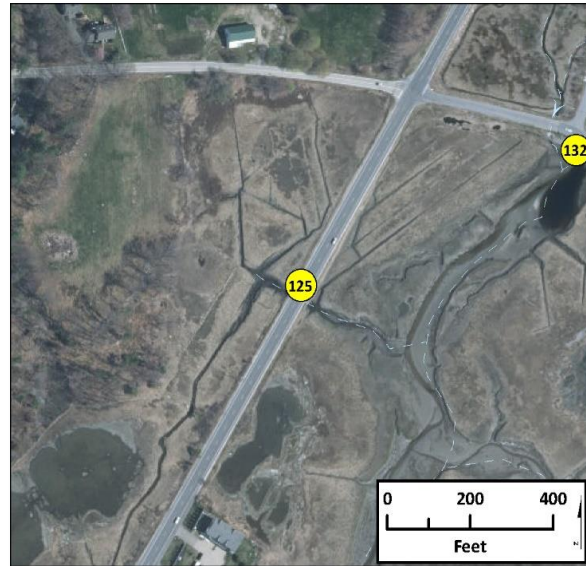
Route 1A crosses an extensive back-barrier salt marsh at Rye Harbor several times and this crossing provides tidal flow to a fragmented marsh that also receives flow through a crossing to the south (#46). Tidal waters are conducted through a 6 by 6-foot concrete culvert installed circa 1997 to restore tidal exchange and halt the spread of exotic *Phragmites* (common reed). The crossing condition is fair, the channel is constricted, and the high tide stain indicates that the culvert overfills regularly. The overall combined score is 4, high priority for replacement.

Crossing Condition:	Headwall Material	Headwall Condition	Wingwall Material	Wingwall Condition	Scour at Structure	Scour Severity
Upstream	Concrete	Good	Rip Rap	Fair	None	None
Downstream	Concrete	Good	Rip Rap	Poor	Wingwalls	High

Scour in Structure	Scour Severity in Structure	Road Surface Condition	Utilities at Crossing	Structure Condition Overall
Culvert	Low	Fair	Overhead electric	Fair
