Resilient Tidal Crossings

*An Assessment and Prioritization to Address New Hampshire's
Tidal Crossing Infrastructure for Coastal Resilience*

May 2019

Prepared in partnership with:
NHDES Coastal Program – Water Division
The Nature Conservancy
University of New Hampshire

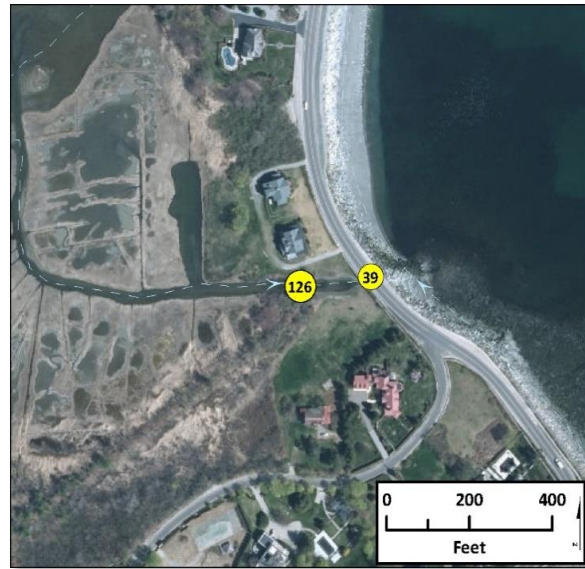
Tidal flow supporting the salt marsh at Philbrick’s Pond has been restricted by the trolley berm of the early 1900s as well as Route 1A (crossing #39). A recent investigation into the hydrodynamic flows and how they may be restored to rejuvenate the degraded salt marsh showed that the small clay pipe (2.5 feet in diameter) under the trolley berm was intact, but restricted tides, while the culvert under Route 1A was less restrictive (CMA Engineers 2018). The overall combined score of 5 indicates highest priority for replacement, but it will require landowner permission.

Crossing Condition:	Headwall Material	Headwall Condition	Wingwall Material	Wingwall Condition	Scour at Structure	Scour Severity
Upstream	Dry Fit Stone	Fair	None	N/A	Headwall	Medium
Downstream	Dry Fit Stone	Fair	None	N/A	Headwall	Medium

Structure Condition Comments:	Clay pipe, completely flooded
--------------------------------------	-------------------------------

Site Identified in Hazard Mitigation Plan:	No
Emergency Access or Evacuation Route:	N/A
History of Flooding:	undersized culvert, flooded US marsh

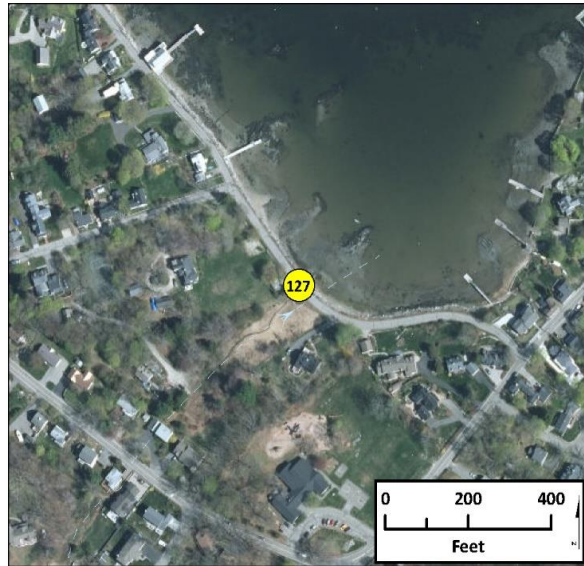
A small head of tide marsh on New Castle Island is crossed by River Road and a new 1.25-foot round pipe was installed in 2011 to improve tidal flow to the marsh, which was being invaded by weedy species such as a non-native form of common reed (Phragmites). The site has a history of flooding and continues to show signs of restriction. The overall combined score is 5: highest priority for replacement.

Scour in Structure	Scour Severity in Structure	Road Surface Condition	Utilities at Crossing	Structure Condition Overall
None	None	Fair	Overhead electric	Fair

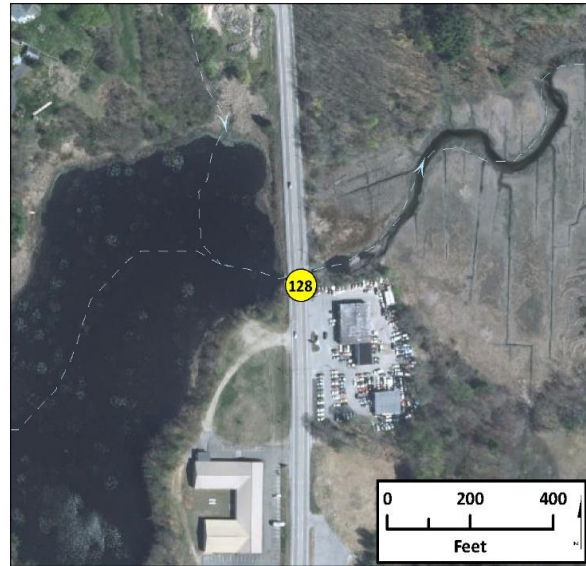
In Hampton Falls the head of tide for a narrow marsh ‘finger’ ends at the Dodge Ponds Dam just upstream of Route 1. The Route 1 cement culvert over the waterway is approximately 10 by 9 feet with wingwalls and fitted with slots for stoplogs (absent). The tide reaches about 5 feet above the culvert invert but is stopped by the dam, which impounds about 8 feet of water. The crossing condition is very good, but the dam restricts the tides completely, leading to an ecological score of 5 and an overall combined score of 5, highest priority for replacement.

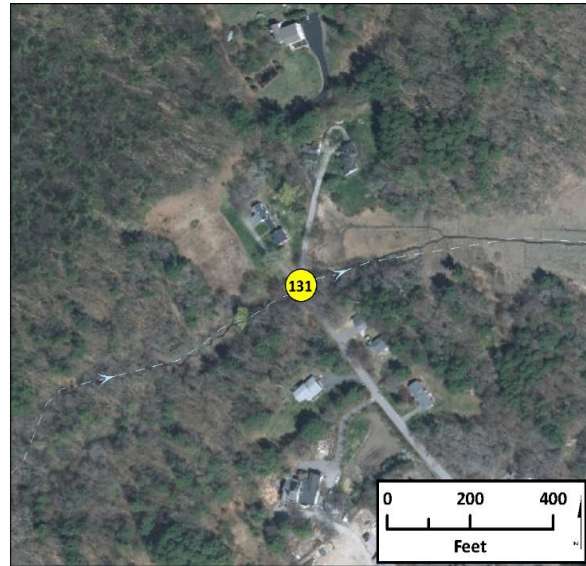
Marsh Lane crosses Kenney Brook in Hampton and conducts flow through a 3-foot round culvert. It is rated an overall combined score of 3, indicating a moderate priority for replacement due to high scour scores and relatively deep downstream pool. It sits at a high position in the landscape, but improvements may benefit fish passage, especially as sea levels rise.

Structure Condition Comments:	Pipe good. Wingwalls fair and road sinking in over pipe
--------------------------------------	---

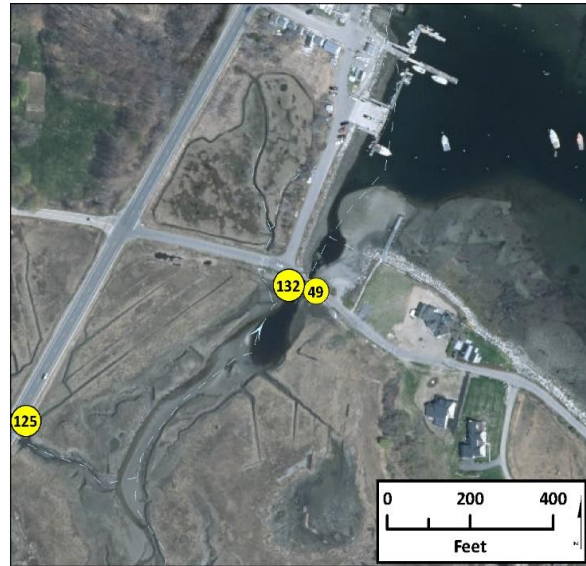
A small rectangular marsh surrounded by roads and cut off from tides during the development of Rye Harbor was restored to tidal exchange in 1998 by the addition of a 3 by 4-foot concrete culvert that runs under Harbor Road. Common reed covered wetland which had been partially filled with dredge spoil. Restoration included the new culvert and the area had the fill and a small tidal creek excavated. The crossing is in very good condition, but the culvert still restricts some of the tidal flow. It has an overall combined score of 3, a moderate priority for replacement.

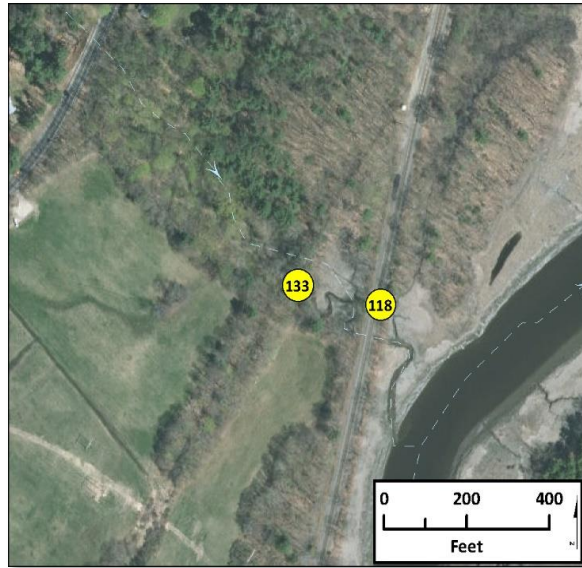
A small head of tide marsh that extends west from the Squamscott River in Newfields is crossed by an unnamed access road that conducts flow through a granite box culvert that may have been 4 by 4 feet in cross-section when installed. Currently, the upstream inlet appears to be collapsed and blocked by sediment. As might be expected, this culvert is not functional and is at risk for failure. The overall combined score is 4: high priority for replacement.

Structure Condition Comments:	Collapsed US, no structure to measure, see photo
--------------------------------------	--

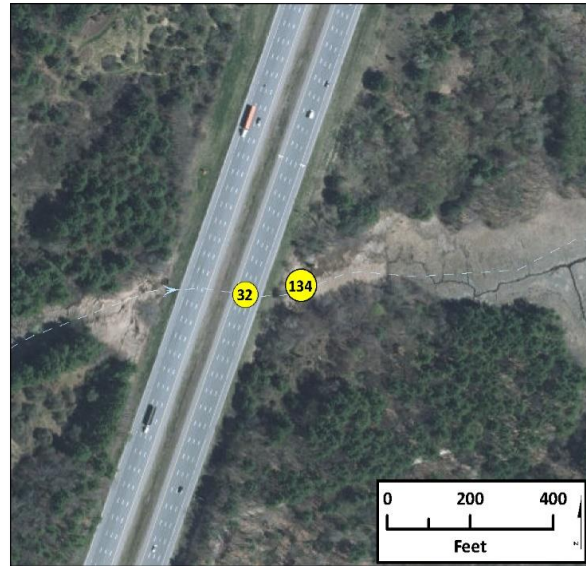
At the head of a tidal creek just south of the Taylor River is a berm barrier to 1-2 feet of tidal flow with a 1-foot metal pipe for drainage that is crushed at the downstream end. Current conditions are poor and prevent tidal flow leading to an overall combined score of 4: high priority for replacement. The culvert should be replaced unless the berm has no current use, in which case it should be removed.

Structure Condition Comments:	NO DS STRUCTURE. BURIED
--------------------------------------	-------------------------

Site Identified in Hazard Mitigation Plan:	No
Emergency Access or Evacuation Route:	N/A
History of Flooding:	Culvert washed out and buried upon assessment.
