# **BEAVER BROOK RESTORATION PLAN**

## **STREAM MORPHOLOGY, WILDLIFE HABITAT, AND LAND USE ASSESSMENT**

## **KEENE, NEW HAMPSHIRE**

**May 2009**

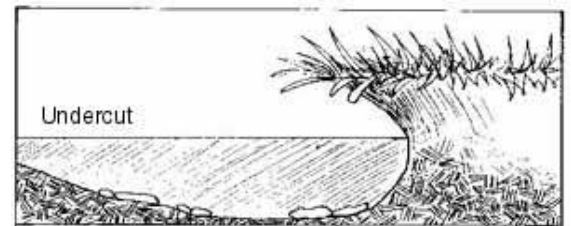
Undercut streambank, bank material has eroded below the root zone of streambank vegetation.  
*Graphic credit: Environmental Protection Agency.*
