Volunteer Lake Assessment Program Individual Lake Reports DEERING RESERVOIR, DEERING, NH

Volunteer Lake Assessment Program Individual Lake Reports Deering Lake, Deering 2020 Data Summary

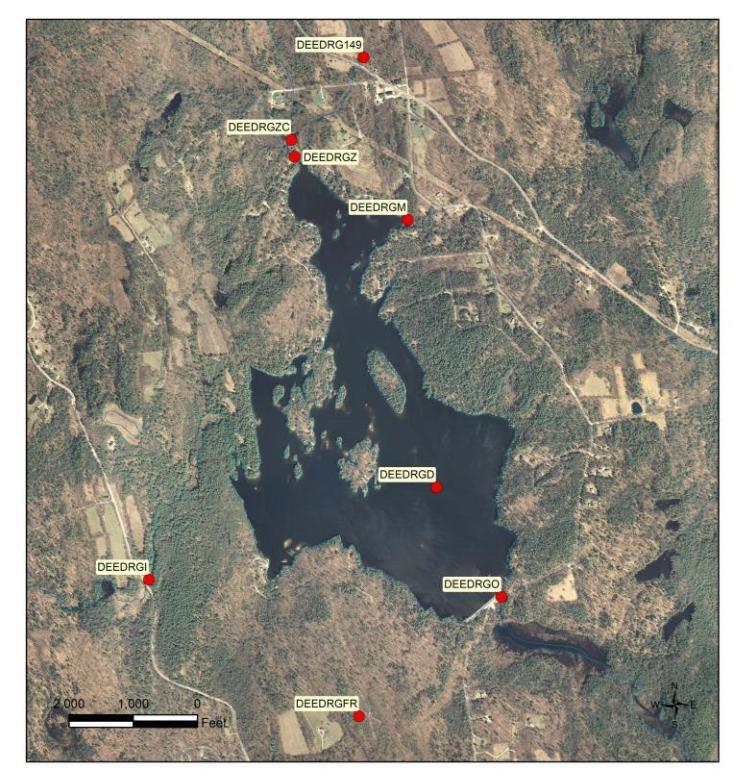
VLAP SAMPLE STATION MAP: This map depicts the location of routine sampling stations discussed on page two of the report.

STATIONID	STATION NAME				
DEEDRGD	DEEP SPOT				
DEEDRGI	MAIN INLET				
DEEDRGM	MORROTTA INLET				
DEEDRGO	OUTLET				
DEEDRGZ	ZOWSKI INLET				
DEEDRG149	RTE 149 CULVERT				
DEEDRGFR	FISHER ROAD CULVERT				
DEEDRGZC	ZOSKI INLET CULVERT
