EXECUTIVE SUMMARY

Mill Pond, East Washington

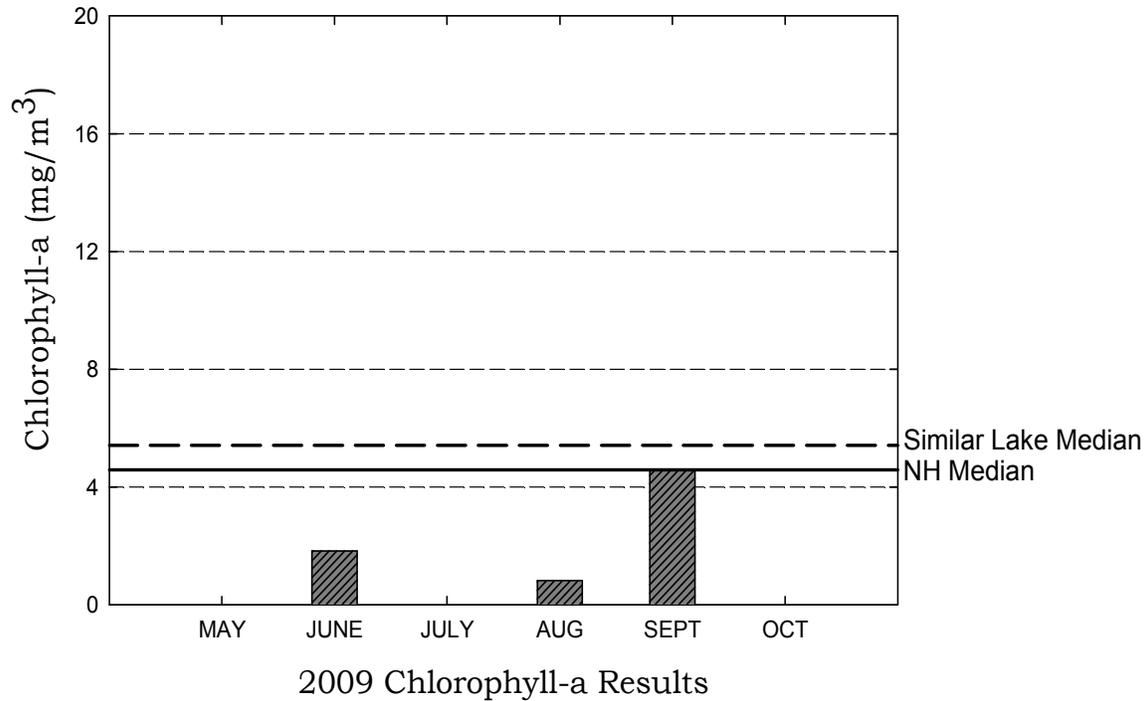
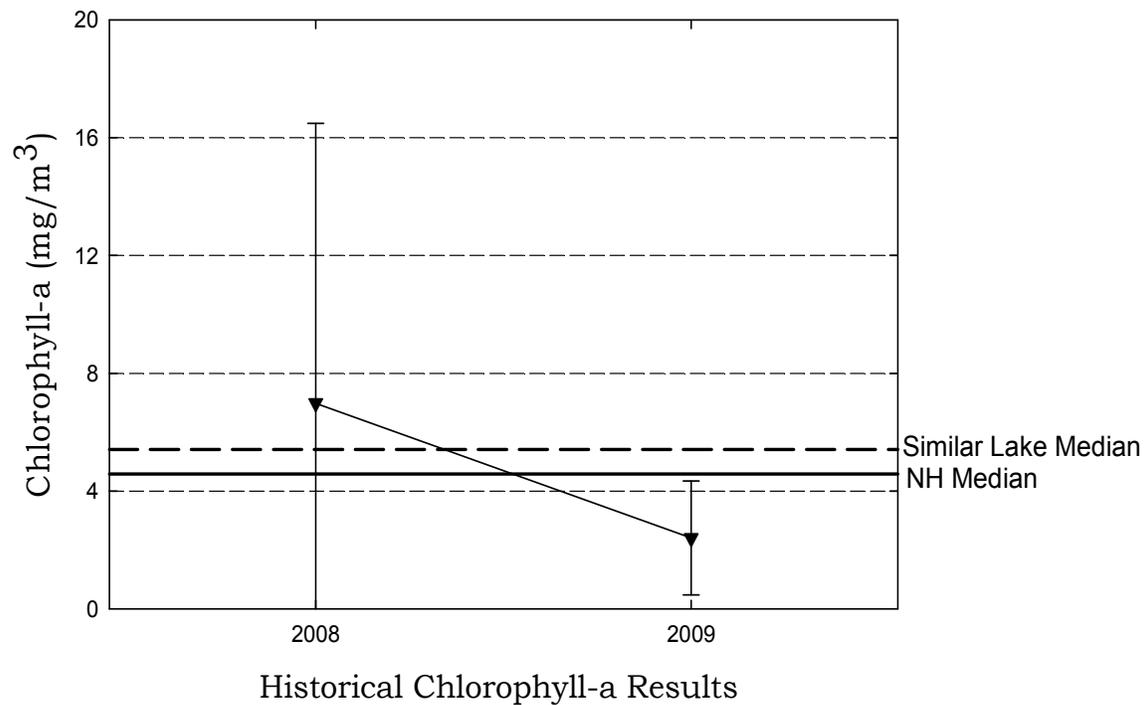
Figure 1. Monthly and Historical Chlorophyll-a Results

Figure 1 depicts the historical and current year chlorophyll-a concentration in the water column.

The current year data (the top graph) show that the chlorophyll-a concentration **decreased** from **June to August**, and then **increased** from **August to September**.

The historical data (the bottom graph) show that the **2009** chlorophyll-a mean is **less than** the state and similar lake medians. For more information on the similar lake median, refer to Appendix D.

Overall, visual inspection of the historical data trend line (the bottom graph) shows a **decreasing** in-lake chlorophyll-a trend since monitoring began. Specifically the mean chlorophyll concentration has **improved** since **2008**.

Therefore, it is extremely important for volunteer monitors to continually educate all watershed residents about management practices that can be implemented to minimize phosphorus loading to surface waters.

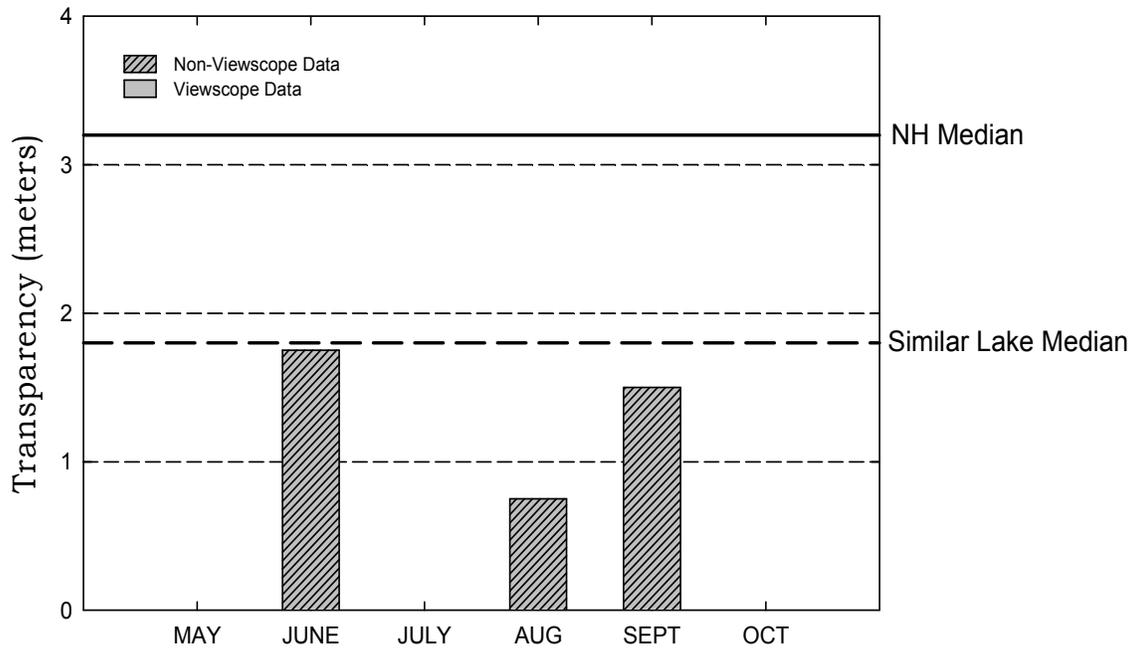
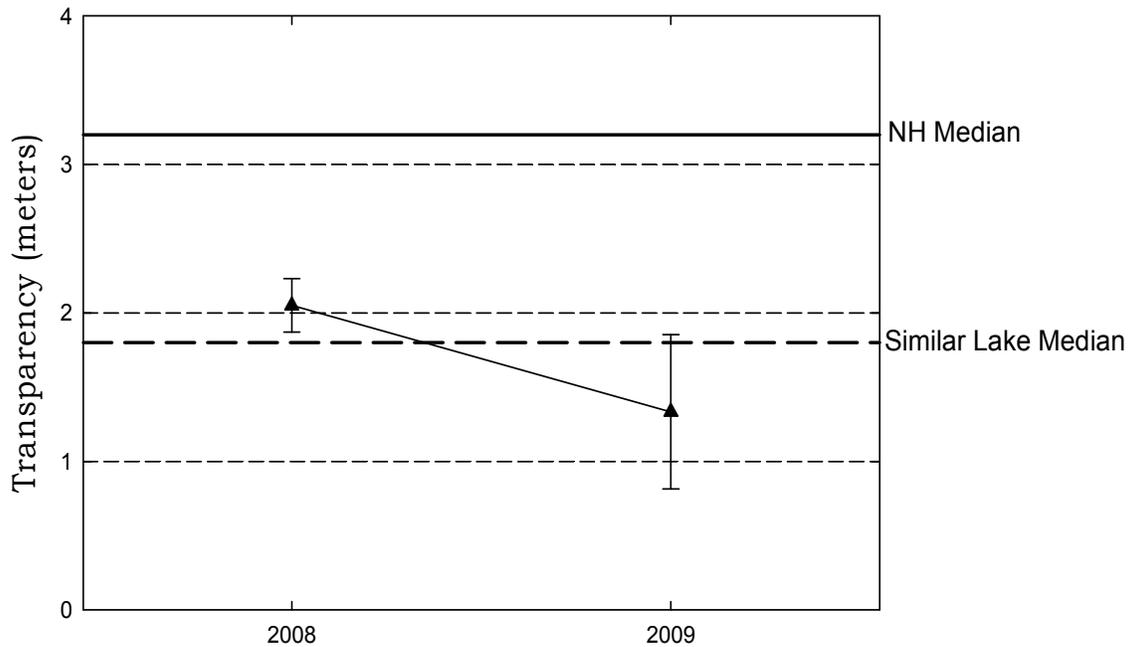
Figure 2. Monthly and Historical Transparency Results

Figure 2 depicts the historical and current year transparency *with and without* the use of a viewscope.

The current year *non-viewscope* in-lake transparency **decreased** from **June** to **August**, and then **increased** from **August** to **September**. The Secchi disk was visible on the pond bottom in June and September; therefore a viewscope measurement was not recorded.

The historical data (the bottom graph) show that the **2009** mean non-viewscope transparency is ***much less than*** the state median and is ***slightly less than*** the similar lake median. Please refer to Appendix D for more information about the similar lake median.

Visual inspection of the historical data trend line (the bottom graph) shows a **decreasing** trend, meaning that the transparency has **worsened** since monitoring began in **2008**. However, the Secchi disk was visible on the pond bottom and the transparency depth appears to fluctuate with pond water levels, which indicates that the transparency is not worsening.

2009 Transparency Viewscope and Non-Viewscape Results

Historical Transparency Non-Viewscape Results

Typically, high intensity rainfall causes sediment-laden stormwater runoff to flow into surface waters, thus increasing turbidity and decreasing clarity. Efforts should continually be made to stabilize stream banks, pond shorelines, disturbed soils within the watershed, and especially dirt roads located immediately adjacent to the edge of tributaries and the pond. Guides to best management practices that can be implemented to reduce, and possibly even eliminate, nonpoint source pollutants, are available from DES upon request.

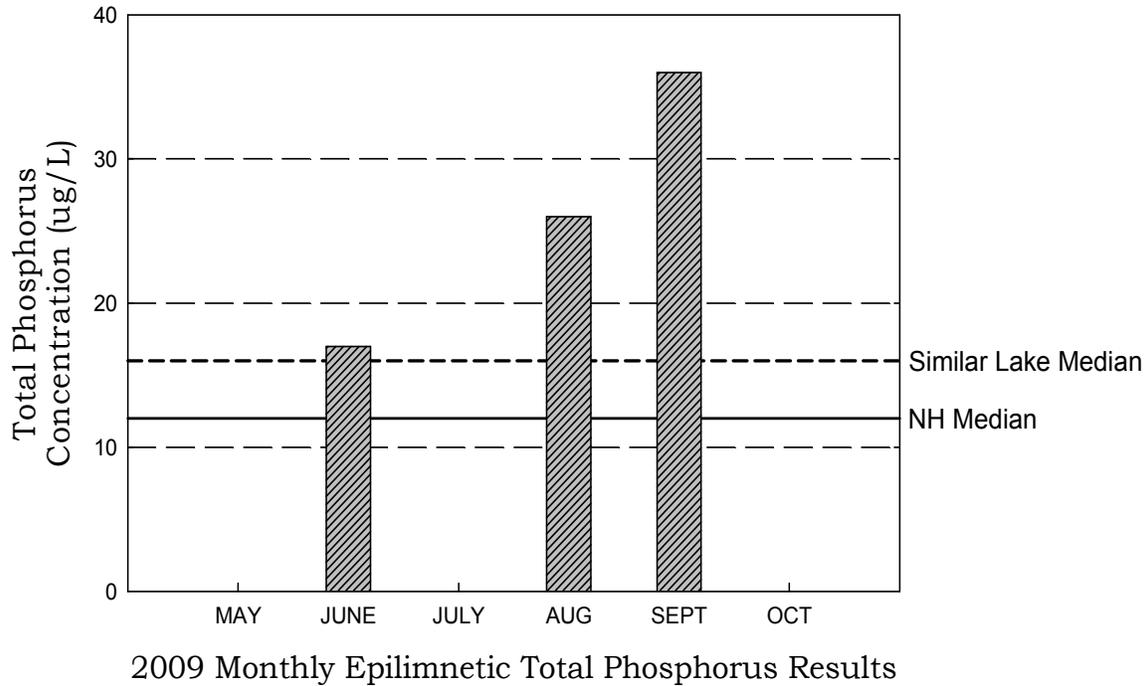
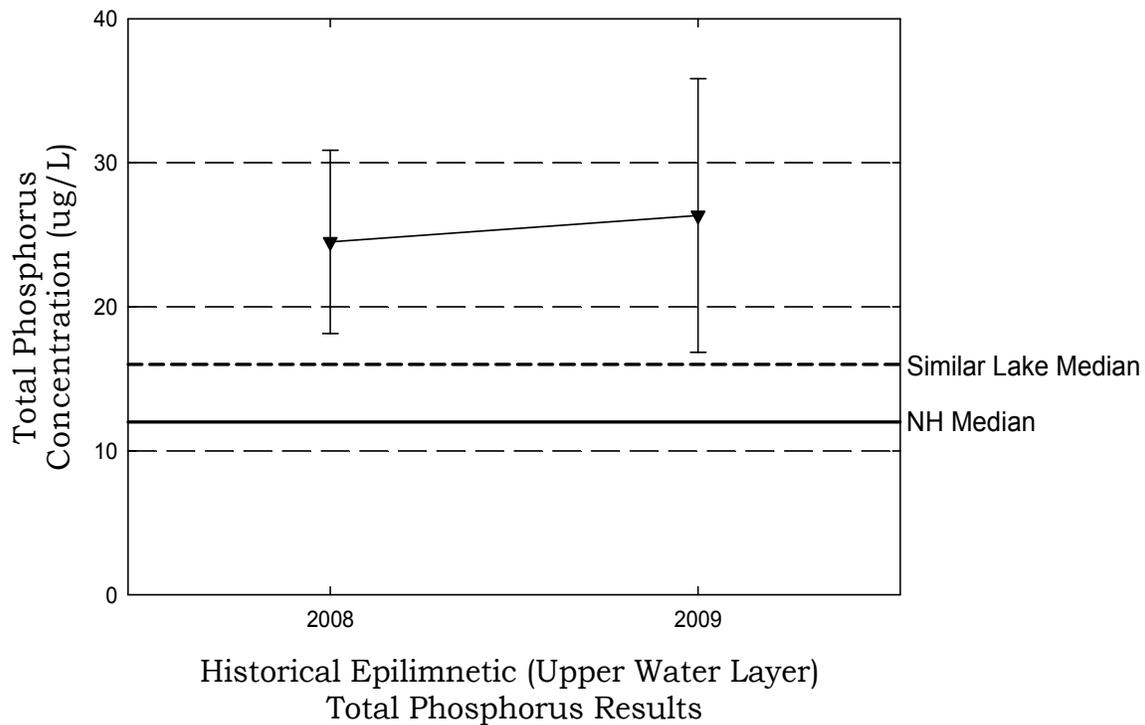
Figure 3. Monthly and Historical Total Phosphorus Data.

The graphs in Figure 3 depict the historical amount of epilimnetic (upper layer) and hypolimnetic (lower layer) total phosphorus concentrations; the inset graphs depict current year total phosphorus data.

The current year data for the epilimnion (the top inset graph) show that the phosphorus concentration **increased** from **June** to **September**.

The historical data show that the **2009** mean epilimnetic phosphorus concentration is **greater than** the state and similar lake medians. Refer to Appendix D for more information about the similar lake median.

Overall, visual inspection of the epilimnetic historical data trend line shows a **relatively stable** phosphorus trend. Specifically, the mean annual epilimnetic phosphorus concentration has **remained approximately the same** since monitoring began in **2008**.

One of the most important approaches to reducing phosphorus loading to a waterbody is to continually educate watershed residents about the watershed sources of phosphorus and how excessive phosphorus loading can negatively affect the ecology and the recreational, economical, and ecological value of lakes and ponds.
