ENVIRONMENTAL Fact Sheet

WD-DWGB-1-14

Extending Bedrock Well Casings

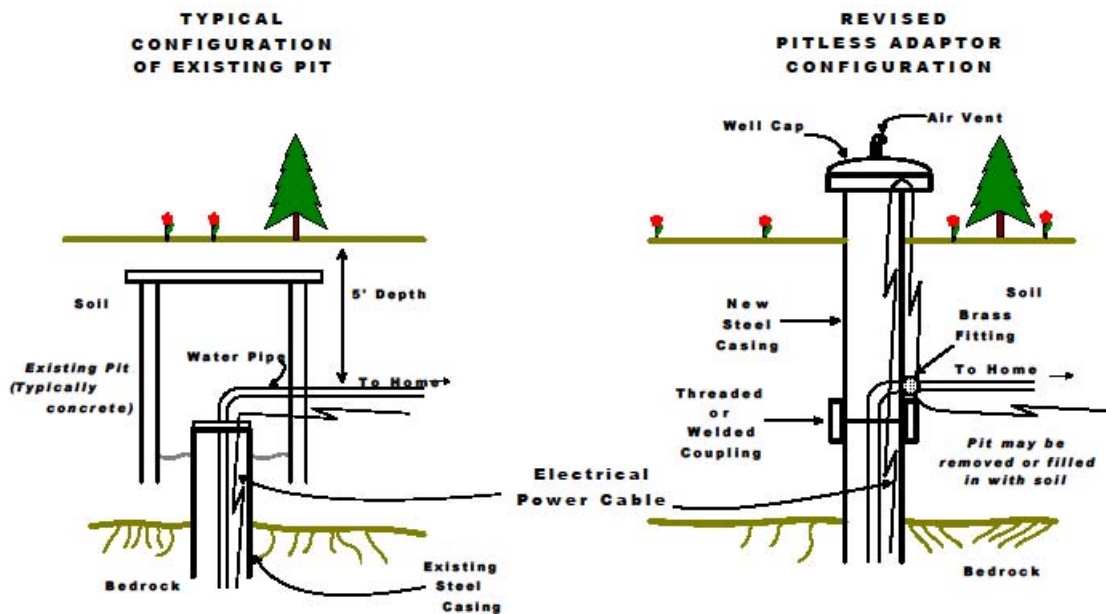
Before and after drawings of a well casing extension are shown on page 3. A well casing extension is a structural improvement for wells which terminate below or too close to grade. Well casing extensions must be water tight. Well casing extensions must also be constructed of the same material as the existing casing and be of sufficient strength and weight to ensure adequate performance.

The normal design of a modern bedrock well ensures that leakage cannot enter the interior of the well by requiring that the top of the well be above any possible flood level. This is achieved by using a so called “pitless adaptor.” This configuration places the top of the well above the level of flooding while allowing the pressurized well water to exit the casing below the ground level in a way that ensures no leakage of contaminants into the well, and provides protections of the pressurized water line from freezing.
