**Balsams Resort Snowmelt Analysis
Letter Report by Horizons Engineering
July 14, 2015**

***The Snowmelt Report (6/23/98)*
Joan Carlson and Stephen Fay
White Mountain National Forest
Laconia, New Hampshire**

Subject: Balsams Resort –WQC 2014-404P-001 Revised Snowmelt Runoff Analysis

The Snowmelt Report
(6/23/98)

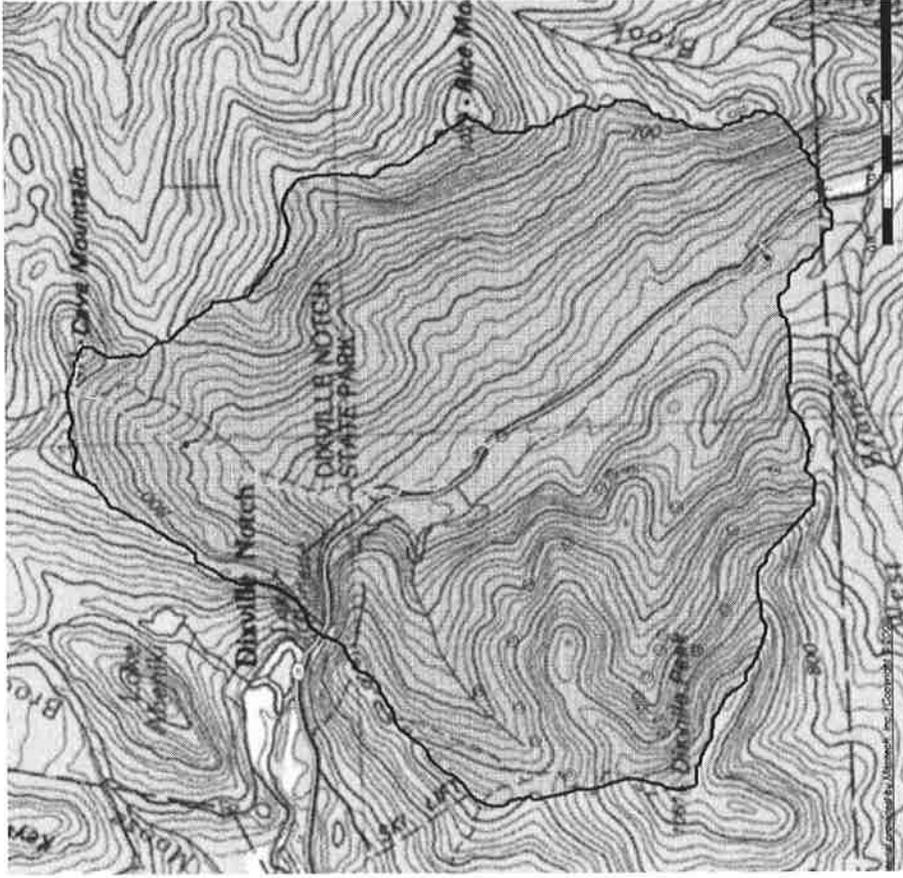
Balsams Snowmelt Runoff Assessment – Location 1: Clear Stream Watershed Millsfield/Dixville Town Line

LowFlows Region Grid Basin Characteristics			
100% Low Flow Statewide (10.9 mi ²)			
Parameter	Value	Regression Equation Valid Range	
		Min	Max
Drainage Area (square miles)	10.9	3.26	689
Mean Basin Slope from 30m DEM (percent)	24.759	3.19	38.1
Maximum Basin Elevation (feet)	3474.500	260	6290
Percent Coniferous Forest (percent)	25.7997	3.07	56.2
Jan to Mar Basin Centroid Precip (inches)	7.76	5.79	15.1
Mean Annual Temperature (degrees F)	37.775	36	48.7
Jun to Oct Mean Basinwide Temp (degrees F)	54.539	52.9	64.4
Jun to Oct Gage Precipitation (inches)	22.2	16.5	23.1
Percent Mixed Forest (percent)	22.0817	6.21	46.1
Mar to May Gage Precipitation (inches)	8.9	6.83	11.5

Peak Flows Region Grid Streamflow Statistics					
Statistic	Flow (ft ³ /s)	Prediction Error (percent)	Equivalent years of record	90-Percent Prediction Interval	
				Minimum	Maximum
PK2	448	30	3.2	275	728
PK5	710	31	4.7	430	1170
PK10	924	32	6.2	550	1550
PK25	1210	34	8	695	2100
PK50	1440	36	9	803	2570
PK100	1710	39	9.8	923	3160
PK500	2340	44	11	1170	4710

Location 1 - Clear Stream at the Dixville / Millsfield Boundary

This location was chosen to represent the highest point within the Clear Stream drainage basin that would receive runoff from all ski trails within the Clear Stream watershed. The point is also approximately concurrent with the easterly down-stream limit of the project area.

Results indicate that for a 5 year storm event StreamStats estimates a flow of 710 cubic feet per second (cfs) at the analysis point. If one were to assume that snowmelt occurred during this 5 year flow event, adding 0.5 inches of runoff resulting from the melting natural snowpack from the entire drainage basin above the analysis point adds an estimated 146.54 cfs to this flow (~21% increase). Melting of man-made snowpack on only the ~800 acres of ski trail within this watershed adds an estimated 16.81 cfs. If this melting of man-made snow were to occur during a 5 year flow event the analysis predicts a 2.37% increase in flow at the analysis point.

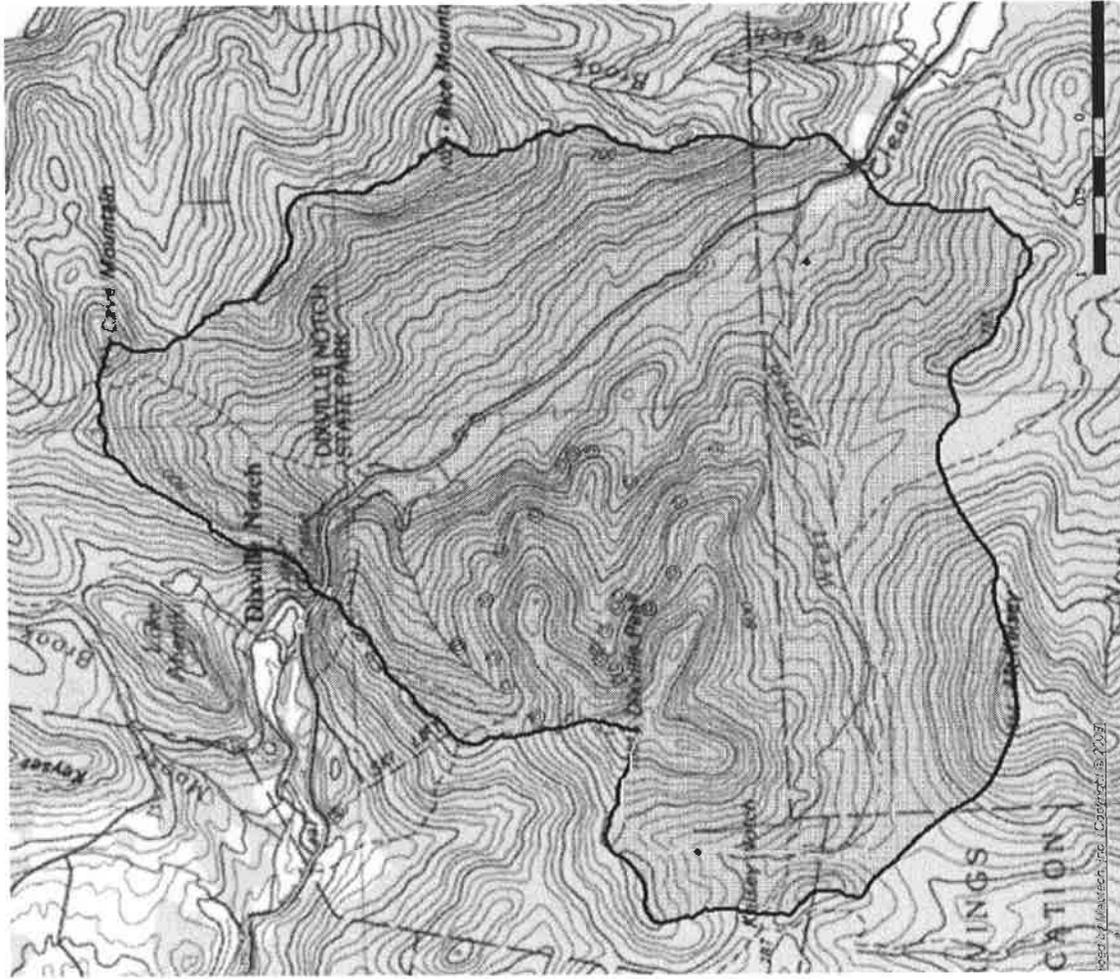
Balsams Snowmelt Runoff Assessment— Location 2: Clear Stream Watershed Junction Clear Stream and West Branch

Parameter	Value	Regression Equation Valid Range	
		Min	Max
Drainage Area (square miles)	19.2	3.26	689
Mean Basin Slope from 30m DEM (percent)	22.294	3.19	38.1
Maximum Basin Elevation (feet)	3474.500	260	6290
Percent Coniferous Forest (percent)	31.3550	3.07	56.2
Jan to Mar Basin Centroid Precip (inches)	7.99	5.79	15.1
Mean Annual Temperature (degrees F)	37.794	36	48.7
Jun to Oct Mean Basinwide Temp (degrees F)	54.565	52.9	64.4
Jun to Oct Gage Precipitation (inches)	22.4	16.5	25.1
Percent Mixed Forest (percent)	24.5746	6.21	46.1
Mar to May Gage Precipitation (inches)	8.9	6.83	11.5

Peak Flows Region Grid Streamflow Statistics					
Statistic	Flow (ft ³ /s)	Prediction Error (percent)	Equivalent years of record	90-Percent Prediction Interval	
				Minimum	Maximum
PK2	800	30	3.2	451	1300
PK5	1250	31	4.7	758	2060
PK10	1620	32	6.2	961	2720
PK25	2090	34	8	1200	3640
PK50	2470	36	9	1380	4420
PK100	2920	39	9.8	1570	5400
PK500	3940	44	11	1960	7320

Location 2 - Clear Stream/West Branch Junction

This location was chosen to represent a point in the watershed where developed property was in the vicinity of Clear Stream.

Results indicate that for a 5 year storm event, StreamStats estimates a flow of 1,250 cubic feet per second at the Clear Stream/West Branch junction. If one were to assume that snowmelt occurred during this 5 year flow event, adding 0.5 inches of runoff resulting from the melting natural snowpack from the entire drainage basin above the analysis point adds an estimated 258.13 cfs to this flow (~21% increase). Melting of man-made snowpack on only the ~800 acres of ski trail within this watershed adds an estimated 16.81 cfs. If this melting of man-made snow were to occur during a 5 year flow event the analysis predicts a 1.34% increase in flow at the Clear Stream/West Branch Junction.

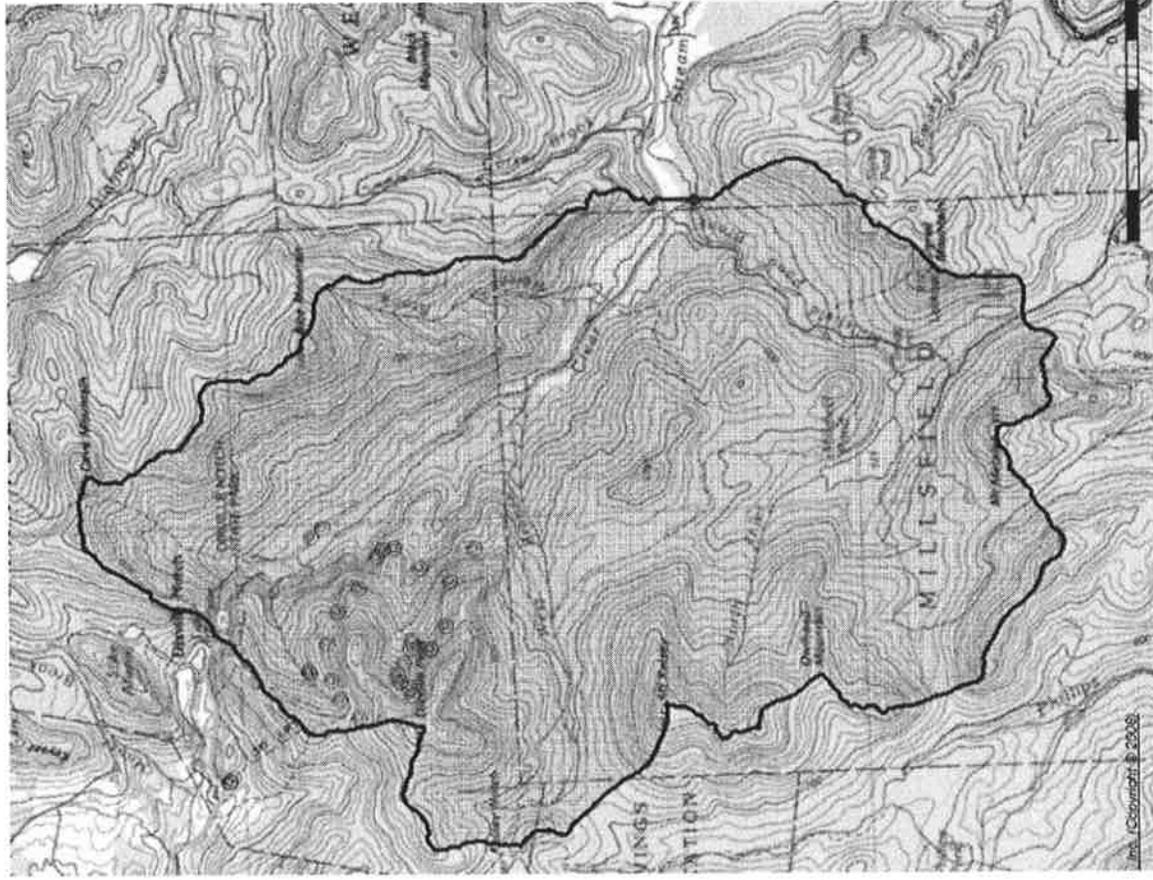
Balsams Snowmelt Runoff Assessment – Location 3: Clear Stream Watershed Junction Clear Stream and Millsfield Pond Brook

LOWFlows Region Grid Basin Characteristics

100% Low Flow Statewide (40.9 mi²)

Parameter	Value	Regression Equation Valid Range	
		Min	Max
Drainage Area (square miles)	40.9	3.26	689
Mean Basin Slope from 30m DEM (percent)	19.290	3.19	38.1
Maximum Basin Elevation (feet)	3474.500	260	6290
Percent Coniferous Forest (percent)	23.1714	3.07	56.2
Jan to Mar Basin Centroid Precip (inches)	7.68	5.79	15.1
Mean Annual Temperature (degrees F)	38.190	36	48.7
Jun to Oct Mean Basinwide Temp (degrees F)	55.002	52.9	64.4
Jun to Oct Gage Precipitation (inches)	19.8	16.5	23.1
Percent Mixed Forest (percent)	25.6121	6.21	46.1
Mar to May Gage Precipitation (inches)	8.2	6.83	11.5

Peak Flows Region Grid Streamflow Statistics

Statistic	Flow (ft ³ /s)	Prediction Error (percent)	Equivalent years of record	90-Percent Prediction Interval	
				Minimum	Maximum
PK2	1370	30	3.2	841	2240
PK5	2090	31	4.7	1270	3460
PK10	2660	32	6.2	1580	4480
PK25	3390	34	8	1950	5910
PK50	3970	36	9	2210	7120
PK100	4640	39	9.8	2500	8620
PK500	6160	44	11	3060	12400

Location 3 - Clear Stream/Millsfield Pond Brook Junction

This location was chosen to represent a point farther down in the watershed where Clear Stream flows are significantly higher than at the project boundary.

At the Clear Stream/Millsfield Pond Brook junction, StreamStats estimates a 5 year storm event flow of 2,090 cfs. Basin-wide snow melt would be expected to result in an estimated

549.88 cfs addition to this flow (~26% increase). Melting of man-made snowpack on only the ~800 acres of ski trail within this watershed adds an estimated 16.81 cfs. If this melting of man-made snow were to occur during a 5 year flow event the analysis predicts an increase in flow of 0.8% at the analysis point.

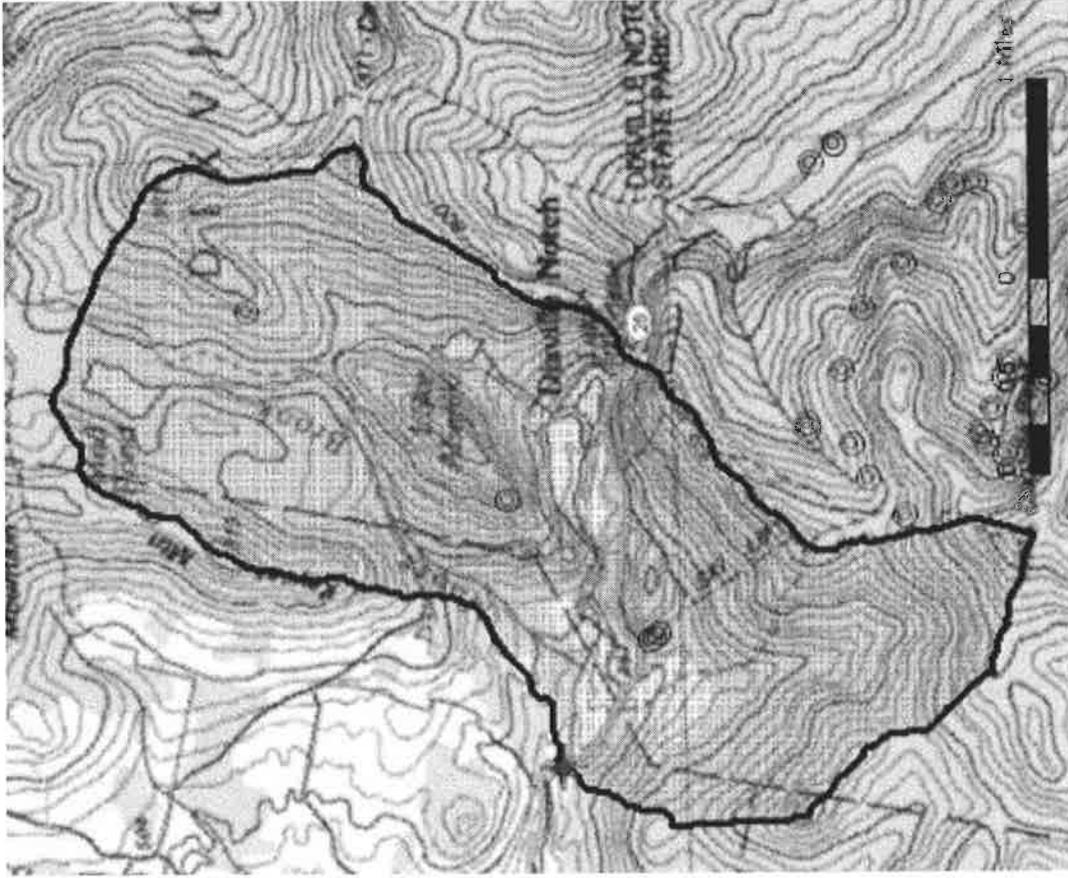
Balsams Snowmelt Runoff Assessment – Location 4: Mohawk River Watershed Mohawk River at Convergence with Hodge Brook

LowFlows Region Grid Basin Characteristics			
100% Low Flow Statewide (8.08 mi ²)			
Parameter	Value	Regression Equation Valid Range	
		Min	Max
Drainage Area (square miles)	8.08	3.28	689
Mean Basin Slope from 30m DEM (percent)	21.677	3.19	38.1
Maximum Basin Elevation (feet)	3474.313	260	6290
Percent Coniferous Forest (percent)	18.6275	3.07	56.2
Jan to Mar Basin Centroid Precip (inches)	7.4	5.79	15.1
Mean Annual Temperature (degrees F)	37.548	36	48.7
Jun to Oct Mean Basinwide Temp (degrees F)	54.467	52.9	64.4
Jun to Oct Gage Precipitation (inches)	21.9	16.5	23.1
Percent Mixed Forest (percent)	32.4246	6.21	46.1
Mar to May Gage Precipitation (inches)	8.6	6.83	11.5

Peak Flows Region Grid Streamflow Statistics				
Statistic	Prediction Error (percent)	Equivalent years of record	90-Percent Prediction Interval	
			Minimum	Maximum
PK2	30	3.2	172	456
PK5	31	4.7	268	729
PK10	32	6.2	342	968
PK25	34	8	433	1310
PK50	36	9	502	1620
PK100	39	9.8	576	1990
PK500	44	11	736	2990

Location 4 – Mohawk River/Hodge Brook Intersection

This location was chosen to represent the highest point within the Mohawk River drainage basin that would receive runoff from all ski trails within the Mohawk River watershed. The point is also approximately concurrent with the westerly down-stream limit of the project area.

At the Mohawk River/Hodge Brook junction, StreamStats estimates a 5 year storm event flow of 442 cfs just downstream of the junction. Basin-wide snow melt would be expected to result in an estimated 549.88 cfs addition to this flow (~25% increase) if the melting occurred during the 5 year event predicted by Stream Stats. Melting of man-made snowpack on just the ~400 acres of ski trail within this watershed adds an estimated 8.40 cfs, resulting in an increase in flow of 1.9% at the analysis point.
