Volunteer Lake Assessment Program Individual Lake Reports PEA PORRIDGE POND, MIDDLE, MADISON, NH

Volunteer Lake Assessment Program Individual Lake Reports Middle Pea Porridge Pond, Madison 2020 Data Summary

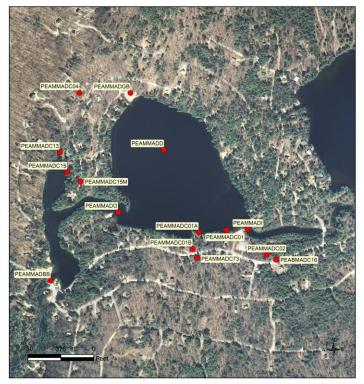
VLAP SAMPLE STATION MAP: This map depicts the location of routine sampling stations discussed on page two of the report.
