MtBE Settlement Funds

Annual Report

Fiscal Year 2020 & 2021 Biennium

Prepared by
Michael W. Juranty, *Administrator*
MtBE Remediation Bureau

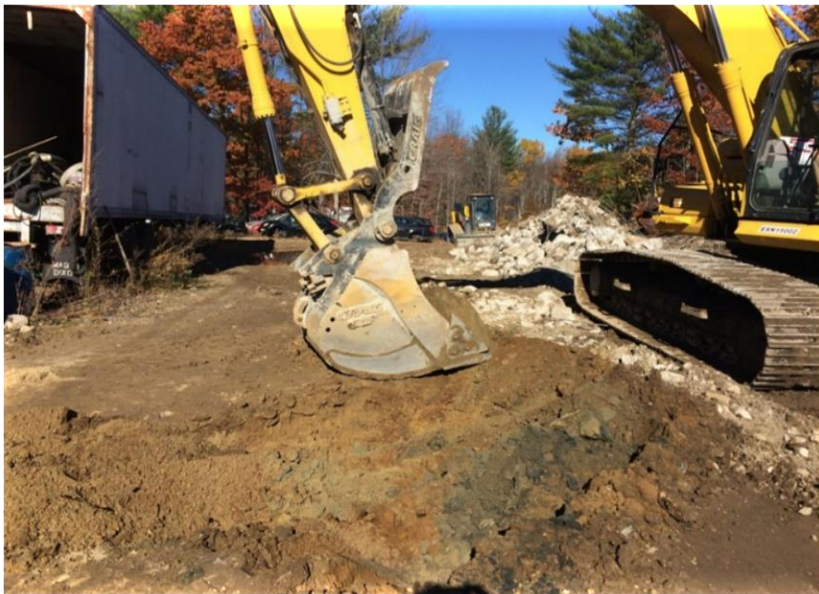
Photo of contaminated soil excavation at Epping Auto Salvage.

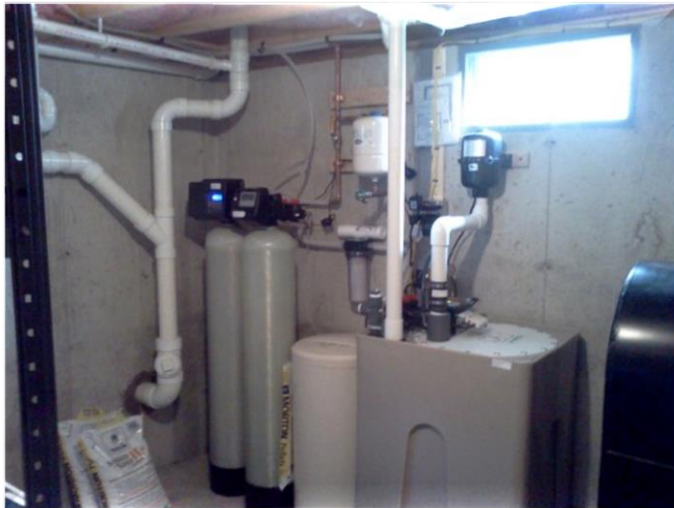
Photo of water treatment system that addresses complex MtBE contamination issue.

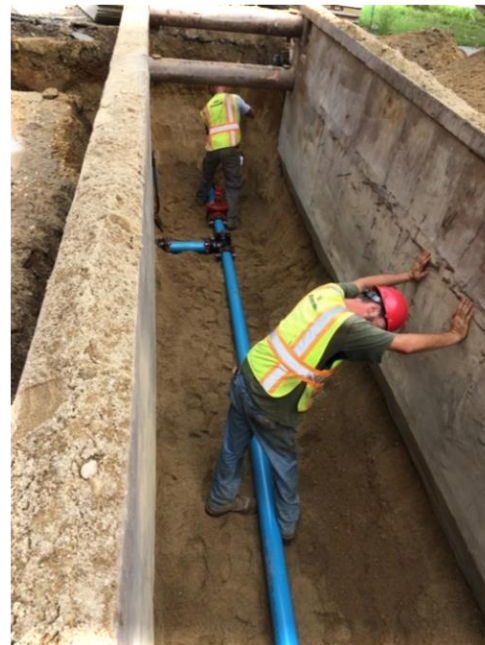
Water line installation at the Little Falls Cooperative in Rochester.

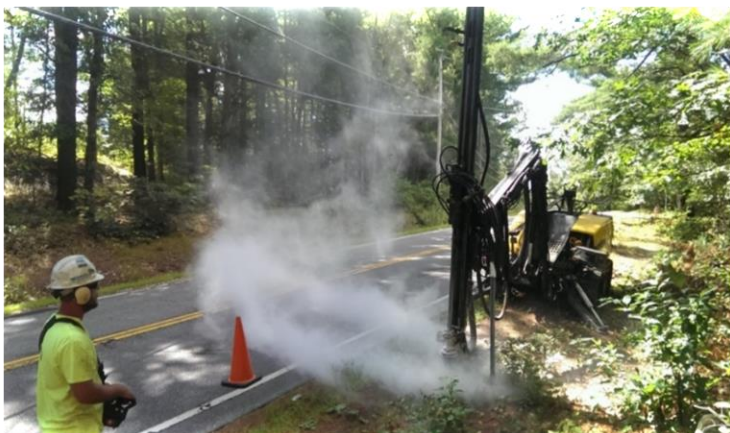
Ledge probes for the Windham water line extension.

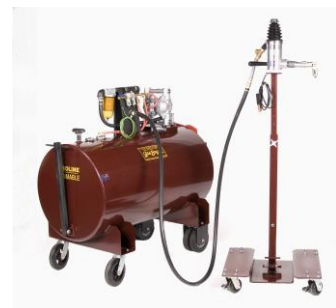
Picture of a gas buggy and drill system.

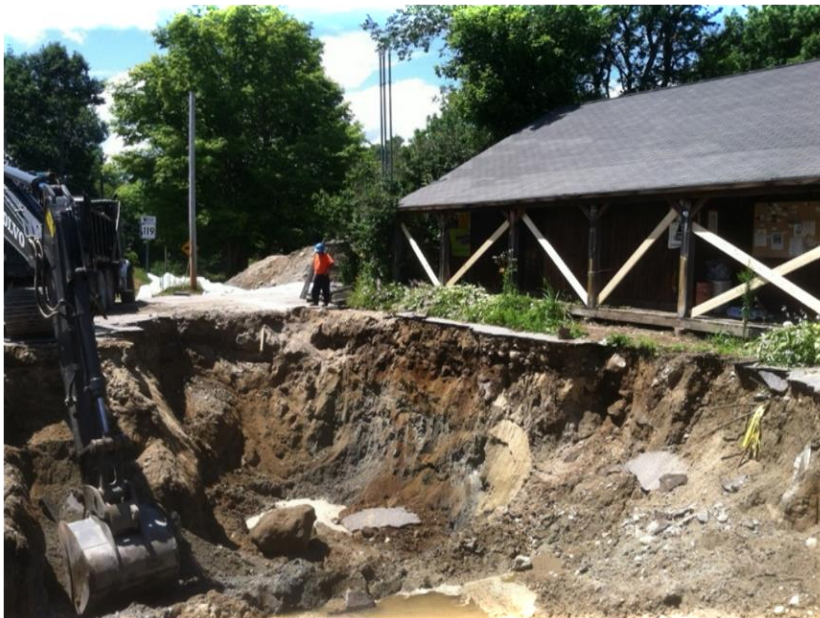
During excavation, as the excavator reached the impacted soil, there was enough petroleum vapor from the soil contamination to ignite as the excavator bucket scraped against a cobble. This suggested that gasoline was recently released, in addition to the larger, older gasoline release. Approximately 964 tons of contaminated soil was removed, including some contaminated soil removed from beneath the earthen floor of the building. The excavation project generated a great deal of community interest and one gracious and grateful nearby landowner provided freshly baked corn muffins and lemon bars to the hungry work crew.

Richmond Four Corners Store contaminated soil excavation in July 2014.

A tank closure and remedial implementation report was submitted to NHDES in late 2014. Soil contamination extending under the existing building foundation could not be removed and was left in place. The Town of Richmond subsequently acquired the site for back taxes and held a community charrette with Southwest Regional Planning Commission to consider possible future uses of the property. Due to the prominent central

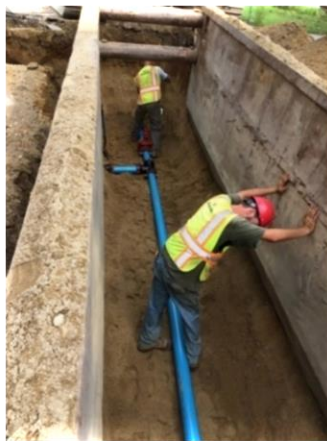
Waterline installation workers in a trench box.

Fourteen-hundred feet of water line, a central metering pit and individual metering pits for each house were installed. The total project cost was within the engineer's original project estimate.

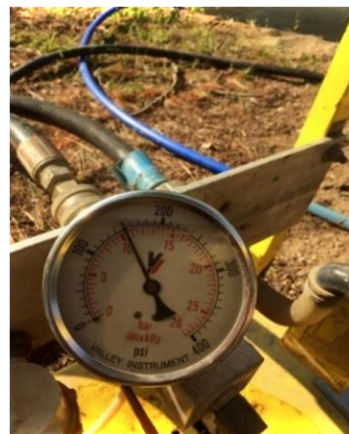
Successful pressure testing of installed piping.

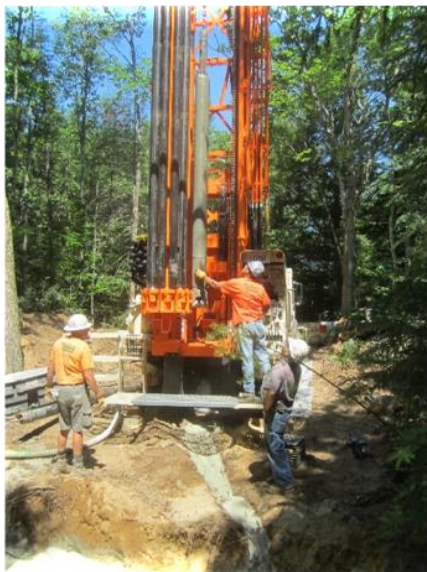
Drillers installing one of the supply wells.

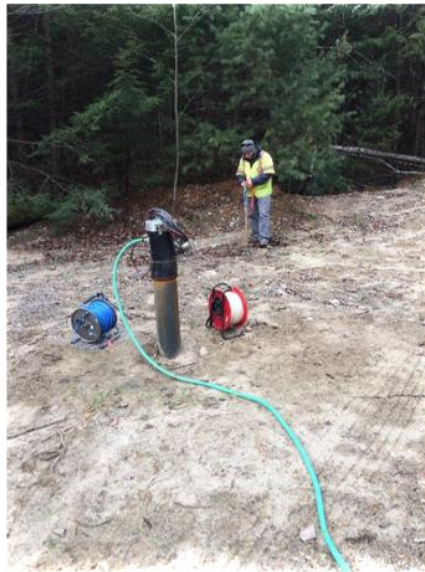
Field technician conducting a pump test.

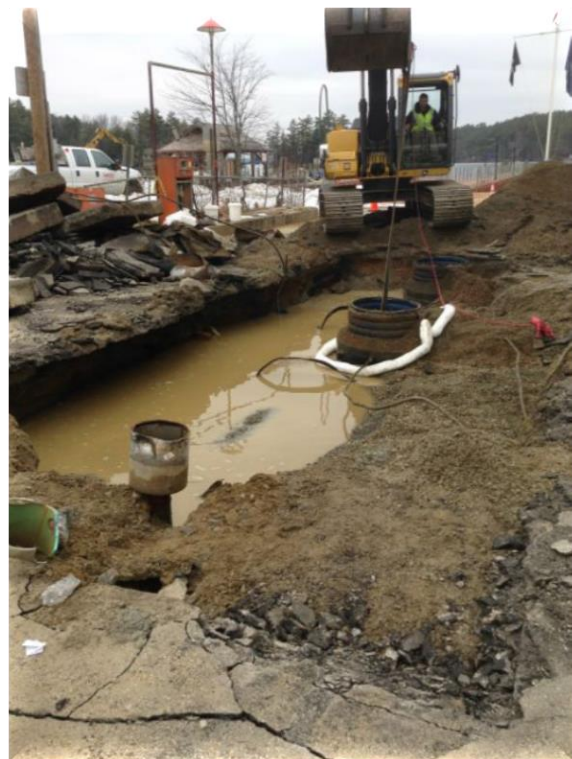
As previously noted, the Marine Patrol tank sumps were frequently full of water and posed no impediment to gasoline releases to the aquifer. Removal of the tank system before a significant release occurred was highly desirable. As can be seen from these situations, removal of unnecessary, unwanted and high-risk UST systems has a number of benefits to the State, as well as property owners.

Submerged Marine Patrol Tank exposed for removal. The hold down straps were broken, and the tank was floated so that water would not get in the tank during cleaning.

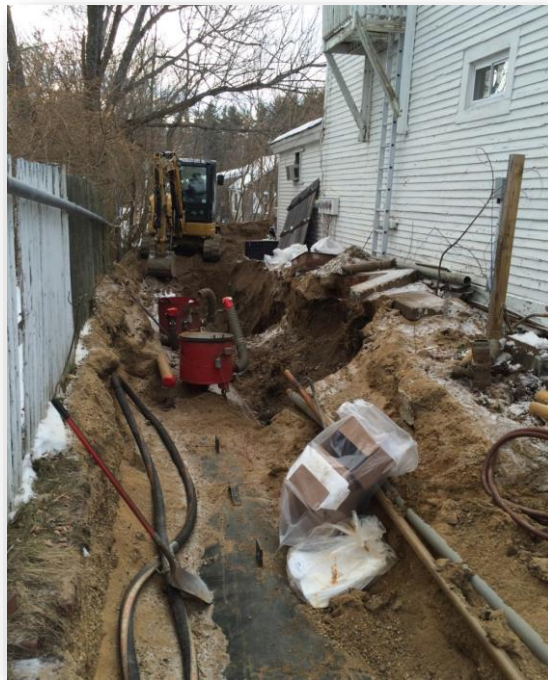
Tank being removed from a tight alley in Gilford. Tanks had to be dragged out and around the back due to power lines and other obstructions.

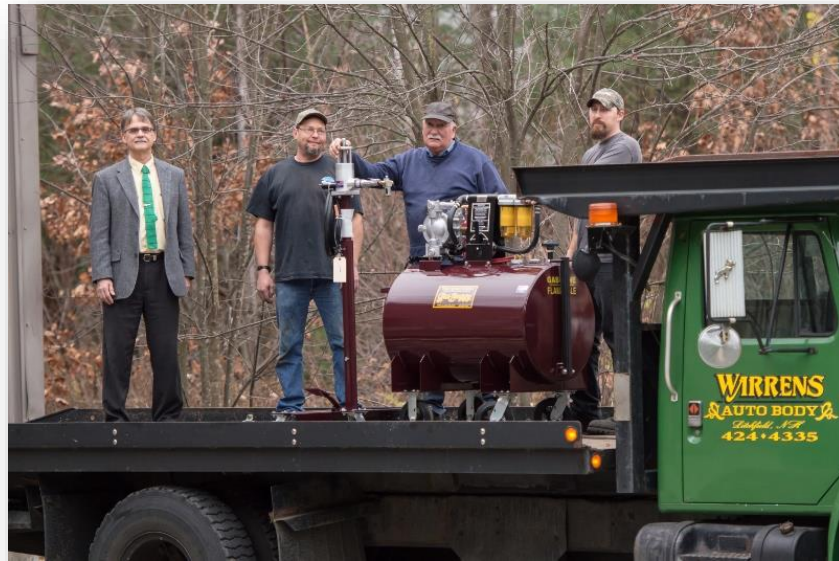
A gas buggy and fuel tank drill system being picked up by Warren's Auto Body. Note the dual fuel filter assembly improvement added to the NHDES order.

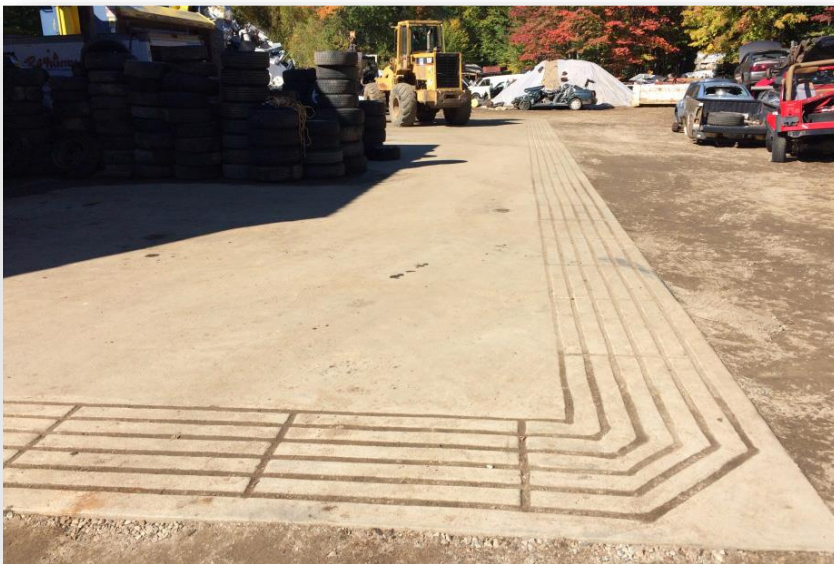
A concrete spill-prevention pad installed by the program. Note the positive limiting barrier (PLB) in the photo. The PBL consists of grooves in the concrete designed to trap spills until they can be cleaned up.

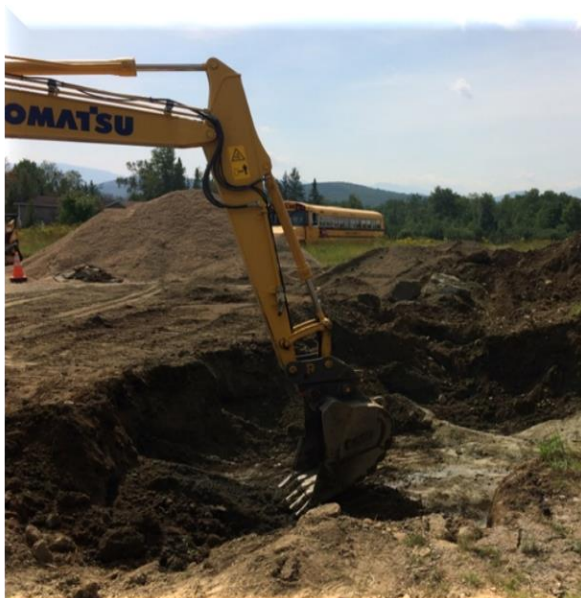
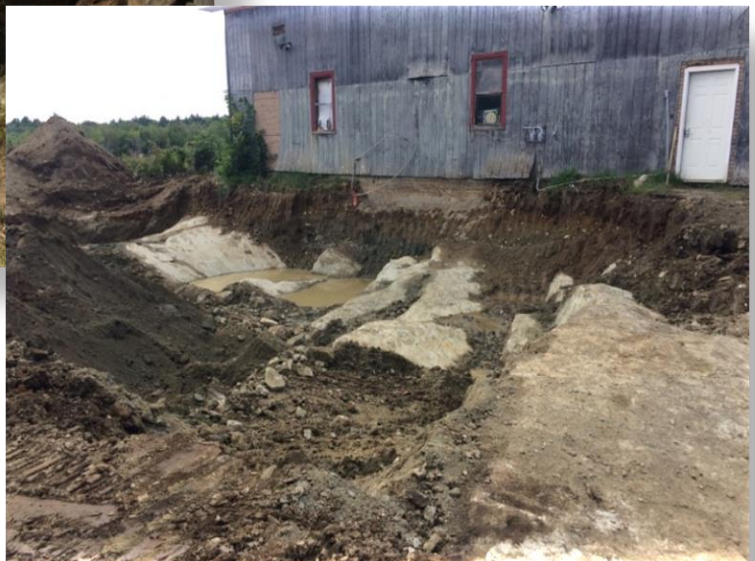
The initial phase of investigation consisted of a site area reconnaissance and records review followed by a geophysical survey and test pit excavation program to determine if the USTs were still in place or had been removed. NHDES records indicated that the tanks had been removed in 1991; however, the removal was conducted by the previous property owner and there was no assessment provided as to whether the USTs had leaked. However, a clue was provided in the closure documents that stated one of the two USTs had been taken out of service the year prior due to “failure,” a tacit indication that a leak may have occurred. The geophysical survey and test pit investigation confirmed that the USTs had been removed and soil samples confirmed the historical petroleum release with elevated field screening results and petroleum related compounds above Soil Remediation Standards in samples collected just above the bedrock surface. Bedrock was encountered at relatively shallow depths ranging from 1 to 12.5 feet below the ground surface (see photos below).

These photos show the contaminated soil being excavated.

Note: In the picture to the right, you can see that the excavation extended to the uneven bedrock surface.

Following the discovery of petroleum-impacted soil, NHDES and the property owner agreed to proceed with a source area soil boring delineation program followed by excavation of the impacted soil. The MtBE Remediation Bureau engaged one of the Initial Response Contractors to conduct the excavation. Soon after breaking ground, it became apparent that the volume of impacted soil was larger than originally estimated from the soil boring delineation program due to the undulating bedrock surface and areas of deeper bedrock missed by the soil borings.

Ultimately, the excavation occupied an area of approximately 11,250 square feet and extended from the maintenance building across the property and beneath Milan Road. The project lasted 33 days and resulted in the removal of approximately 3,000 tons of petroleum impacted soil.
