MtBE Settlement Funds Biennial Report

Fiscal Year 2022 & 2023 Biennium

Prepared by
Matthew T. Taylor, Administrator
MtBE Remediation Bureau

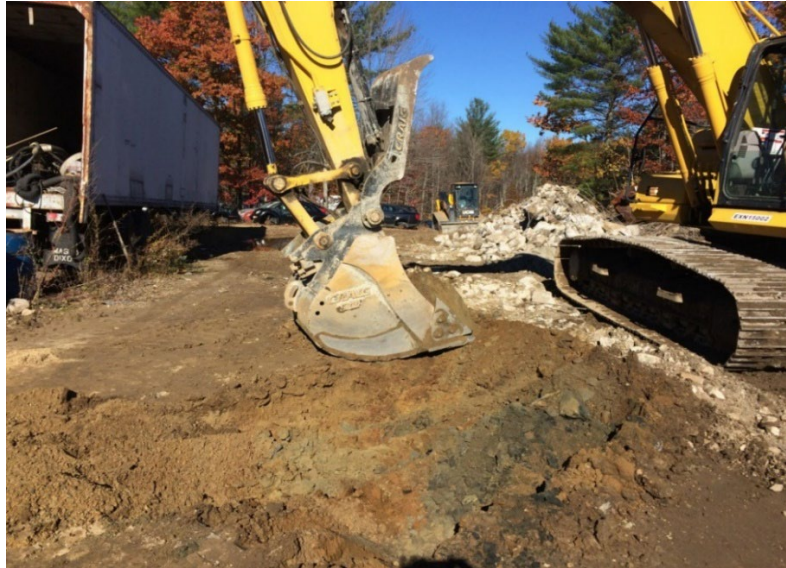
Photo of contaminated soil excavation at Epping Auto Salvage.

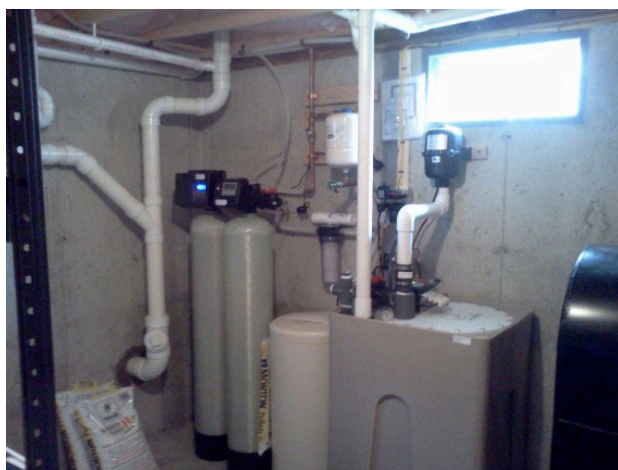
Photo of water treatment system that addresses complex MtBE contamination issue.

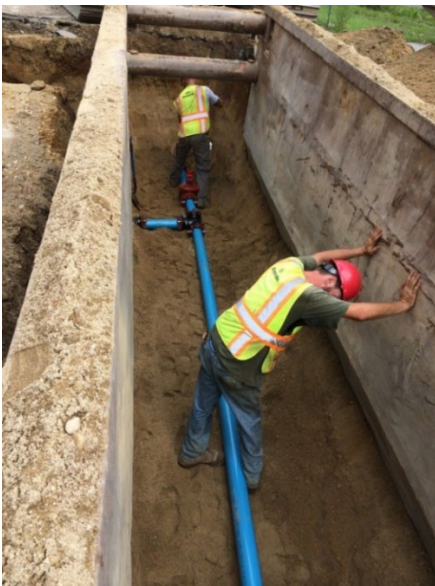
Left: Water line installation at the Little Falls Cooperative in Rochester.

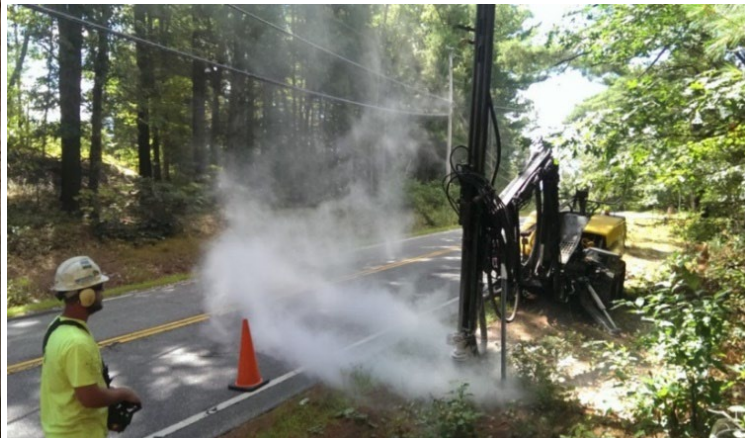
Right: Ledge probes for the Windham water line extension.

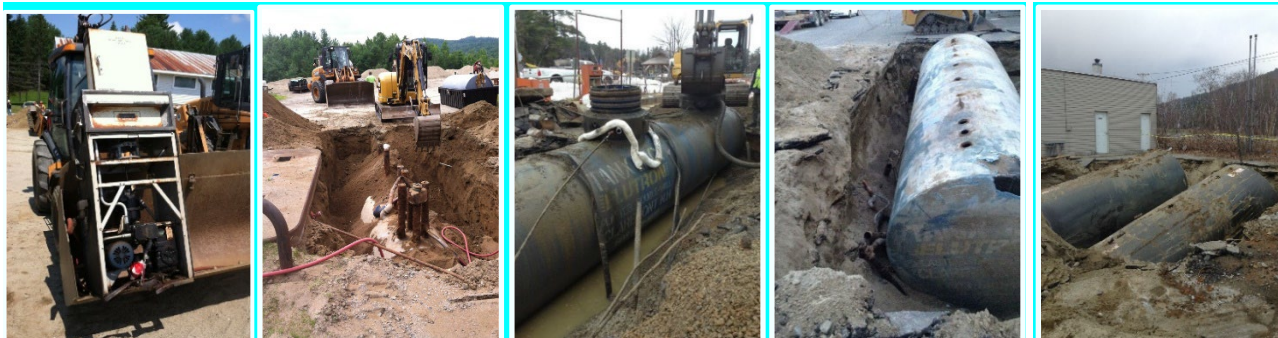
Images below feature, from left to right: a 50' vintage dispenser, post removal; a tank top uncovered during UST removal; a Tank that was buried under the water table after controlled float out of the excavation; USTs prior to removal from tank graves.

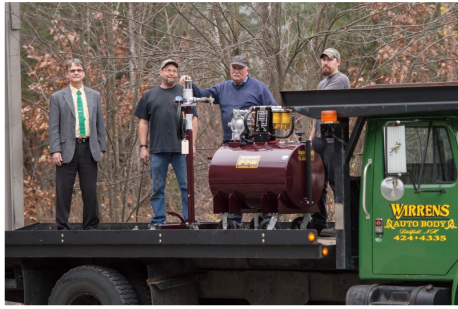
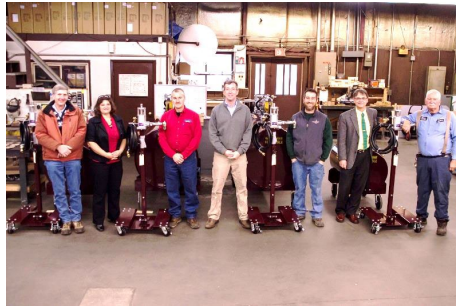
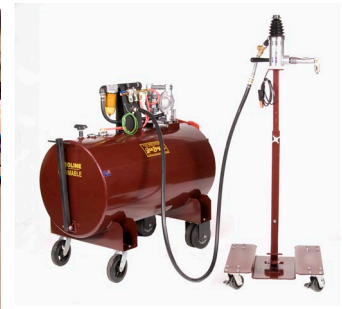
Images feature: Warren’s picking up a gas buggy to save the State on delivery charges; members of the Automotive and Truck Recyclers Association (ATRA) and NHDES next to their equipment; gas buggy and drill system.

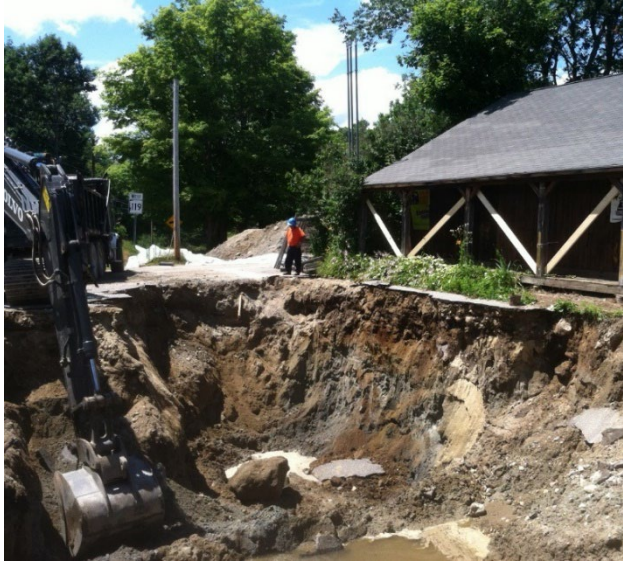
Richmond Four Corners Store contaminated soil excavation in July 2014.

Soil contamination extending under the existing building foundation could not be removed and was left in place. The Town of Richmond subsequently acquired the site for back taxes and held a community charrette with Southwest Regional Planning Commission to consider possible future uses of the property. In 2015, Richmond received brownfields funding for the demolition of the dilapidated building, which made it possible to remove the remaining contaminated soil. The remaining contamination (1,835 tons of contaminated soil) was removed in November 2015, using MtBE settlement funds.

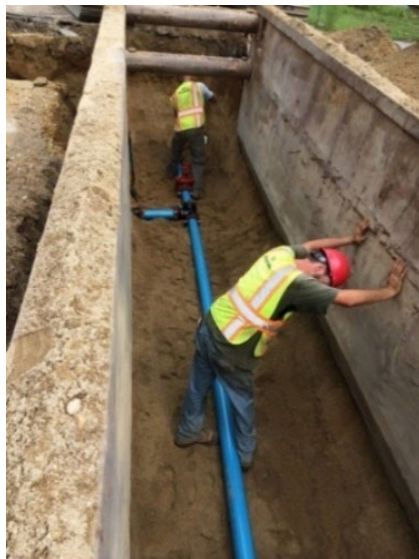
Images feature: water installation workers in a trench box; successful pressure testing of installed piping.

Fourteen-hundred feet of water line, a central metering pit and individual metering pits for each house were installed. The total project cost was within the engineer's original project estimate.

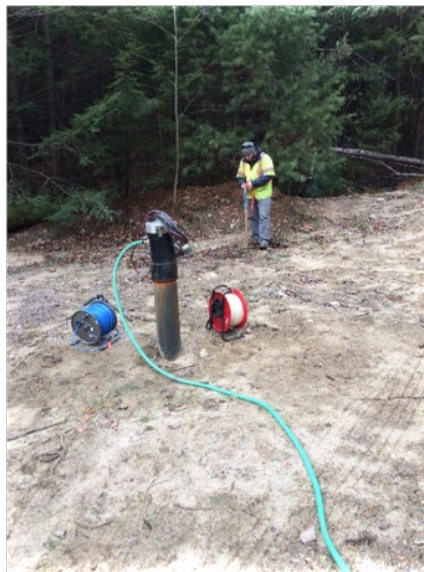
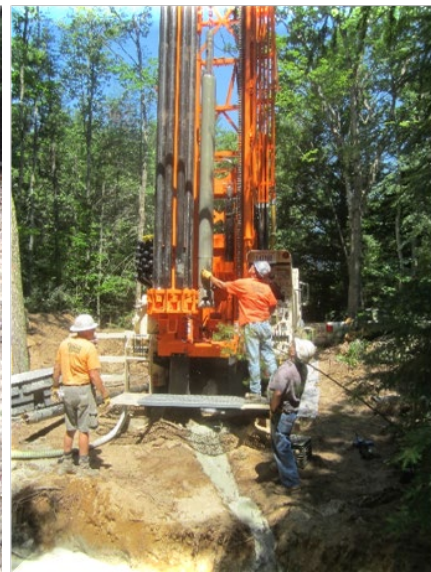
Images feature: drillers installing one of the supply wells; field technician conducting a pump test.

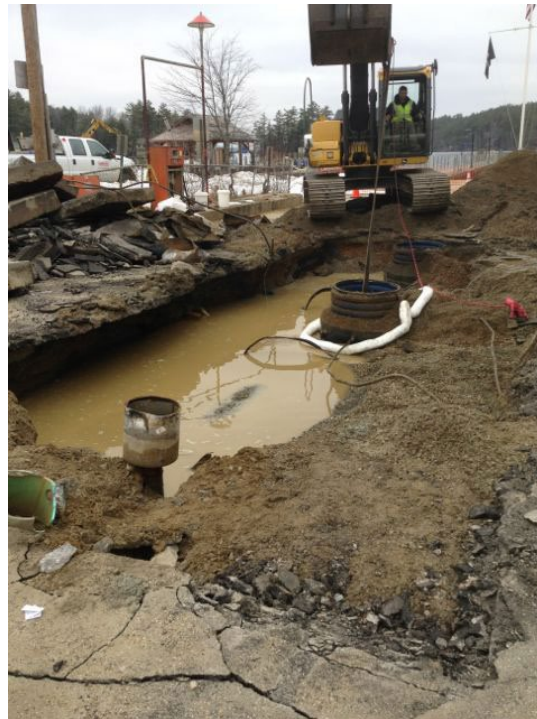
Submerged Marine Patrol Tank exposed for removal. The hold down straps were broken, and the tank was floated so that water would not get in the tank during cleaning.

As previously noted, the Marine Patrol tank sumps were frequently full of water and posed no impediment to gasoline releases to the aquifer. Removal of the tank system before a significant release occurred was highly desirable. As can be seen from these situations, removal of unnecessary, unwanted and high-risk UST systems has a number of benefits to the State, as well as property owners.

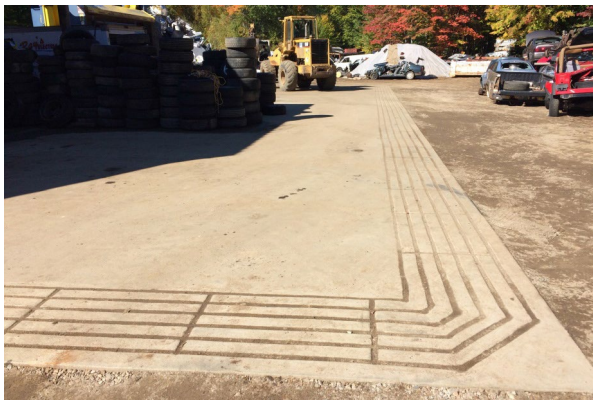
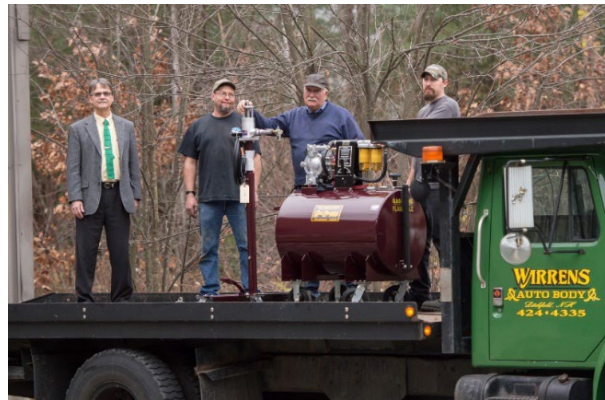
Images feature: A concrete spill-prevention pad installed by the program. Note the positive limiting barrier (PLB) in the photo. The PBL consists of grooves in the concrete designed to trap spills until they can be cleaned up; a gas buggy and fuel tank drill system being picked up by Warren's Auto Body.

As of the end of FY23, concrete pads have been successfully installed at 39 facilities. Prior to pad installation, geotechnical and contamination identification field work was completed. At the Epping Auto Salvage facility, contamination was identified and over 400 tons of contaminated soil was removed in 2016. Continued groundwater quality monitoring has shown a general decrease in MtBE concentrations. Cleanup was also completed at Murray's prior to pad installation.

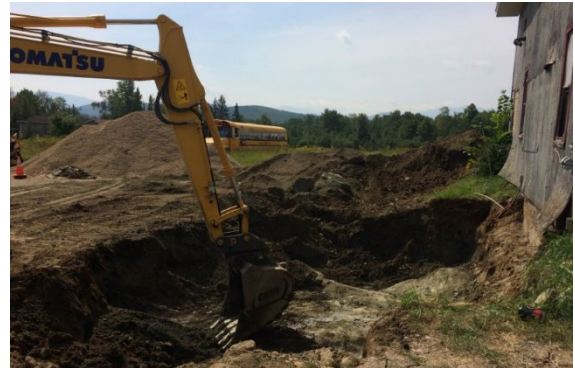
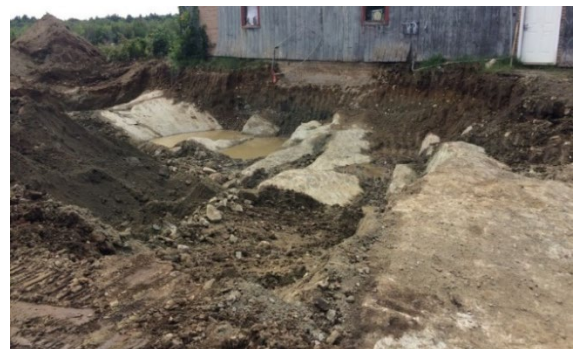
These photos show the contaminated soil being excavated. Note: In the picture at the bottom, you can see that the excavation extended to the uneven bedrock surface

Soon after breaking ground, it became apparent that the volume of impacted soil was larger than originally estimated from the soil boring delineation program due to the undulating bedrock surface and areas of deeper bedrock missed by the soil borings. Ultimately, the excavation occupied an area of approximately 11,250 square feet and extended from the maintenance building across the property and beneath Milan Road.

The project lasted 33 days and resulted in the removal of approximately 3,000 tons of petroleum impacted soil.

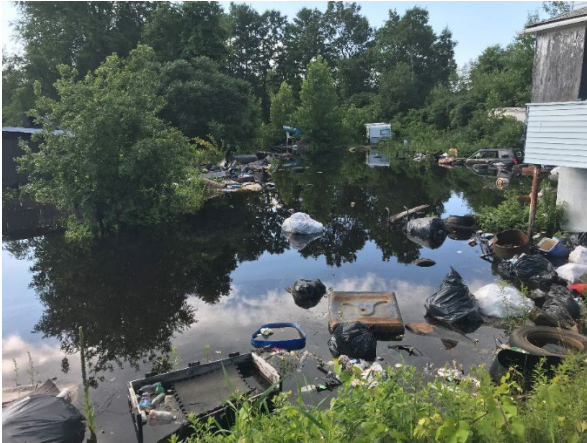
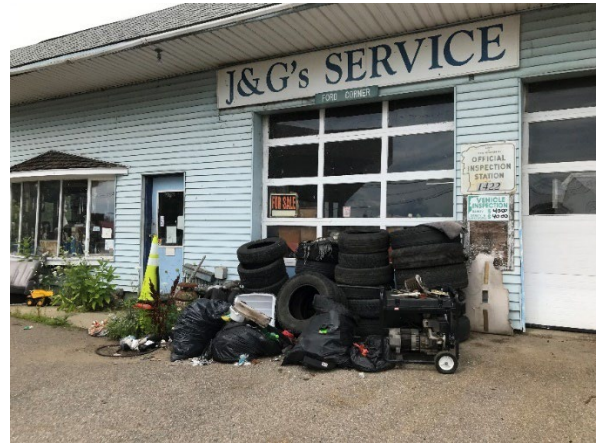
These photos show the 2021 flood and general state of disrepair and abandonment prior to the town taking the property by tax deed.
