Rust Pond

North Inlet and Route 28 Boat Launch Subwatershed Assessment

1. INTRODUCTION

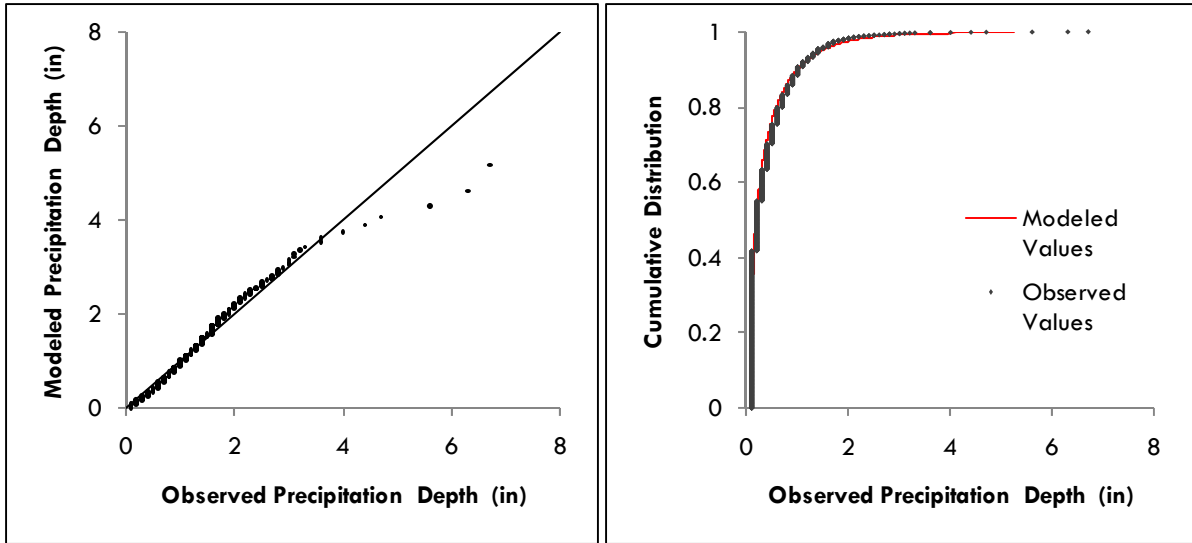
Where γ is the incomplete gamma function and Γ is the gamma function, and α and β are shape and scale parameters, respectively. The distribution of precipitation depths was fit to a gamma distribution with $\alpha = 0.39$ and $\beta = 0.88$. Figures 2.1 and 2.2 show the observed and modeled data plotted on a line with slope 1:1, and the observed and modeled cumulative distribution. The modeled and observed data had a correlation coefficient of 0.99.

Figures 2.1, 2.2. Observed vs. Modeled precipitation event depths, and observed and modeled precipitation event depth CDF. (Note that the events greater than 4 inches were not well described by the model. This represents 0.3% of the observed precipitation events).

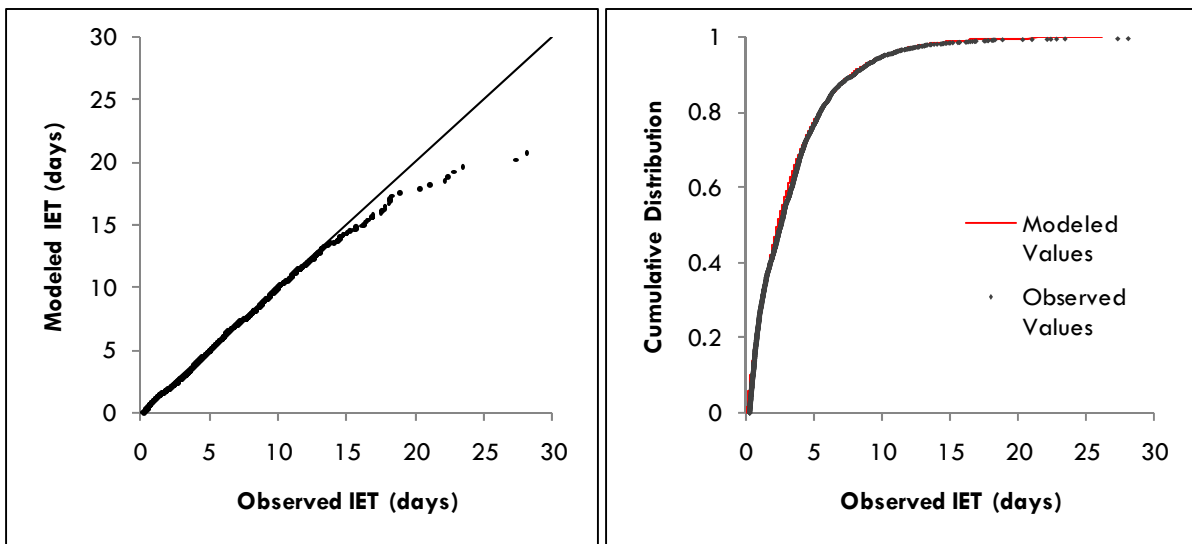
The IET data were fit to an exponential distribution with $\lambda=0.3$. Figures 2.3 and 2.4 show the observed and modeled data plotted on a line with slope 1:1, and the observed and modeled cumulative distribution. The modeled and observed data had a correlation coefficient of 0.96.

Figures 2.3, 2.4. Observed vs. Modeled IETs, and observed and IET CDF. (Note that the events greater than 18 days were not well described by the model. This represents 0.5% of the observed IETs).

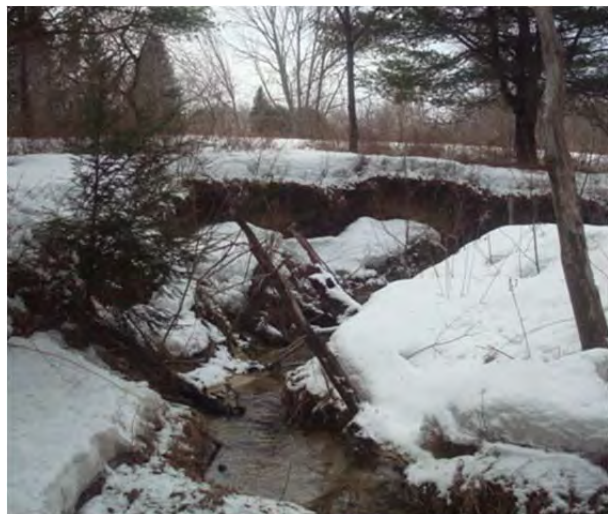
Impaired Streambank Erosion

A stretch of the North Inlet tributary that was adjacent to a former beaver dam contains actively eroding banks. The additional erosion caused by these bank segments is addressed using the “Impaired Streambank” tool included with the USEPA STEP-L (Spreadsheet Tool for Estimating Pollutant Loads) worksheet. The Impaired Streambank load was estimated to be 0.43 tons/yr, assuming a gully approximately 6 feet deep, 10 feet wide, and 40 feet long, experiencing a “severe” rate of lateral recession (for comparison, this load is 17 times higher than the typical streambank erosion when normalized for length). This load was added to the results of the Monte Carlo Analyses for the current and buildout conditions.

A known recent source of sediment contributing to the North Inlet delta is the severely eroded streambank adjacent to the beaver dam. As stated previously, continued erosion from this bank is estimated at approximately 0.43 tons/yr. However, our understanding is that the erosion that led to the current state of the streambank may have occurred rapidly and contributed a load in the past. Using the STEP-L Gully Erosion tool and the dimensions provided above, and assuming that the gully formed over 5 years, the annual TSS load from this source in the past is estimated to be 8.4 tons/yr. This source could have contributed approximately 26 cubic yards of sediment to the delta over the 5 years that it formed. This would account for approximately 3% of the estimated sediment delta volume of 920 cubic yards.

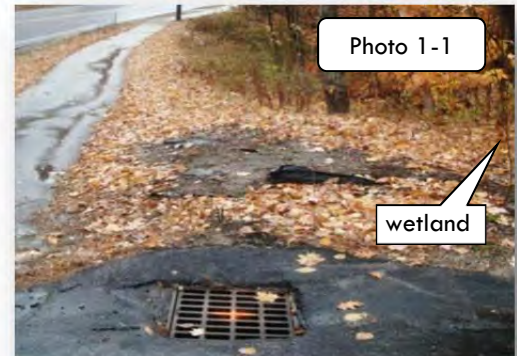
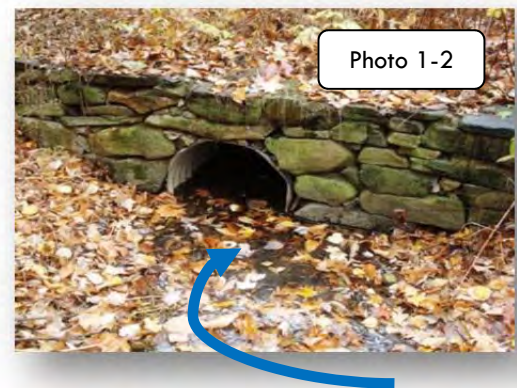
A series of catch basins collect runoff from the intersection of Abenaukee Drive and Route 28. These catch basins and drain pipes include newer structures starting just south of the 569 South Main Street driveway, on the west side of Route 28. One of the catch basin in this series (Photo 1-1) collects runoff from the area of Abenaukee Drive and Route 28 (drainage area for the proposed BMP). In addition to this storm drain system, a wetland west of Route 28 also drains through the culvert under Route 28 (Photo 1-2). The culvert discharges to Rust Pond via an unstabilized channel (Photo 1-3).

- Install a flow splitter in the catch which would divert low flows to a hydrodynamic separator and high flows would discharge directly to the culvert and ultimately to Rust Pond. The hydrodynamic separator would discharge to a bioretention cell, approximately 20 feet long by 5 feet wide, and provide treatment (i.e., settling of suspended sediments). Photo 1-4 is a rendering of the area surrounding the catch basin. Image 1-5 is a cross section of a typical bioretention cell.
- Stabilize the existing culvert outfall (Photo 1-3) with an energy-dissipation device and stabilize the existing 30-foot of drainage channel with natural stone.
