**Balsams Resort Snowmelt Analysis
Letter Report by Horizons Engineering
July 14, 2015**

***The Snowmelt Report (6/23/98)*
Joan Carlson and Stephen Fay
White Mountain National Forest
Laconia, New Hampshire**

Subject: Balsams Resort –WQC 2014-404P-001 Revised Snowmelt Runoff Analysis

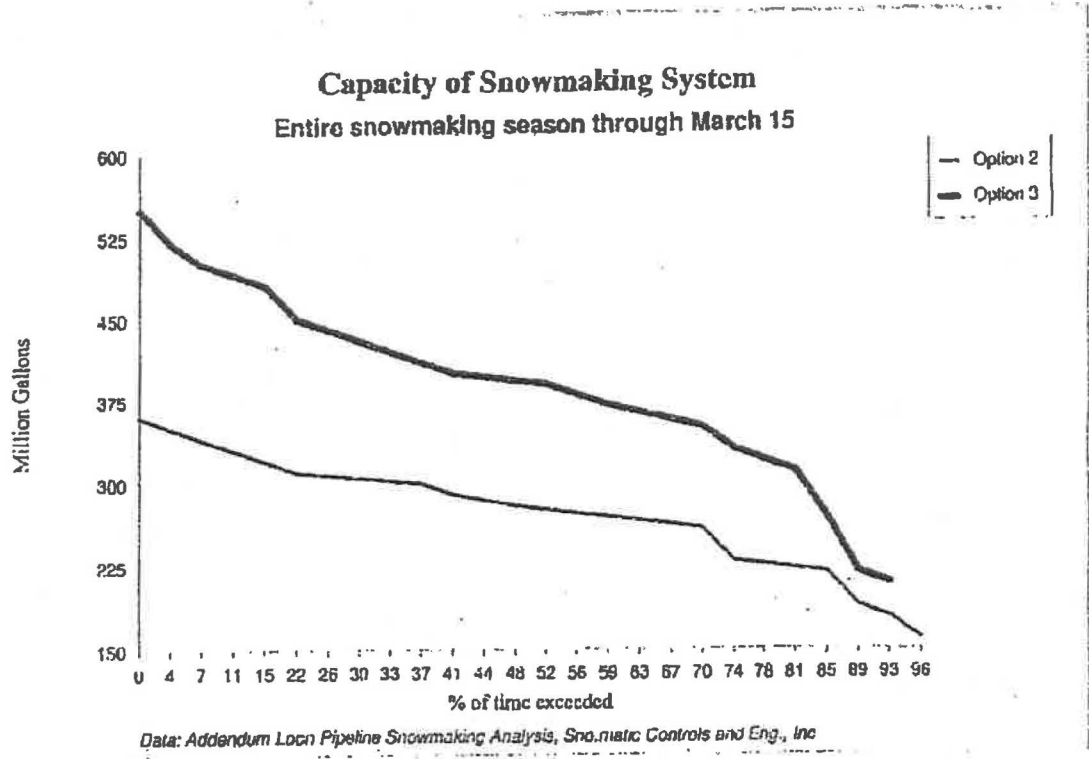
The attached figure shows the results of the model contained in the water demand study addendum. The study concluded that the Baseline system has the capacity to pump at least 250.4 MGAL by the end of the snowmaking season (March 15) in about 74 percent of the years and the Existing system has the capacity to pump at least 250.4 MGAL by March 15 in about 89 percent of the years. Under ideal snowmaking/river flow conditions, the Baseline system has a maximum capacity, constrained only by physical parameters of infrastructure, to pump 369.6 MGAL. The Existing system has a maximum capacity of 559.1 MGAL. Statistically, this volume could only be pumped in 4 percent of the years. In terms of water depth, 369.6 MGAL and 559 MGAL over 220.1 acres equate to 61.8 and 93.5 inches of water respectively.

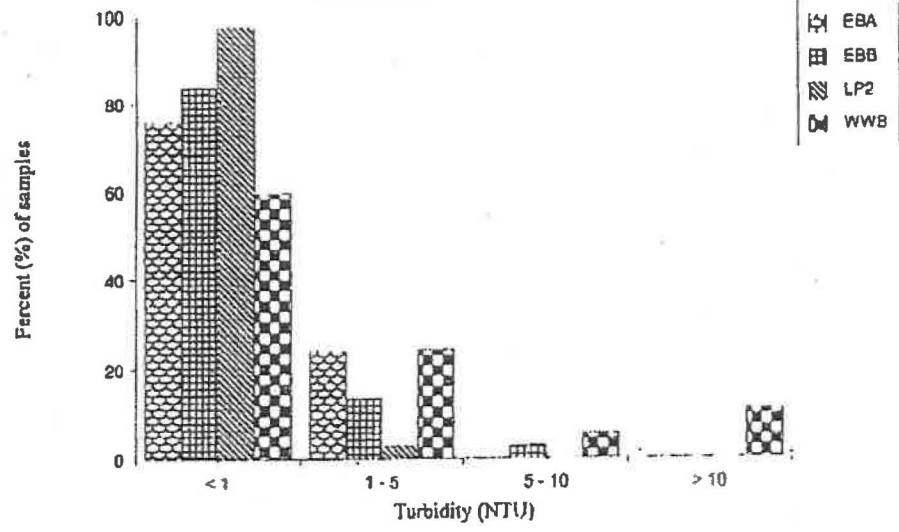
Turbidity during 1996 snowmelt season Loon Mountain Ski Area

Daily turbidity measurements were taken at Loon during the snowmelt season (mid-April through mid-May) in 1996 and again in 1998 (14). Sampling points included the East Branch Pemigewasset River above and below Loon, Loon Pond Brook (at the road crossing), and three smaller drainages: "WWB" which drains the lower slopes and maintenance shed area, and "GG1" and "GG2" which drain the South Mountain area. The attached charts summarize the results of this monitoring. In general, turbidity readings in the East Branch Pemigewasset River and Loon Pond Brook were less than 1 NTU a majority of the time. There were no turbidity readings in these streams greater than 10 NTU, the Class B water quality standard for turbidity. On those occasions when turbidity in the East Branch Pemigewasset River was greater than 1, the upstream station (EBA) had equal or greater turbidity than the downstream station (EBB), which indicates that Loon was not the source of the turbidity.

majority of the turbidity readings in "WWB" were less than 10 NTU. "WWB" had several readings above 10 NTU, primarily in 1996. This stream has known turbidity problems, due to the disturbed area on private land near the Governor Adams Lodge (10, 15). Loon has been working on controlling this situation, through construction of settling basins and erosion control measures. This turbidity is more a function of the disturbed nature of the area and not the volume of water passing through it.
